**MINERALS PROGRAM INSPECTION REPORT**  
**PHONE: (303) 866-3567**

<b>MINE NAME:</b> Revenue Mine	<b>MINE/PROSPECTING ID#:</b> M-2012-032	<b>MINERAL:</b> Lead, silver and gold	<b>COUNTY:</b> Ouray
<b>INSPECTION TYPE:</b> Monitoring	<b>WEATHER:</b> Clear	<b>INSP. DATE:</b> November 1, 2023	<b>INSP. TIME:</b> 10:30
<b>OPERATOR:</b> Ouray Silver Mines Inc.	<b>OPERATOR REPRESENTATIVE:</b> CJ Dickerson	<b>TYPE OF OPERATION:</b> 112d-1 - Designated Mining Operation	
<b>REASON FOR INSPECTION:</b> Priority	<b>BOND CALCULATION TYPE:</b> None	<b>BOND AMOUNT:</b> \$0.00	
<b>DATE OF COMPLAINT:</b> NA	<b>POST INSP. CONTACTS:</b> DRMS	<b>JOINT INSP. AGENCY:</b> None	
<b>INSPECTOR(S):</b> Amy Yeldell	<b>INSPECTOR'S SIGNATURE:</b>

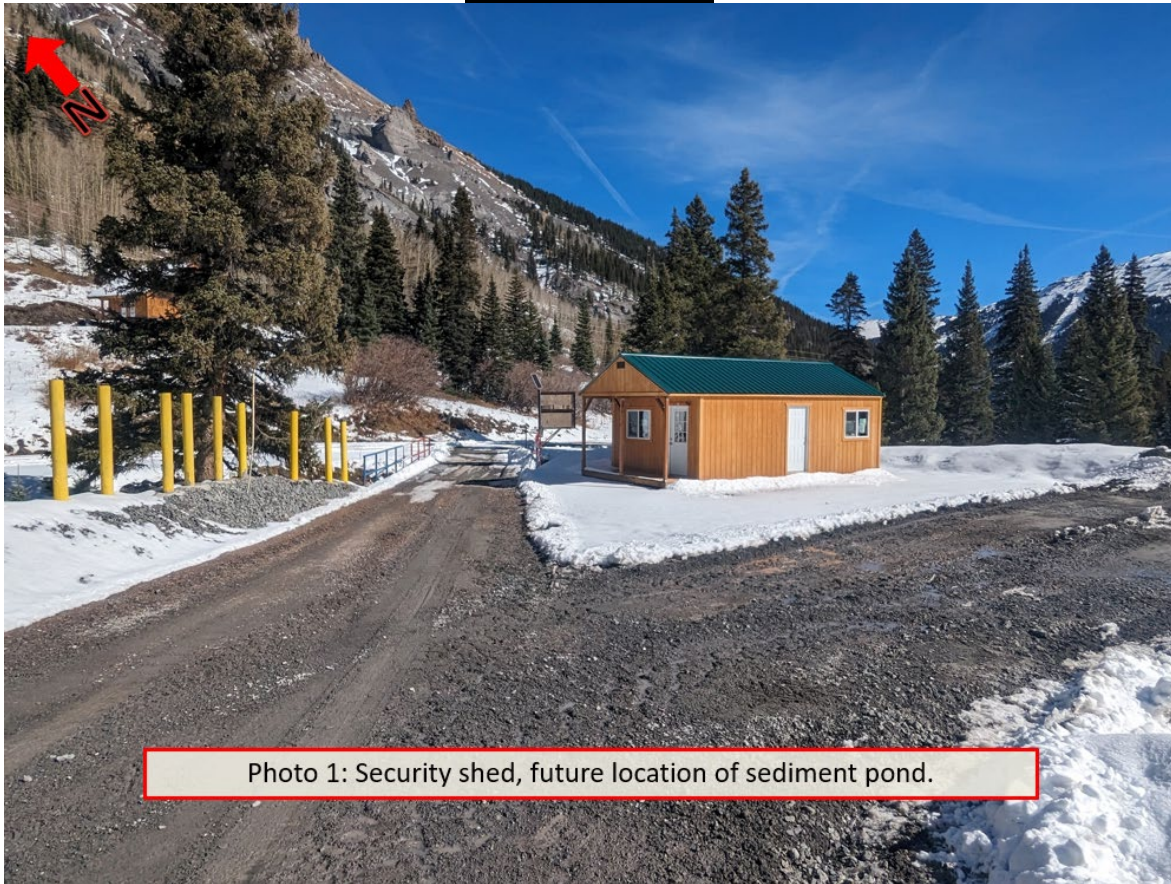
In order to install the sediment pond the security shed will need to be moved. Mr. Dickerson was unsure if they will move and reuse the building or completely remove it from site (Photo One). Currently the Operator is trying to coordinate with the engineer who designed the pond to be available to assist with construction and certification of the sediment pond. No work related to this project was observed.

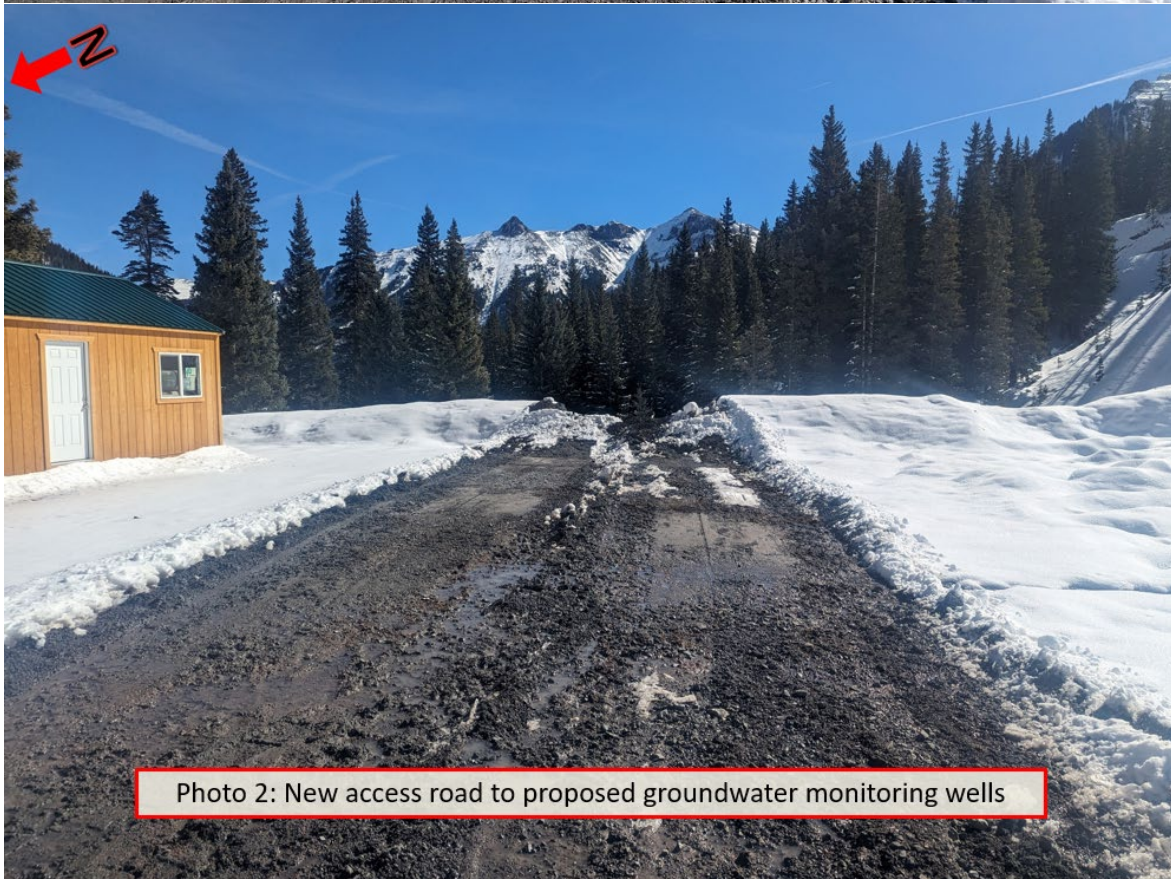
There is a new path dozed down to the east from the security shed towards Sneffels Creek (Photo Two). This access road was installed in preparation for installation of the groundwater monitoring wells required under AM-2. This area has previously been affected so no topsoil was stripped. The area was bladed flat into a small switch back access road (Photo Three). Given the condition of CR 26, Mr. Dickerson was unsure if they could get a drill rig to the site before winter sets in. A safety berm was replaced along the road to the proposed well bores until needed for access.

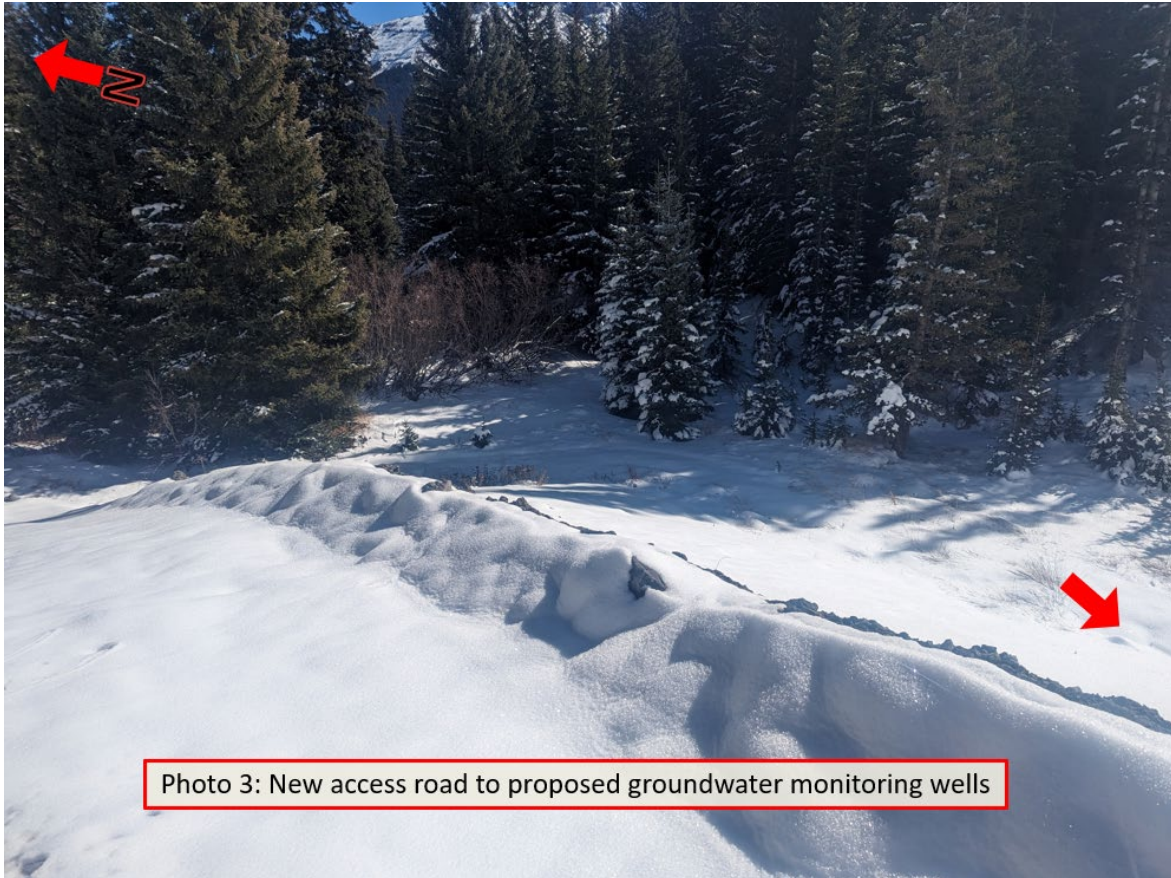
Photo 3: New access road to proposed groundwater monitoring wells

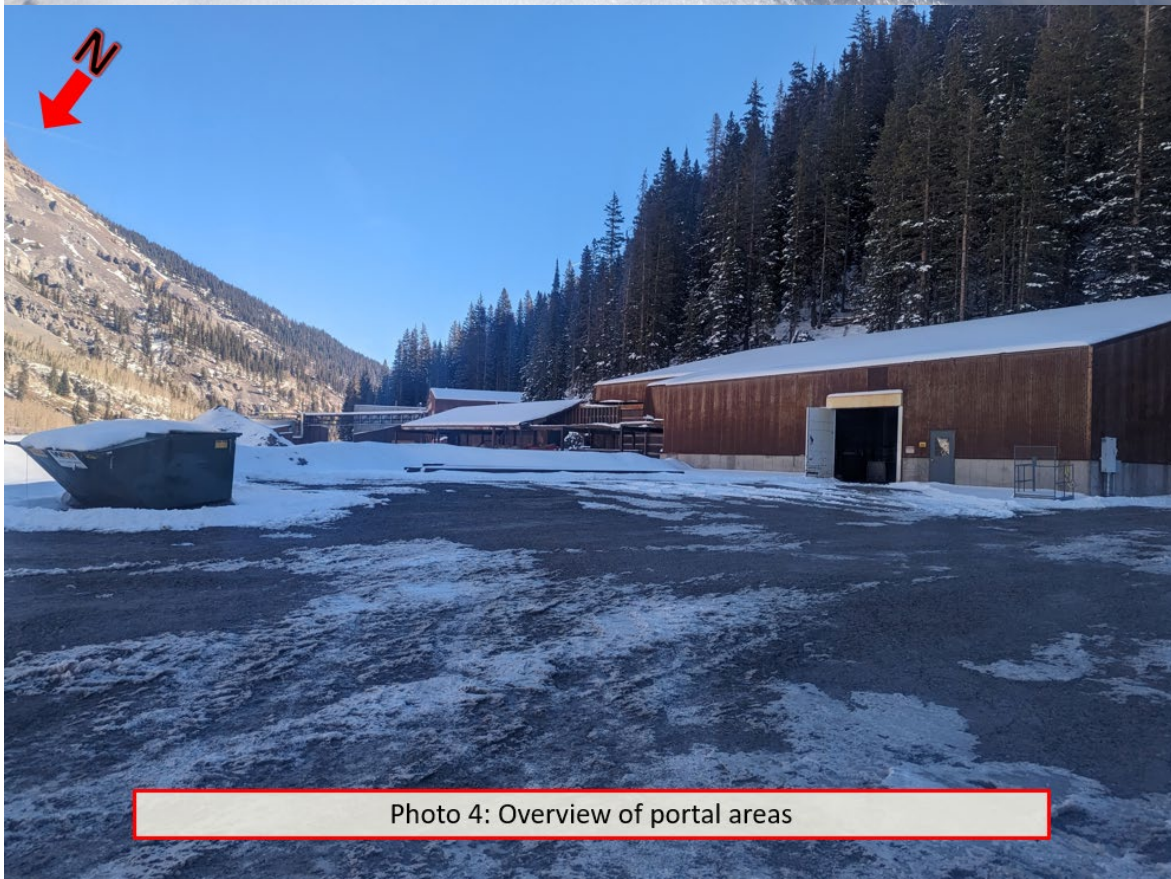
The main portal area was in excellent condition and free from excessive trash and debris (Photo Four and Five). All storm water controls, diversion structures and avalanche deflection structures were observed to be in good condition. No evidence of significant erosion or sedimentation was noted. The out slopes of the pad area and access road appeared stable, and no signs of slumping or failure were observed.

Photo 4: Overview of portal areas

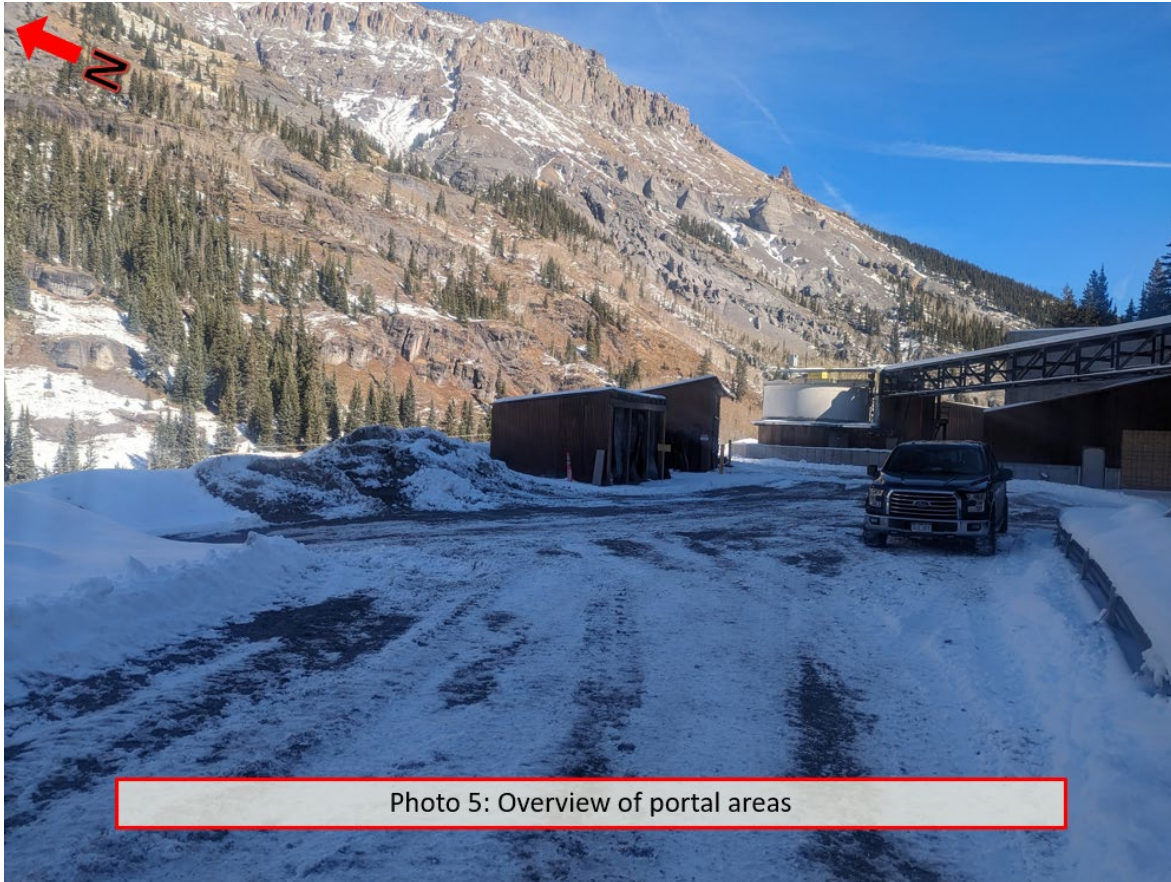
Photo 5: Overview of portal areas

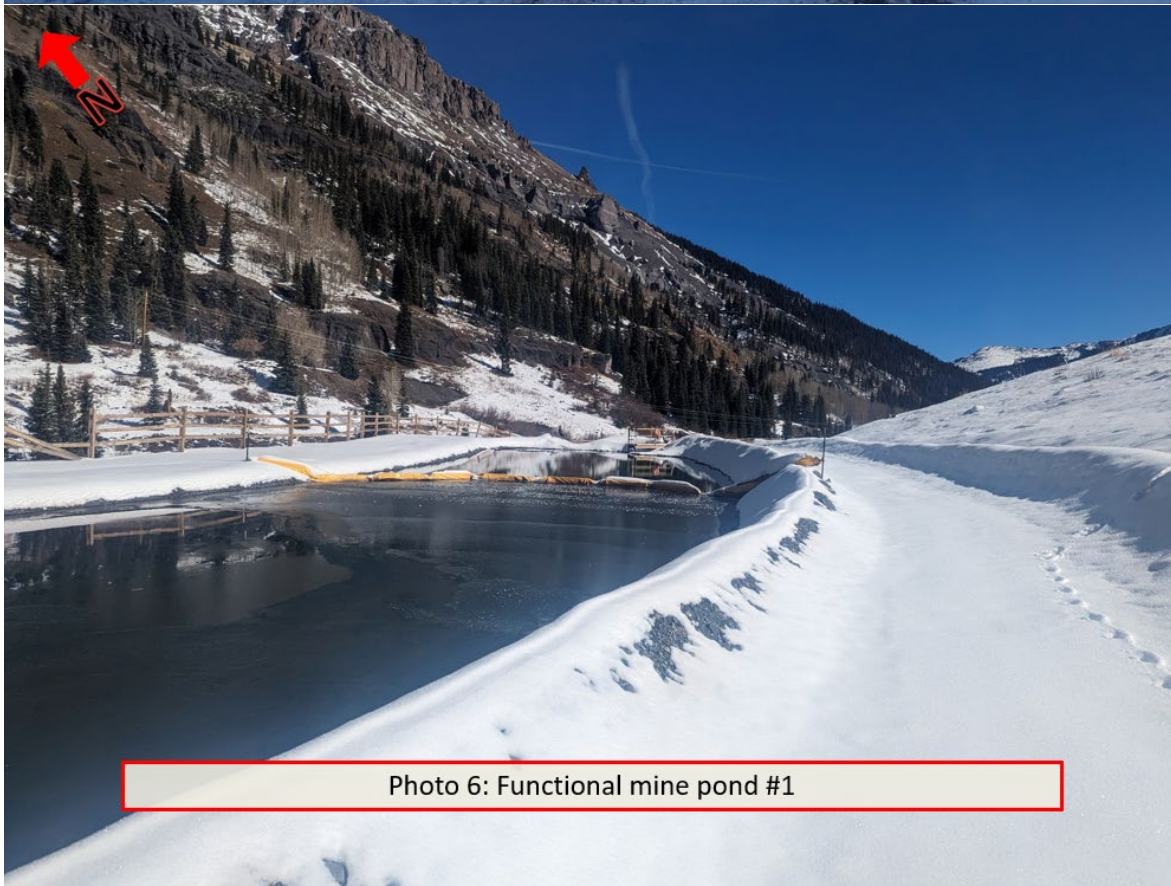
All water treatment ponds appeared to be in good shape. The ponds were beginning to freeze over with the outlet/inlet structures mostly open water. The baffles (floating curtain) in pond #1 remain in working order (Photo Six). No apparent failures to the passive water treatment system were observed.

Photo 6: Functional mine pond #1

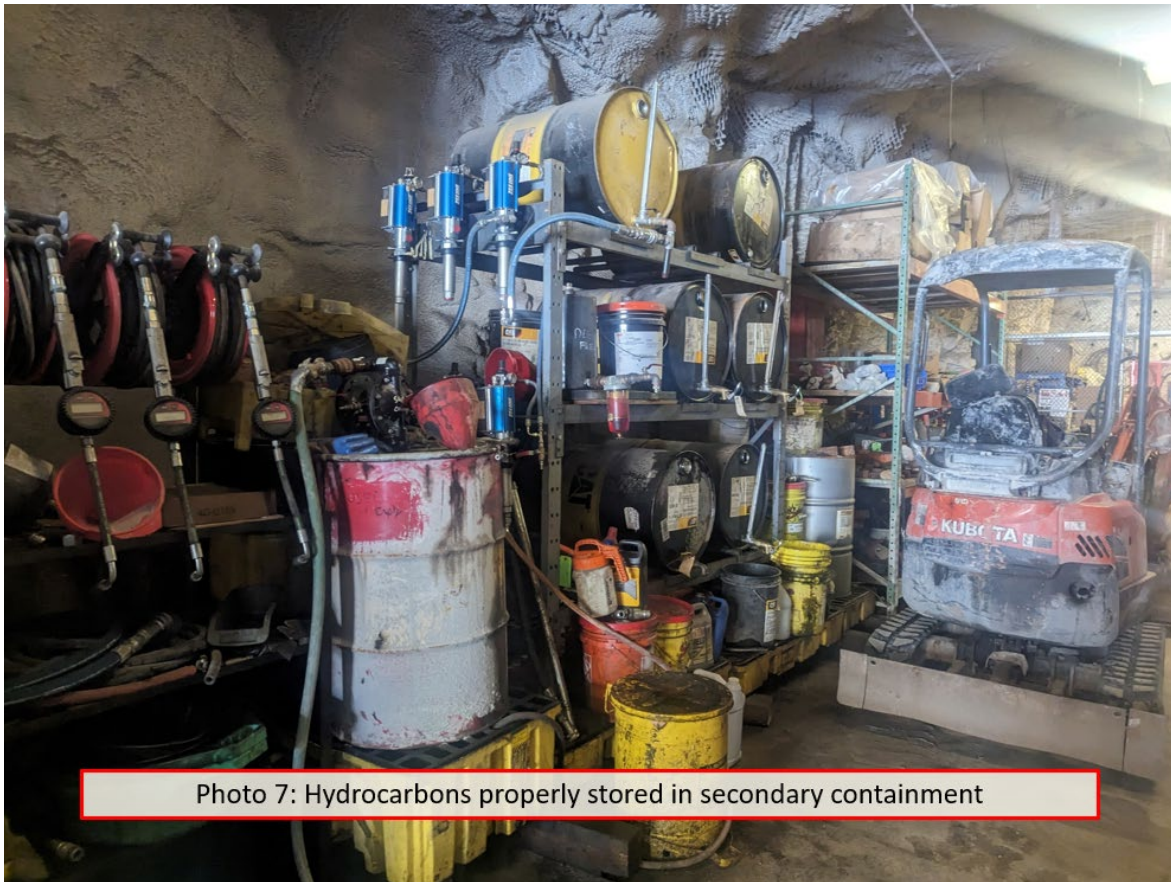
All heavy equipment remains on site and primarily stored on the Revenue TSF. A few pieces of rented equipment have been mobilized to assist in maintaining the site while in TC. Generally, only one person is on site working to keep up on misc. maintenance items. All oil, fuel and other hydrocarbons were neatly stored in various secondary containments throughout the mine site (Photos Seven and Nine). All the buildings appeared to be neat and well organized. Buildings appear to be in a similar condition to previous inspections when the site was active (Photos Eight and Ten).

Photo 7: Hydrocarbons properly stored in secondary containment

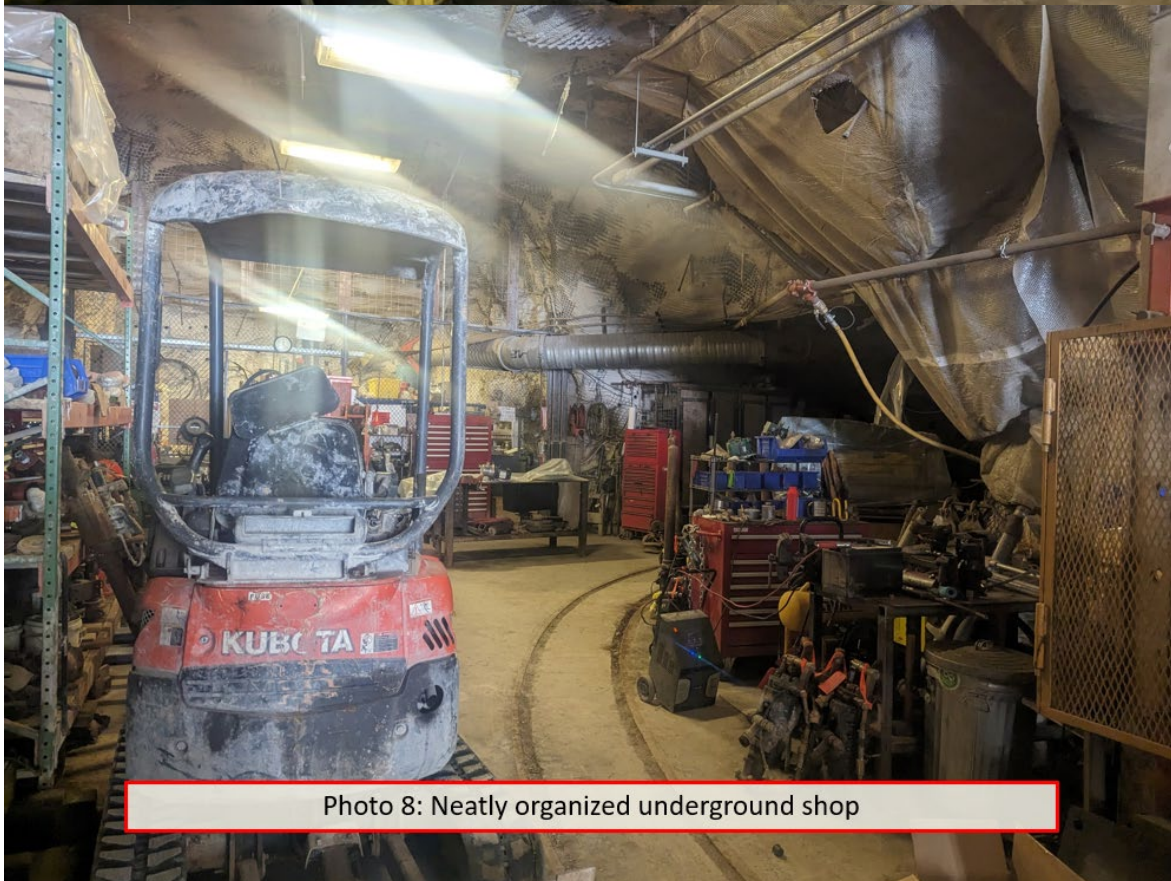
Photo 8: Neatly organized underground shop

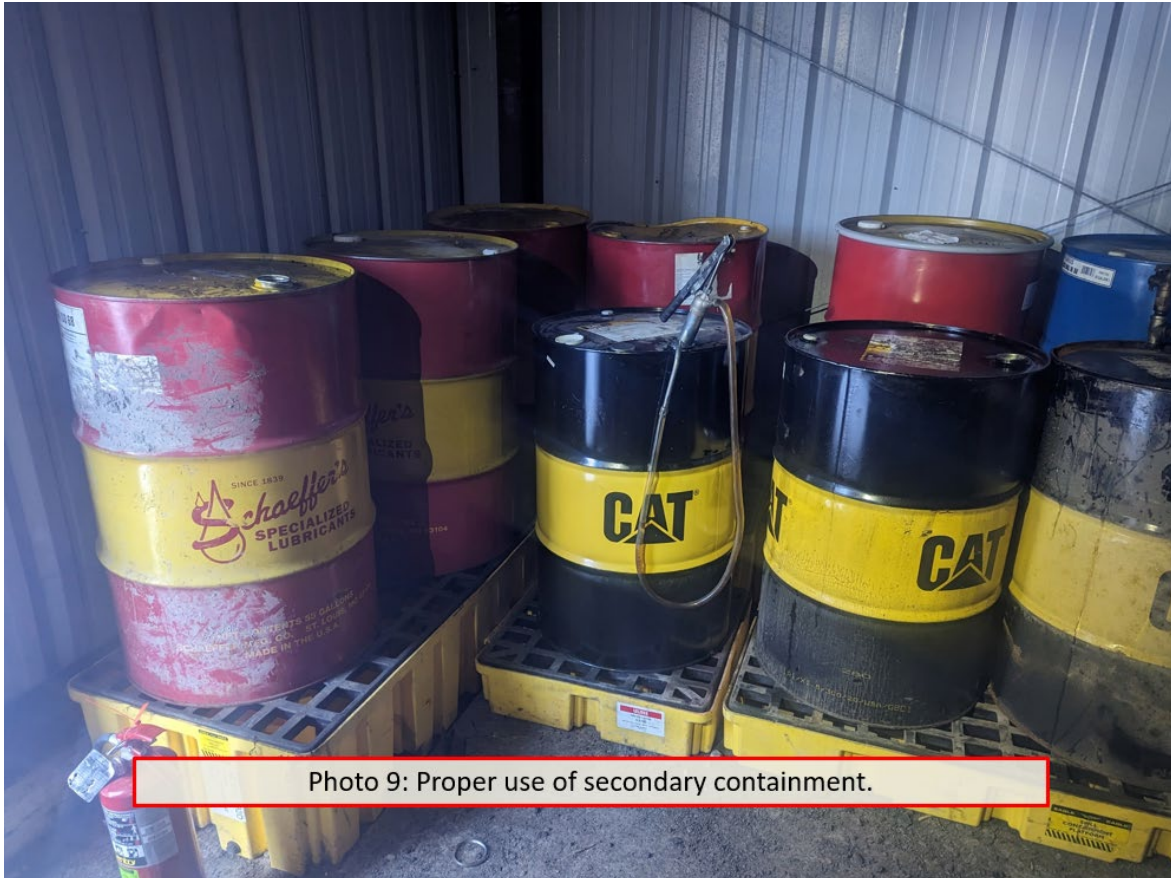
Photo 9: Proper use of secondary containment.

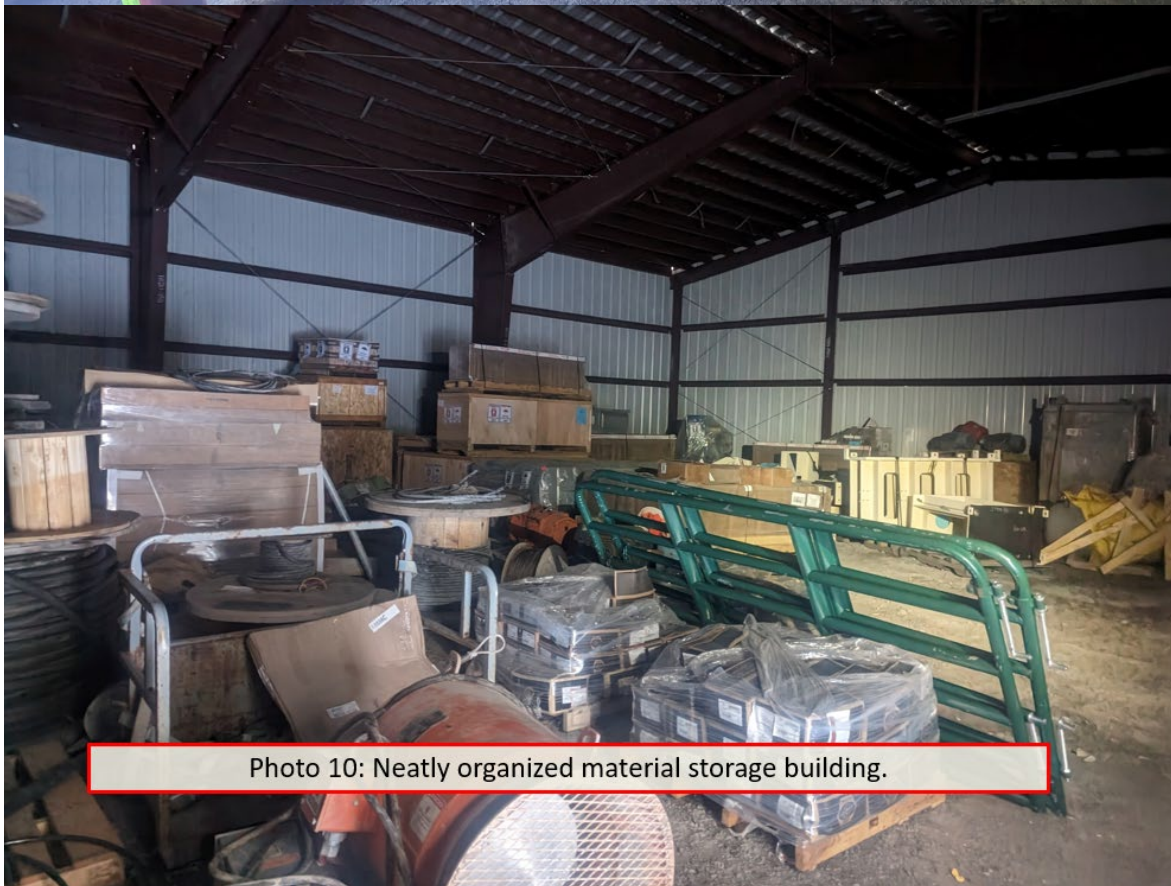
Photo 10: Neatly organized material storage building.
