## MINERALS PROGRAM INSPECTION REPORT

<b>MINE NAME:</b> Pikeview Quarry	<b>MINE/PROSPECTING ID#:</b> M-1977-211	<b>MINERAL:</b> Limestone (general), granite gneiss and do	<b>COUNTY:</b> El Paso
<b>INSPECTION TYPE:</b> Monitoring	<b>WEATHER:</b> Clear	<b>INSP. DATE:</b> October 25, 2023	<b>INSP. TIME:</b> 09:30
<b>OPERATOR:</b> Riverbend Industries Inc.	<b>OPERATOR REPRESENTATIVE:</b> Jerry Schnabel	<b>TYPE OF OPERATION:</b> 112c - Construction Regular Operation	
<b>REASON FOR INSPECTION:</b> Normal I&E Program	<b>BOND CALCULATION TYPE:</b>	<b>BOND AMOUNT:</b> \$13,389,784.00	
<b>DATE OF COMPLAINT:</b> NA	<b>POST INSP. CONTACTS:</b> None	<b>JOINT INSP. AGENCY:</b> U.S.Forest Service	
<b>INSPECTOR(S):</b> Timothy Cazier, P.E.	<b>INSPECTOR'S SIGNATURE:</b>

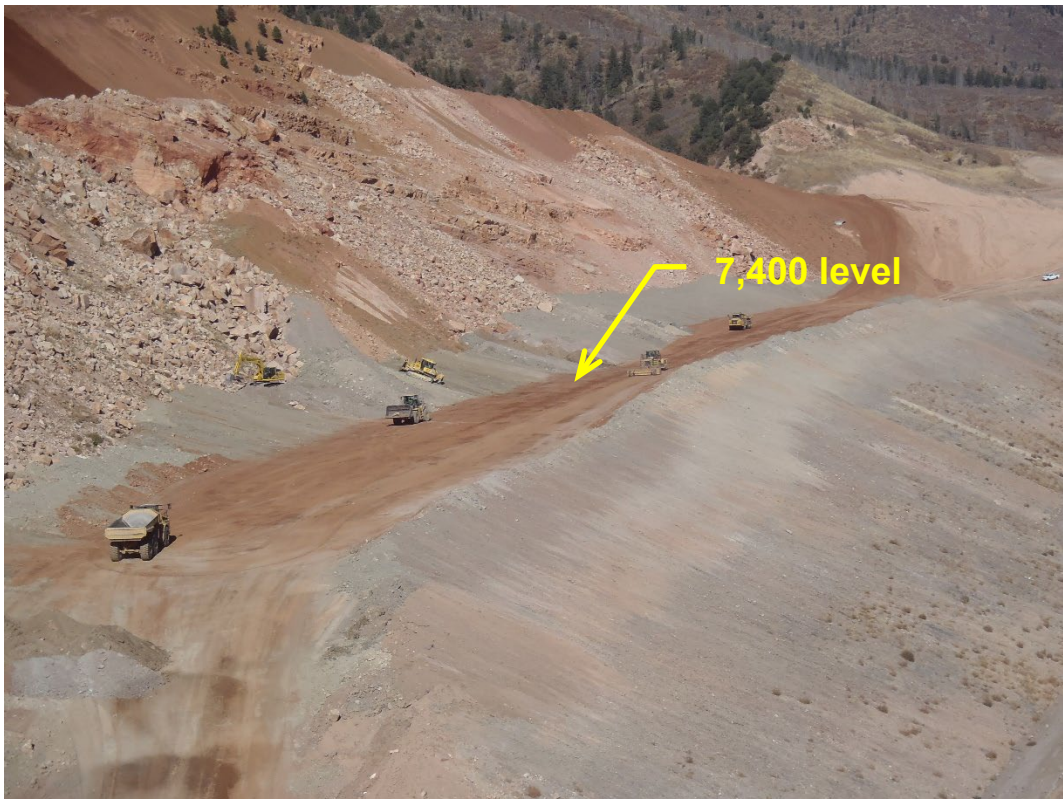
**Backfilling and Grading:** Buttress backfill was being placed at about the 7,400 foot level (**Photo 1**). A D9 dozer was observed pushing material down from above the slide area (**Photo 2**) to construct an access route for near future scraper work. The contractor was also able to access the small hose sized boulder at the top of the south end of the slide. An excavator had been used to removed weathered material from the top of the large rock, thereby significantly reducing its size (**Photo 3** – compare with **Photo 3A** from the April 13, 2023 inspection).

Photo 1. Buttress backfill at ~7400 foot level (looking north).

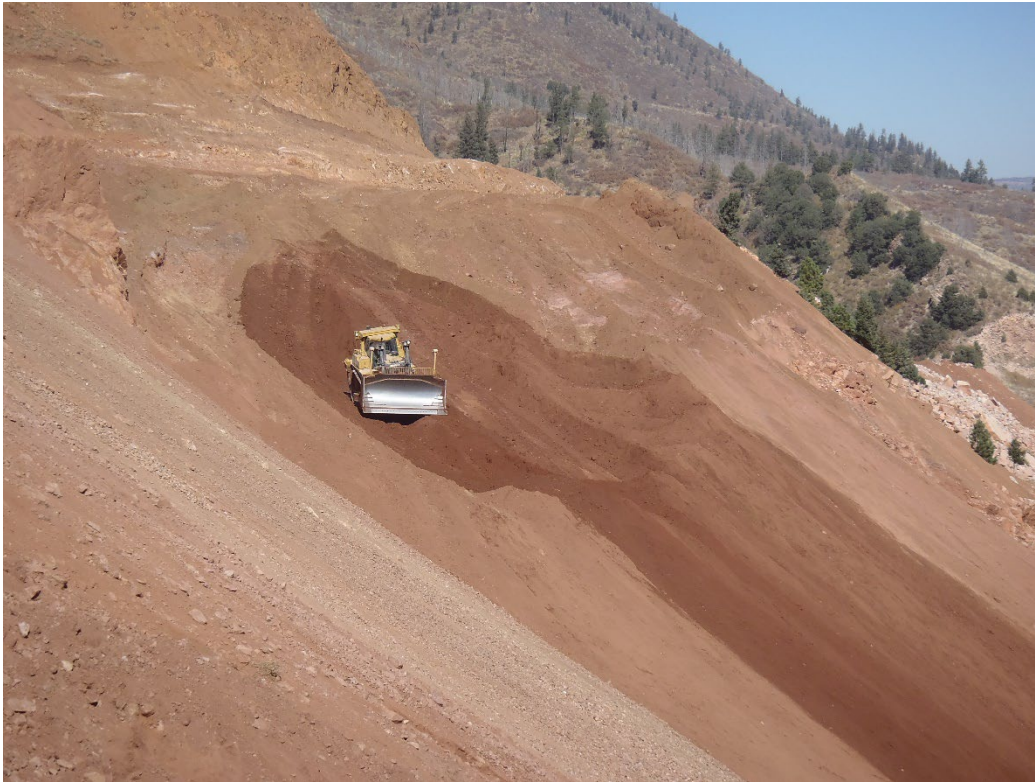
Photo 2. D9 dozer constructing upper access road (looking north).

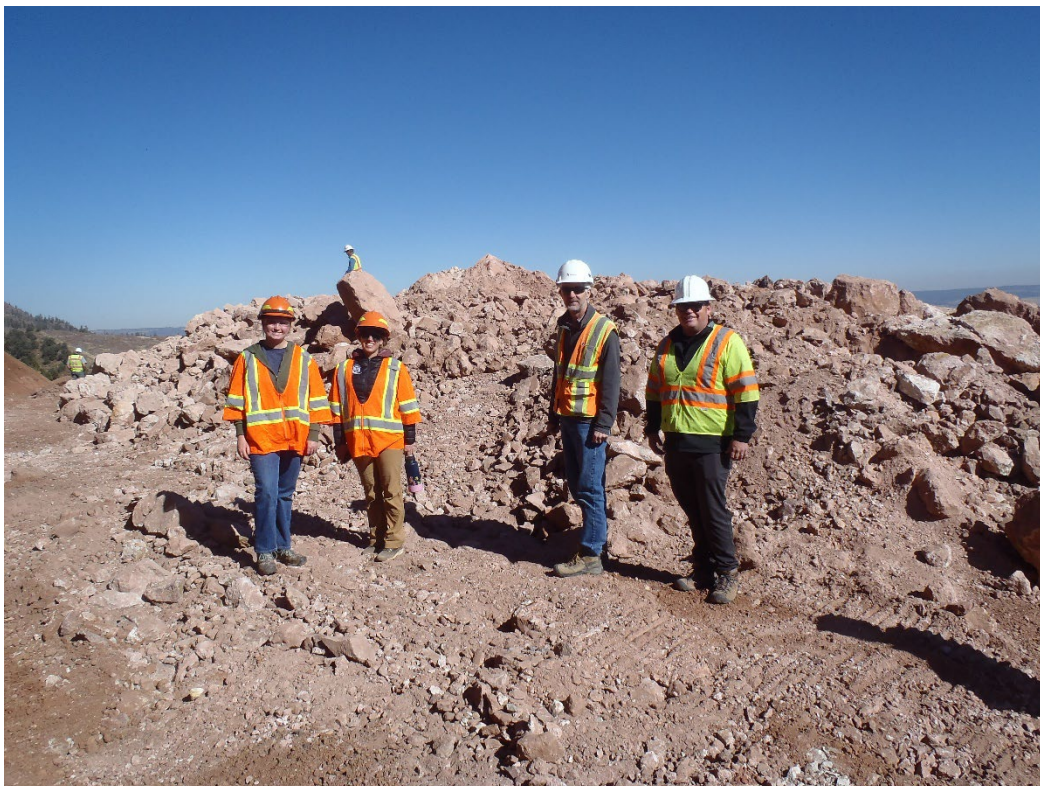
Photo 3. Rubblized/removed top portion of large boulder (upper south end of slide area, west side).

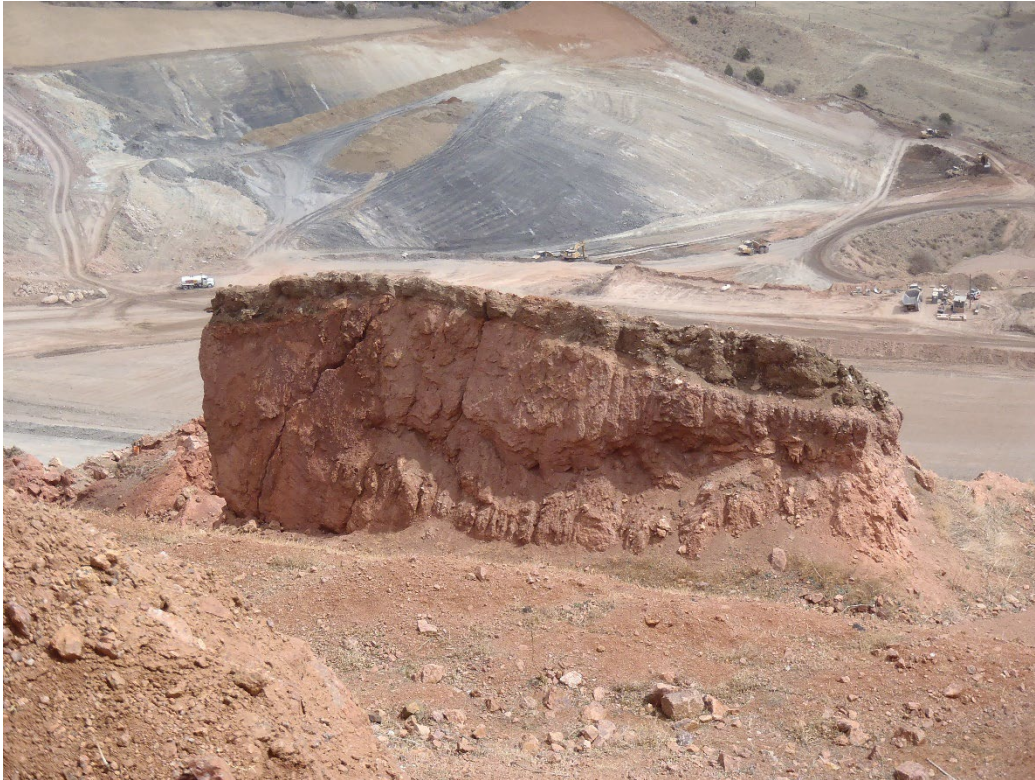
Photo 3A. Large boulder before upper removal (upper south end of slide area, west side; 4/13/23).

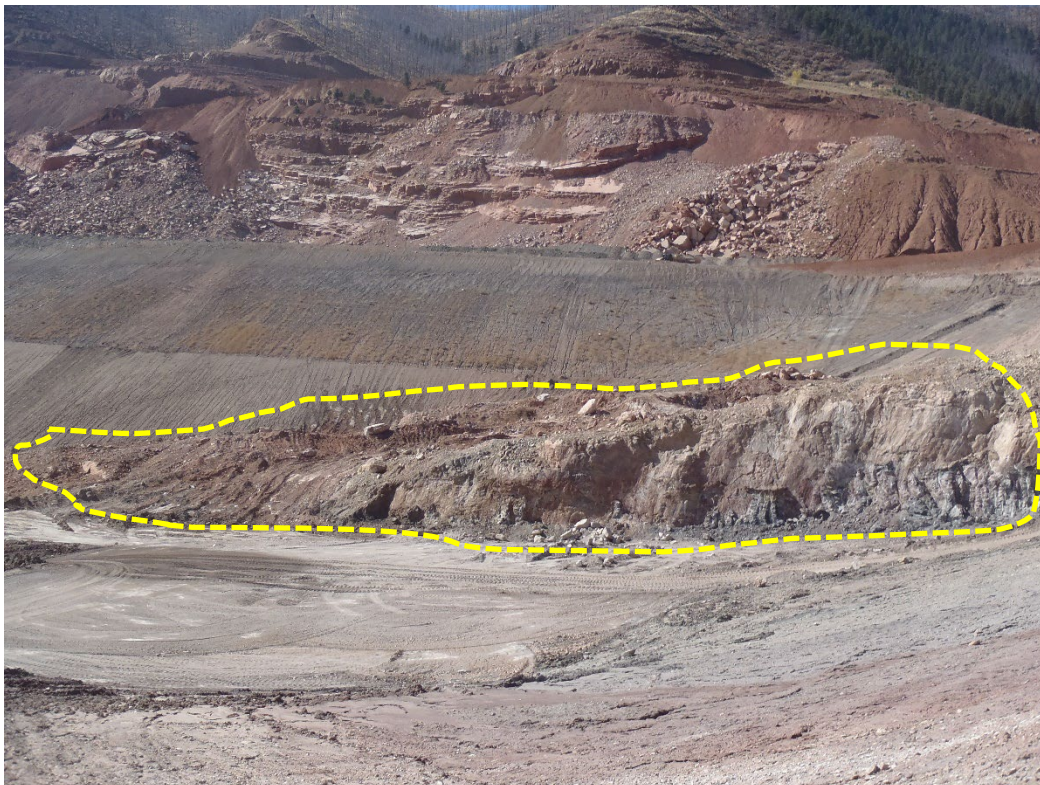
**Explosives:** A ridge of non-rippable quartzite material, referred to as the “dragon back” (**Photo 4**) on the north end of the backfill area was discussed as providing a challenge to the approved grading plan. Site representatives stated options being considered included blasting or re-routing the north drainage channel. The DRMS reminded them that [if blasting is selected, technical revision to update the blasting plan will need to be submitted to the DRMS for approval prior to initiating blasting activities.](#)

Photo 4. Non-rippable "dragon back" (north end, looking SW).

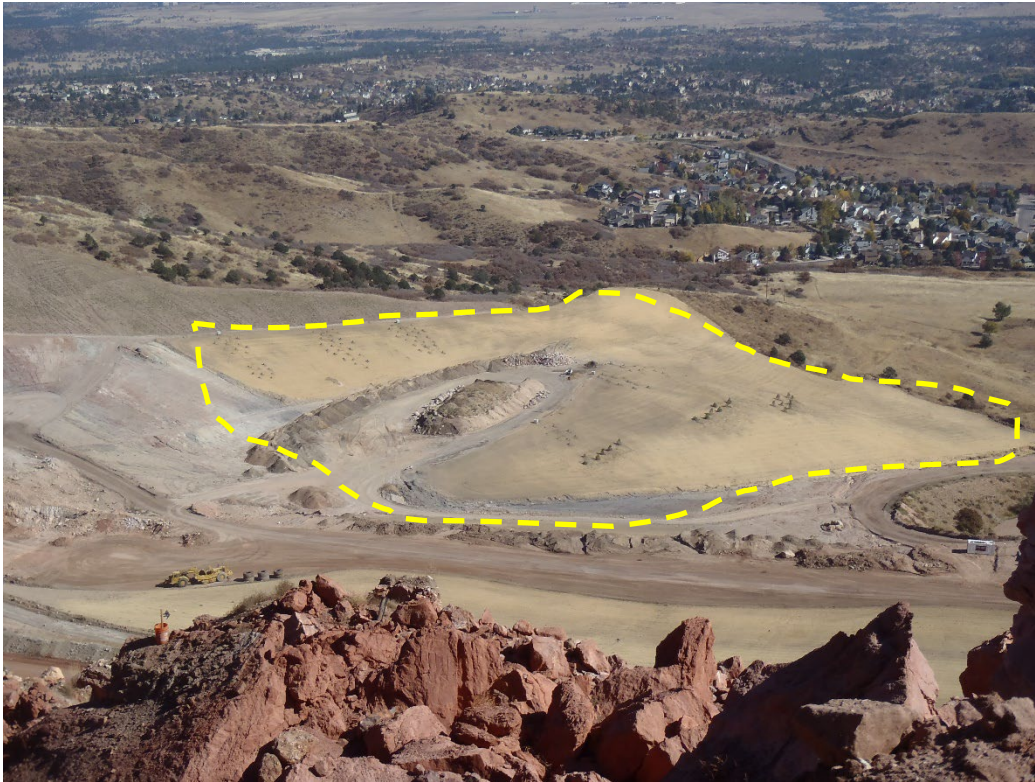
Reclamation Success: Topsoiling and seeding had been completed in most of the former shop area (see **Photo 5**).

Photo 5. View of topsoiled and seeded former shop area (looking NE).

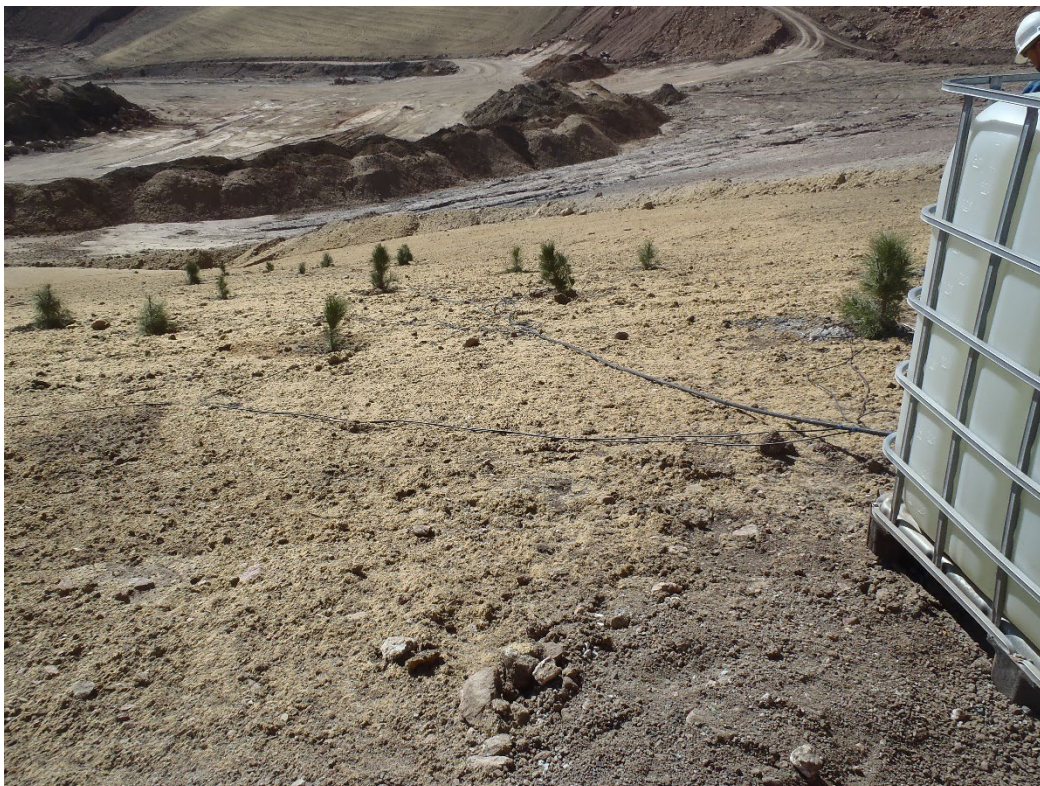
Revegetation: Some conifers had been planted (see **Photo 6**) in the former shop area and drip irrigation systems were in place and functioning for the trees (see **Photo 7**). Evidence of the removal of the Myrtle Spurge (a List A noxious weed) was observed. However, some smaller Myrtle spurge plants were observed emerging near areas that had been cleared.

Photo 6. Newly planted conifers and typical irrigation system (former shop area).

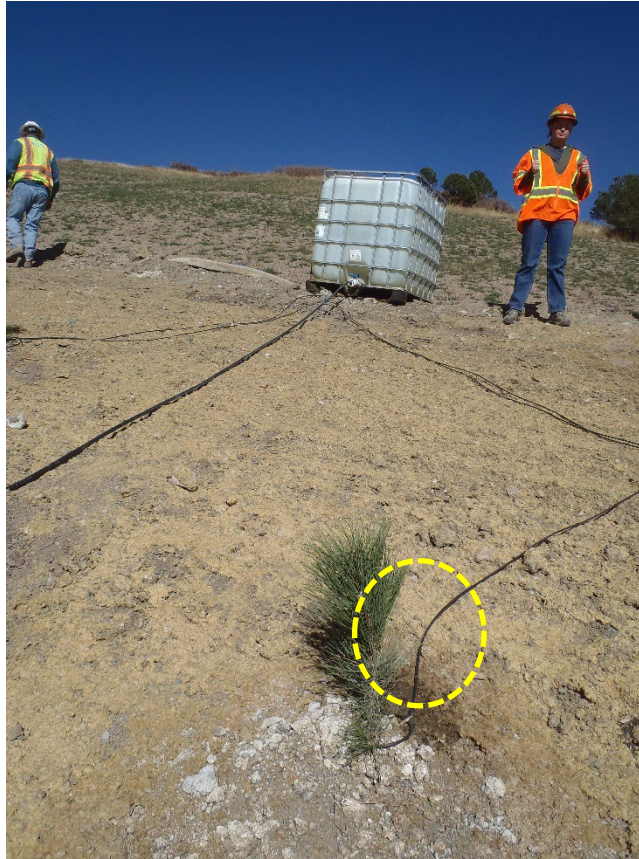
Photo 7. Functioning irrigation system (note wet soil - circled).
