## Inspection report

**PERMIT INFORMATION**

<b>Permit Number:</b> C-1981-028 <b>Mine Name:</b> Keenesburg Strip Mine <b>Operator:</b> Coors Energy Company <b>Operator Address:</b> Mr. Ben Moline P.O. Box 4030 Golden, CO 80402	<b>County:</b> Weld <b>Operation Type:</b> Surface <b>Permit Status:</b> Permanent Cessation <b>Ownership:</b> Private
	<b>Operator Representative Present:</b>  None
<b>Operator Representative Signature: (Field Issuance Only)</b>

**INSPECTION INFORMATION**

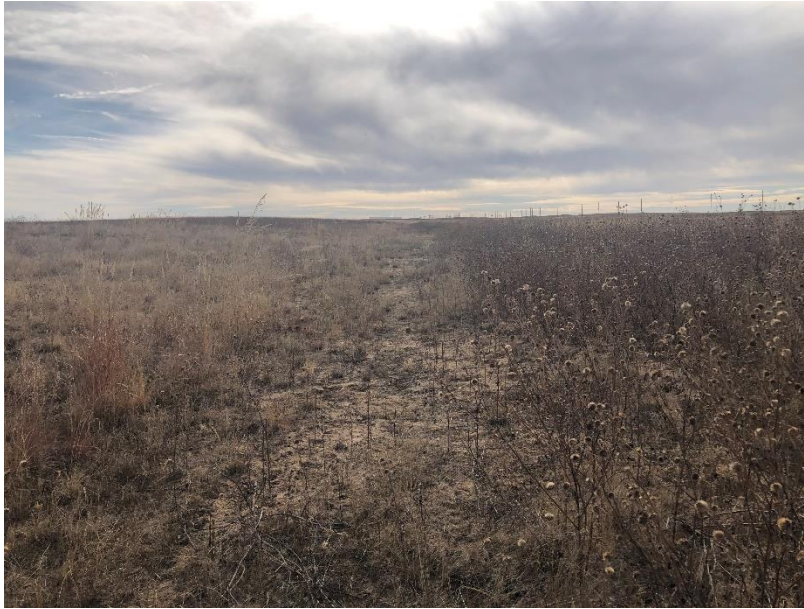
**West side of site, looking south, with Area 44 on the left and undisturbed area on the right**

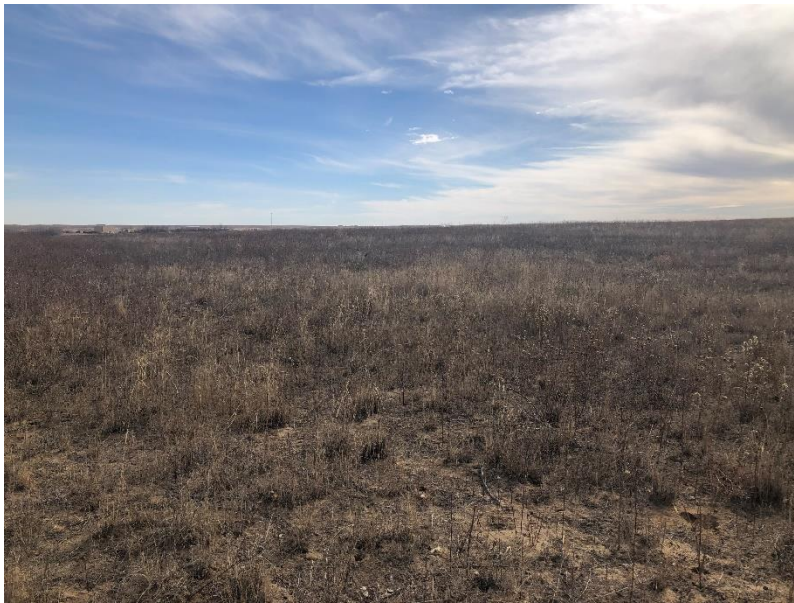
**Looking southeast from the northwest corner of Area 43  
(northwest corner of all of disturbance in the permit)**

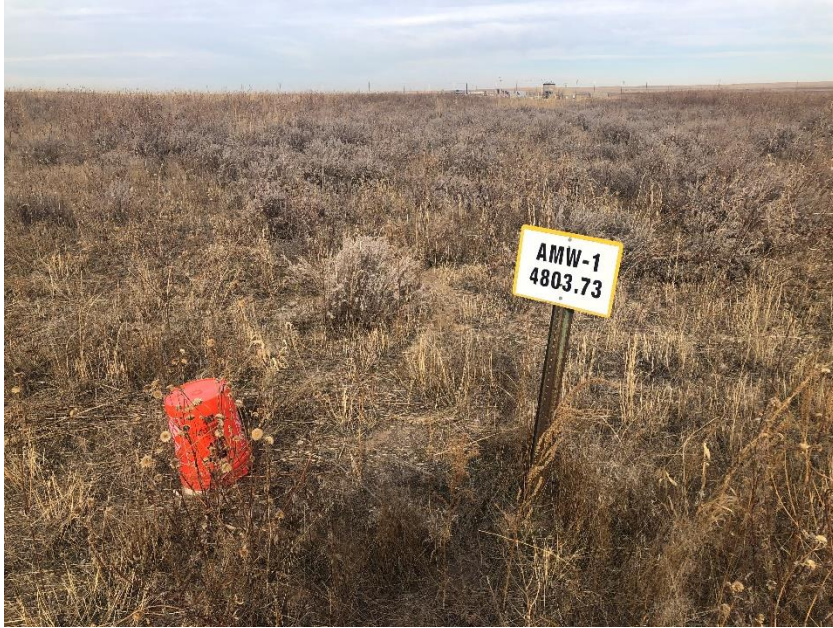
Monitoring wells were in place including AMW-1.

**Monitoring well in Area 43**

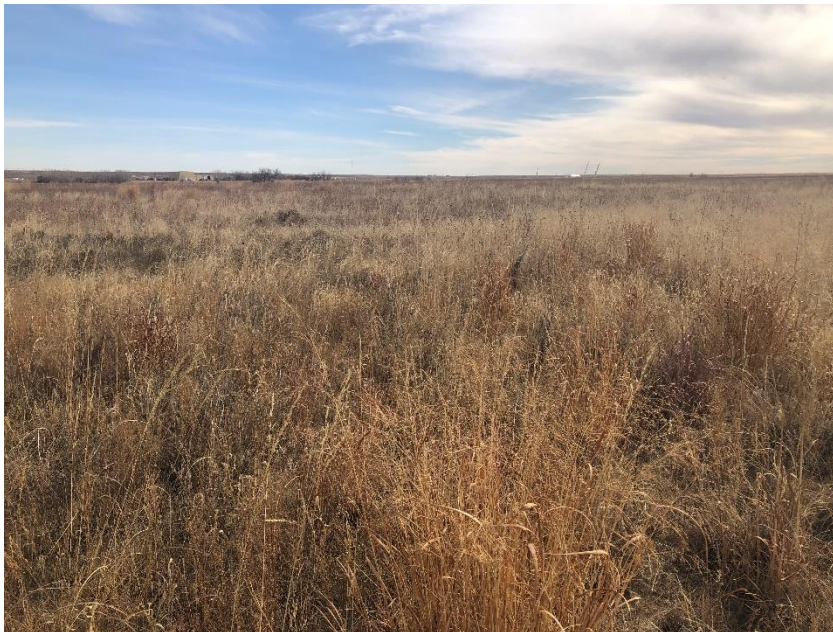
Sunflowers were found to be the dominant species in many areas, including Area 35 and the southeast part of Area 37. Other areas that were inspected contained decent to very good stands of grasses, as well as many sunflowers; these include Areas 37 (northwest portion), 43, and 44.

**Good vegetation in northeast portion of Area 43 (Area 37 in background)**
