## **Bowie #1 inspection report**

# **PERMIT INFORMATION**

<b></b>				
Permit Number: C-1981-038 Mine Name: Bowie No. 1 Mine Operator: Bowie Resources, LLC Operator Address: Mr. Basil R Bear	County: Delta Operation Type: Underground Permit Status: Active Ownership: Private			
P.O. Box 1488	<b>Operator Representative Present:</b>			
Paonia, CO 81428				
,	None			
Operator Representative Signature: (Field Issuance Only)

Inspection Start Date: November 14, 2023 Inspection Start Time: 10:00 (estimated) Inspection End Date: November 14, 2023 Inspection End Time: 10:30 (estimated)			Inspection Type: Aerial Inspection Inspection Reason: Normal I&E Program Weather: Clear		
Joint Inspection Agency:		Joint	<b>Joint Inspection Contacts:</b>		
None					
Post Inspection Agency:		Post	Post Inspection Contacts:		
None					
Inspector(s):	Inspecto	r's Sig	nature:	Signature Date:	
Robert Zuber, P.E.	Phot	D	21		
Brock Bowles				11/15/2023

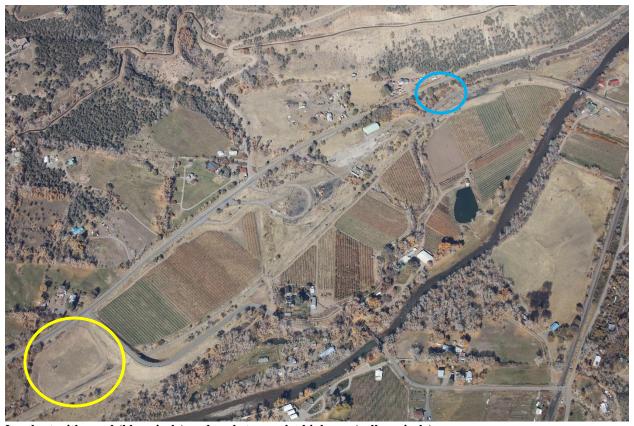
The ponds at the West Mine were completely dry. No problems were seen with the embankments or other portions of these ponds. The ponds at the coal storage by the highway and the loadout also appeared to have no problems.

No erosion or other problems were identified at the loadout. This includes the eastern portion, along the UPRR tracks and adjacent to Grange Road and Black Bridge Road.

Loadout with pond (blue circle) and coal storage by highway (yellow circle)

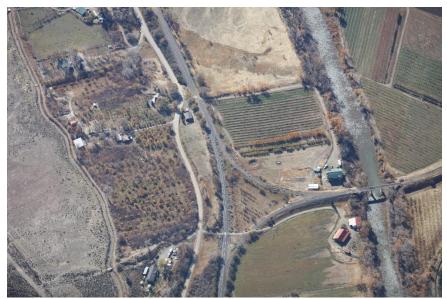
"Y" northeast of loadout

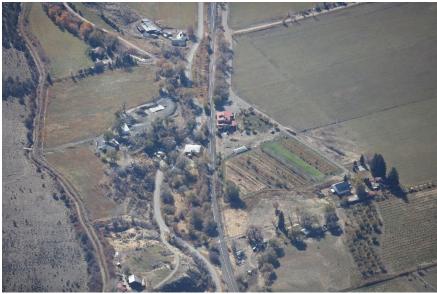
Tracks south of "Y"

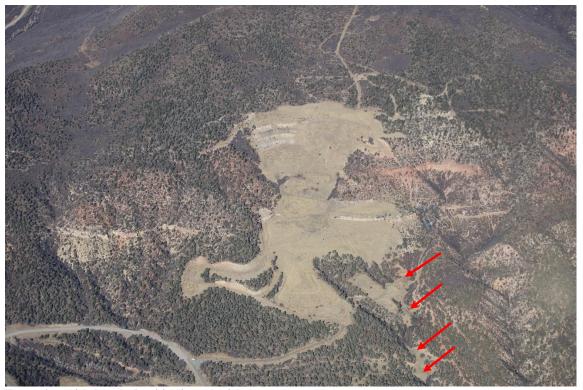
Reclaimed Ponds 1-4 southeast of the East Mine were inspected. The West Mine was also inspected, especially the area near the creek and the road at the north end. No erosion or other problems were identified.

East mine with Ponds 1 – 4 indicated with arrows

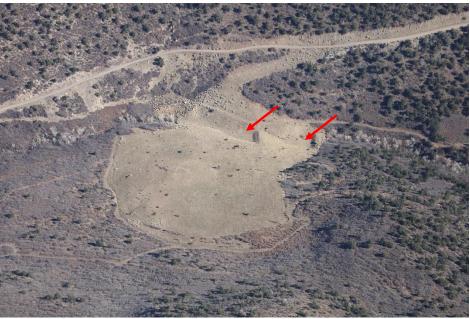
West Mine with ponds indicated with arrows
