## November Aerial Inspection Report

**Roadside Mine, C-1981-041, November Aerial Inspection Report\_CCW.pdf**

<b>Permit Number:</b> C-1981-041 <b>Mine Name:</b> Roadside Portals <b>Operator:</b> Snowcap Coal Company, Inc. <b>Operator Address:</b> MS Tonya Hammond P.O. Box 1430 Palisade, CO 81526	<b>County:</b> Mesa <b>Operation Type:</b> Underground <b>Permit Status:</b> Active <b>Ownership:</b> Private
	<b>Operator Representative Present:</b>  NA
<b>Operator Representative Signature: (Field Issuance Only)</b>

<b>Inspection Start Date:</b> November 14, 2023 <b>Inspection Start Time:</b> 12:00 <b>Inspection End Date:</b> November 14, 2023 <b>Inspection End Time:</b> 12:05		<b>Inspection Type:</b> Aerial Inspection <b>Inspection Reason:</b> Normal I&E Program <b>Weather:</b> Clear	
<b>Joint Inspection Agency:</b>  None		<b>Joint Inspection Contacts:</b>  None	
<b>Post Inspection Agency:</b>  None		<b>Post Inspection Contacts:</b>  None	
<b>Inspector(s):</b>  Clayton Wein  Brock Bowles	<b>Inspector's Signature:</b>  <i>Clayton Wein</i>  <b>Signature Date:</b> 11/16/2023

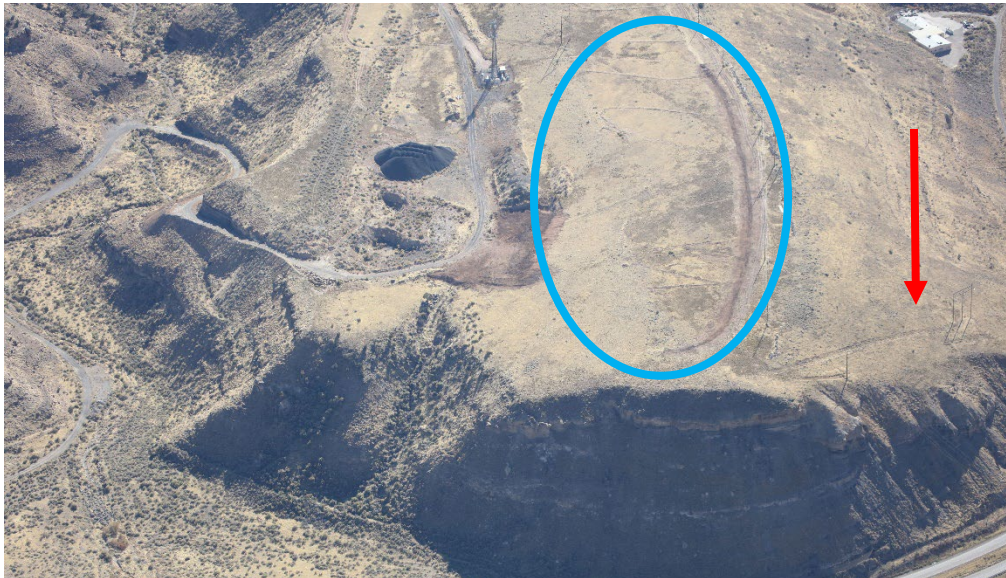
During the inspection the landowner's trenches on Tract 70 were observed to be dry (Photo 1 and 2). There were no indications or recent water application to the area. The Tract 70 Mesa was stable with no erosional features identified.

Photo 1: Mr. Fontanari's trenches on the northern part of tract 70 were dry. The trenches are located in the blue oval in the photo

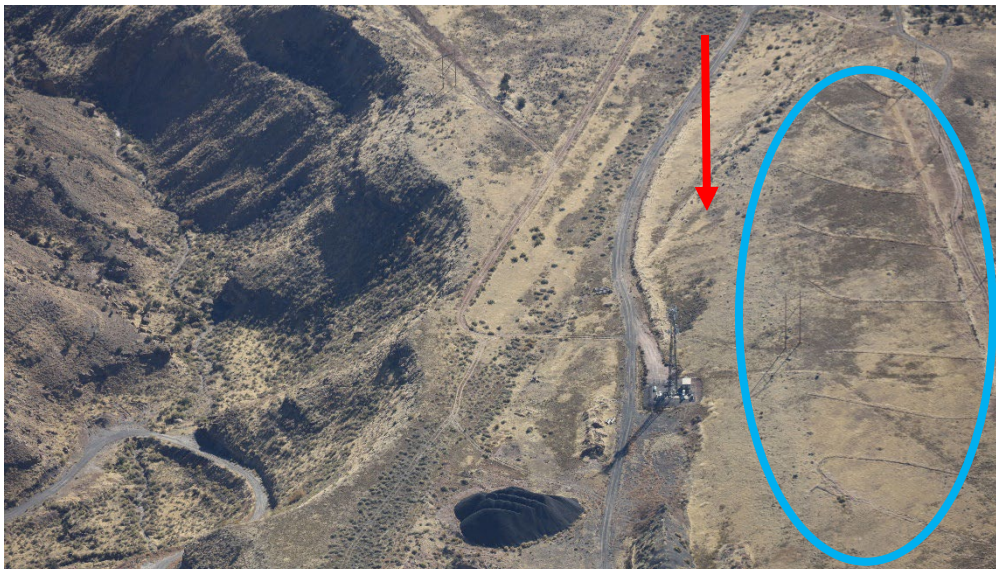
Photo 2: Mr. Fontanari's trenches on the southern part of Tract 70 were dry. The trenches are located within the blue oval in the photo.

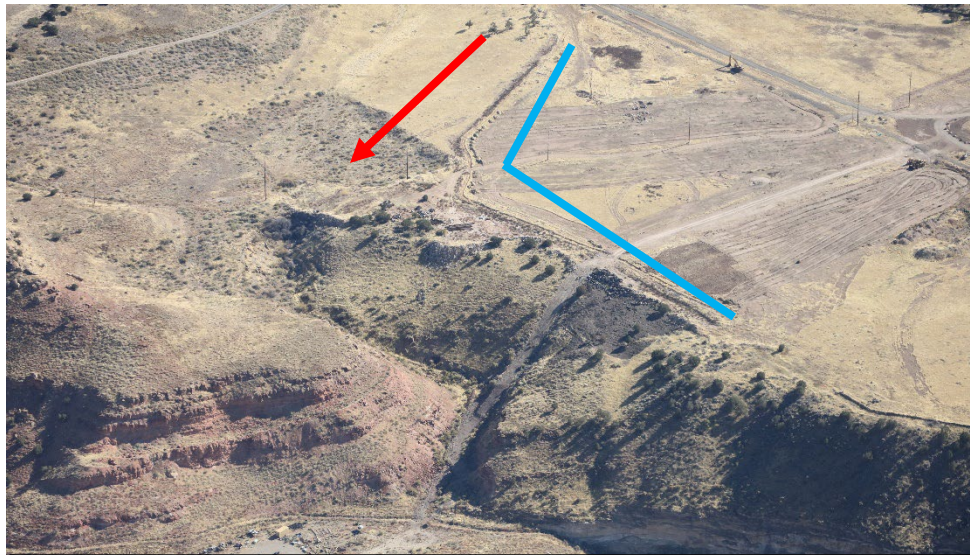
The landowner has a trench located on the east and north portions of Tract 71 (Photo 3). Both portions of the trench were dry during the inspection. There was no evidence of recent water application within the trench.

Photo 3: Mr. Fontanari's trench on the east and northern section of Tract 71 is marked by the adjacent blue line.

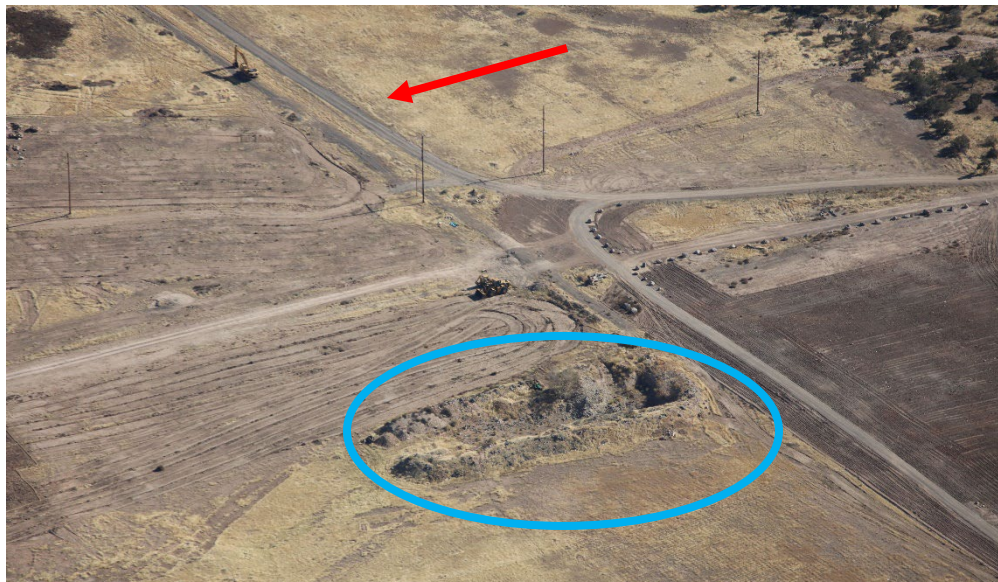
The Carey Pit is located in the Southwestern corner of Tract 71 (Photo 4). The pit was dry at the time of the inspection. There was no indication of water being recently applied within the pit.

Photo 4: The Carey pit located in the southwest corner of Tract 71 outlined in blue in the photo above.

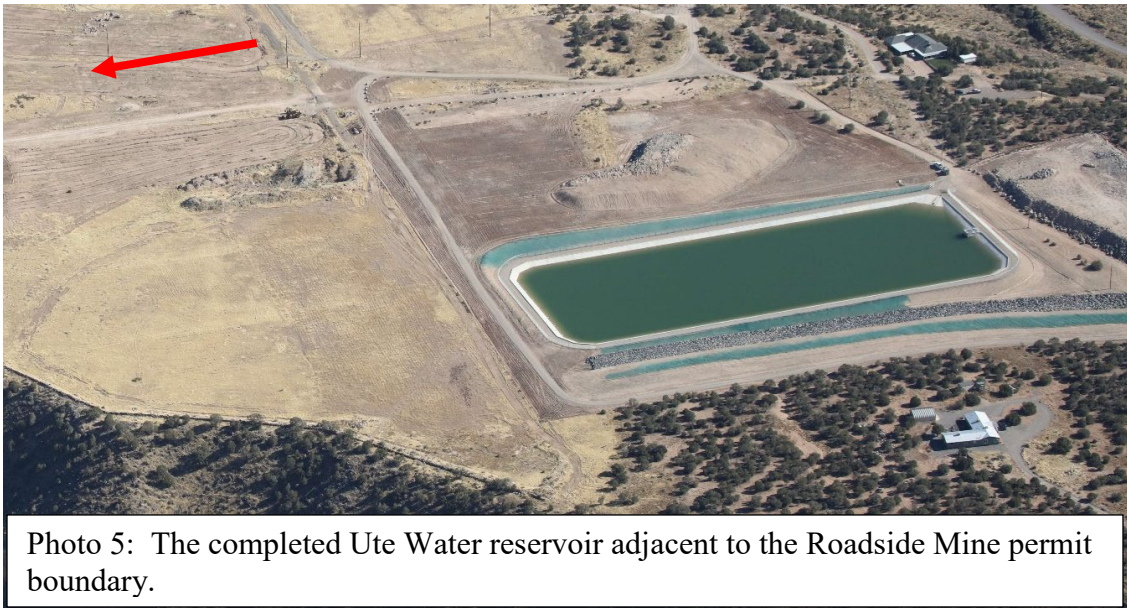
Located to the southwest of the Carey pit and outside and adjacent to the Roadside Mine permit boundary, Ute Water has completed constructing a new water storage reservoir (Photo 5). This impoundment is not associated with Snowcap Coal Company or the Roadside Mine.

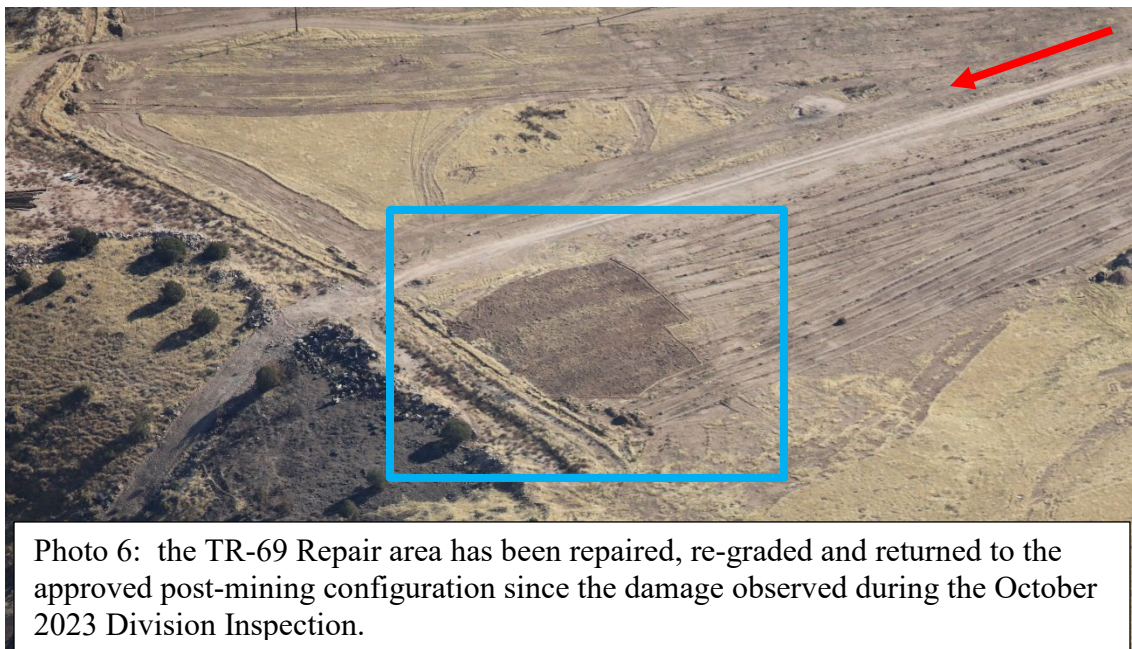
The TR-69 Repair area is located in the northern portion of Tract 71 (Photo 6). The TR-69 Repair Area is approximately 0.4 acres in size and is the remaining disturbance permitted at the Roadside Mine. In

October of 2023 the landowner, Mr. Fontanari, bladed the reclamation within the TR-69 Repair Area. Please see the Division's October Inspection Report for more details. During this inspection, the Division observed that the disturbed boundary markers and straw waddles had been replaced. The operator had also re-graded the TR-69 repair area to approximate original contour. The repaired TR-69 Repair area was observed to be stable with no erosional concerns. Discussions with the operator indicated that the repaired TR-69 Repair Area will be reseeded in the first half of November. There were no impacts to the TR-69 Repair Area from Mr. Fontanari identified during this inspection.
