Bowie #2 report

Permit Number: C-1996-083 Mine Name: Bowie No. 2 Mine Operator: Bowie Resources, LLC Operator Address: Mr. Basil Bear P.O. Box 1488 Paonia, CO 81428	County: Delta Operation Type: Underground Permit Status: Active Ownership: Private
	Operator Representative Present: None
Operator Representative Signature: (Field Issuance Only)

Inspection Start Date: November 14, 2023 Inspection Start Time: 09:30 Inspection End Date: November 14, 2023 Inspection End Time: 10:00		Inspection Type: Aerial Inspection Inspection Reason: Normal I&E Program Weather: Clear	
Joint Inspection Agency: None		Joint Inspection Contacts:	
Post Inspection Agency: None		Post Inspection Contacts:	
Inspector(s): Robert Zuber, P.E. Brock Bowles	Inspector's Signature:

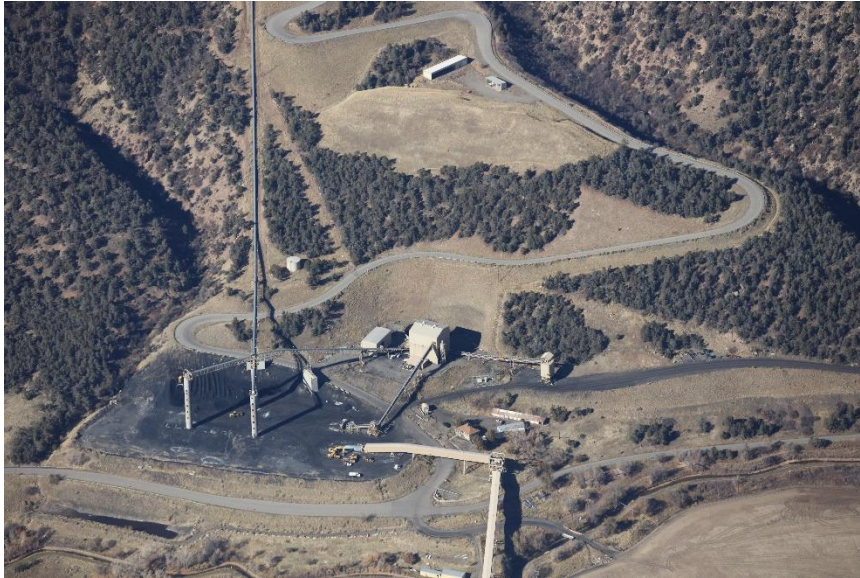
Coal Storage pad, Prep Plant, and lower haul road

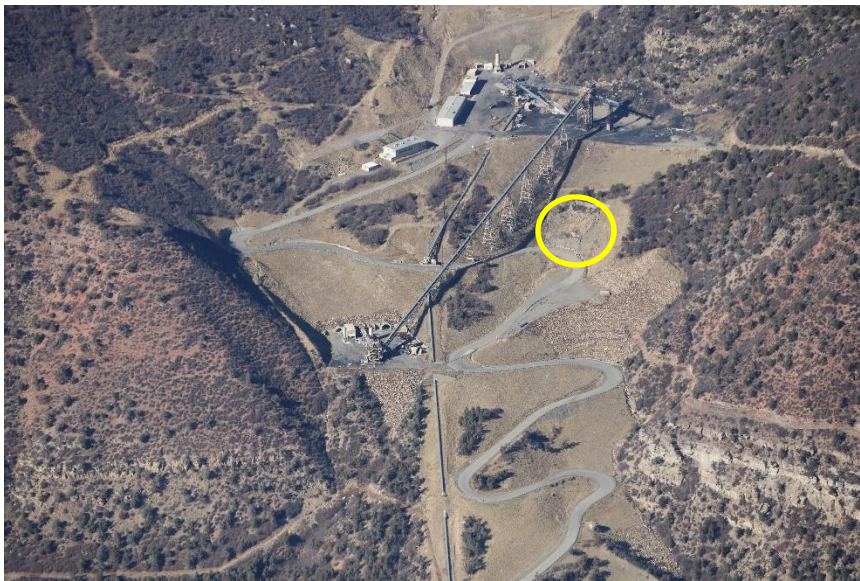
The slumps above the B Portal Bench, at Curve 11, and above the road to the Utility Bench have not worsened in recent months. However, the slide at Curve 10 is large and must be closely watched for the next few years. BRL has performed significant work at this slide (including the addition of a culvert along the road) and additional work may be required at and above this area.

Portal benches and upper haul road (slide area circled)

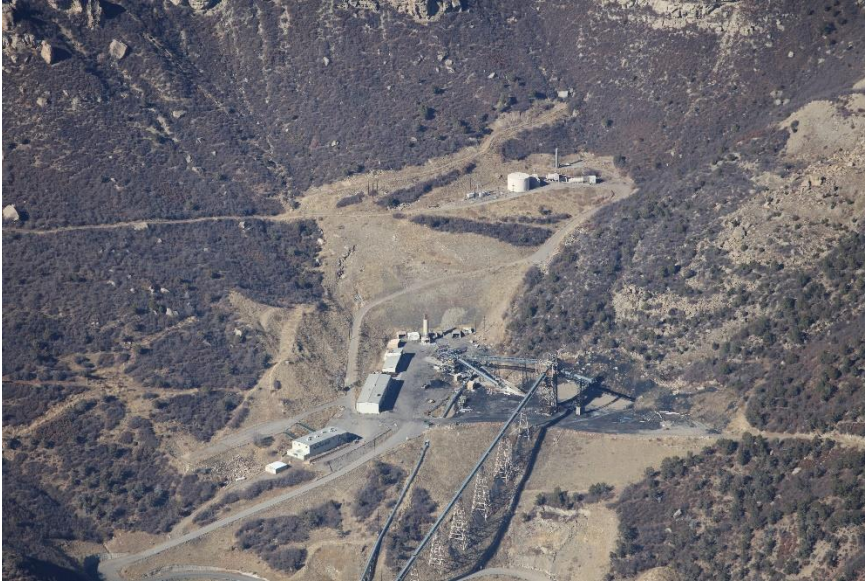
D Portal Bench and Utility Bench

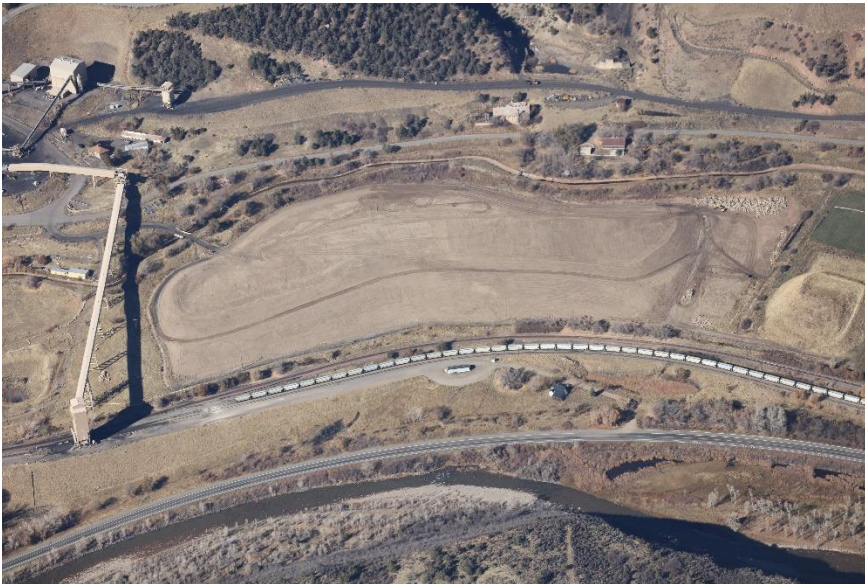
The reclamation of Gob Pile #3 appears to be nearly complete, and no erosion was seen.

Gob Pile #3

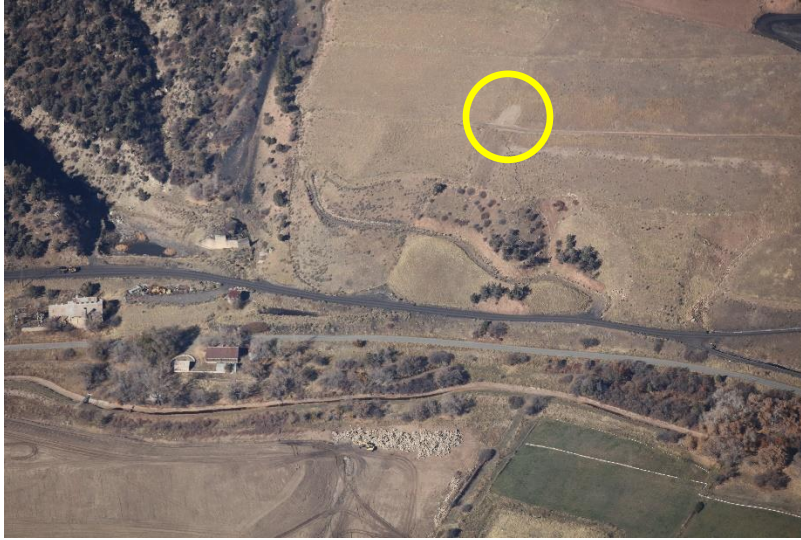
The repair of the blowout that occurred on Gob Pile #4 in the spring of 2023 appears stable. BRL is performing reclamation in an area above this blowout to help prevent the blowout from occurring again.

Blowout on Gob Pile #4 (circled), Ponds Cand D, Old Power Plant, and Filter Building

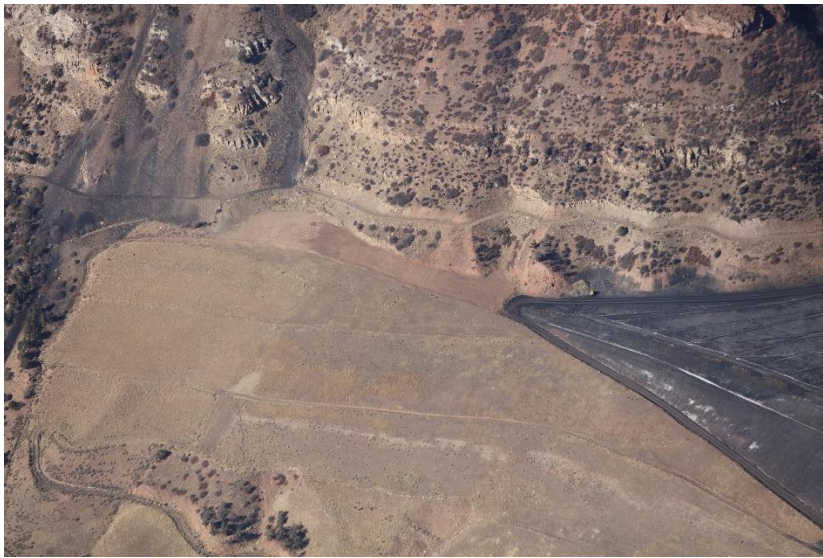
Fresh earth work near top of Gob Pile #4 (center of photo)

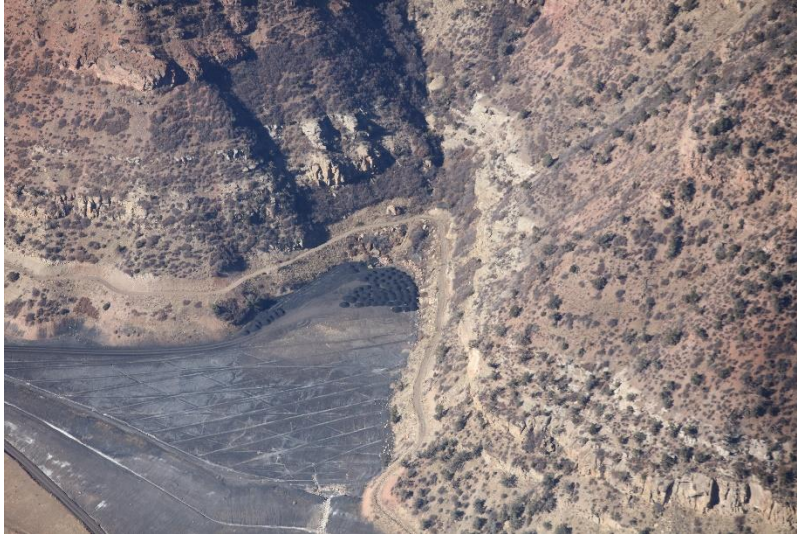
Minor erosion on Gob Pile #2 does not appear to be a problem. Gob material on the upper portion of Gob Pile #2 (from the coal stockpile pad per correspondence with a BRL representative) should be spread in the near future to avoid ponding.

Upper portion of Gob Pile #2 with material to be spread on the pile

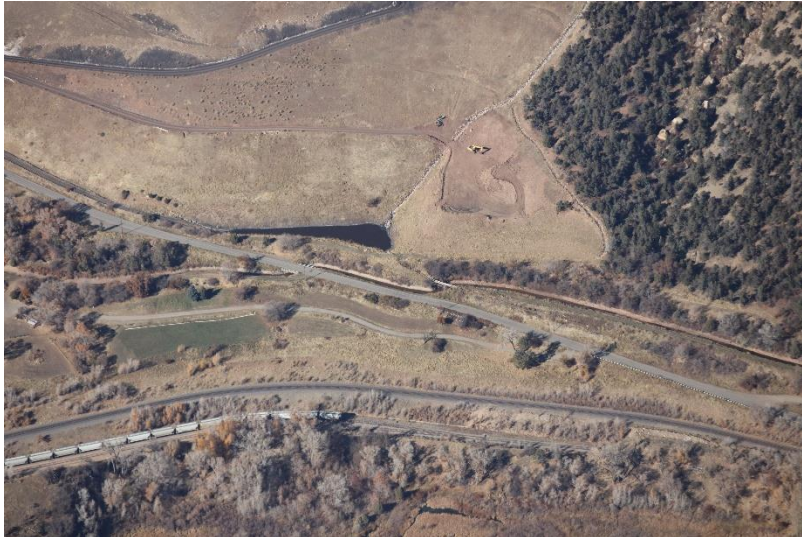
Pond F and coverfill pile

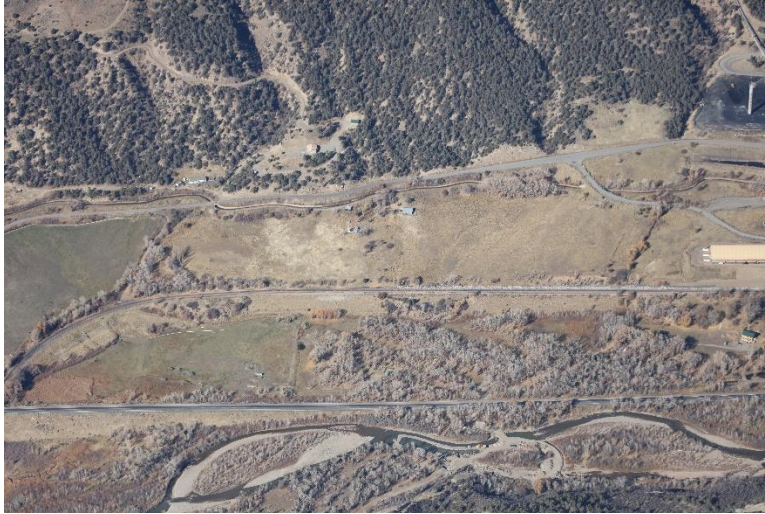
Western end of railroad tracks to Unit Train Loadout

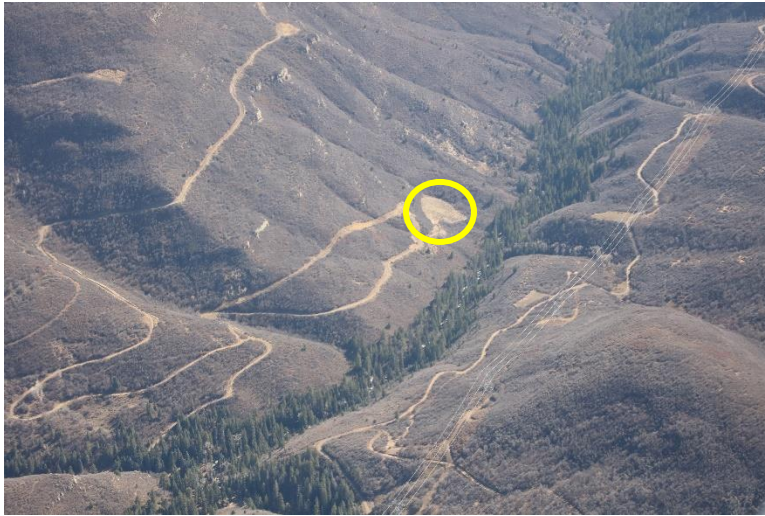
The Terror Creek Vent Shaft has been sealed, and the pad reclaimed. No problems were identified. Also, no problems were seen at the Section 5 Road or the pads for GVB-B17A, GVB-B17B, GVB-B17C, or GVB-B17D.

Reclaimed Terror Creek Vent Shaft pad (circled)

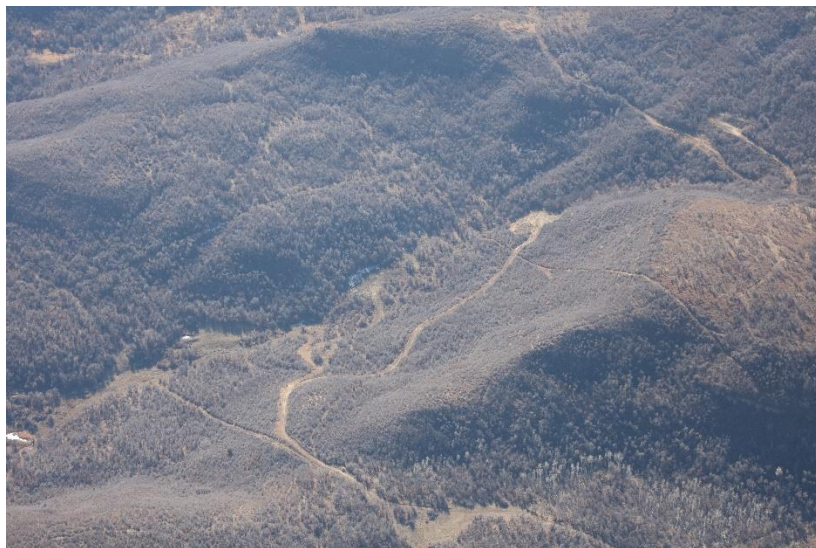
Roads and pads for the B17 series of gob vent boreholes

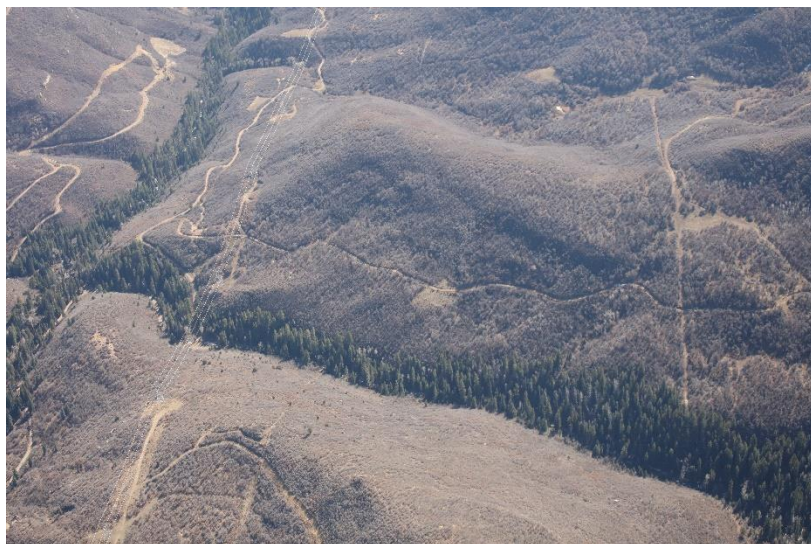
Section 5 Road, in center of photo
