## Pit 29 M 1980183 Inspection Report

**MINERALS PROGRAM INSPECTION REPORT**  
**PHONE: (303) 866-3567**

<b>MINE NAME:</b> Pit 29	<b>MINE/PROSPECTING ID#:</b> M-1980-183	<b>MINERAL:</b> Sand and gravel	<b>COUNTY:</b> Adams
<b>INSPECTION TYPE:</b> Monitoring	<b>WEATHER:</b> Clear	<b>INSP. DATE:</b> September 27, 2023	<b>INSP. TIME:</b> 11:00
<b>OPERATOR:</b> Brannan Sand and Gravel Company, L.L.C.	<b>OPERATOR REPRESENTATIVE:</b> Steve Kelton and Alex Schatz	<b>TYPE OF OPERATION:</b> 112c - Construction Regular Operation

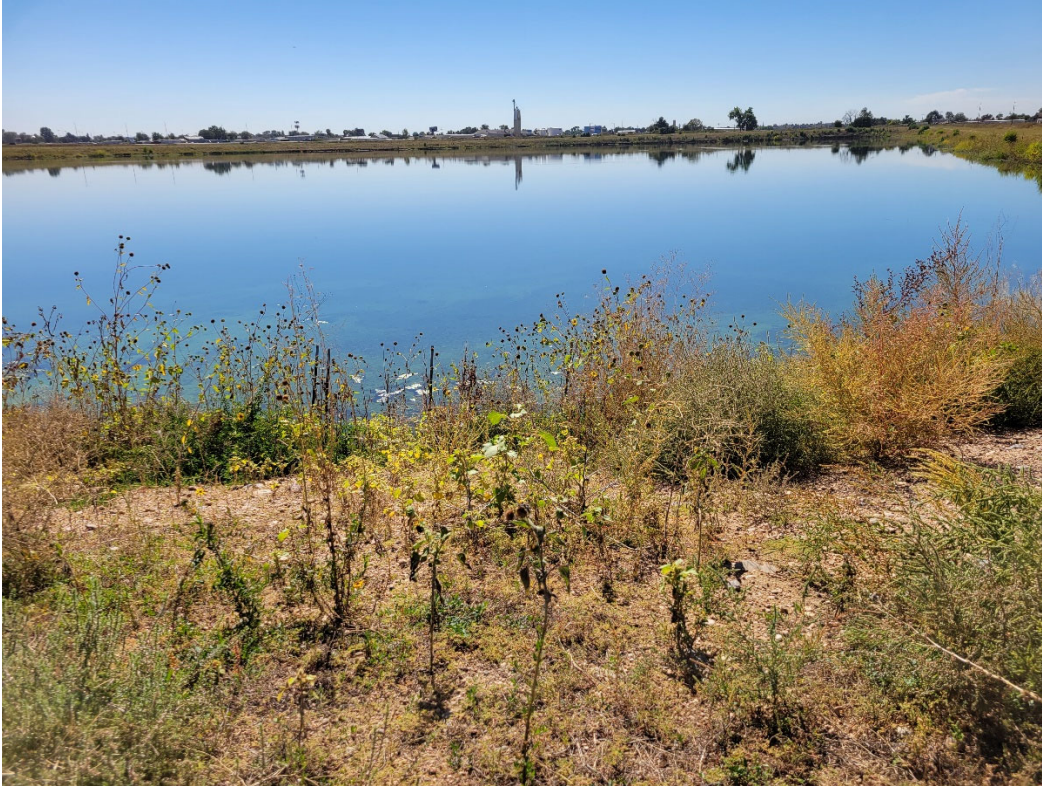
Photo 1: Looking south across the reservoir in Mining Area I.

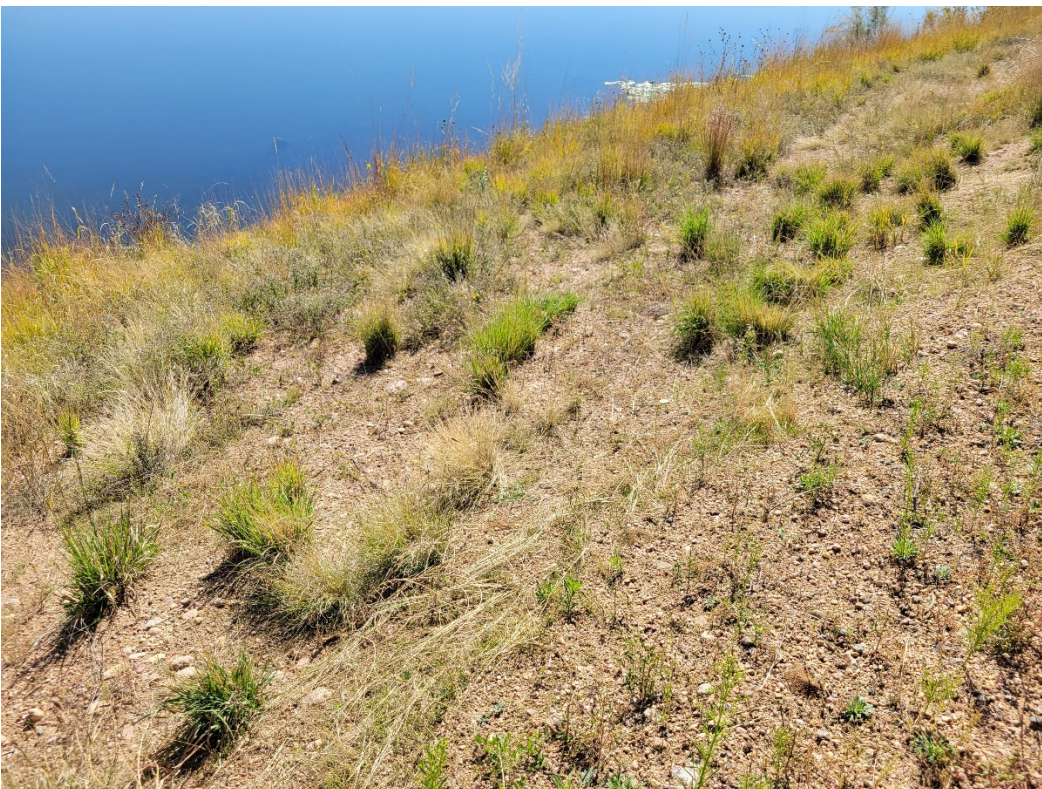
Photo 2: Western slope of reservoir in Mining Area I.

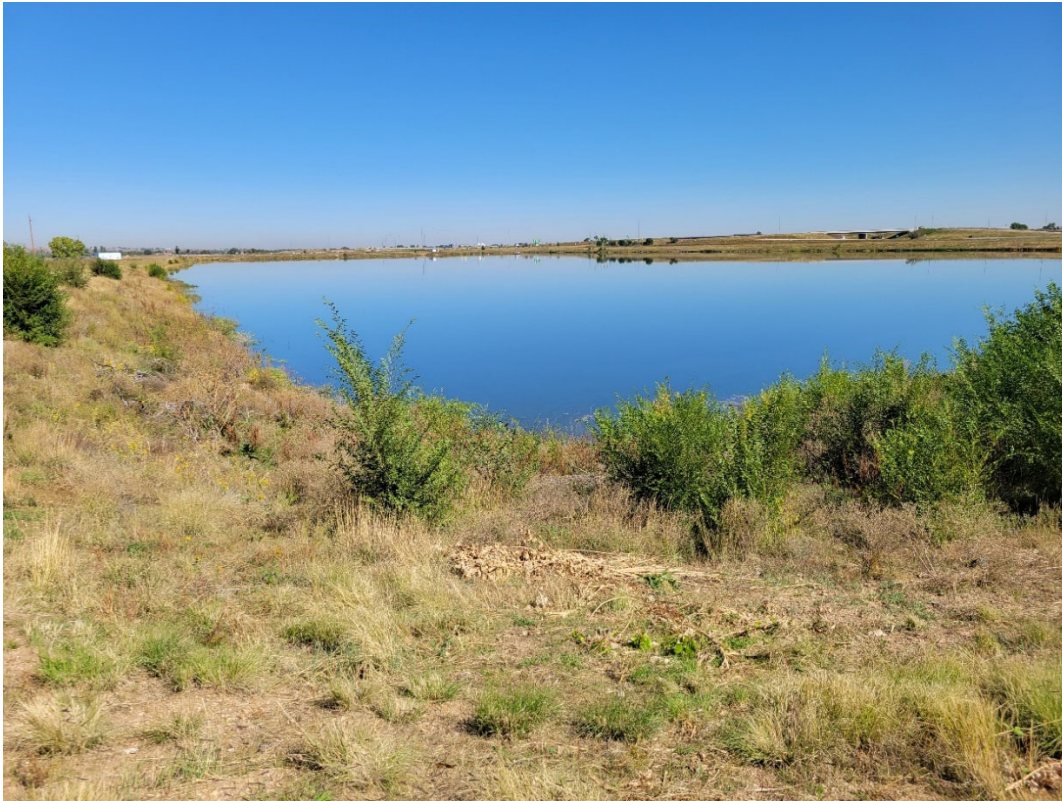
Photo 3: Looking north from the southwest corner of the reservoir in Mining Area I.

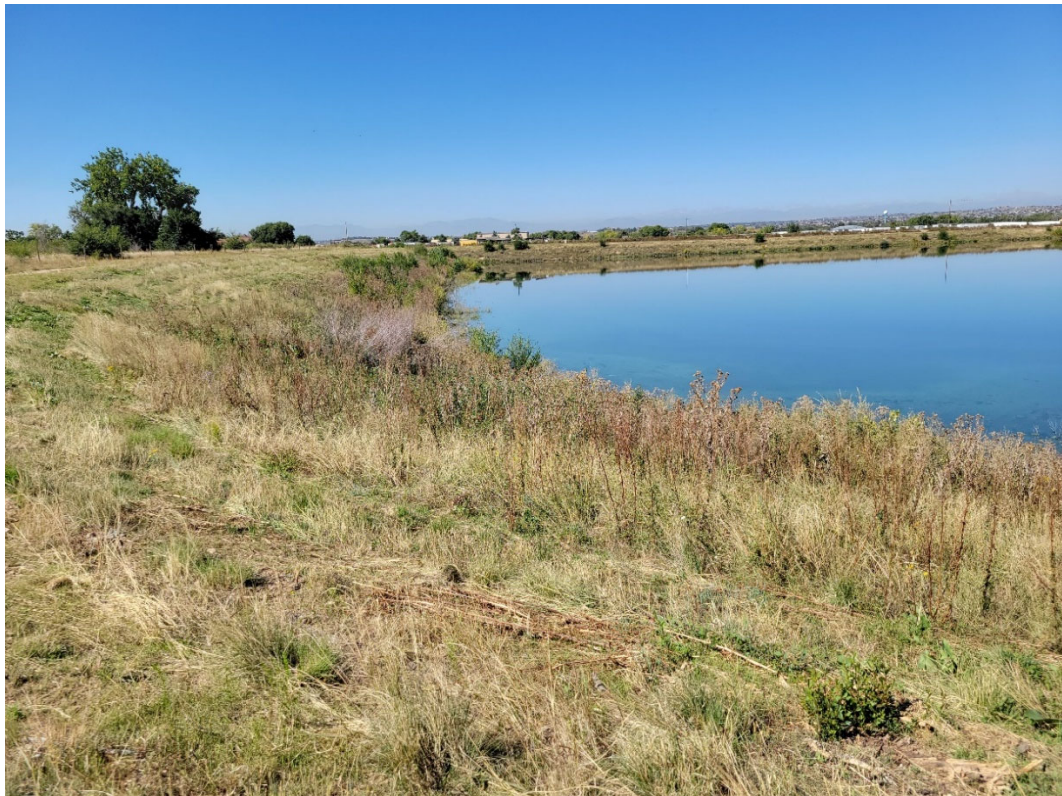
Photo 4: Looking west along the southern slope of the reservoir in Mining Area I.

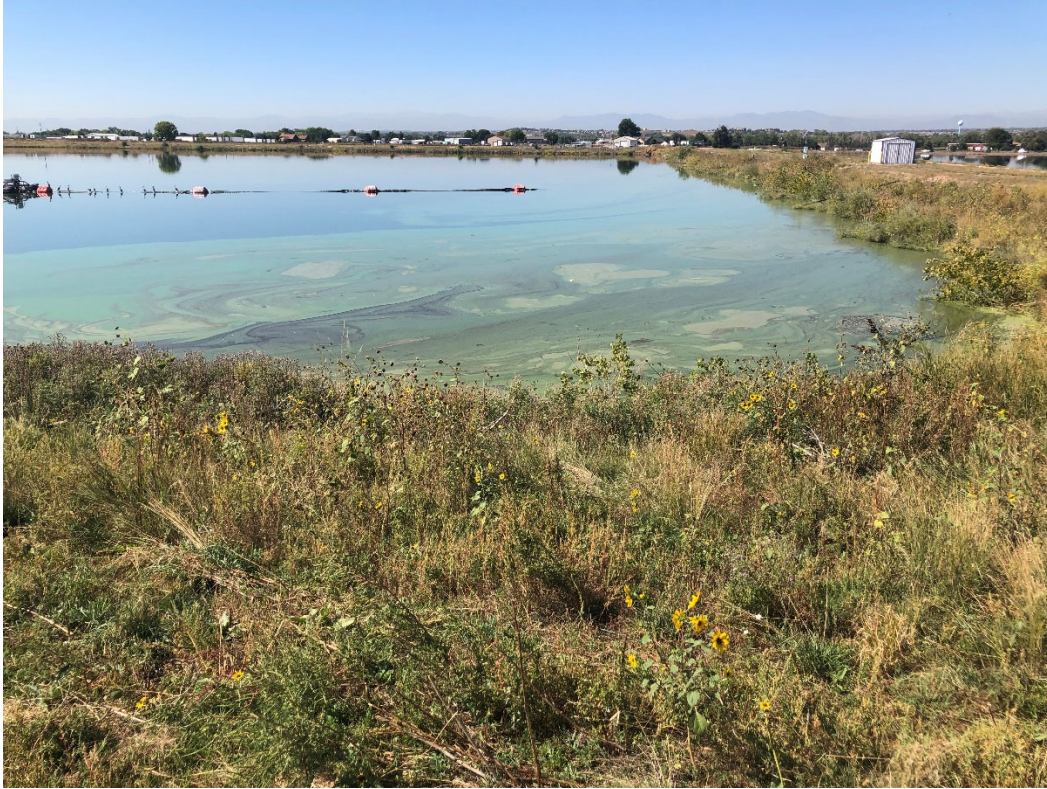
Photo 5: Northeastern corner of the reservoir in Mining Area I. Algae bloom observed in the water.

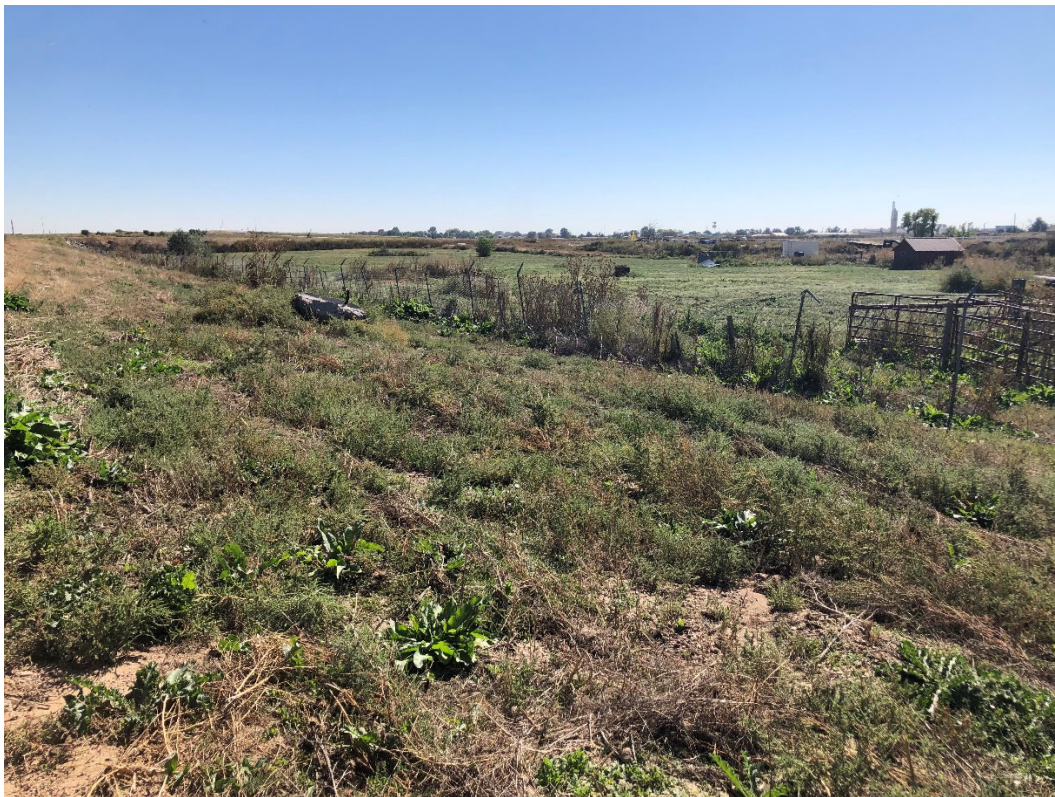
A French drain was installed in 2015 on the upgradient (south) side of Pit 29 to alleviate groundwater mounding and flooding on the adjacent property. The drain runs from east to west along the southwestern edge of Mining Area II. The drain pipe continues north for approximately 750 feet along the western boundary of Mining Area II before it turns west to discharge into an existing ditch that flows to the South Platt River. The final engineering certification and as-built drawing for this drain/pipe system were accepted by the Division on March 30, 2016. The adjacent property on the south side of Mining Area II was observed to be dry during this inspection, an indication that the French drain continues to control flooding south of Mining Area II.

Photo 6: Property on the south side of Mining Area II. French drain installed below the berm.

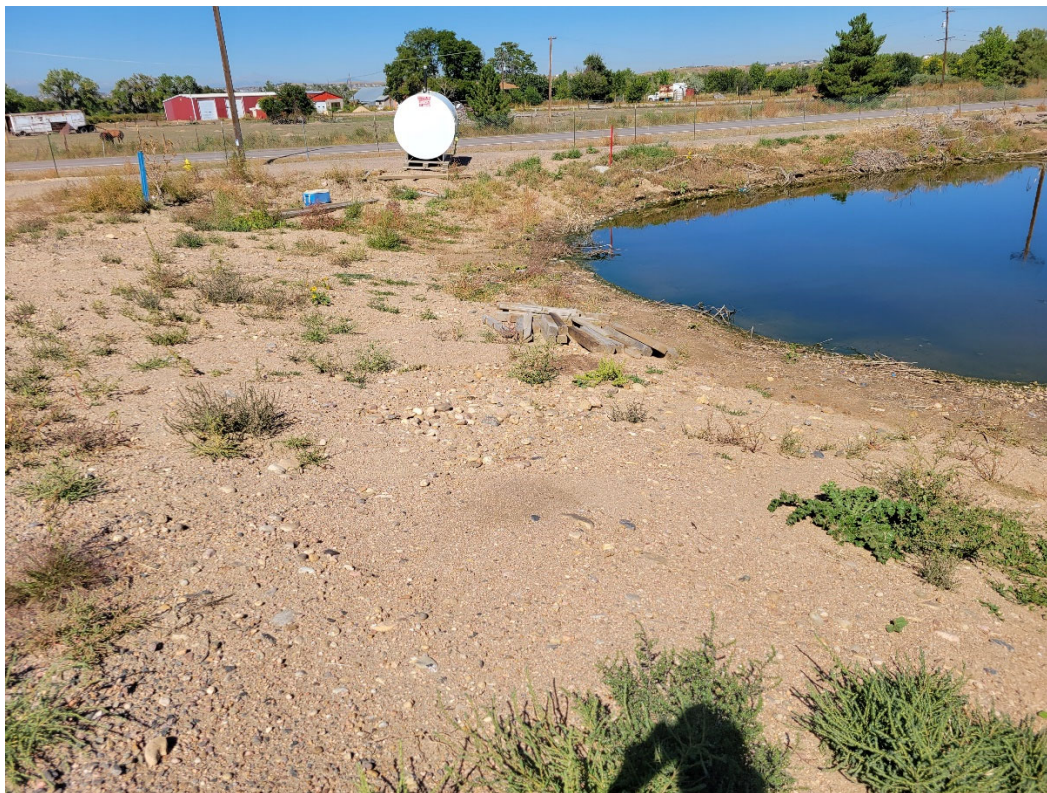
Photo 7: Southwest corner of the reservoir in Mining Area II.

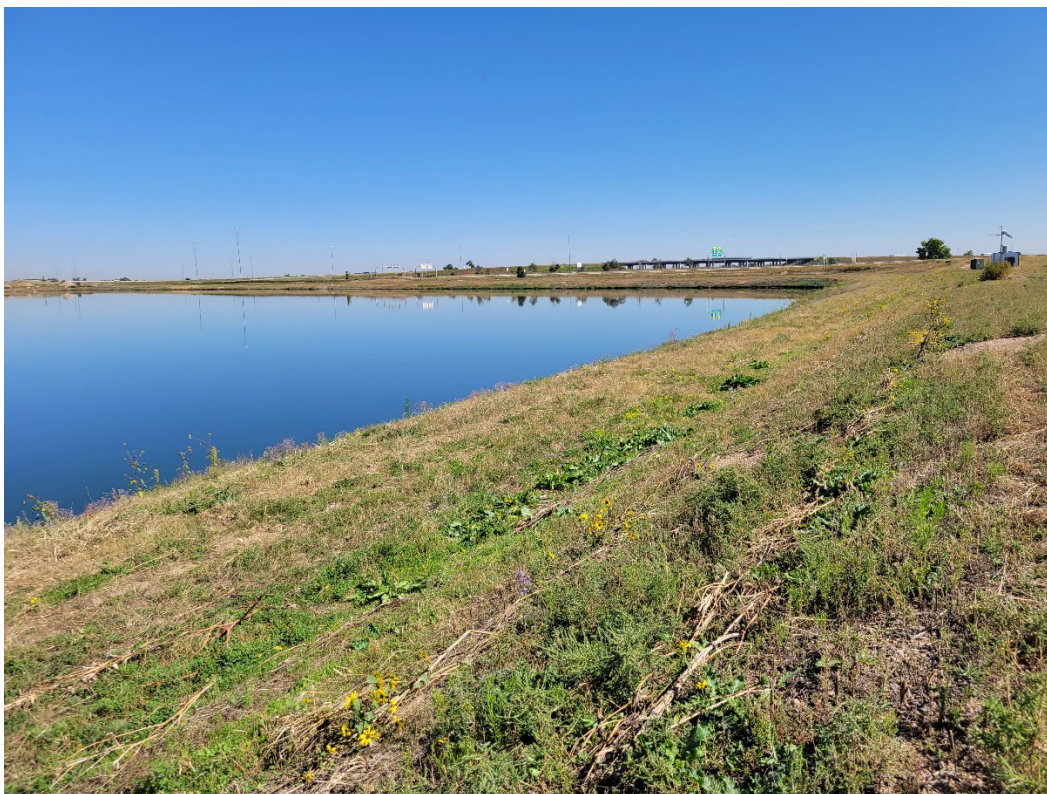
Photo 8: Southern shoreline of the reservoir in Mining Area II.

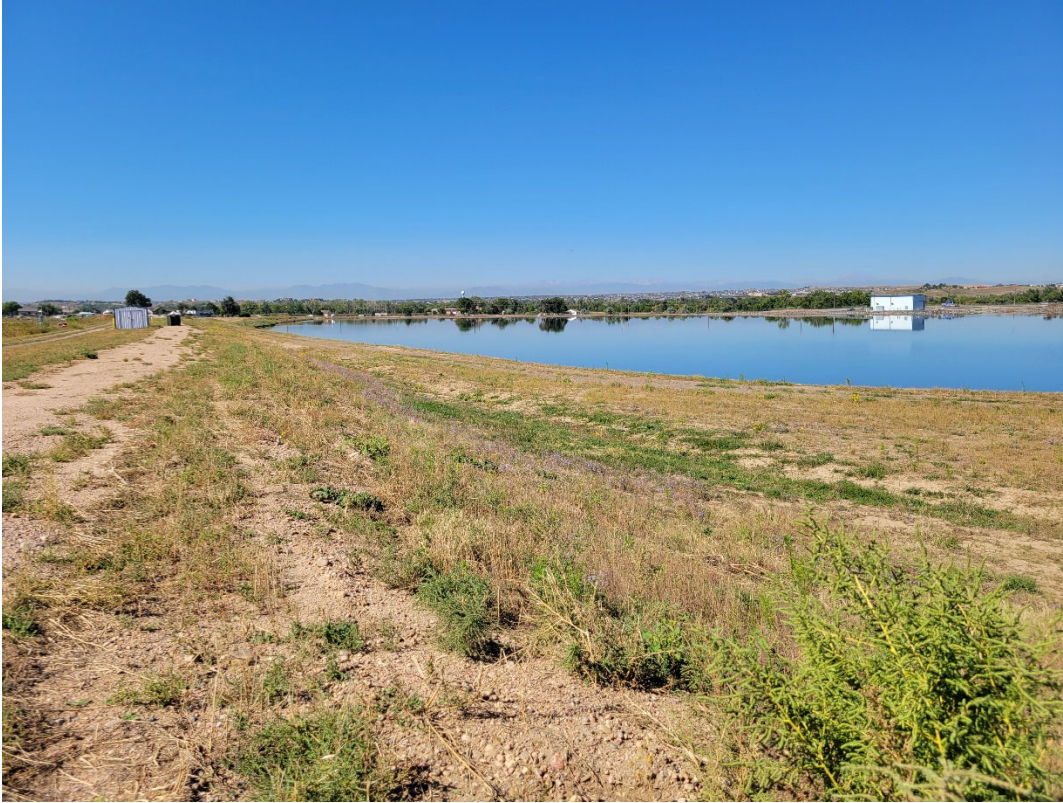
Photo 9: Southeast corner of Mining Area II.

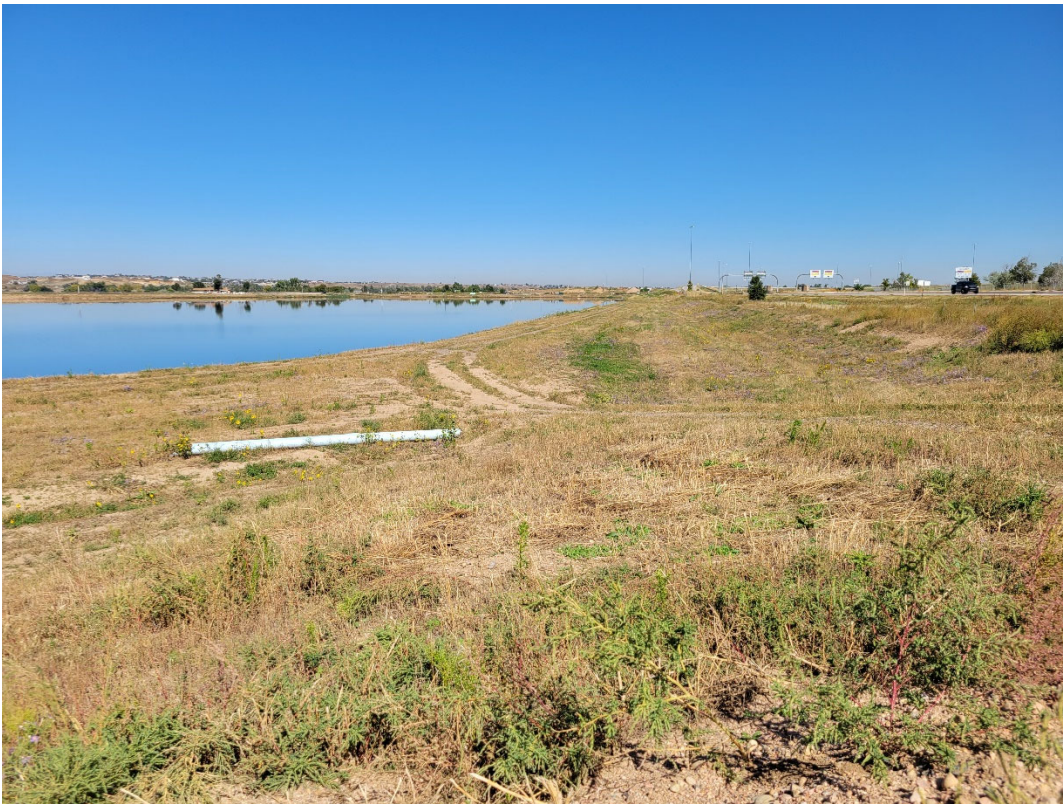
Photo 10: Looking north along the eastern shoreline of the reservoir in Mining Area II.

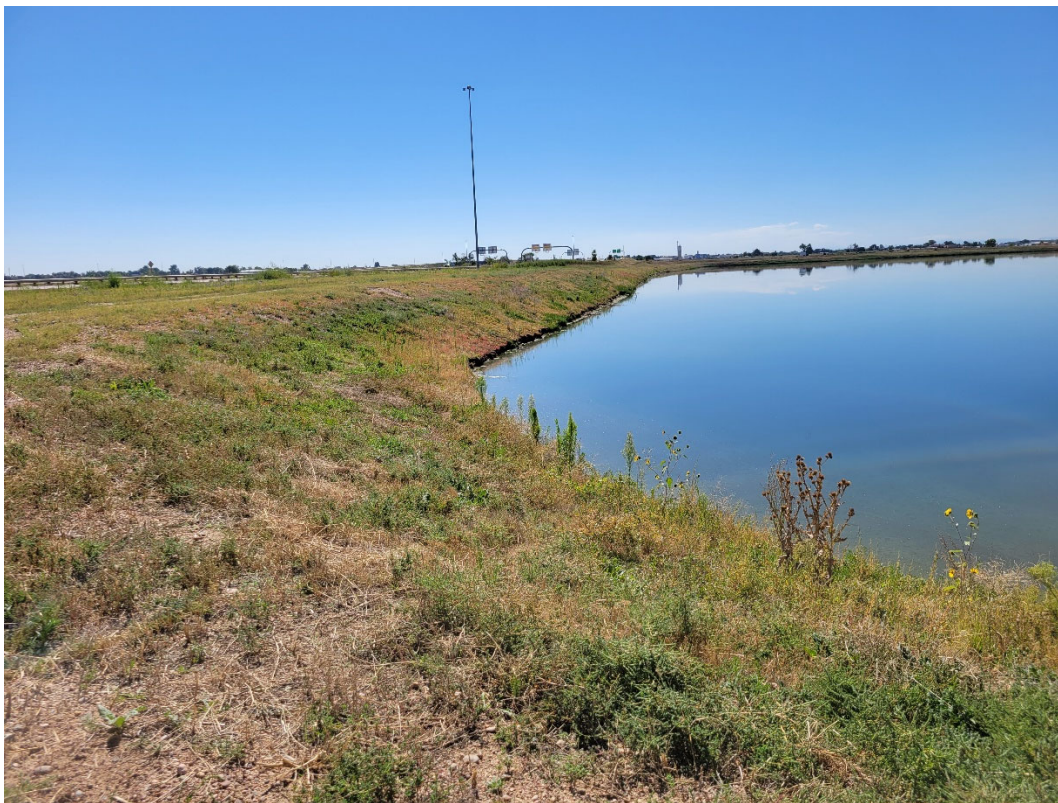
Photo 11: Northeast corner of the reservoir in Mining Area II.

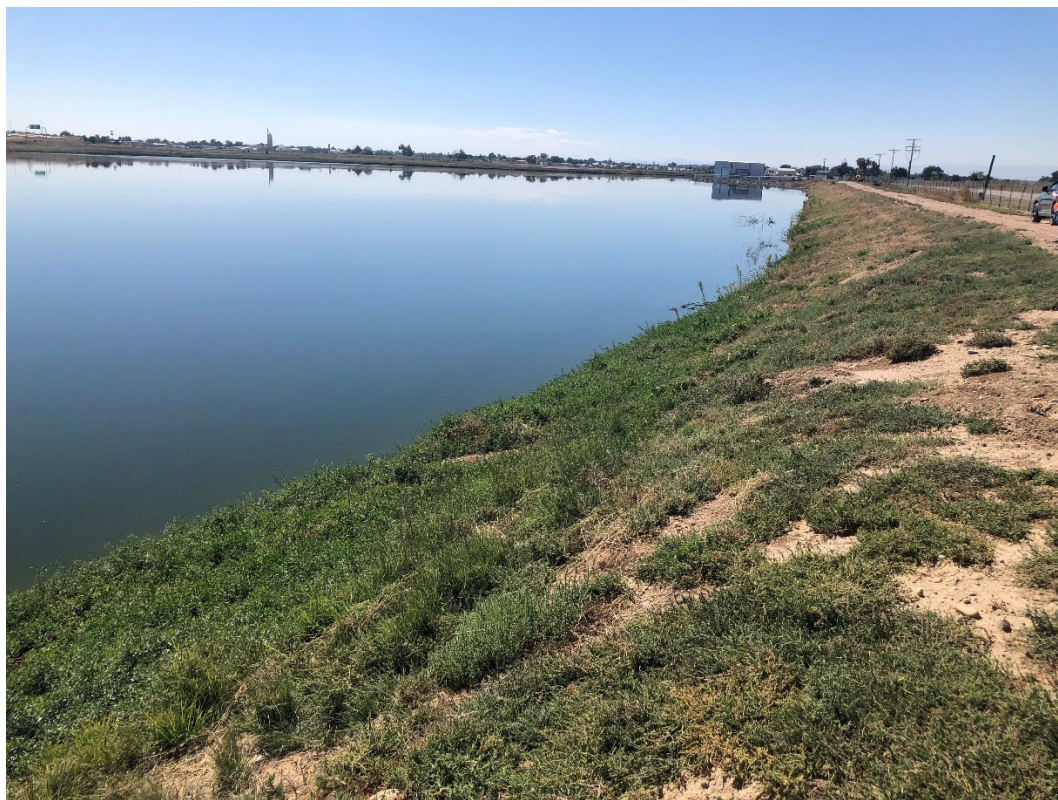
Photo 12: Western shoreline of the reservoir in Mining Area II.

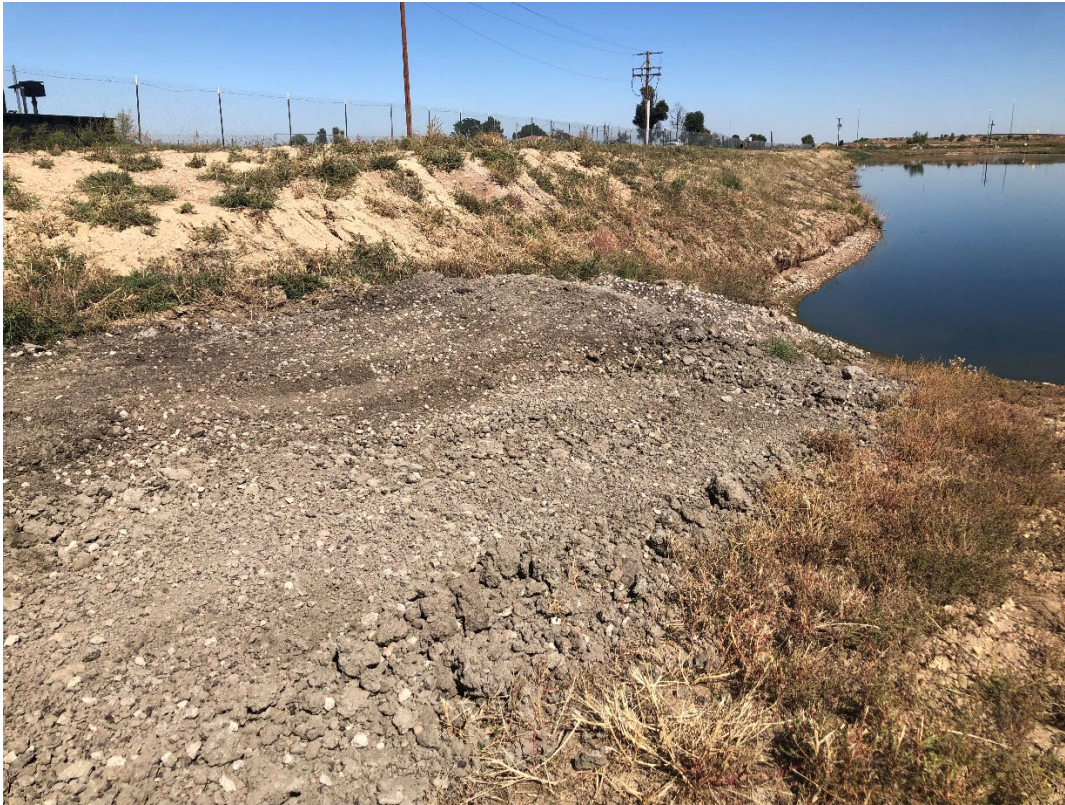
Photo 13: Boat ramp installed near the pumphouse in Mining Area II.

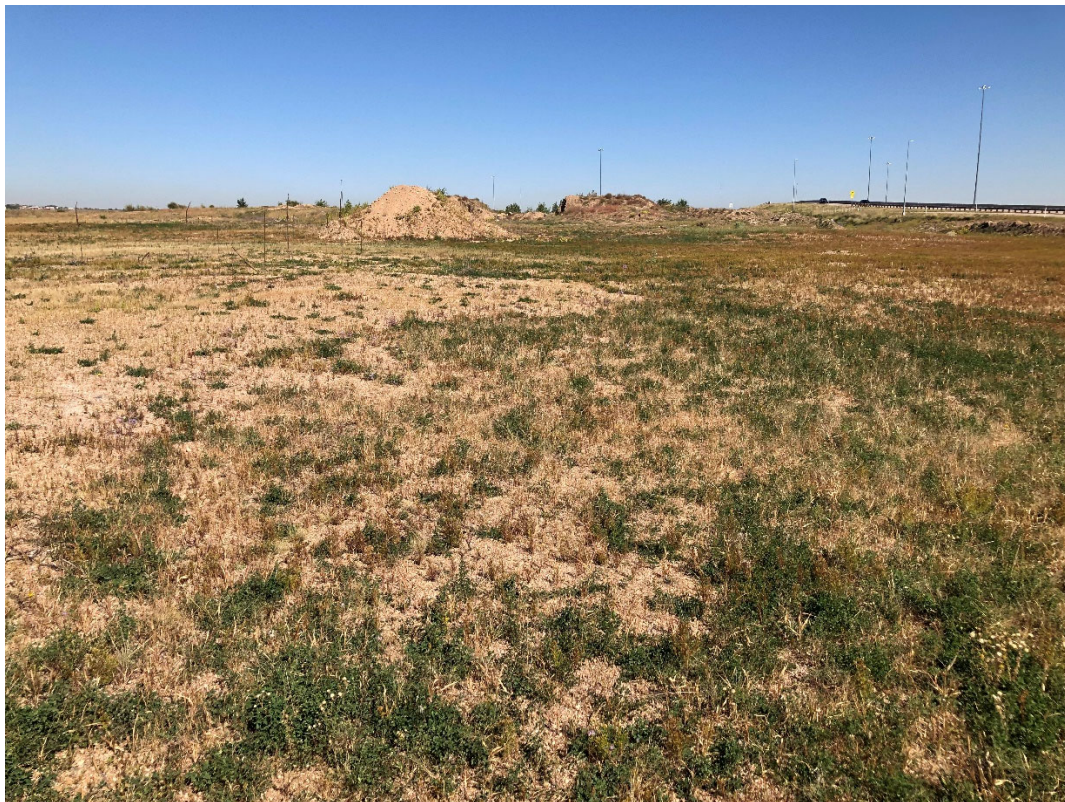
Photo 14: Looking north across Mining Area III. Stockpiles of material in background.

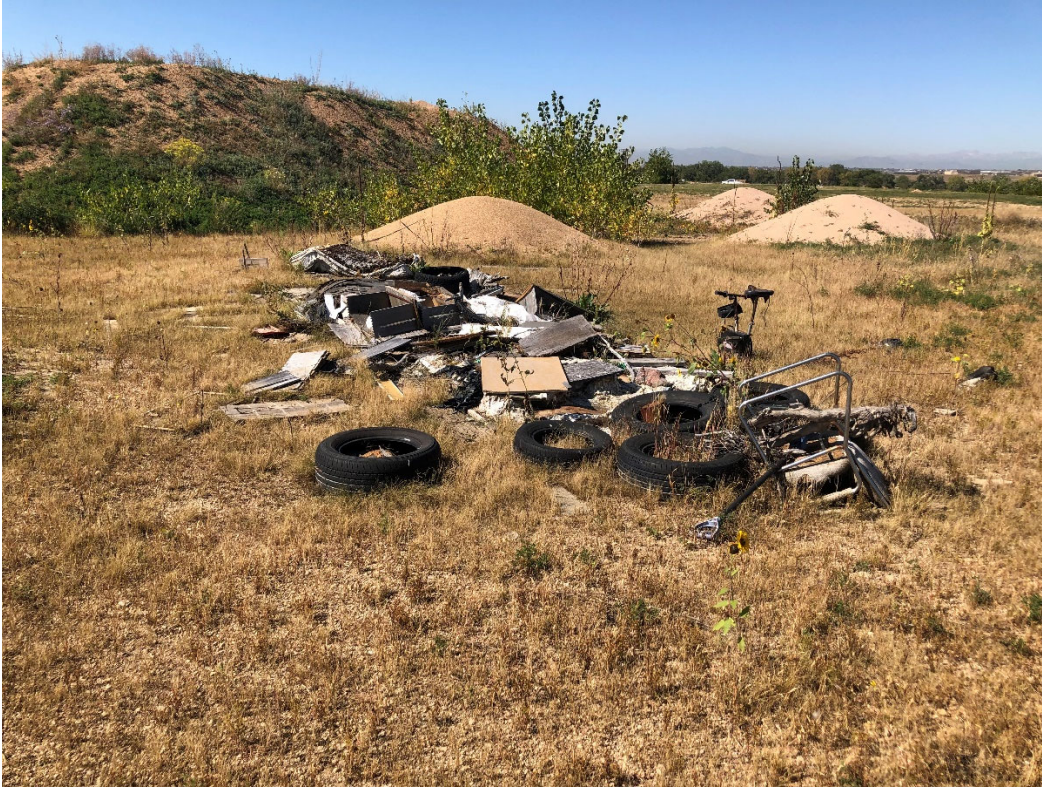
**PROBLEM/POSSIBLE VIOLATION:** Problem #2: Trash and refuse was noticed on the site. This is a problem at this time for failure to dispose of refuse in a manner that controls unsightliness or deleterious effects of such refuse pursuant to C.R.S. 34-32.5-116(4)(e).

Trash was observed behind the stockpiles in Mining Area III. Additionally, discarded equipment and piping was observed on the north end of the permit area in Mining Area II. This is cited as a problem for failure to dispose of refuse in a manner that controls unsightliness or deleterious effects of such refuse. As noted in Problem #2 above, the operator shall submit a written notice to the Division with photo documentation, that the trash, discarded equipment, and piping has been cleaned up by the corrective action date. Additionally, the Operator stated there has been a problem with illegal dumping on the road between Mining Areas II and III and they planned to work with the city to close the road off to the public.

Photo 15: Stockpiled material in Mining Area III. Trash observed behind the stockpiles.

**CORRECTIVE ACTIONS:** The operator shall submit a written notice to the Division with photo documentation, that the trash has been removed from the site by the corrective action date.

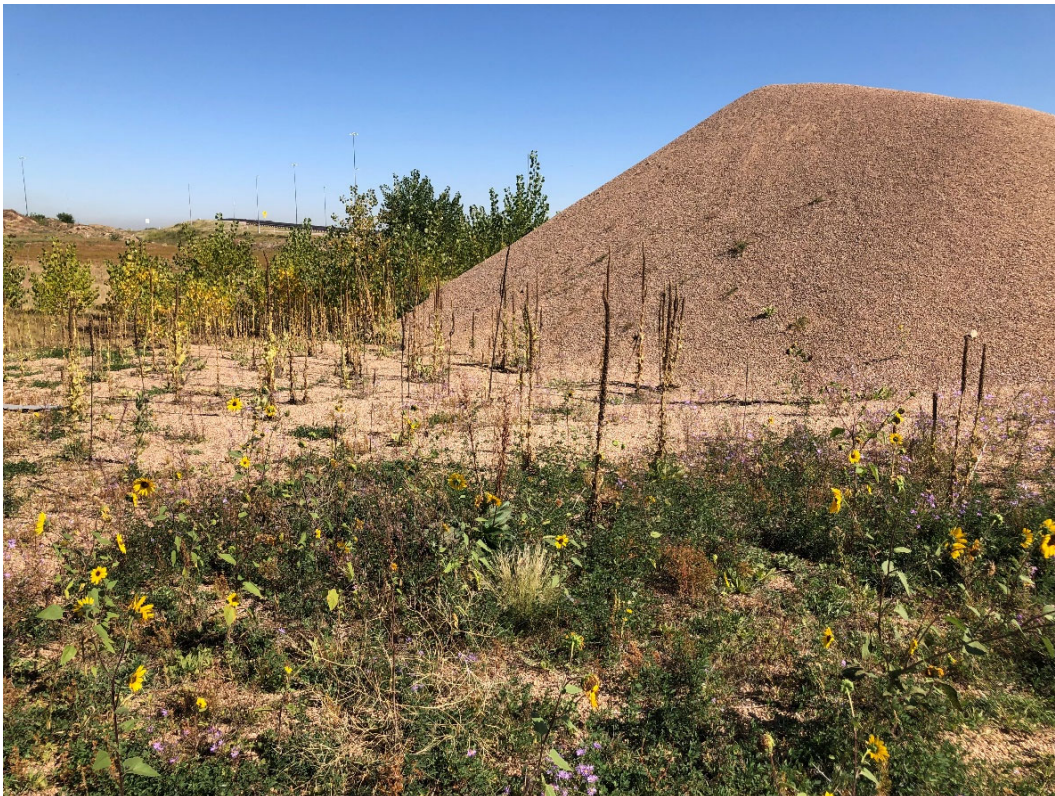
Photo 16: Stockpiled material in Mining Area III. Annual weeds, sunflowers and common mullein, and volunteer cottonwoods are growing around the piles.

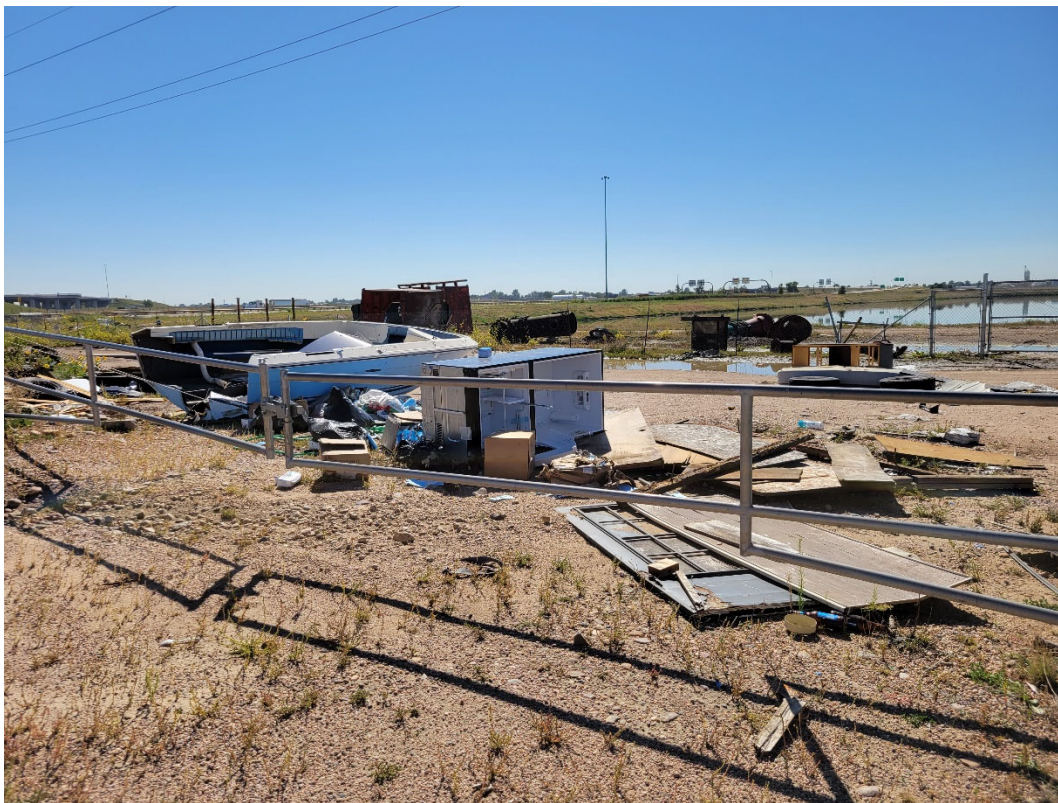
Photo 17: Illegal dumping area observed at the entrance to Mining Area III.

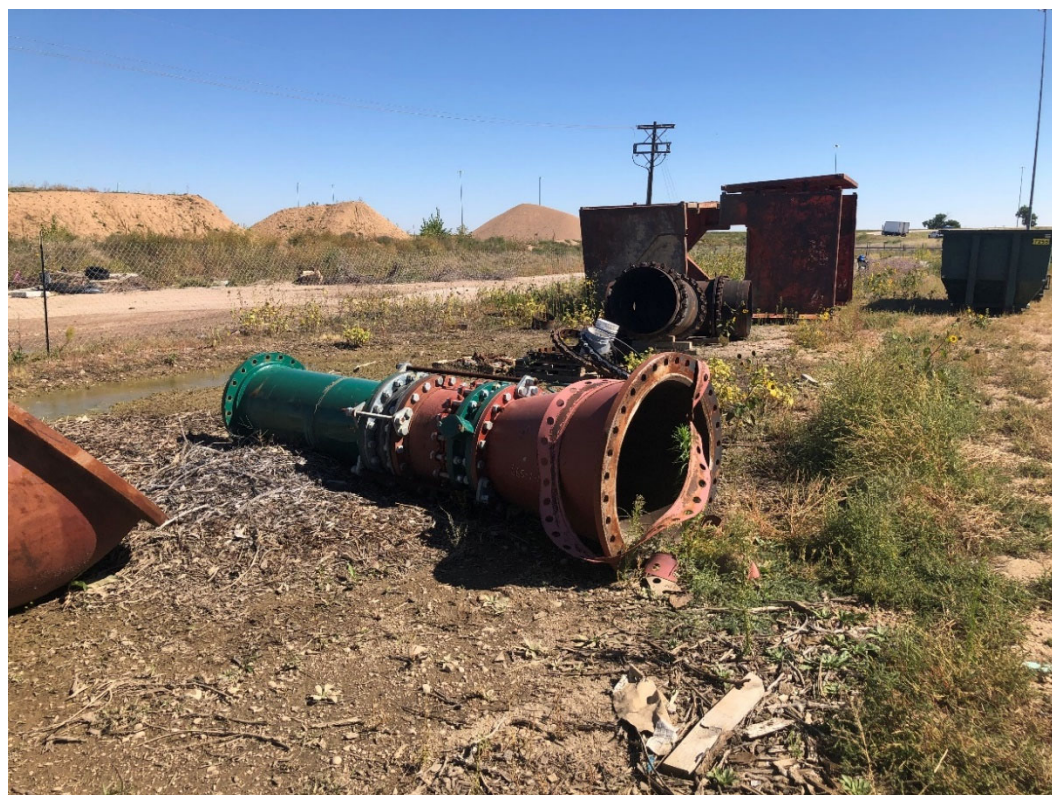
Photo 18: Discarded pipes and equipment observed in the permit area along the north end of Mining Area II.

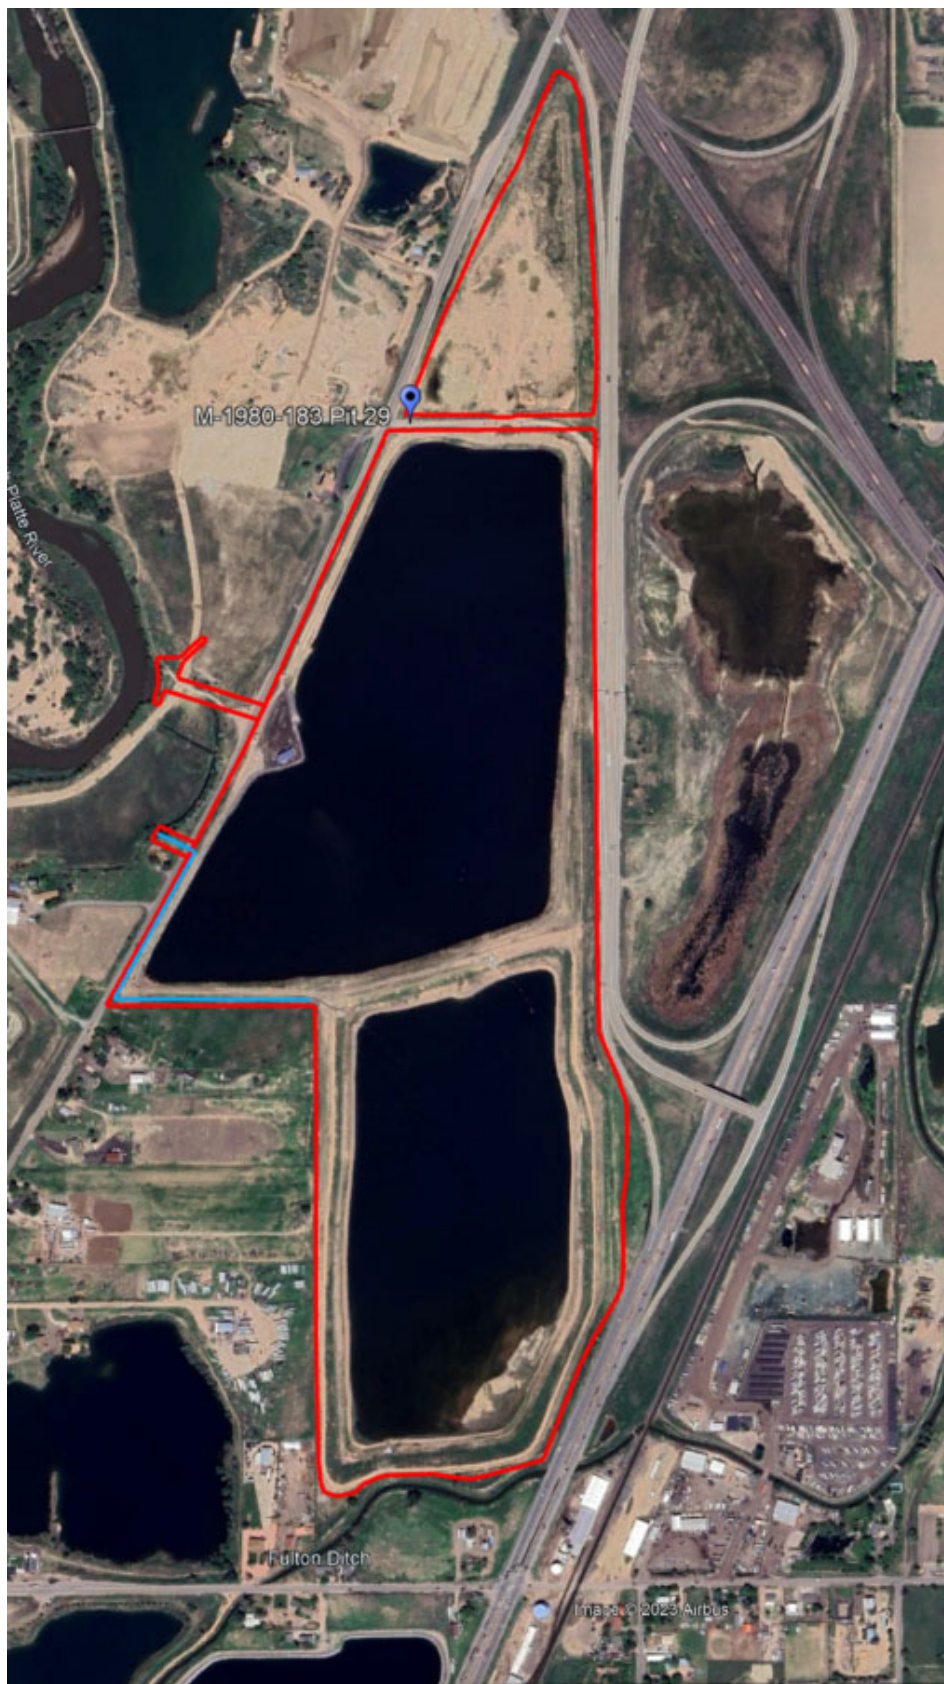
Figure 1: Google Earth imagery from May 24, 2023. Permit boundary is shown by the red line. Blue line on Mining Area II represents the French drain.
