**MINERALS PROGRAM INSPECTION REPORT**  
**PHONE: (303) 866-3567**

<b>MINE NAME:</b> Cross Gold Mine	<b>MINE/PROSPECTING ID#:</b> M-1977-410	<b>MINERAL:</b> Gold, copper, silver,	<b>COUNTY:</b> Boulder
<b>INSPECTION TYPE:</b> Monitoring	<b>WEATHER:</b> Windy	<b>INSP. DATE:</b> November 16, 2023	<b>INSP. TIME:</b> 09:30
<b>OPERATOR:</b> Grand Island Resources LLC	<b>OPERATOR REPRESENTATIVE:</b> Je'an-Paul Brewer	<b>TYPE OF OPERATION:</b> 110(2) - Hard Rock Limited Impact	
<b>REASON FOR INSPECTION:</b> Priority	<b>BOND CALCULATION TYPE:</b> None	<b>BOND AMOUNT:</b> \$546,751.00	
<b>DATE OF COMPLAINT:</b> NA	<b>POST INSP. CONTACTS:</b> None	<b>JOINT INSP. AGENCY:</b> None	
<b>INSPECTOR(S):</b> Patrick Lennberg	<b>INSPECTOR'S SIGNATURE:</b>

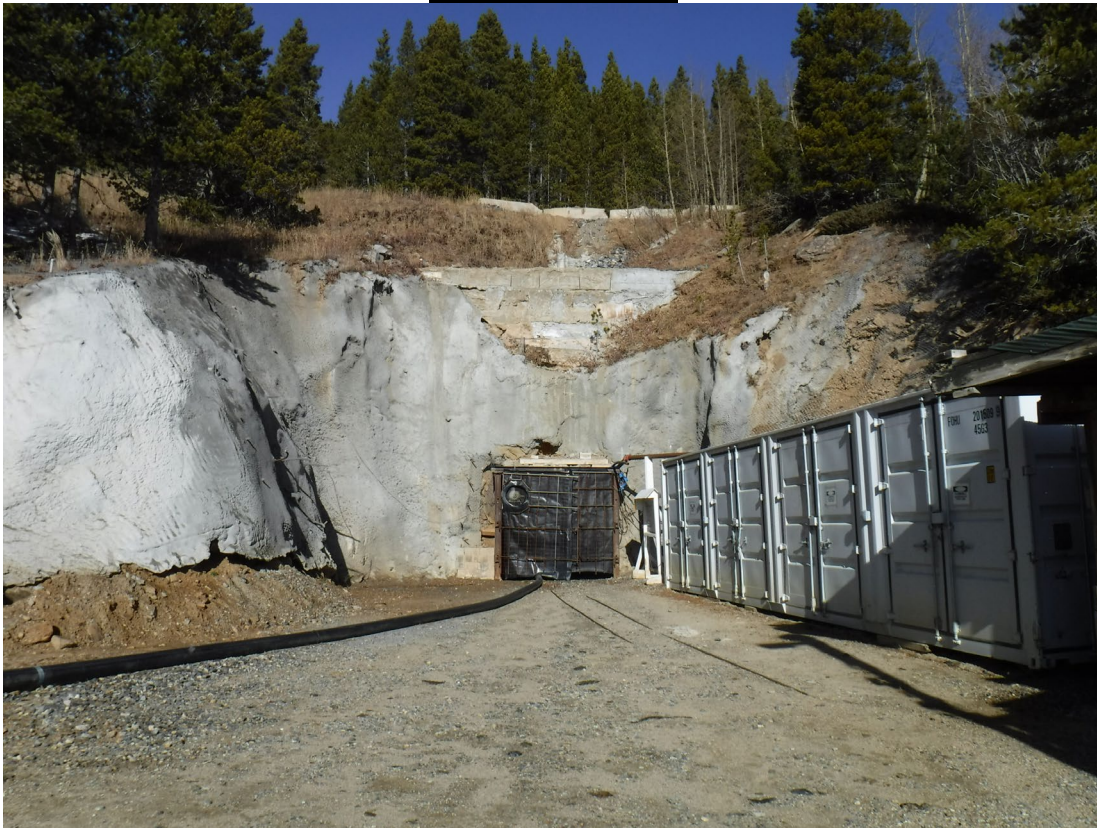
**Photo 1:** Idaho Tunnel entrance

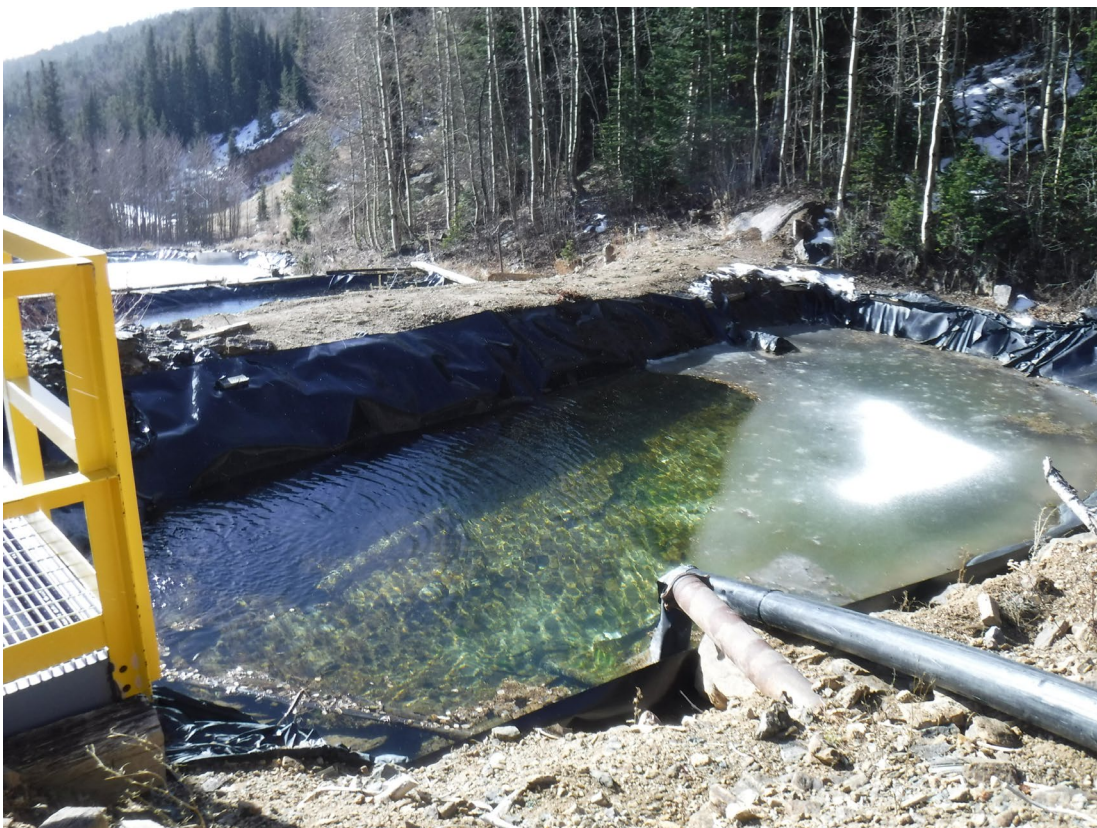
The site was not active at the time of inspection and is currently being maintained by a reduced staff. The Division observed water being discharged from the Idaho Tunnel into Ponds 3a, b and c. The water is then conveyed to Pond 1 and then to the Joliet Raise. The Operator stated that the ponds are beginning to ice over as winter approaches.

**Photo 2:** Ponds 3a, 3b and 3c

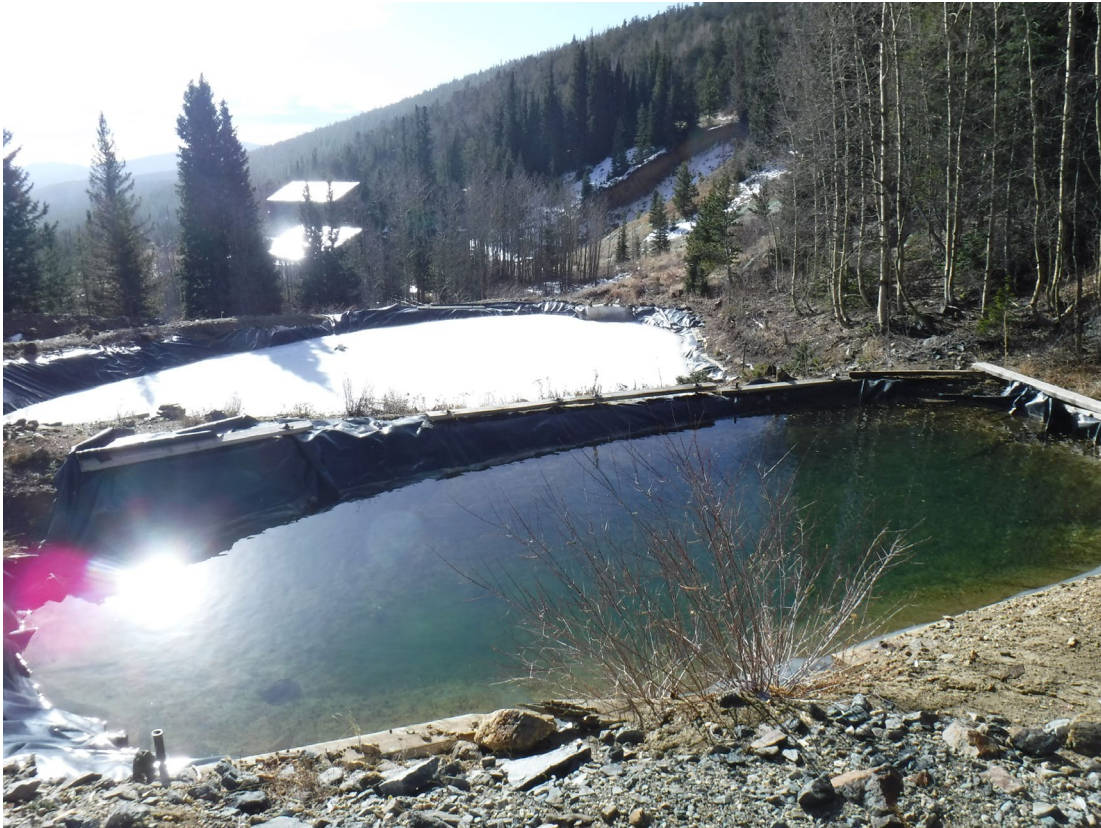
**Photo 3:** Ponds 3b and 3c

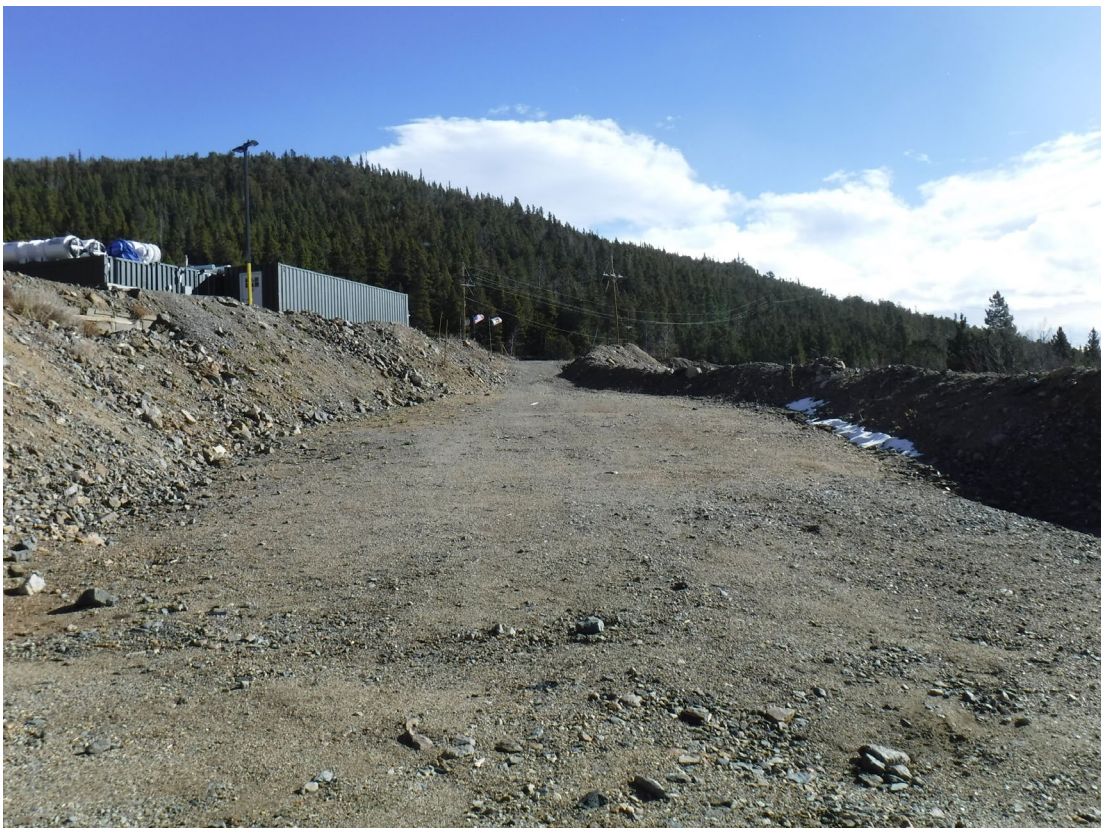
**Photo 4:** Service road leading down from the main office area to Pond 1

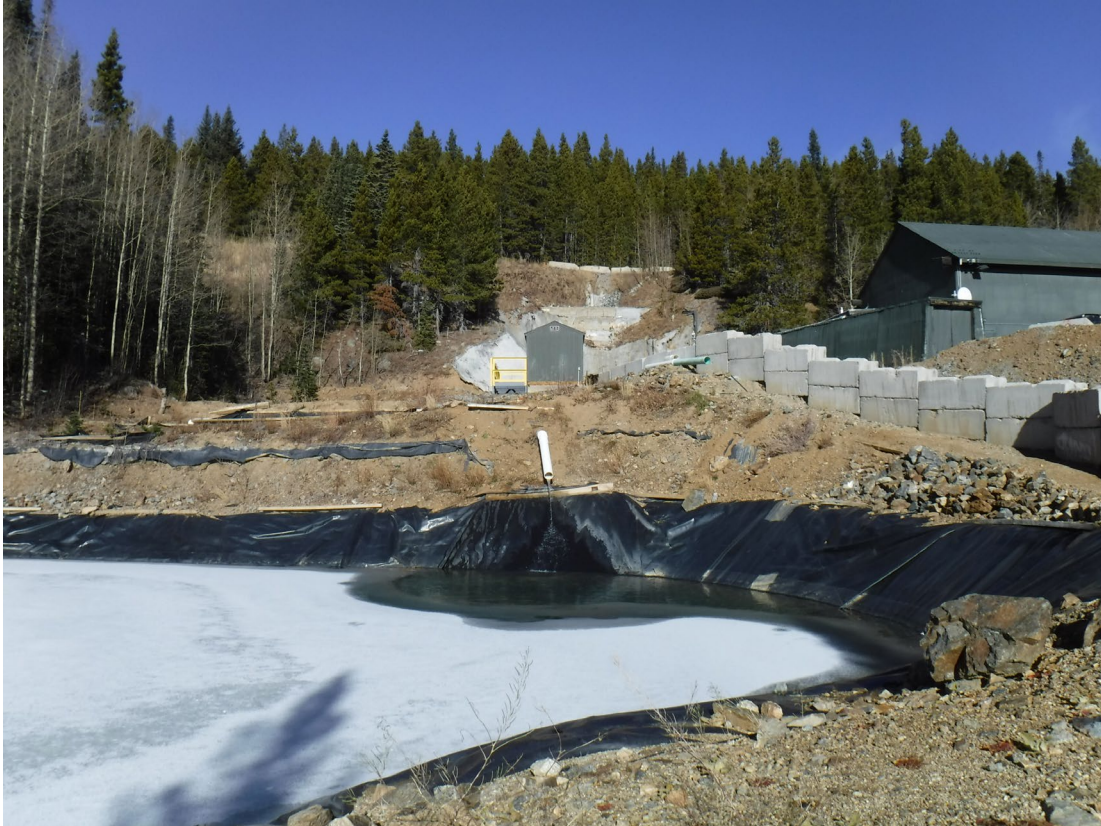
**Photo 5:** Looking towards the Idaho Tunnel from Pond 3c

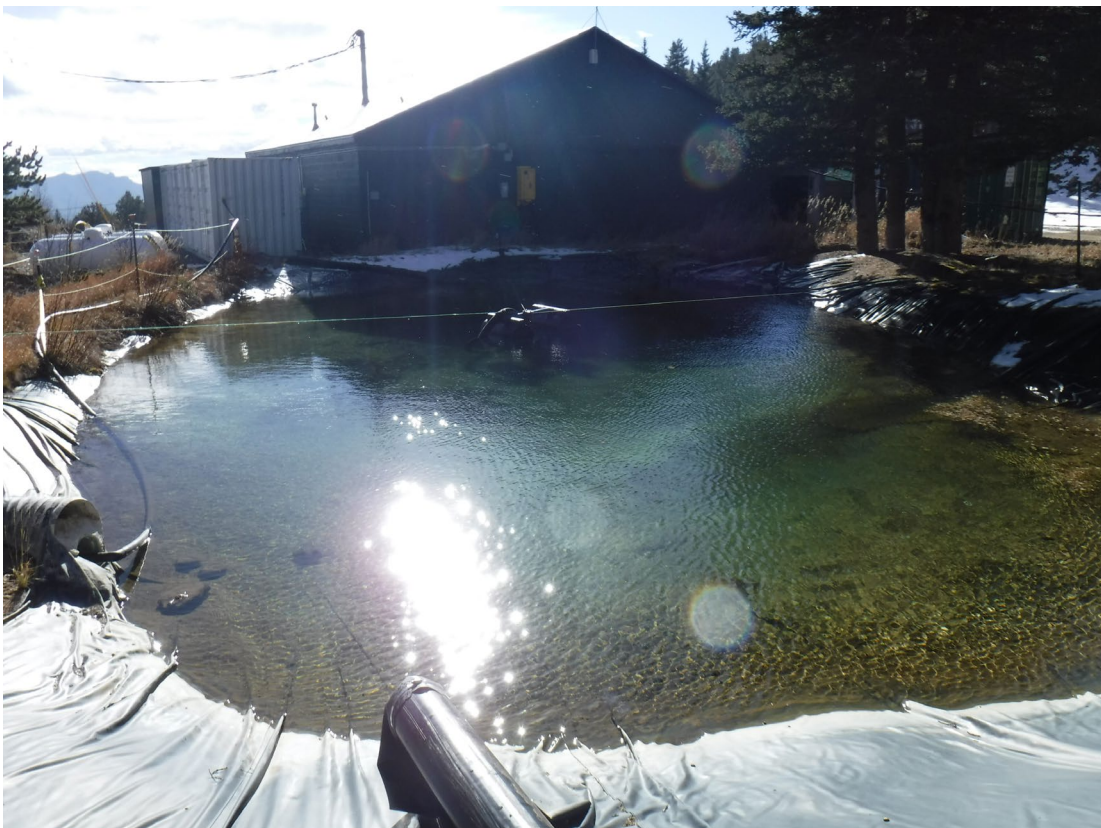
**Photo 6:** Pond 1

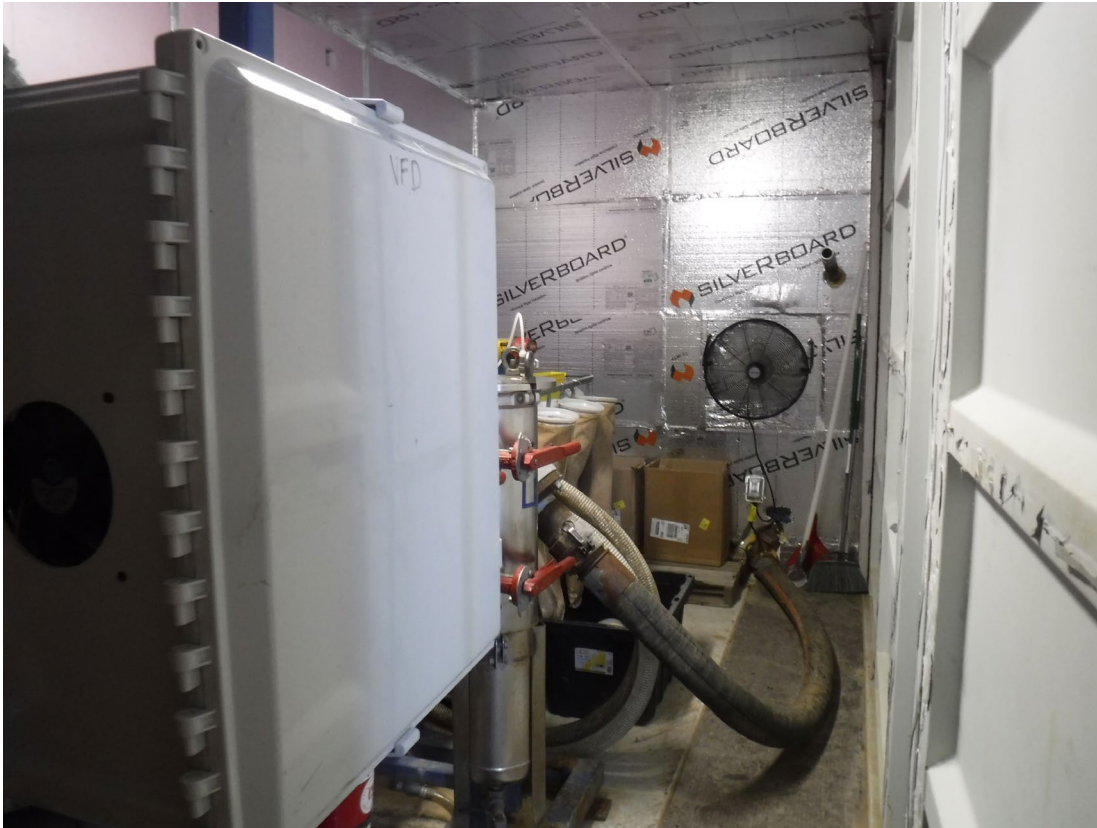
The water treatment plant was observed inside the heated conex boxes. The Division reiterated, from previous inspections, that when the Operator determines a proper disposable facility for sediment and discarded filters they need to provide the Division with the letter of acceptance from the facility along with the analytical results. It was also stated these similar documents were also needed for disposal of the water treatment sludge.

**Photo 7:** Inside water treatment facility

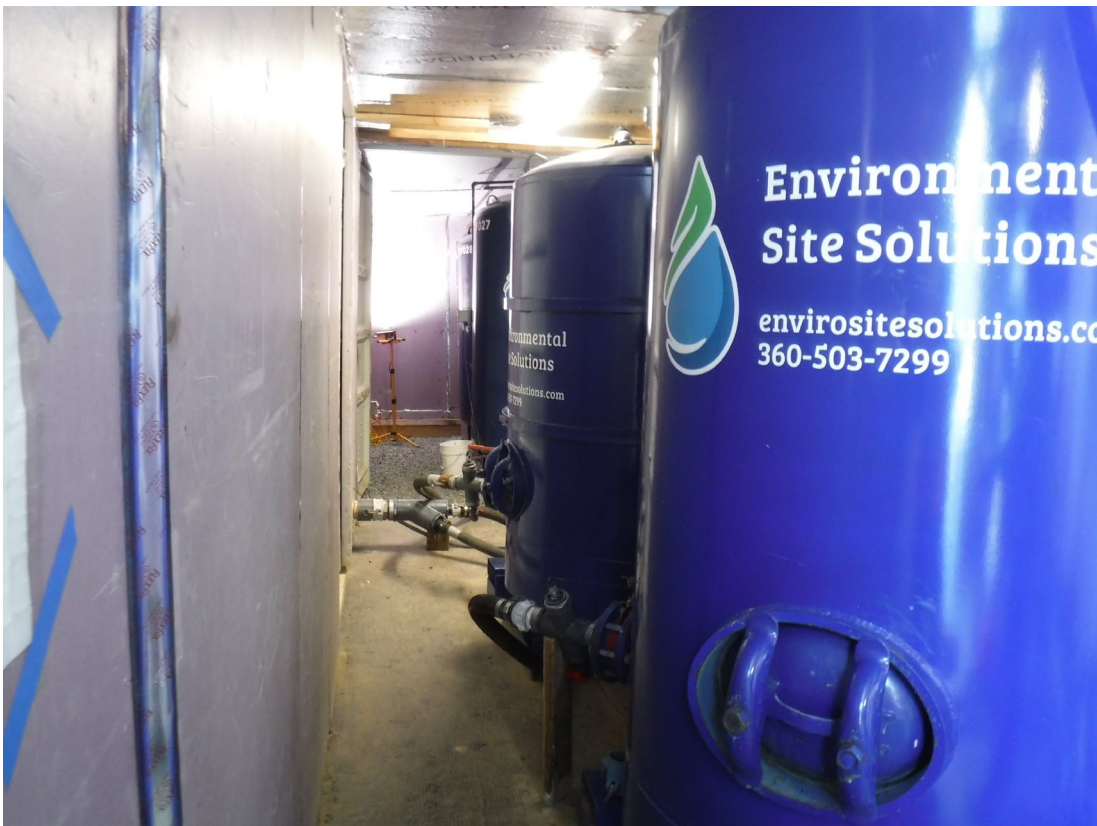
**Photo 8:** Inside water treatment facility

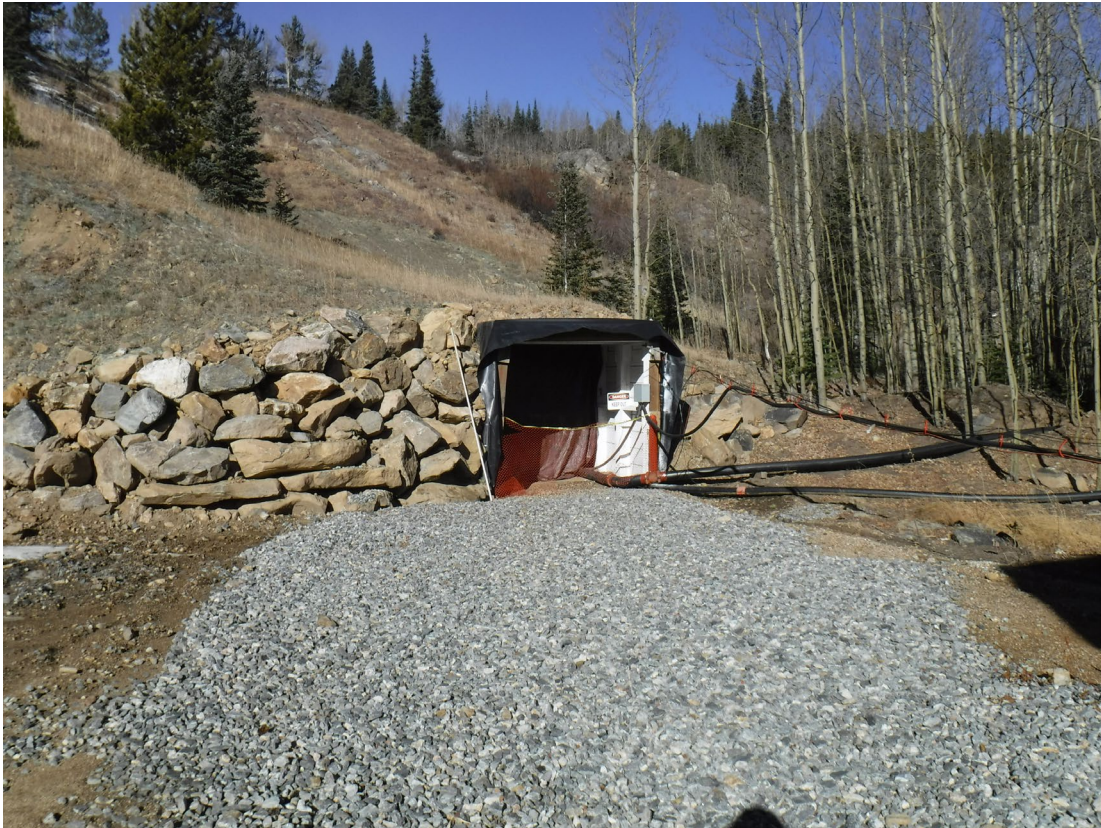
**Photo 9:** Cross Mine Tunnel entrance

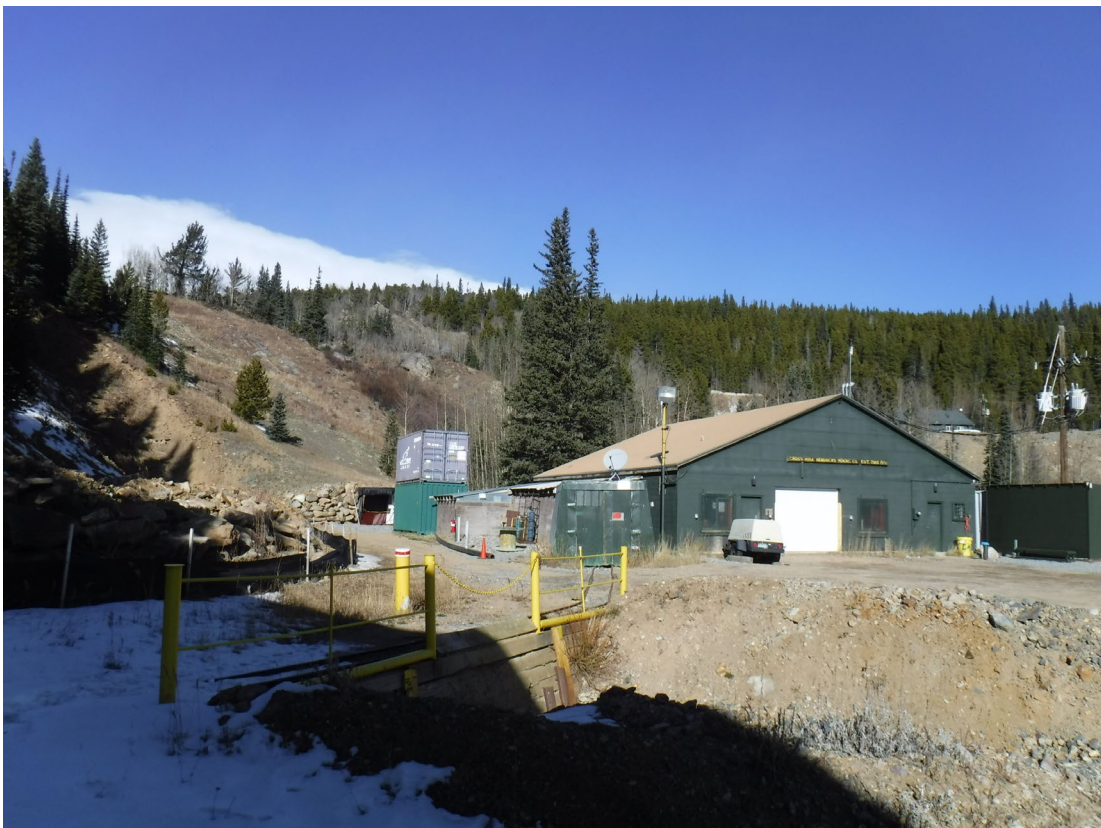
**Photo 10:** Looking north across the site from the warehouse
