MINERALS PROGRAM INSPECTION REPORT
PHONE: (303) 866-3567

MINE NAME: Sunny Side Gravel Pt	MINE/PROSPECTING ID#: M-1986-160	MINERAL: Sand and gravel	COUNTY: Mesa
INSPECTION TYPE: Monitoring	WEATHER: Clear	INSP. DATE: October 25, 2023	INSP. TIME: 09:50
OPERATOR: Kilgore Companies LLC dba Elam Construction	OPERATOR REPRESENTATIVE: None	TYPE OF OPERATION: 110c - Construction Limited Impact	
REASON FOR INSPECTION: Normal I&E Program	BOND CALCULATION TYPE: Complete Bond	BOND AMOUNT: \$93,264.38	
DATE OF COMPLAINT: NA	POST INSP. CONTACTS: DRMS	JOINT INSP. AGENCY: None	
INSPECTOR(S): Amy Yeldell	INSPECTOR'S SIGNATURE:

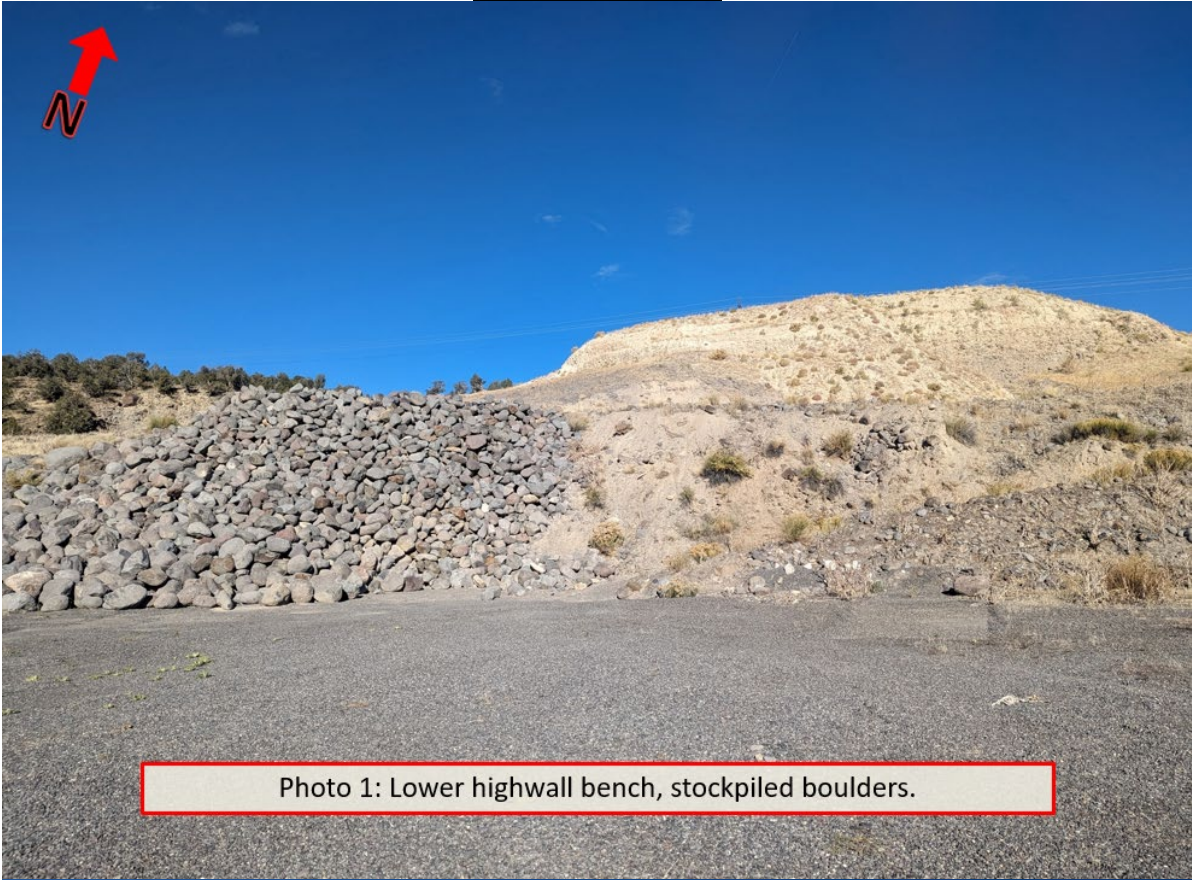
The site consists of two main benches. The lower highwall is approximately 30'H at a 1H: 1V slope and 600' wide (Photos One and Two). The bench can be pushed down. The bench between the highwalls is approximately 120' deep (Photo Three). The highwall above does not appear to have any recent mining. The upper highwall is approx. 100' high with slopes that vary from 1.5H: 1V to near vertical (Photos Four and Five).

Photo 1: Lower highwall bench, stockpiled boulders.

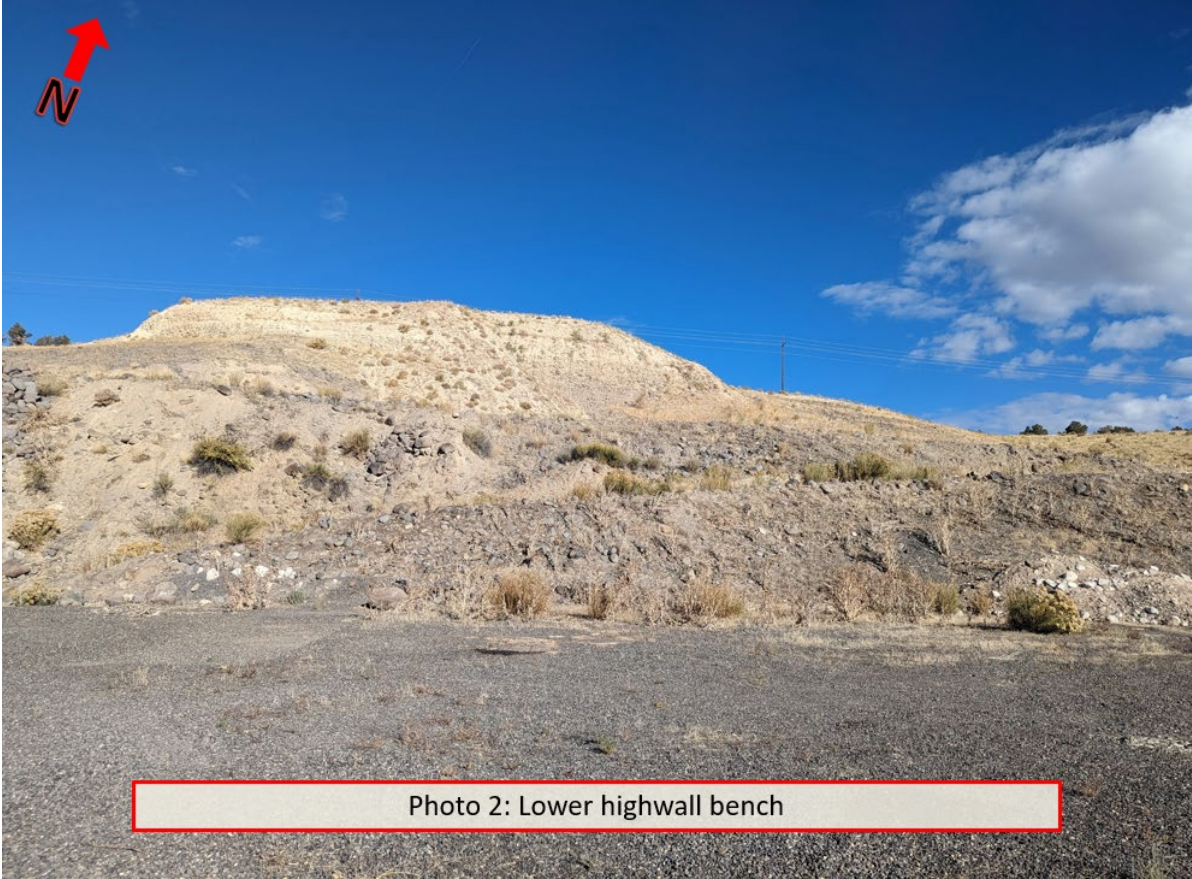
Photo 2: Lower highwall bench

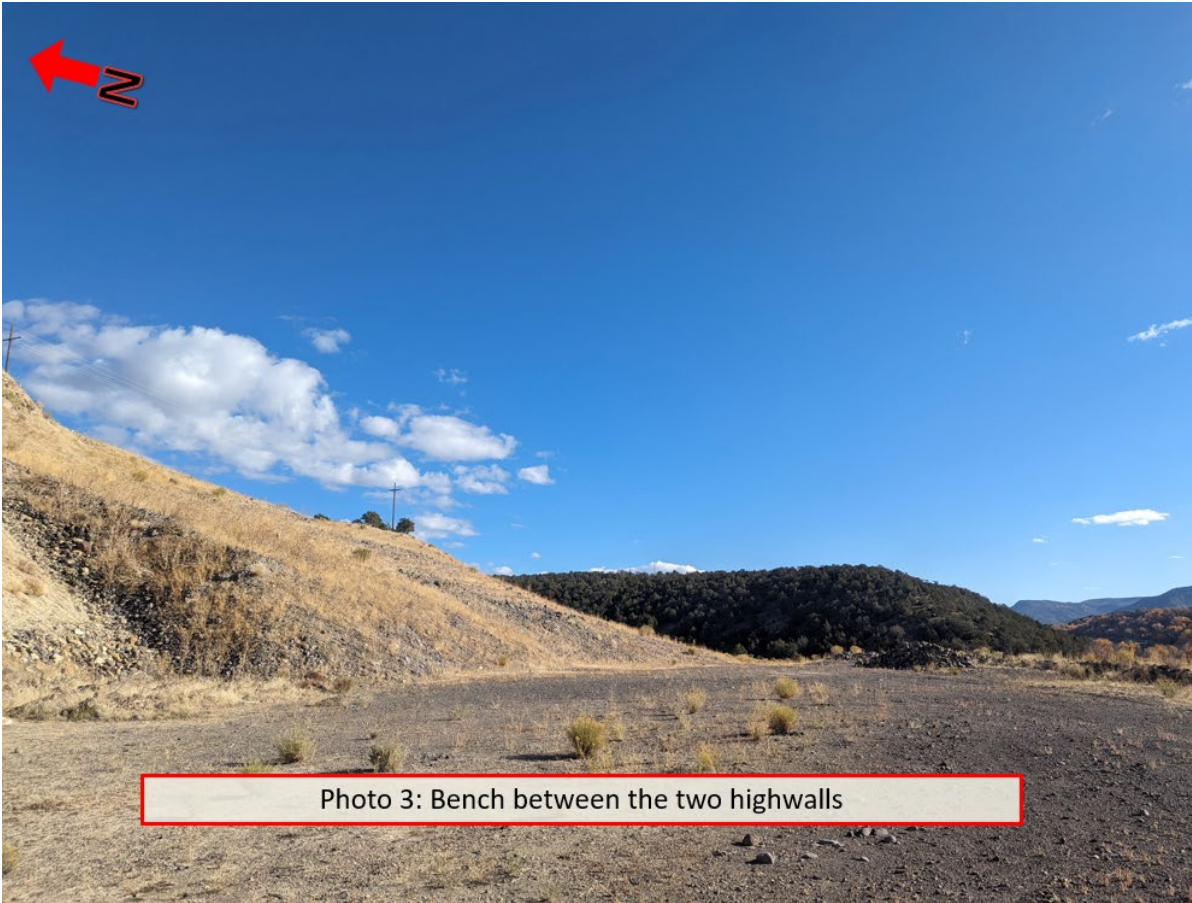
Photo 3: Bench between the two highwalls

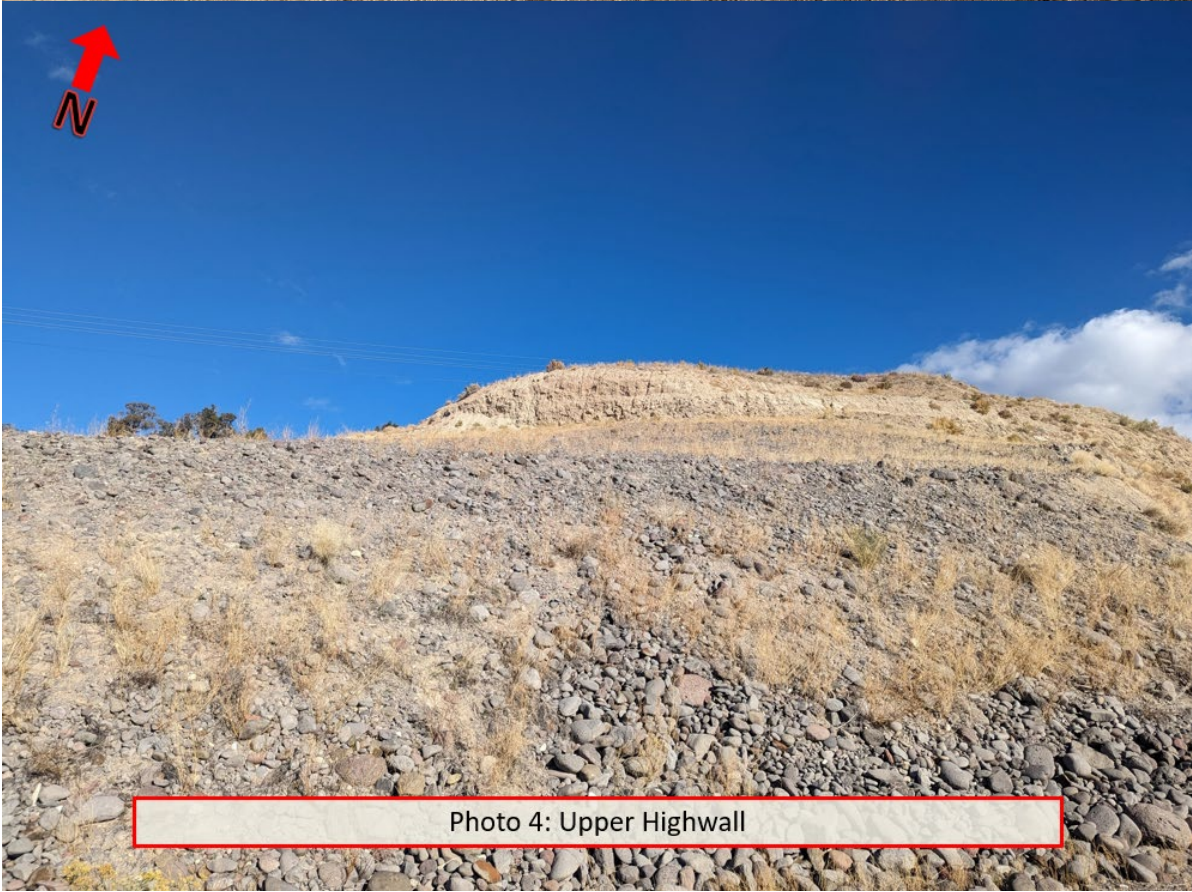
Photo 4: Upper Highwall

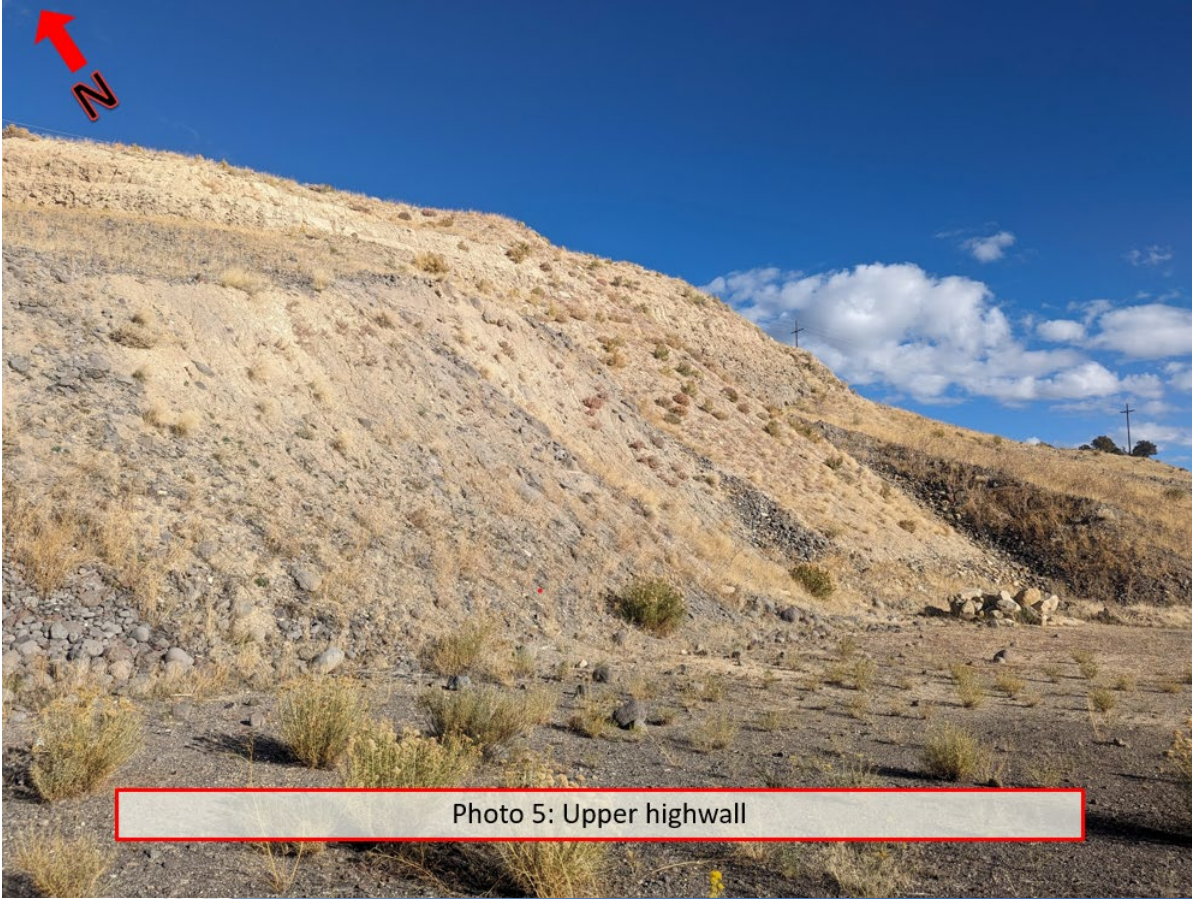
Photo 5: Upper highwall

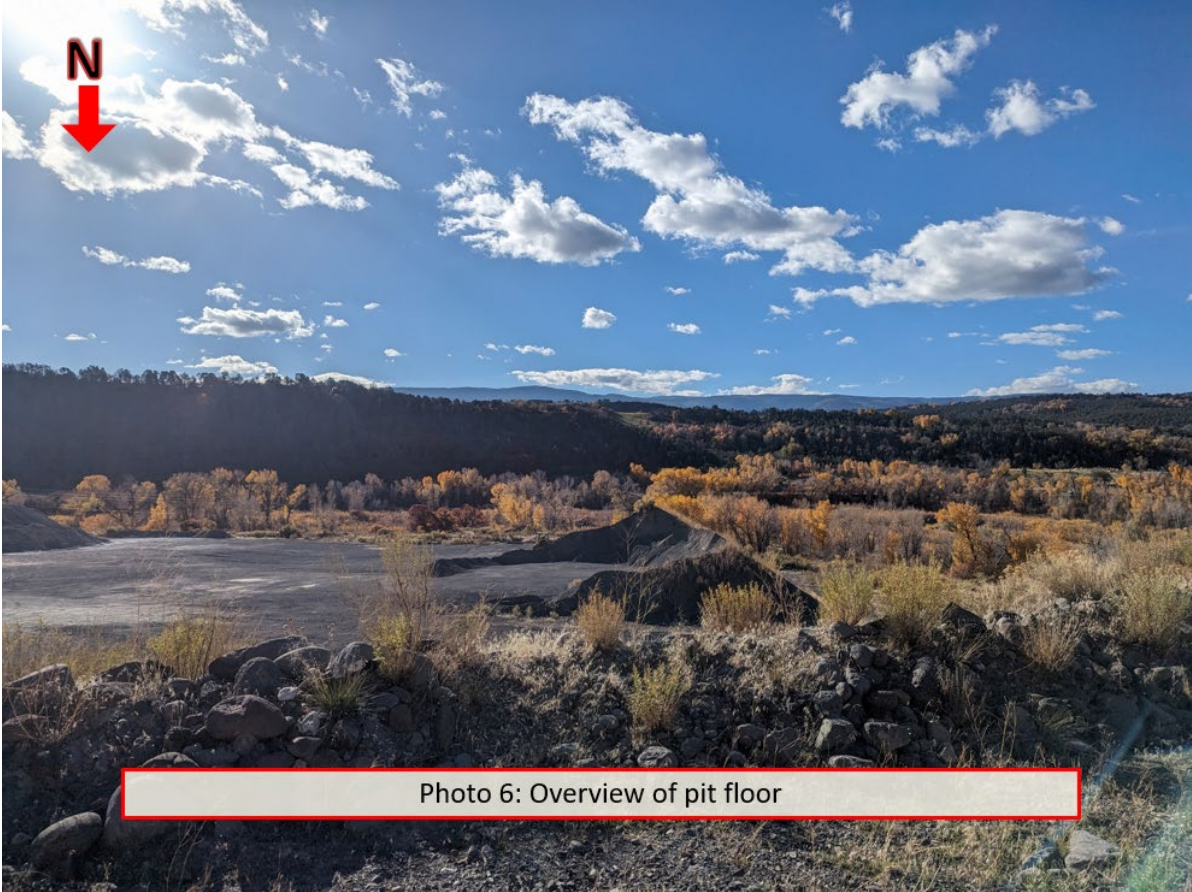
The southern portion of the pit is where processed materials are stockpiled (Photos Six and Seven). There are three main stockpiles of processed material. All stockpiles appear to be stable and neatly organized. A large pile of boulders is stored on the western highwall slope between the production bench and the processing stockpile area (Photo One). The site is approved for an asphalt hot mix plant, however none was present on site or evidence of recent use.

Photo 6: Overview of pit floor

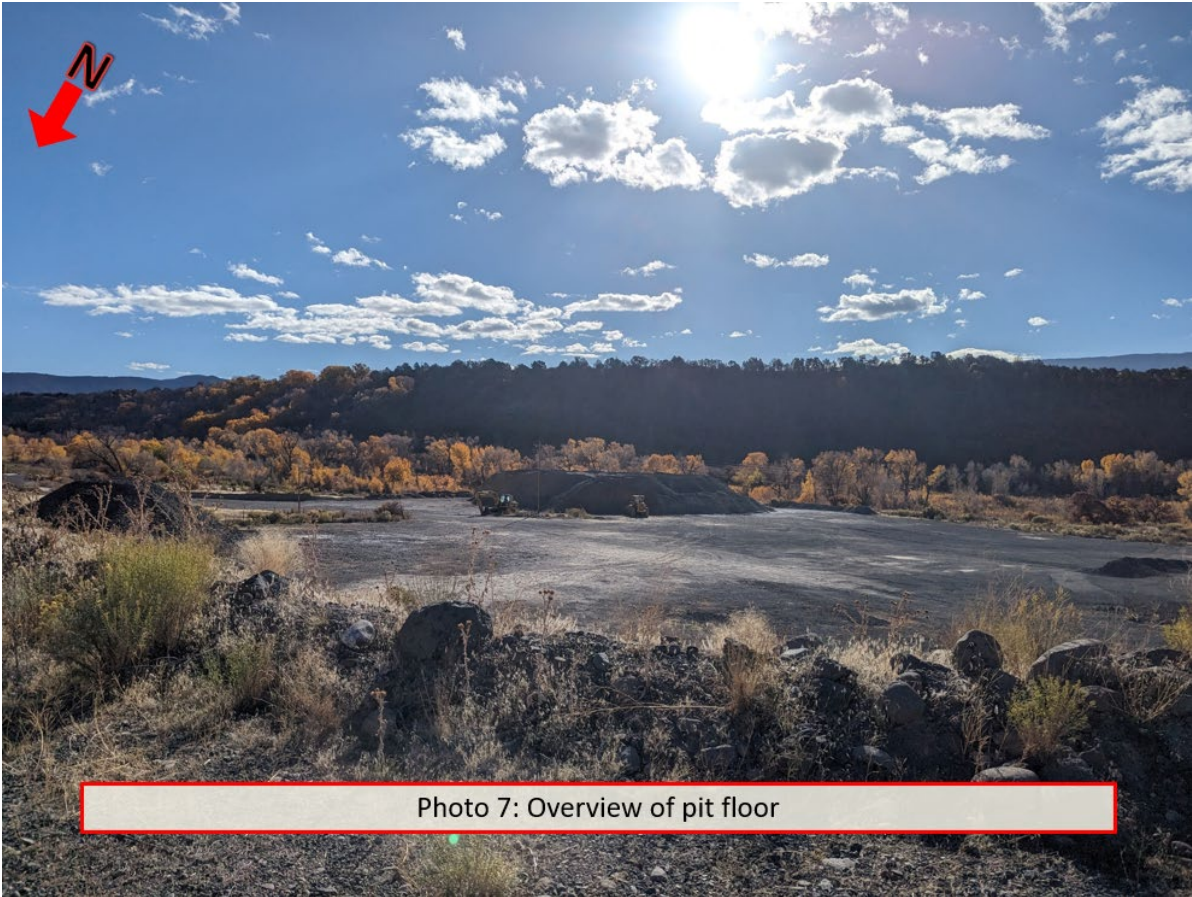
Photo 7: Overview of pit floor

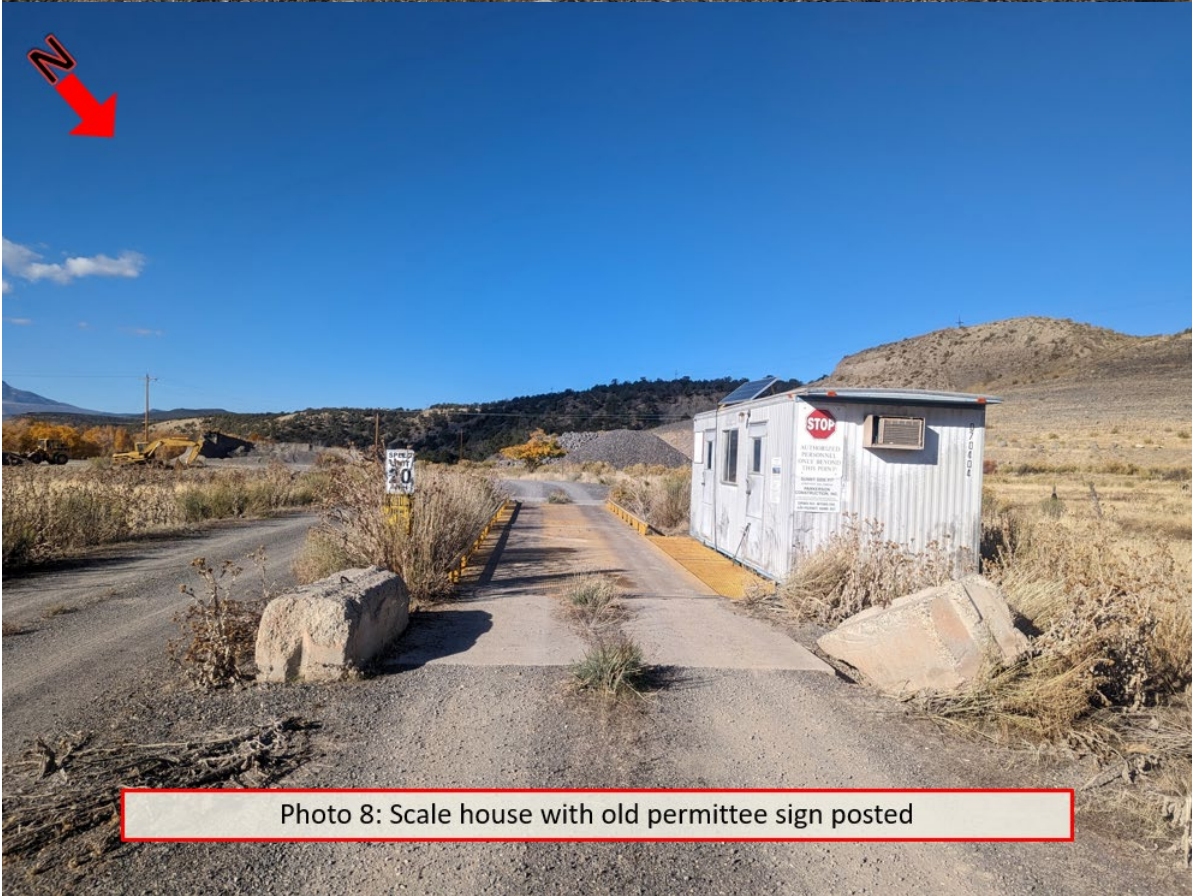
PROBLEM: The mine identification sign and affected area boundary markers were not observed per the requirements of Rule 3.1.12. The Operator shall, at the entrance of the mine site post a sign, which shall be clearly visible from the access road, with a minimum size equaling one hundred and eighty-seven (187) square inches, such as eleven (11) inches in height and seventeen (17) inches in width, with appropriate font size, with the following: the name of the Operator, a statement that a reclamation permit for the operation has been issued by the Colorado Mined Land Reclamation Board; and the permit number. The permit boundary should be delineated by markers.

A mine sign was posted at the entrance to the mine site as required by Rule 3.1.12(1). The information depicted was incorrect as it still displays the previous Operators name (Photo Eight). This is cited as an inspection problem. Please replace or update the sign.

Photo 8: Scale house with old permittee sign posted

CORRECTIVE ACTIONS: The operator must post a sign at the entrance to the mine site which shall be clearly visible from the access road and specify the following; the name of the operator, indicate that a reclamation permit for the operation has been issued by the Colorado Mined Land Reclamation Board, and the permit number. The boundaries of the affected area must be marked by monuments or other markers that are clearly visible and adequate to delineate such boundaries.

CORRECTIVE ACTION DUE DATE: 1/19/24
