## **APPENDIX E – WEEKLY REPORTS**

## FIELD WEEKLY PROGRESS REPORT

**PROJECT:** VALLEY LEACH FACILITY 2 PHASE 3 2023 QUALITY ASSURANCE OVERSIGHT  
**SITE:** CRIPPLE CREEK & VICTOR GOLD MINE (COLORADO)  
**CONTRACTOR:** NEWMONT CC&V MINING OPERATIONS  
JHL CONSTRUCTORS  
KELLEY TRUCKING INC.  
**WEEK ENDING:** FRIDAY, APRIL 21, 2023

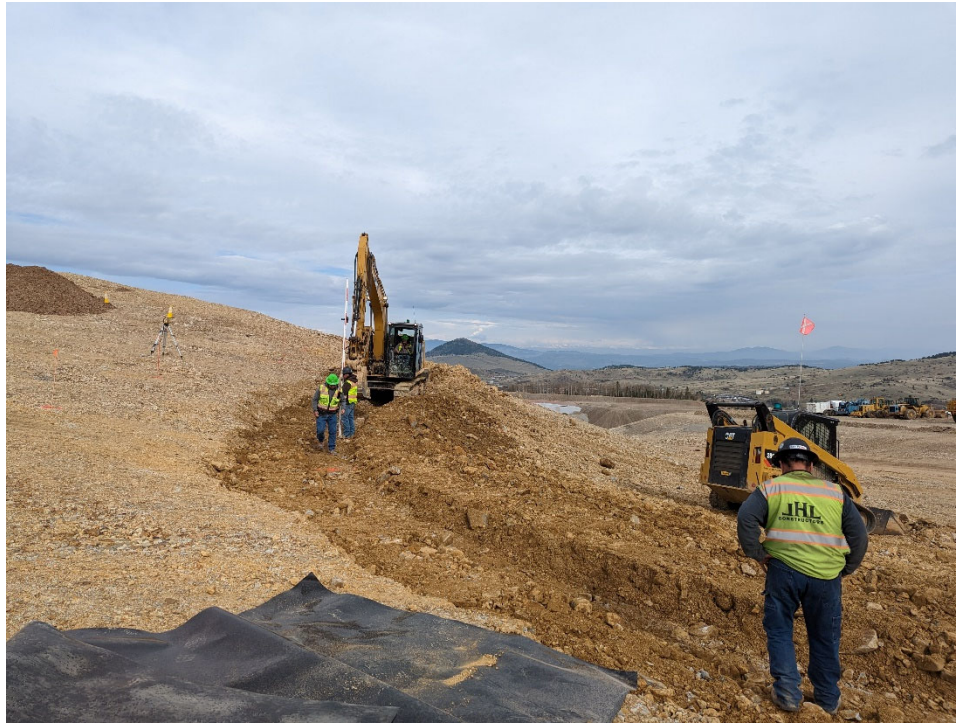
**May 22, 2023 – Anchor trench exposure at the VLF2 tie-in**

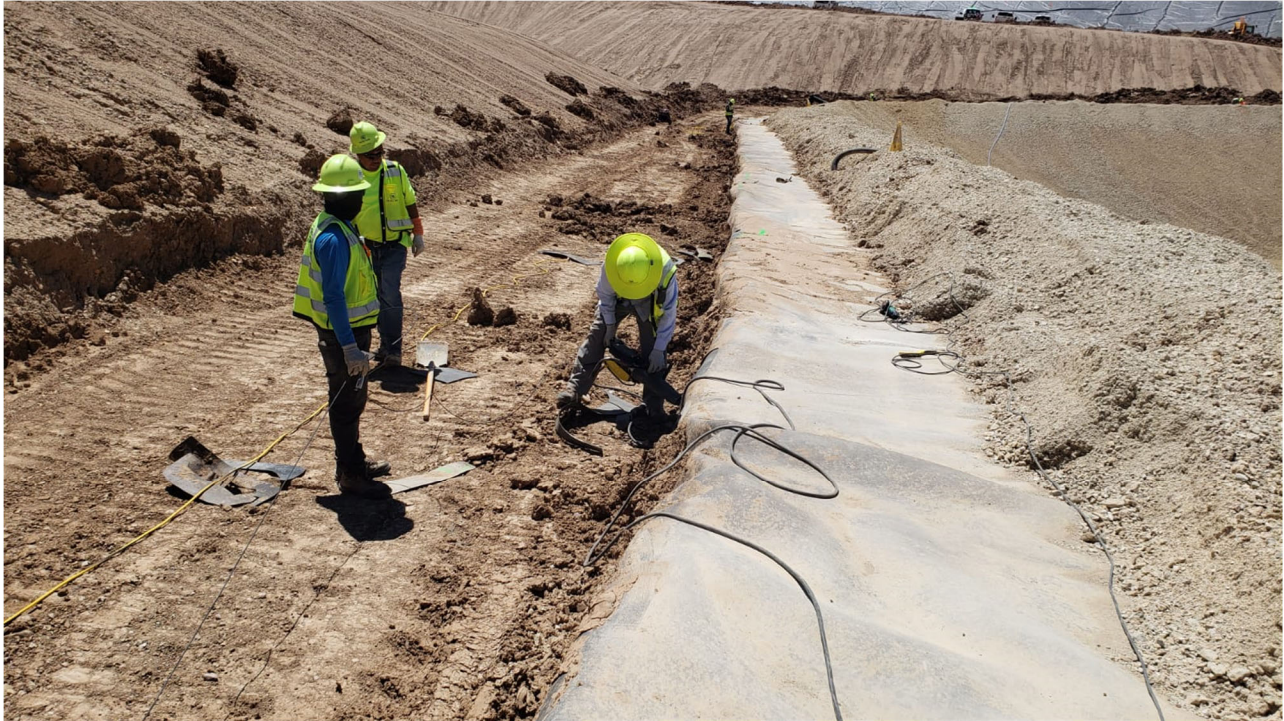
- NewFields personnel requested that any damaged 100-mil geomembrane along the 10,000' bench be repaired before the 80-mil deployment began on the slopes above the PSSA. Damages were exposed completely, including by excavating SLF material and patched with 100-mil geomembrane using the extrusion welding method. Vacuum testing took place on all

**June 25, 2023 – 100-mil geomembrane repair on 10,000' bench**

repaired areas. Once the inspection and repair activities were complete, new SLF material was placed back and compacted in the excavated areas.

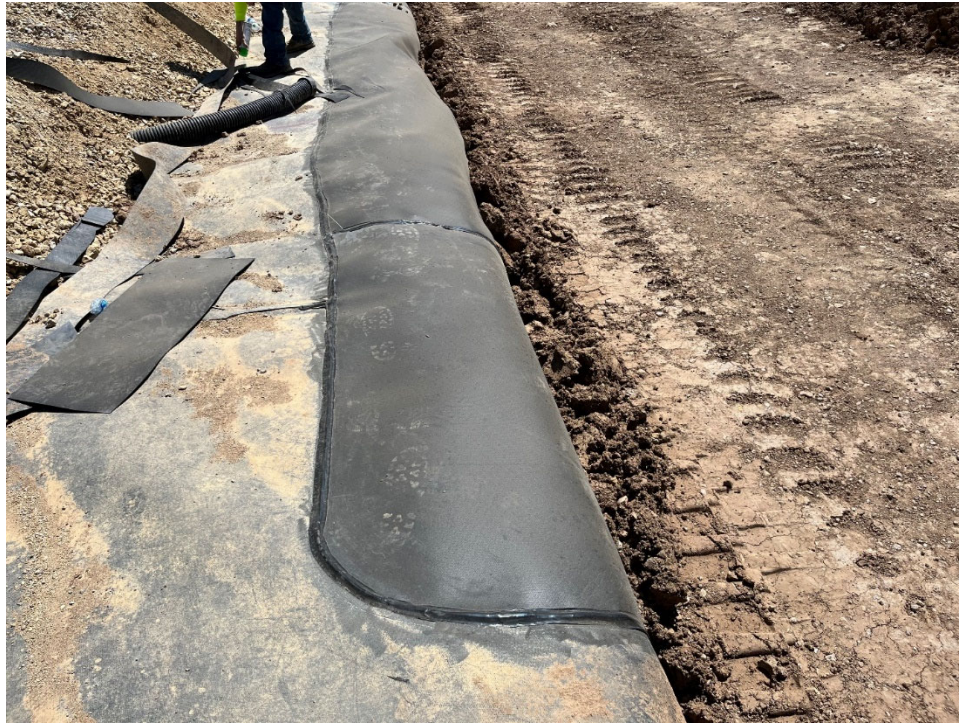
**June 27, 2023 – 100-mil geomembrane repair on 10,000' bench**

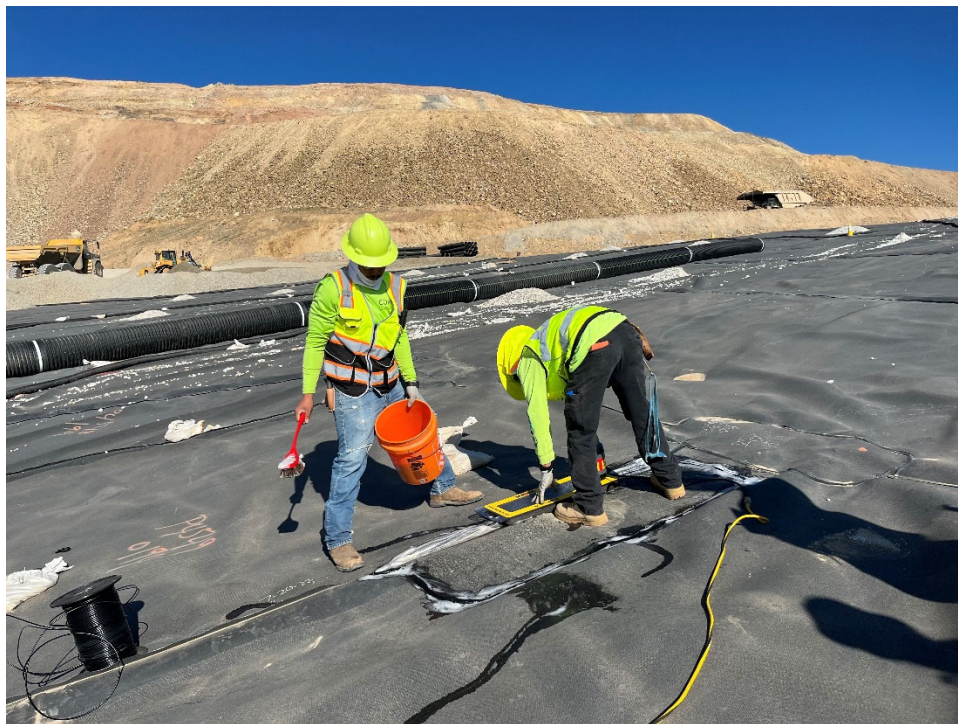
**August 14, 2023 – Vacuum testing of LLDPE repairs**

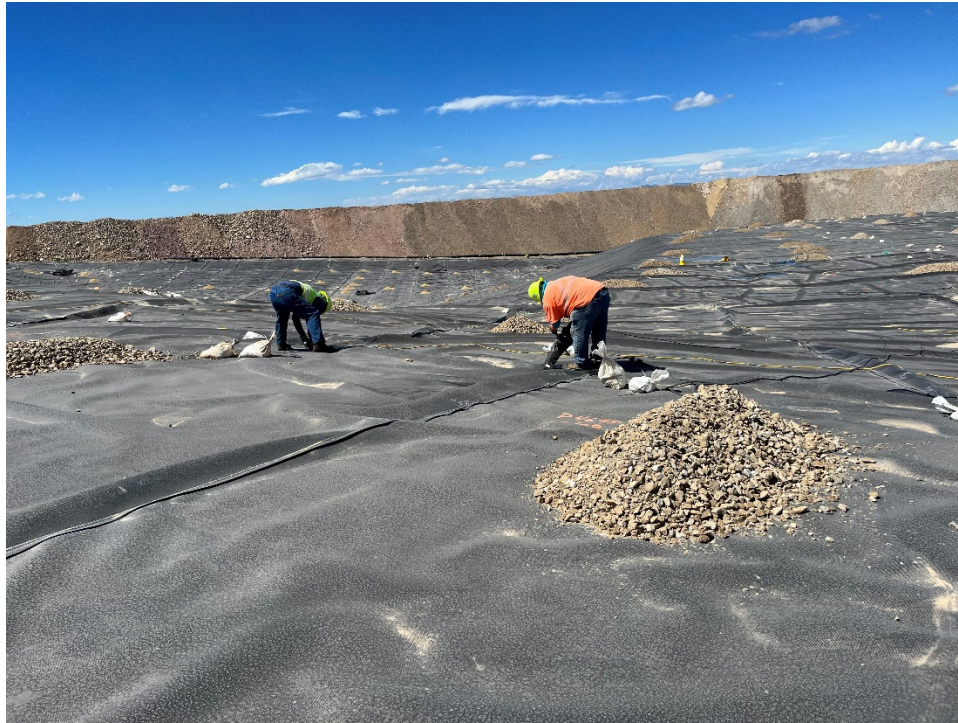
**August 18, 2023 – Extrusion welding of LLDPE defects**

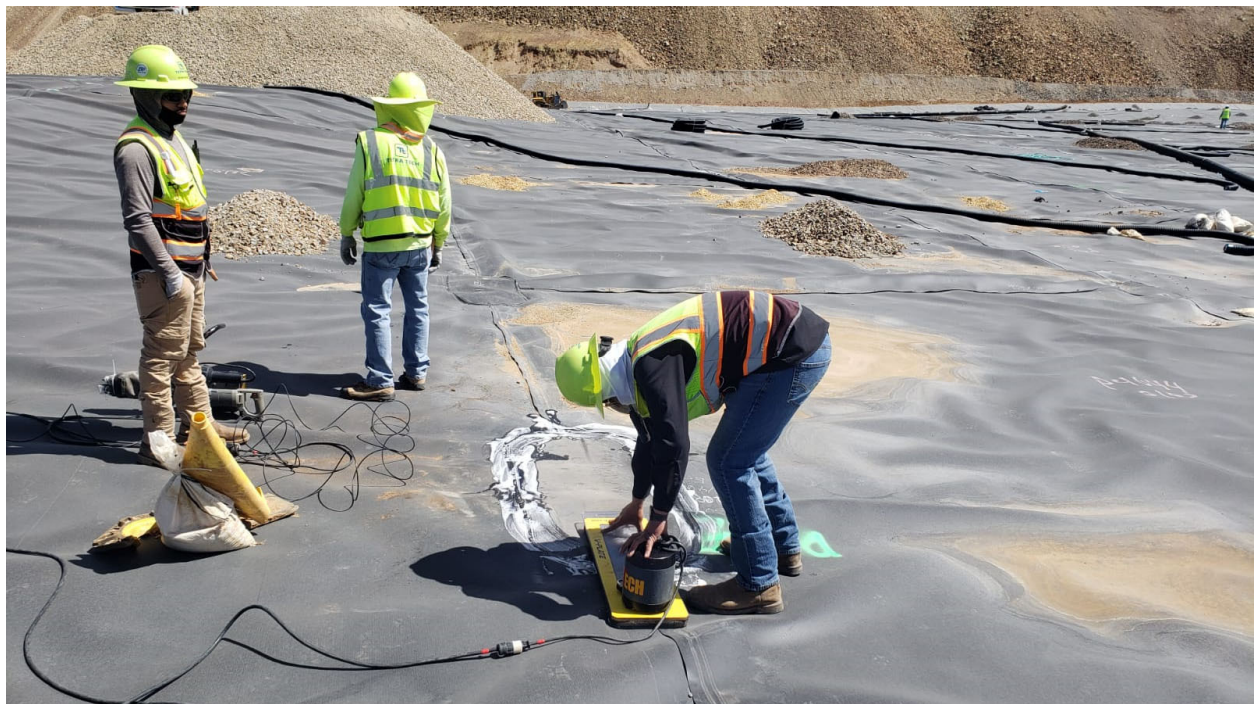
**September 5, 2023 – Vacuum testing of LLDPE repairs**
