MINERALS PROGRAM INSPECTION REPORT

MINE NAME: Ewing Gravel Pit	MINE/PROSPECTING ID#: M-2023-033	MINERAL: Sand and gravel	COUNTY: Weld
INSPECTION TYPE: Preoperation Inspection	WEATHER: Clear	INSP. DATE: November 15, 2023	INSP. TIME: 09:30
OPERATOR: BURNCO Colorado, LLC	OPERATOR REPRESENTATIVE: Devon Glosser	TYPE OF OPERATION: 112c - Construction Regular Operation

This was a pre-operation inspection for the proposed BURNCO Ewing Gravel Pit (M2023-033) application currently under review by DMRS. The application is for a proposed 116 acre sand and gravel operation located on the west side of Hwy 85, between the highway and the South Platte River, and approximately one mile north of Ft Lupton. The inspection was conducted by Eric Scott of DRMS, who met BURNCO representative Devon Glosser, and BURNCO permitting consultant Ben Lewicki of Lewicki and Associates at the site entrance at approximately 9:30.

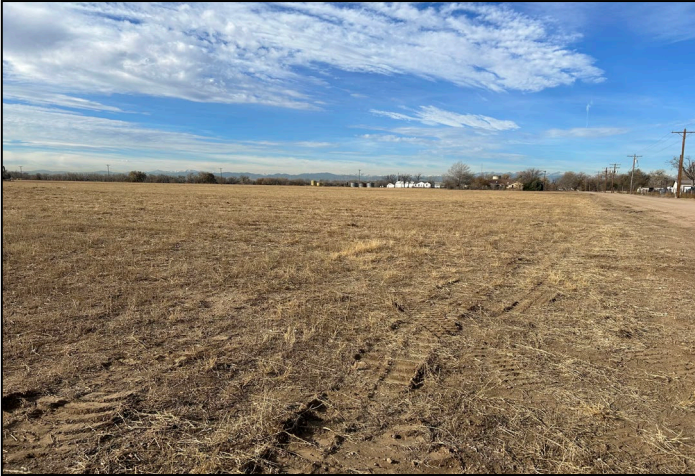
Photo 1 – Photo of existing cropland taken looking west from site access point near Hwy 85.

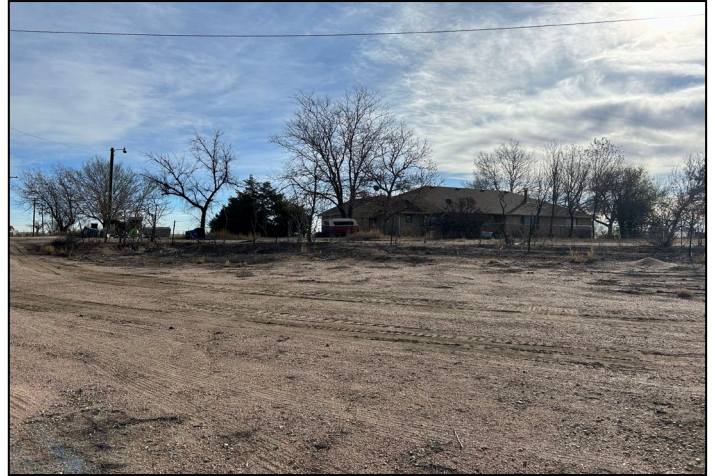
The site is currently primarily cropland, with some farm buildings and residential structures located in the north-center permit area (see attached photos). DRMS was informed that the structures have been vacated, and would be removed from the site prior to mining with the exception of a steel building in good condition that may be retained as a shop for the site. Several gas and oil structures, an irrigation ditch, and several wells owned by Excel for cooling water supply are also present within the proposed permit area and have been accurately shown on the existing conditions map.

Photo 2 – Photo of existing vacant residence in north center of proposed permit area.

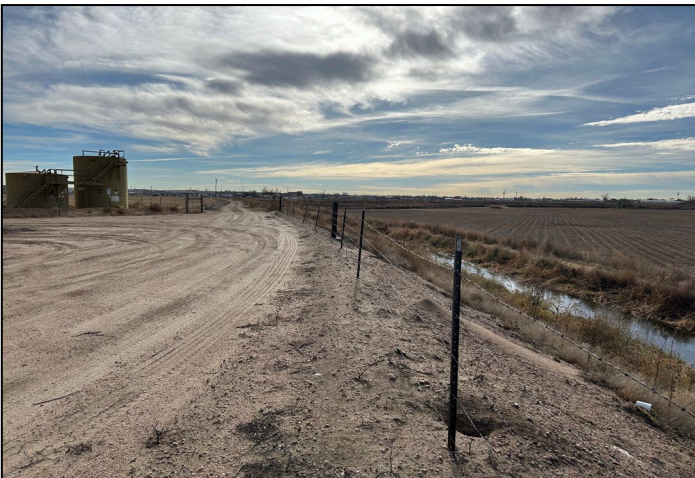
Photo 3 – Photo of some existing gas and oil structures and irrigation ditch located south of structures near north center of proposed permit.

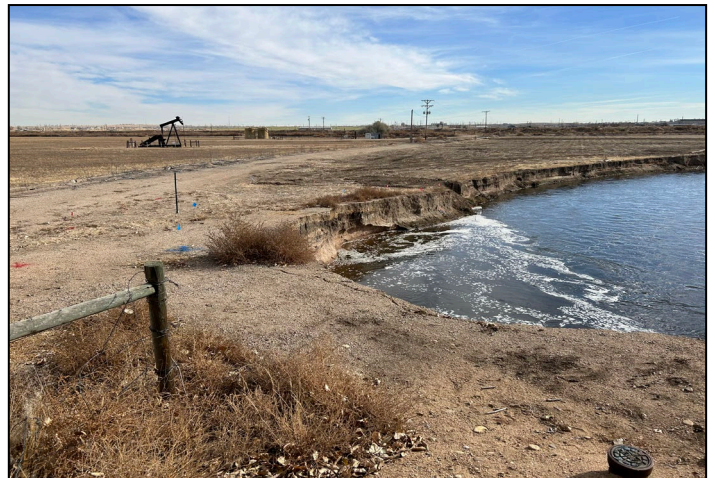
Photo 4 – Area of existing active bank scouring on north bank of Platte River near south center of proposed permit.
