**MINERALS PROGRAM INSPECTION REPORT**  
**PHONE: (303) 866-3567**

<b>MINE NAME:</b> North LaPoudre Pit	<b>MINE/PROSPECTING ID#:</b> M-2000-144	<b>MINERAL:</b> Sand and gravel	<b>COUNTY:</b> Weld
<b>INSPECTION TYPE:</b> Monitoring	<b>WEATHER:</b> Clear	<b>INSP. DATE:</b> November 15, 2023	<b>INSP. TIME:</b> 12:00
<b>OPERATOR:</b> Bestway Concrete Company (BURNCO)	<b>OPERATOR REPRESENTATIVE:</b> Devon Glosser	<b>TYPE OF OPERATION:</b> 112c - Construction Regular Operation

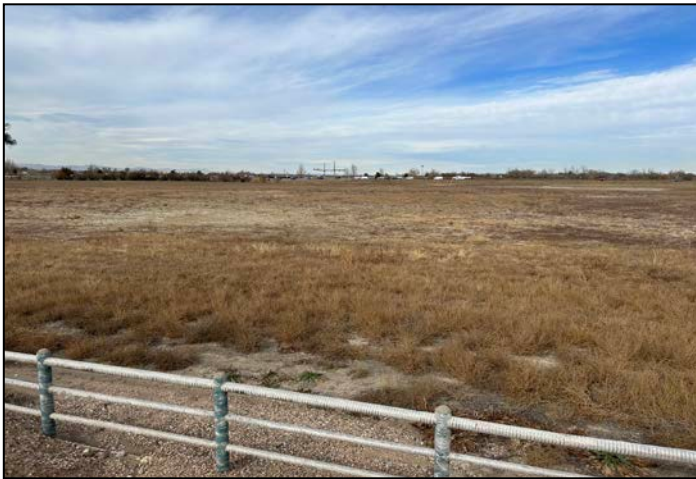
DRMS toured the site with the Mr. Glosser. The approximately 20 acres that was amended to the west end of the permit has been mined out, and has been backfilled to original grade as approved. No mining activity was observed within the permit area. In addition, the 2023 SWSP submitted and approved for the site indicates that no additional material excavation will take place in this permit. Based on this information, DRMS has concluded that mining activity has ended at the North LaPoudre permit. The current post-mining land use for this site is pastureland.

**Photo 1 - Photo taken from parking area looking NW at backfilled area in NW permit area. Reclamation vegetation will need to be established across the site.**

As summarized on the first page of this report, Rule 34-32.5-112(6) states: "Reclamation shall be completed within five years after the date...of construction material extraction has been completed..." This requirement is reiterated in section 34-32.5-116 (4) (q). Therefore, the current reclamation plan needs to be implemented and updated pursuant to C.R.S. 34-32.5-116 (1). The operator must provide sufficient information to describe or identify how the operator intends to conduct reclamation - this includes the reclamation of the existing exposed

groundwater areas. The operator shall submit a Technical Revision, with the required \$216 revision fee, which will provide sufficient detail as to how the site will be reclaimed, including addressing existing exposed groundwater areas within the permit area, and an enforceable timeline to complete the remaining required reclamation, by the corrective action date.

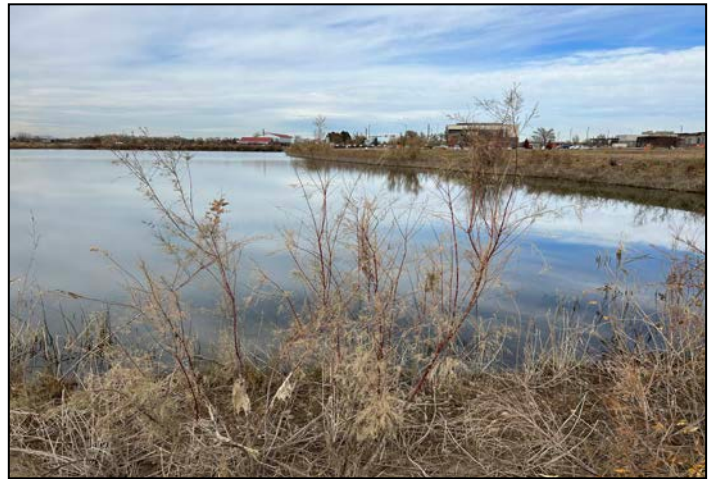
**PROBLEM/POSSIBLE VIOLATION:** Problem: Russian olive and Tamarisk trees are present within or have volunteered into the permit area and are becoming established. This is a problem for failure to employ the existing weed control plan and weed control methods for a state listed noxious weed species within the permitted area, and to reduce the spread of weeds to nearby areas as required by Section 3.1.10 (6) of the rule.

Also as noted previously in his report, as well as in the 2020 inspection report, Tamarisk and several other noxious weeds were noted during this inspection. These noxious species will need to be eliminated from the permit area, and proof of this will need to be provided to the Division by the listed corrective action date of 5/31/24. Additional weed control measures, mowing at a minimum, and likely spraying as needed, will need to be implemented to control noxious weeds within the permit area until the permit can be released.

**Photo 2 – Tamarisk trees growing on bank of exposed groundwater area in center of permit area. Tamarisk and Russian Olive trees will need to be eliminated from permit area.**

**CORRECTIVE ACTIONS:** The operator shall implement the existing weed control plan, eliminate the Russian Olive and Tamarisk present on site, and provide proof to the Division that this has been done, by the corrective action date.
