MINERALS PROGRAM INSPECTION REPORT
PHONE: (303) 866-3567

MINE NAME: Climax Mine	MINE/PROSPECTING ID#: M-1977-493	MINERAL: Molybdenum	COUNTY: Lake, Summit
INSPECTION TYPE: Aerial Inspection	INSPECTOR(S): Dustin Czapla	INSP. DATE: November 14, 2023	INSP. TIME: 15:20
OPERATOR: Climax Molybdenum Company	OPERATOR REPRESENTATIVE:	TYPE OF OPERATION: 112d-3 - Designated Mining Operation	
REASON FOR INSPECTION: Normal I&E Program	BOND CALCULATION TYPE:	BOND AMOUNT: \$91,011,850.00	
DATE OF COMPLAINT: NA	POST INSP. CONTACTS: None	JOINT INSP. AGENCY: None	
WEATHER: Clear	INSPECTOR'S SIGNATURE:

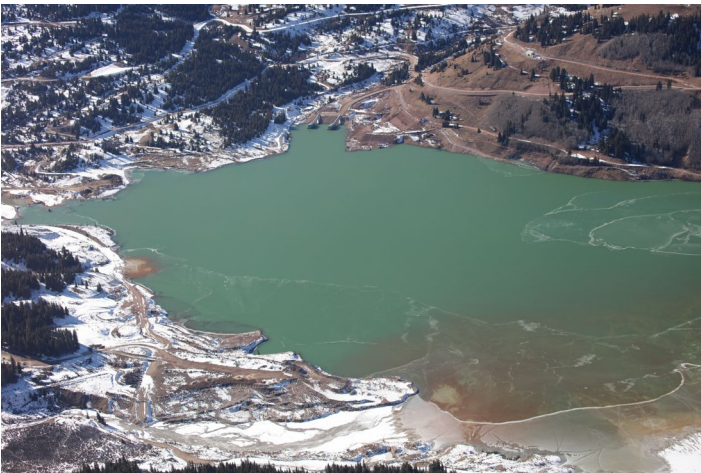
The Mayflower TSF and 5 Dam, Tenmile TSF and 3 Dam, Robinson TSF and 1 and 2 Dams, Robinson Lake, Eagle Park Reservoir and 4 Dam were observed. No abnormal conditions were noted. TSF's appear to be functioning within the established design criteria.

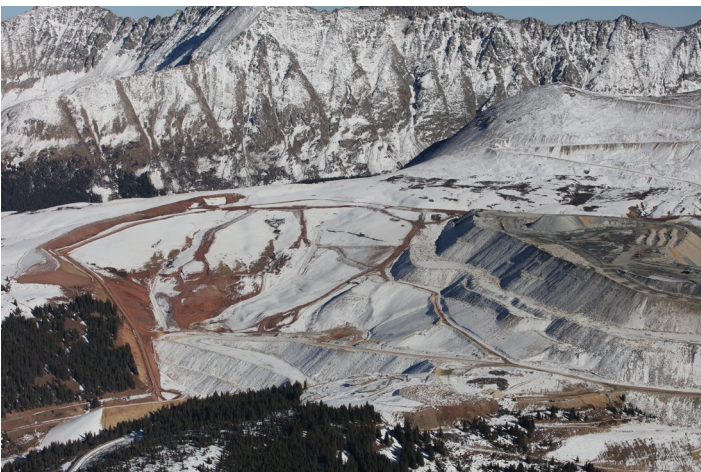
McNulty OSF

The McNulty and North 40 OSF's were observed. No abnormal conditions were noted. OSF's appear to be functioning within the established design criteria.
