MINERALS PROGRAM INSPECTION REPORT
PHONE: (303) 866-3567

MINE NAME: Woodring Pit	MINE/PROSPECTING ID#: M-1978-323	MINERAL: Sand and gravel	COUNTY: Mesa
INSPECTION TYPE: Monitoring	WEATHER: Clear	INSP. DATE: October 25, 2023	INSP. TIME: 10:30
OPERATOR: Kilgore Companies LLC dba Elam Construction	OPERATOR REPRESENTATIVE: None	TYPE OF OPERATION: 112c - Construction Regular Operation	
REASON FOR INSPECTION: Normal I&E Program	BOND CALCULATION TYPE: Complete Bond	BOND AMOUNT: \$284,766.42	
DATE OF COMPLAINT: NA	POST INSP. CONTACTS: DRMS	JOINT INSP. AGENCY: None	
INSPECTOR(S): Amy Yeldell	INSPECTOR'S SIGNATURE:

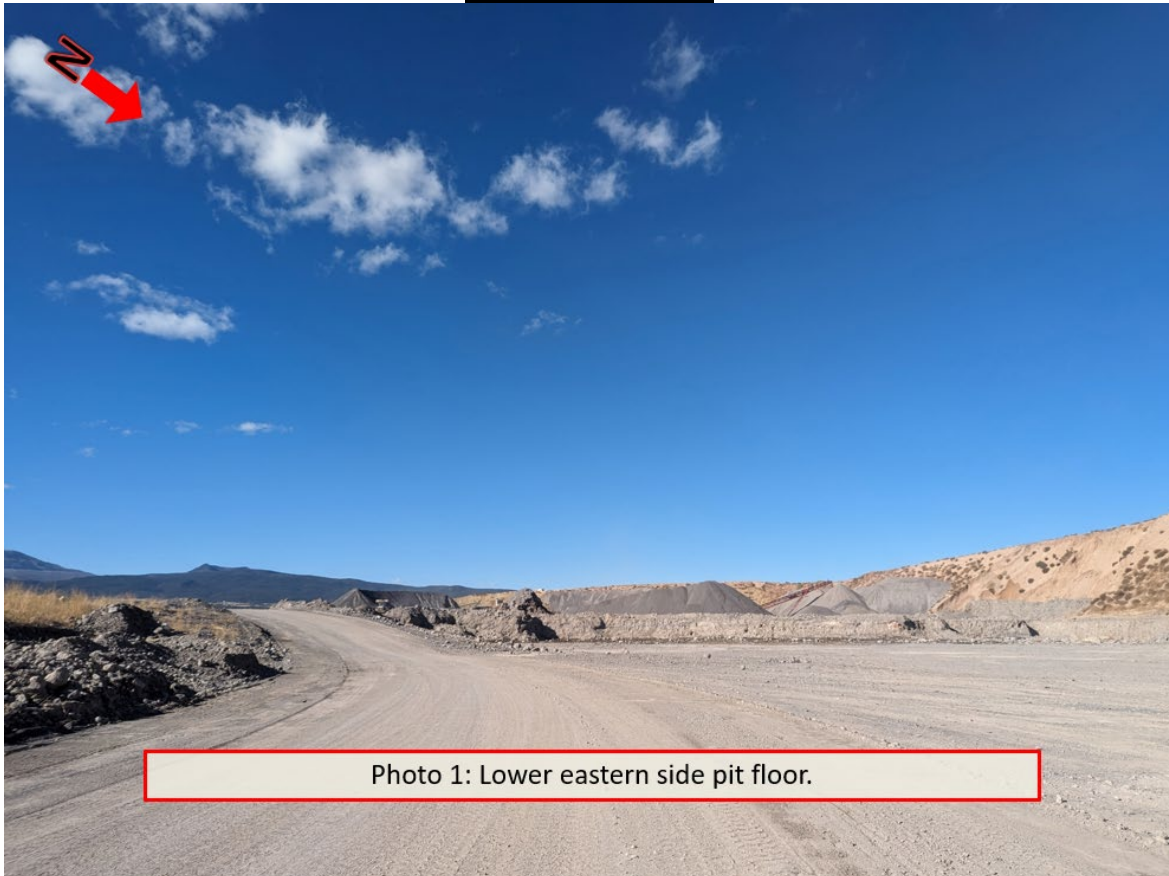
Recent mining is occurring along the northeast highwall. The pit floor on the east side of the pit is lower than the western half of the pit (Photo One). The slopes are near vertical and approaching the permit boundary in the northeast corner (Photo Two). The highwall is estimated to be 70' high and 500' long. A smaller bench is also present on the far east side that is approximately 20' high, near vertical and 150' long (Photo Three). The highwall to the east above the bench is approx. 2H:1V. The more northwestern slopes are slightly shorter as the pit floor has not yet been dropped down. The western highwalls are approximately a 1H: 1V (Photo Four). The internal highwalls between the pit floor benches are also near vertical. There is also a small highwall on the southern side of the pit between the haul road and the pit that is a 1H: 1V. for final reclamation all slopes need to be 2H: 1V or less.

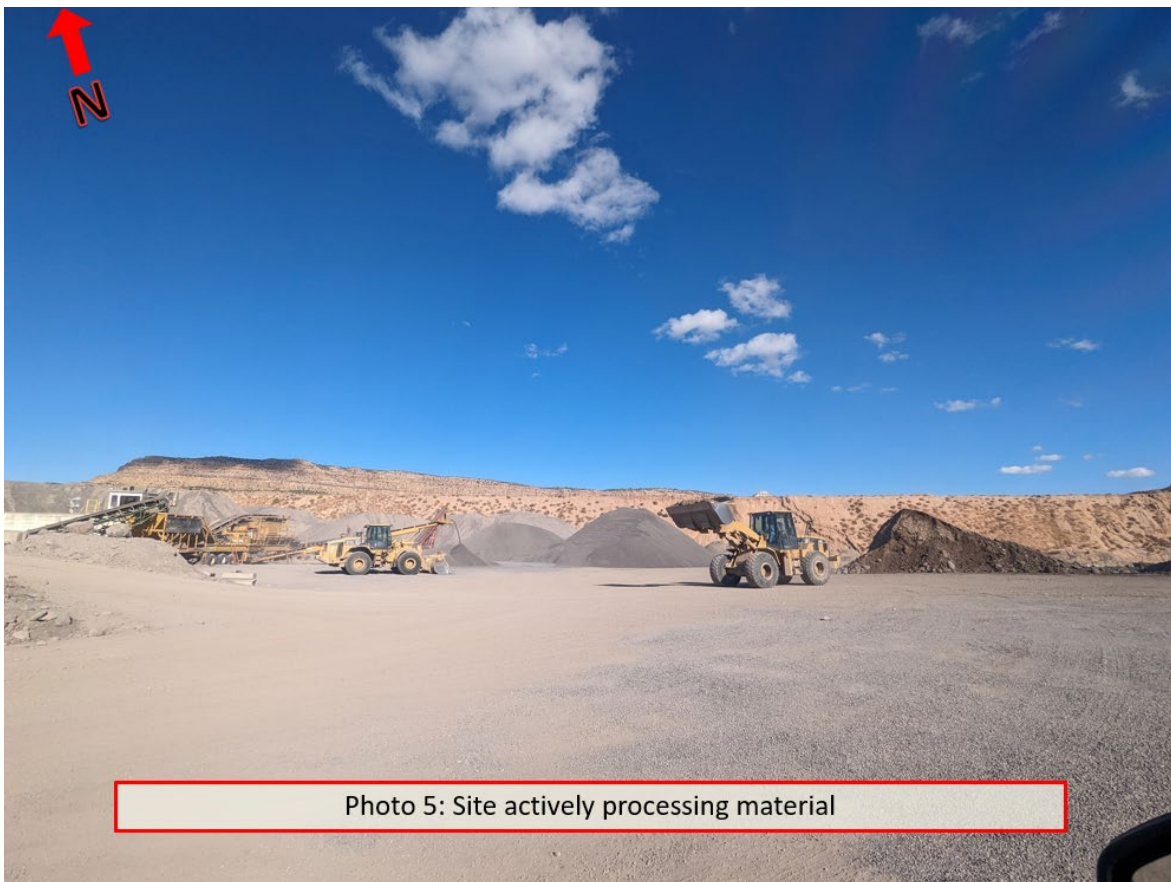
The site was active at the time of the inspection. The Division observed material being crushed and trucks hauling material off site (Photo Five). Processed stockpiles are stored on the western side of the pit. There are several very large stockpiles. They all appear stable and well organized. There are also several stockpiles of oversized boulders located throughout the pits (Photo Six). These large rocks will need to be transported and buried before final reclamation. Nearly the entire site has been affected to date.

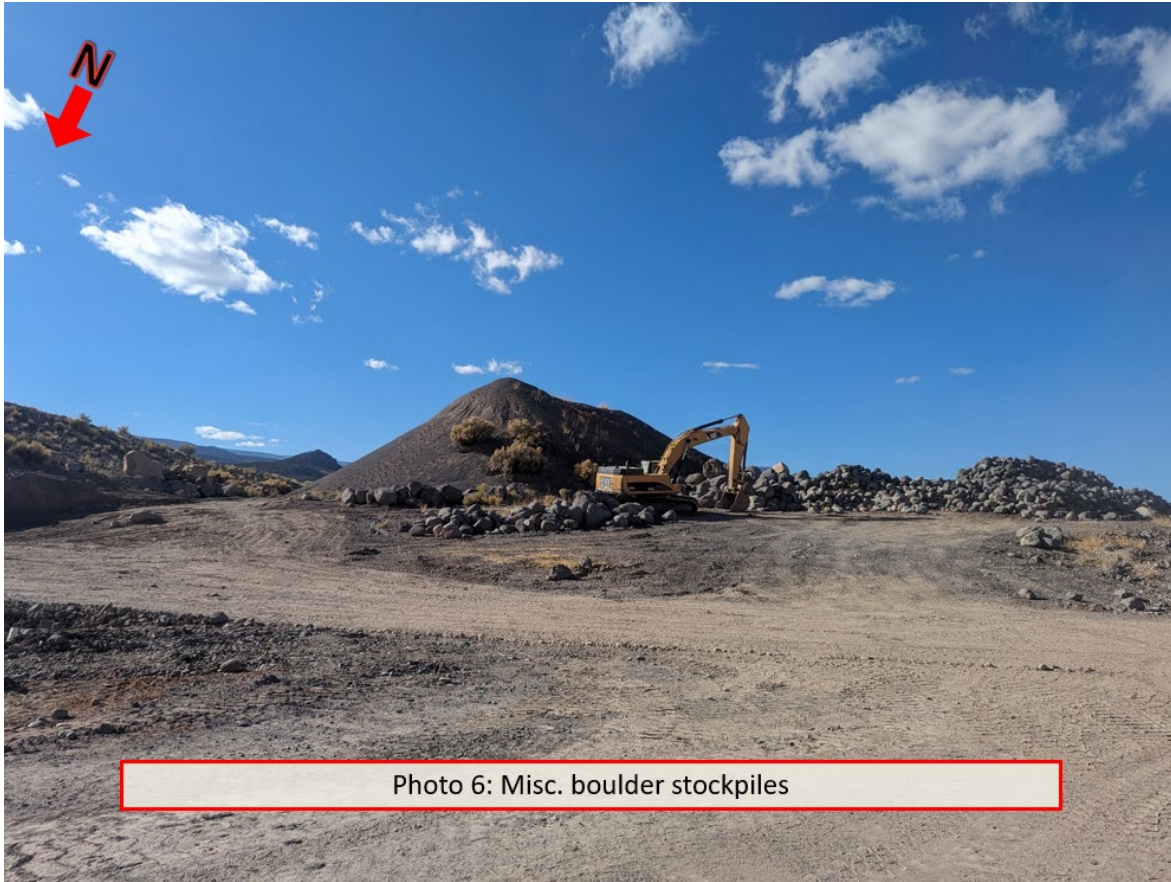
Photo 6: Misc. boulder stockpiles

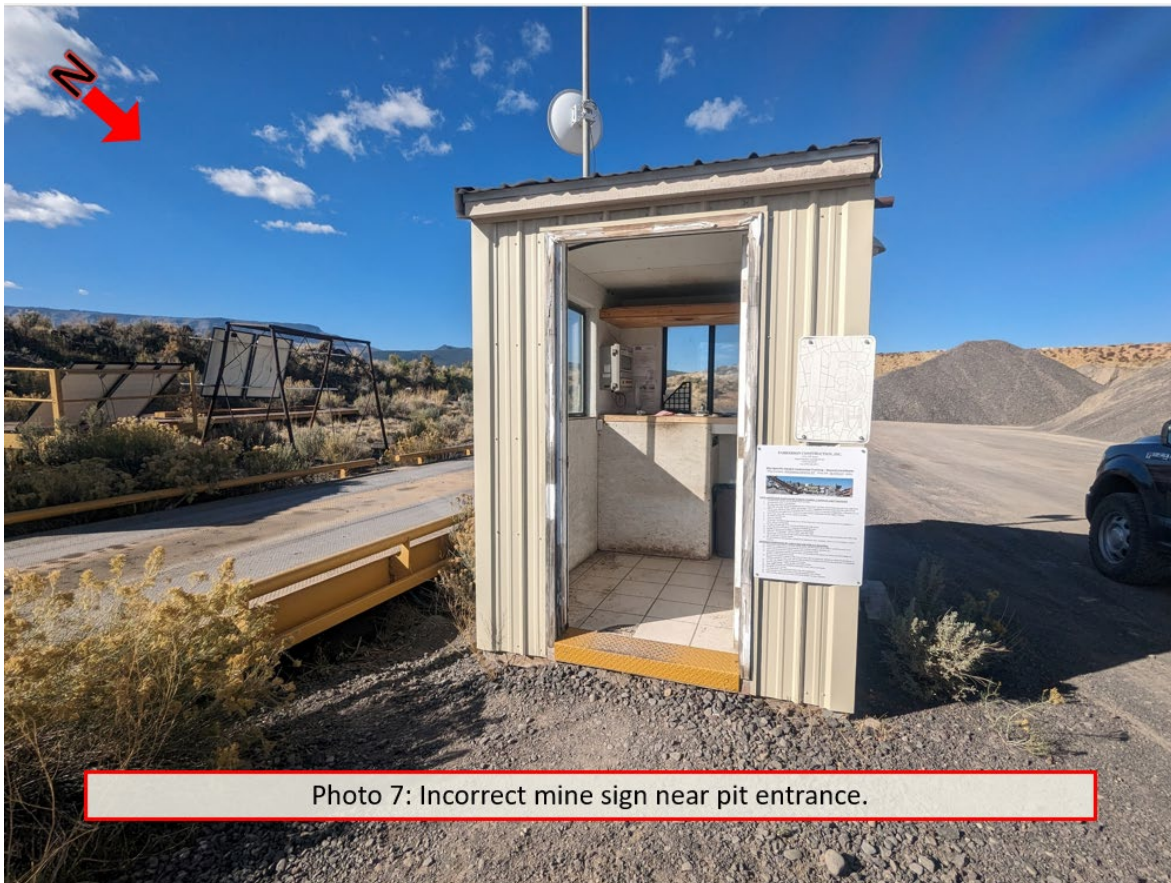
PROBLEM: The mine identification sign depicted incorrect information. This is a problem for failure to post a mine identification sign as required by Section 3.1.12(1) of the rule. The Operator shall, at the entrance of the mine site post a sign, which shall be clearly visible from the access road, with a minimum size equaling one hundred and eighty-seven (187) square inches, such as eleven (11) inches in height and seventeen (17) inches in width, with appropriate font size, with the following: the name of the Operator, a statement that a reclamation permit for the operation has been issued by the Colorado Mined Land Reclamation Board; and the permit number.

A mine sign was posted at the entrance to the mine site as required by Rule 3.1.12(1). The information depicted was incorrect as it still displays the previous Operators name (Photo Seven). This is cited as an inspection problem. Please replace or update the sign.

Photo 7: Incorrect mine sign near pit entrance.

CORRECTIVE ACTIONS: The operator shall, at the entrance of the mine site, post a sign which shall be clearly visible from the access road with the following: the name of the operator, a statement that a reclamation permit for the operation has been issued by the Colorado Mined Land Reclamation Board; and the permit number. The operator shall submit photo documentation that a proper sign has been posted by the corrective action date.

CORRECTIVE ACTION DUE DATE: 1/22/24
