PERMIT INFORMATION

Permit Number: C-1992-081 Mine Name: Hayden Gulch Loadout Operator: Hayden Gulch Terminal, LLC Operator Address: Ms Miranda Kawcak 29515 Routt County Road 27 Oak Creek, CO 80467	County: Routt Operation Type: Loadout Permit Status: Active Ownership: Private
	Operator Representative Present:
Operator Representative Signature: (Field Issuance Only)

INSPECTION INFORMATION

This was a complete inspection of the Hayden Gulch Loadout; DRMS Permit No. C-1992-081, operated by Hayden Gulch Terminal, LLC (HGT). This inspection was conducted by Hunter Ridley with the Colorado Division of Reclamation, Mining, and Safety (Division). No mining activity was occurring on site at the time of inspection. **Please address the Bold items below.**

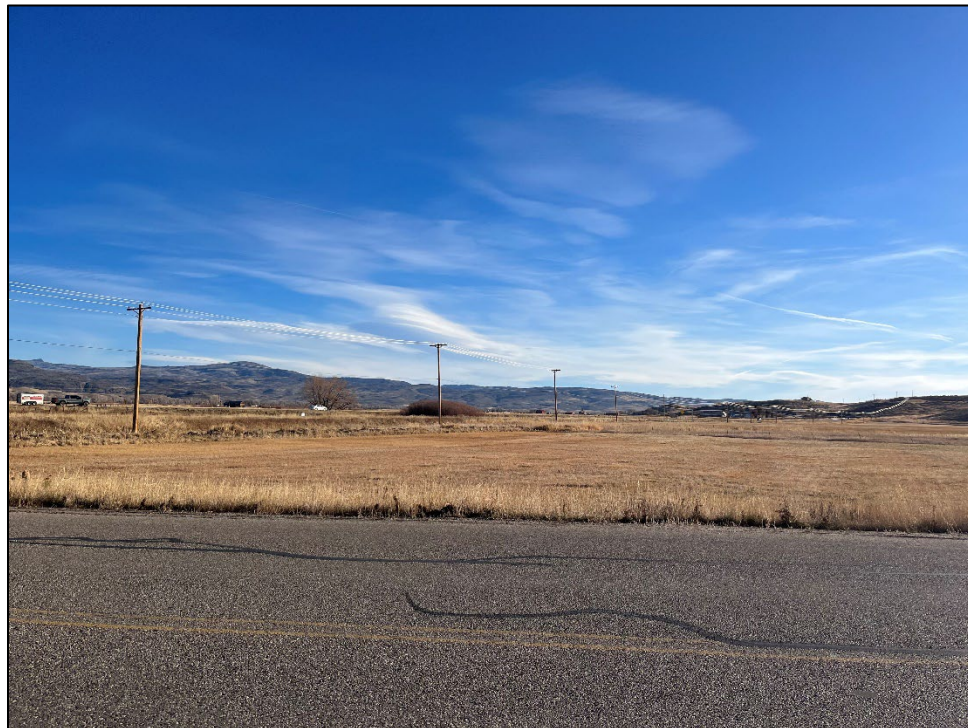
Areas not Phase III bond released and not included in the current SL-3 release includes the area directly north and south of Hwy 40, to be reclaimed to agricultural use as hay fields. It is the only part of the previous rail loop not donated to Routt County. This area includes 6.8 acres of which 2.3 are disturbed (Photos 3 & 4).

The remaining permit area near Hwy 40 was well vegetated and blends in well to the surrounding vegetation (Photos 3 and 4). This area of disturbance will be fully incorporated into adjacent hay fields at the conclusion of the 10-year liability period.

Photo 3: Revegetated hayfields at the northern edge of the permit boundary.

Photo 4: View east of the revegetated hay fields.
