Inspection Report, Hayden Gulch Loadout, C-1992-081

PERMIT INFORMATION

INSPECTION INFORMATION

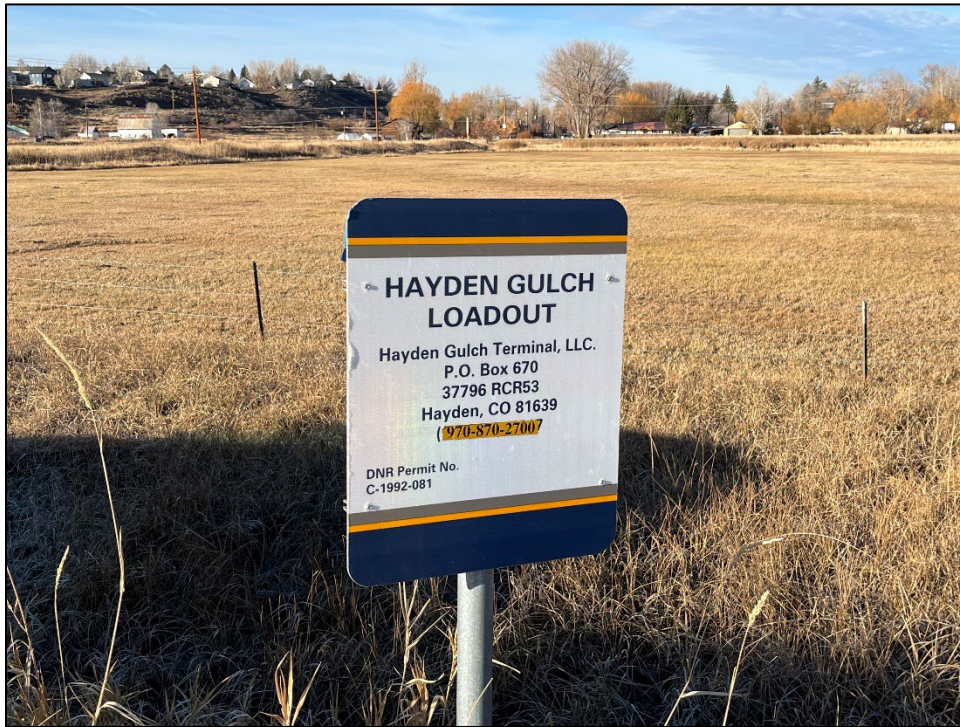
Mine identification signs were observed at the western end of the TAHR (Photo 1) and adjacent to the unreleased agricultural section north and south of Hwy 40 (Photo 2). All required information was present on the signage.

Photo 1: Mine sign located at the intersection of Highway 40 and Hawthorne St.

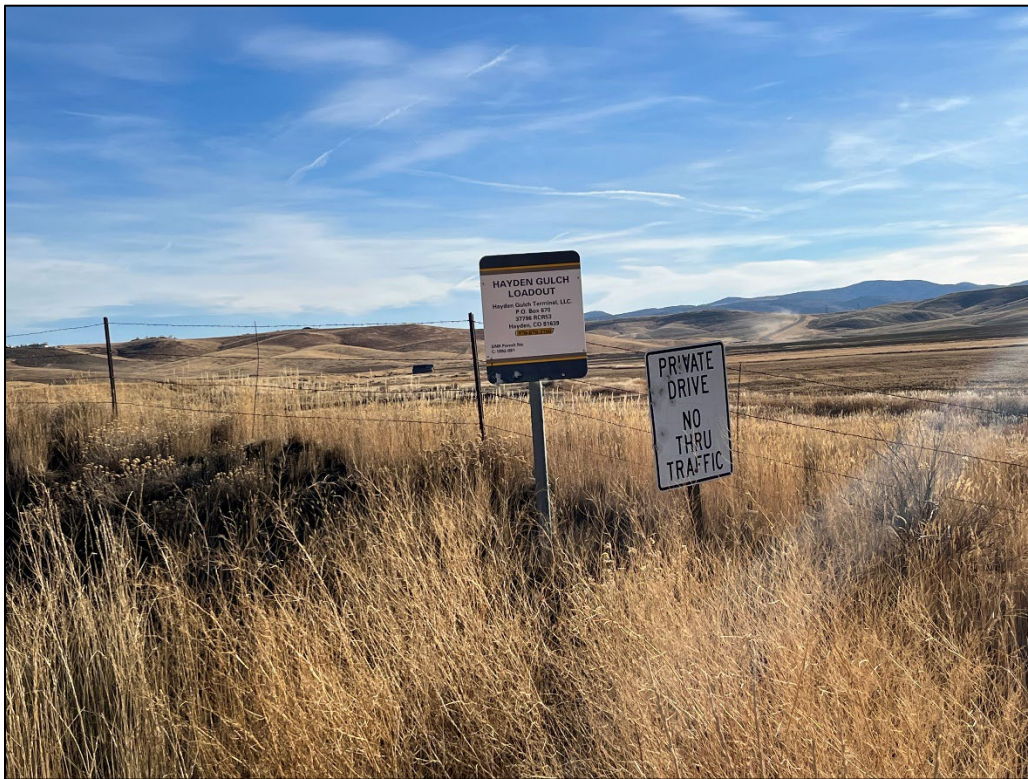
Photo 2: Mine sign located at the western end of the TAHR.

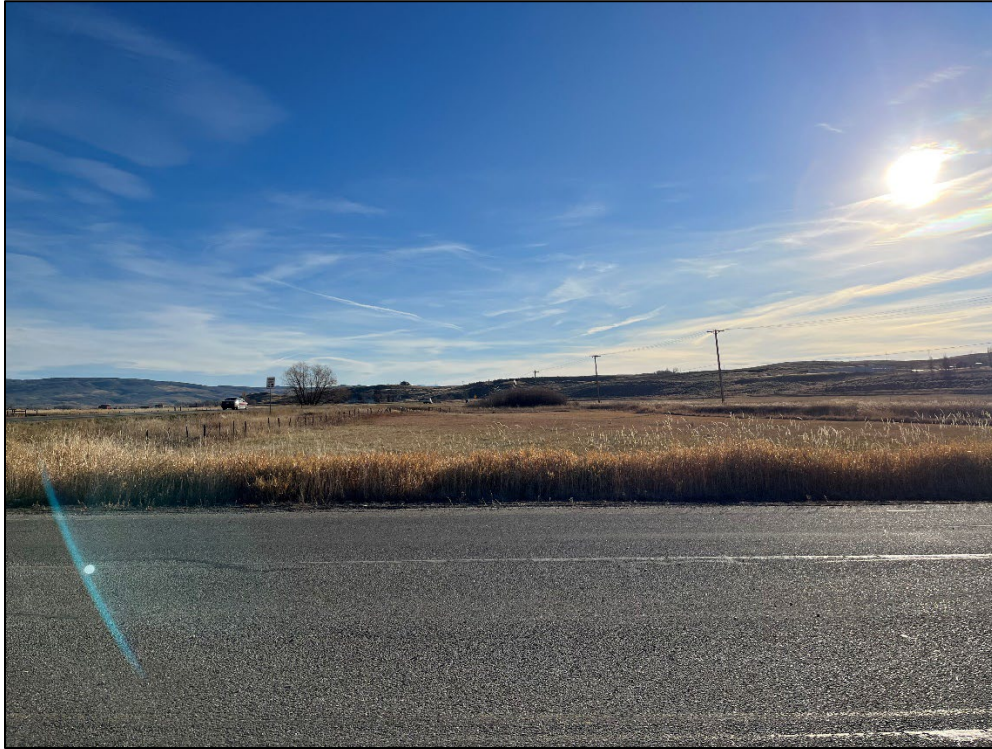
Areas not Phase III bond released and not included in the current SL-3 release includes the area directly north and south of Hwy 40, to be reclaimed to agricultural use as hay fields. It is the only part of the previous rail loop not donated to Routt County. This area includes 6.8 acres of which 2.3 are disturbed (Photos 3 & 4).

The remaining permit area near Hwy 40 was well vegetated and blends in well to the surrounding vegetation (Photos 3 and 4). This area of disturbance will be fully incorporated into adjacent hay fields at the conclusion of the 10-year liability period.

Photo 3: Revegetated hayfields at the northern edge of the permit boundary.

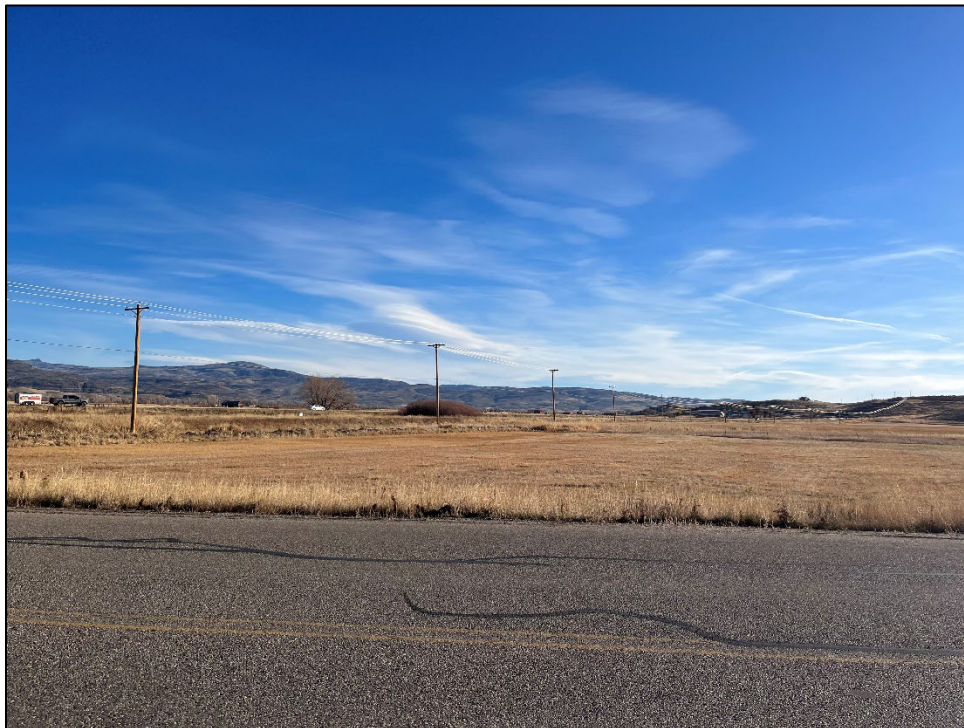
Photo 4: View east of the revegetated hay fields.

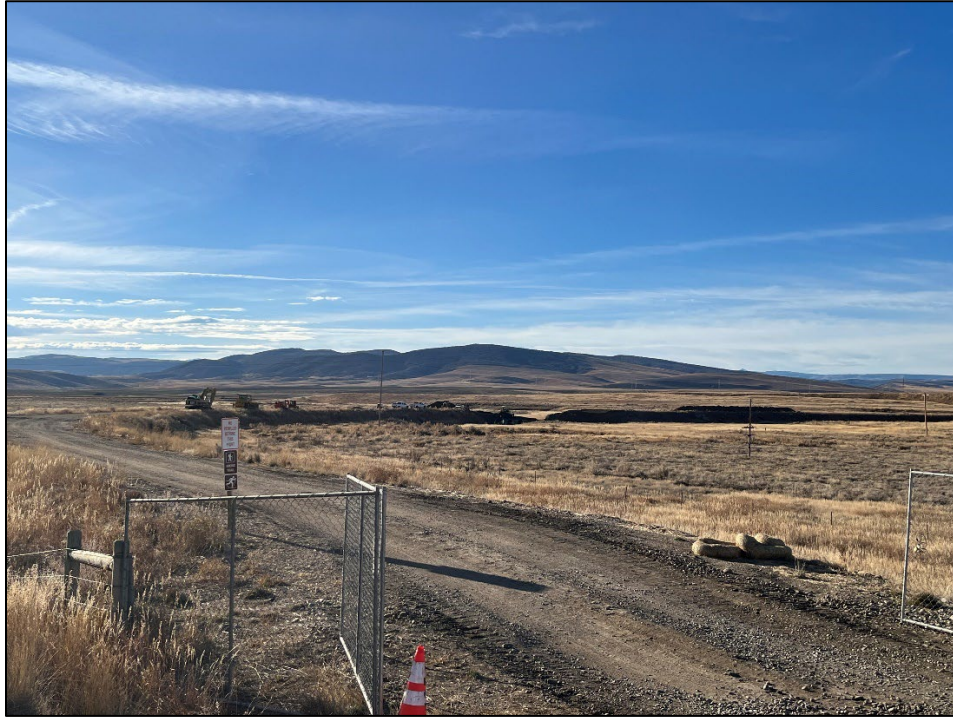
Culverts within the previously released Tracks to Trails area were being replaced by the City of Hayden at the time of inspection (Photos 5 and 6). This area was turned over to the City of Hayden for recreational use with the approval of SL-2 in 2022. Culverts in this area which were not being replaced were flowing and free of blockages.

Photo 5: Culverts were being replaced in the previously Phase III bond released Tracks to Trails rail loop area.

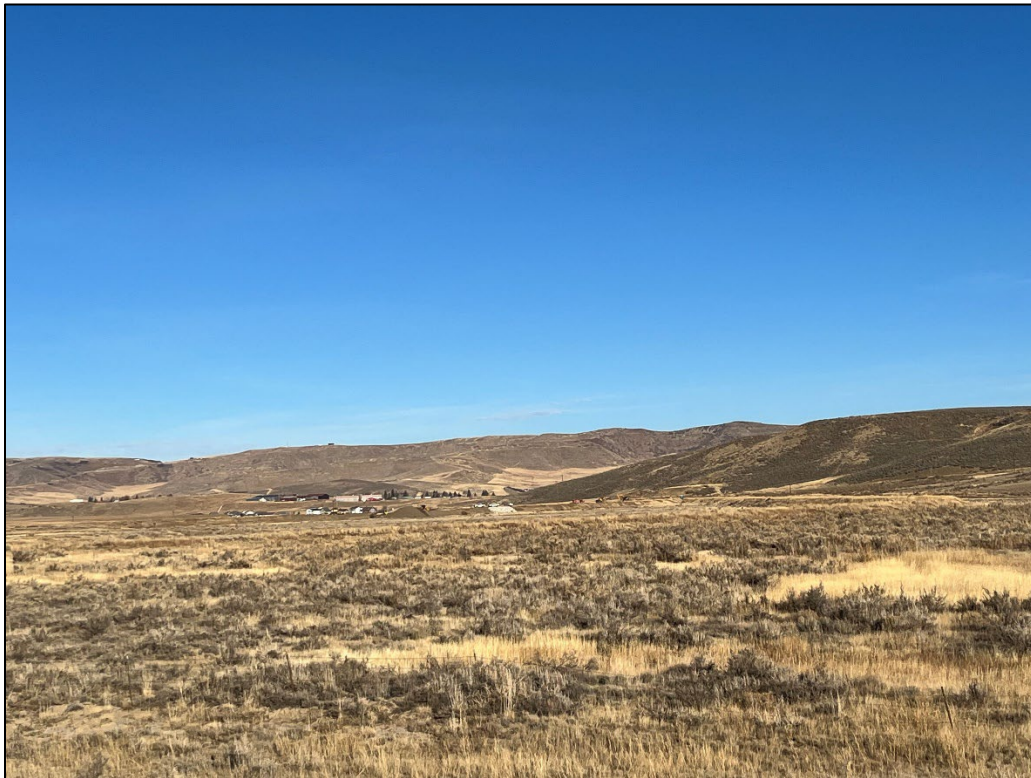
Photo 6: View north of area where culverts are being replaced by the City of Hayden.

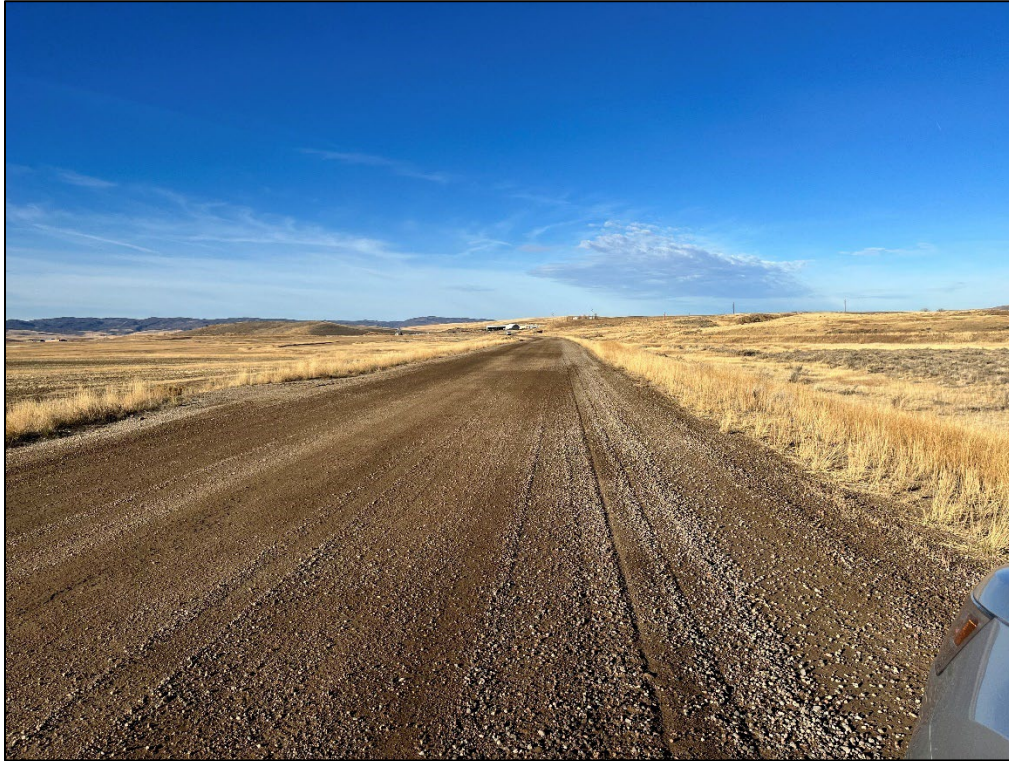
The Tie Across Haul Road (TAHR) was well maintained and free of erosional features (Photo 7). The TAHR and its associated permanent topsoil pile features will be Phase III released with the approval of SL-3.

Photo 7: View west of TAHR.

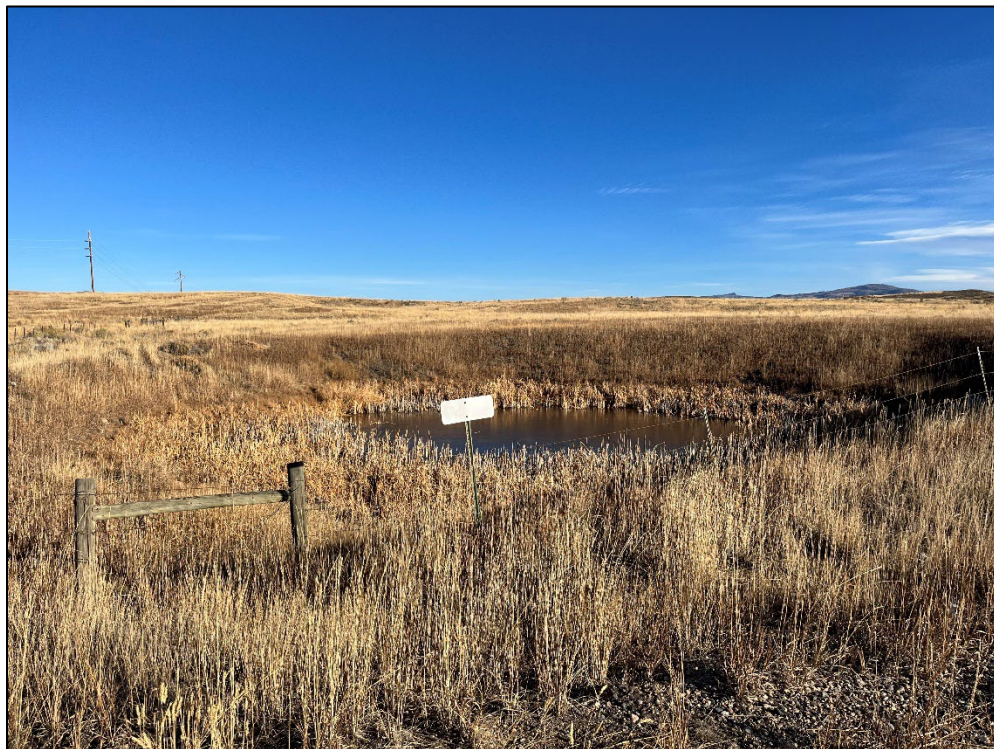
Truck Loop Pond 001 was functioning properly (Photo 8). Rail Loop Pond 002 was inaccessible due to the culvert construction happening along the Sage Creek Trail.

Photo 8: Truck Loop Pond 001 from the TAHR.

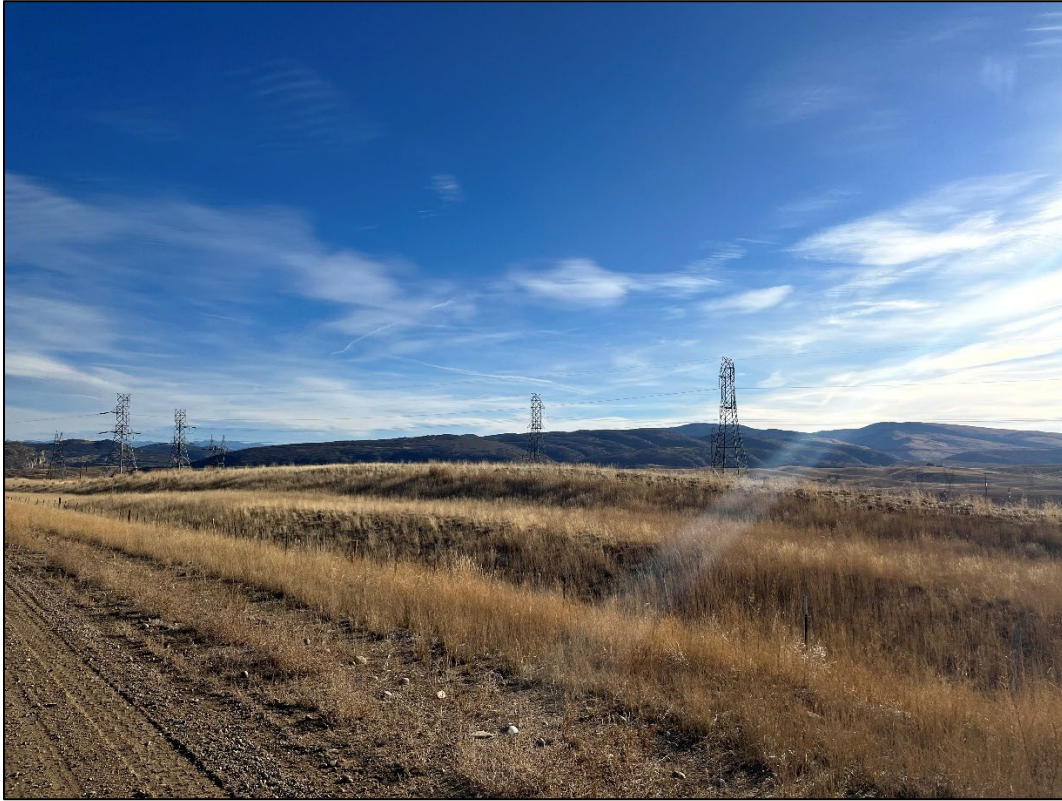
Several permanent topsoil pile features are located to the east along the currently unreleased TAHR. All piles were well vegetated and marked by either a sign or a flagged post (Photo 9). These features will be released with the approval of SL-3.

Photo 9: Topsoil pile located along the TAHR.
