## C-1981-008 November Aerial Inspection Report

**C-1981-008 November 2023 Aerial Inspection Report.pdf**

<b>Permit Number:</b> C-1981-008 <b>Mine Name:</b> New Horizon Mine <b>Operator:</b> Elk Ridge Mining and Reclamation, LLC <b>Operator Address:</b> Mr Tony Tennyson P.O. Box 628 27646 West 5th Avenue Nucla, CO 81424	<b>County:</b> Montrose <b>Operation Type:</b> Surface <b>Permit Status:</b> Active <b>Ownership:</b> Private
	<b>Operator Representative Present:</b>  None Present
<b>Operator Representative Signature: (Field Issuance Only)</b>

<b>Inspection Start Date:</b> November 14, 2023 <b>Inspection Start Time:</b> 12:22 <b>Inspection End Date:</b> November 14, 2023 <b>Inspection End Time:</b> 12:23	<b>Inspection Type:</b> Aerial Inspection <b>Inspection Reason:</b> Normal I&E Program <b>Weather:</b> Clear
<b>Joint Inspection Agency:</b>  None	<b>Joint Inspection Contacts:</b>
<b>Post Inspection Agency:</b>  None	<b>Post Inspection Contacts:</b>
<b>Inspector(s):</b>  Lucas West	<b>Inspector's Signature:</b>

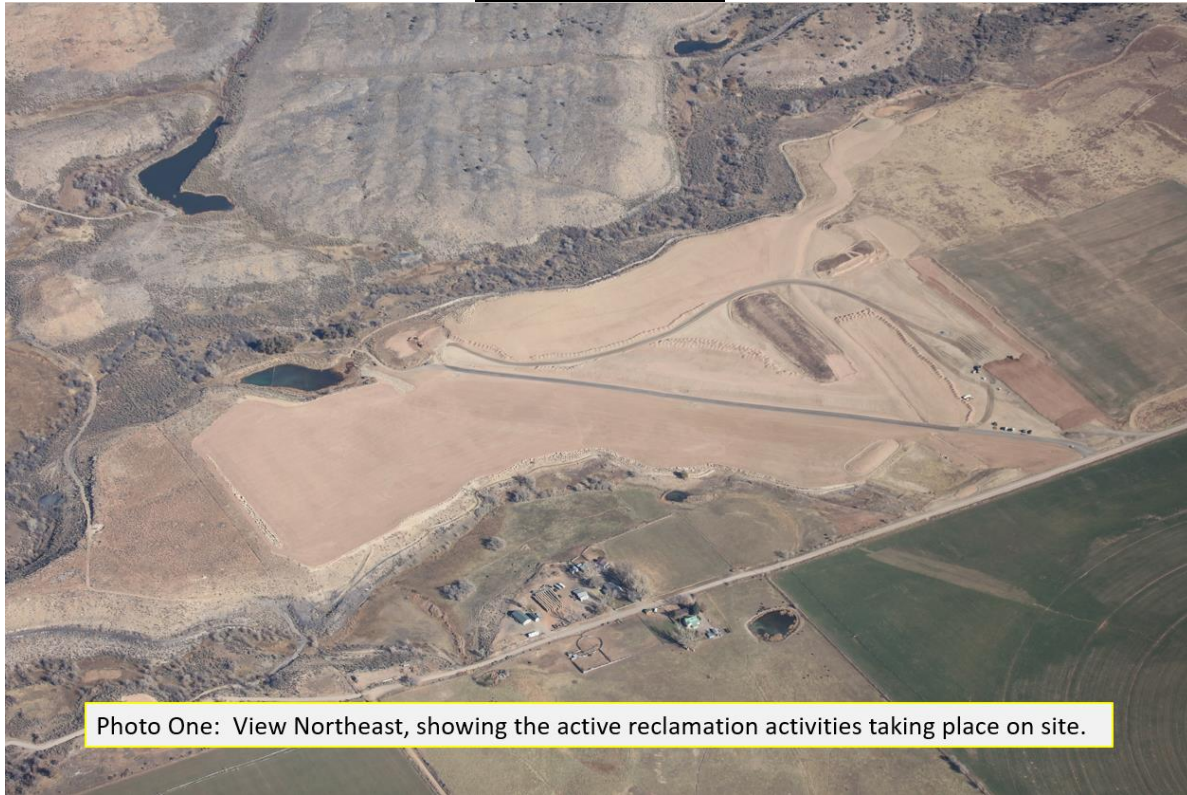
An overview of the active reclamation area can be seen in Photo One. At the time of the inspection, it is seen that almost all of the backfill area has been graded with Bench 1 material and a significant area has also had topsoil applied. From the photos no signs of settling, slumping or significant erosion was noted. Photo Two shows the area being actively topsoiled and graded during the inspection.

Also visible in Photo One, are the two access roads leading to Pond 13, traversing the backfill area. Both

access roads enter the area at the same location, with one meandering to the north, the other taking a straighter path to Pond 13. The meandering access road is slated to be reclaimed, leaving the southern access road as the permanent path to Pond 13. This was accomplished through a recent revision, both roads appear stable and in good condition. No erosional issues were noted.

Photo One: View Northeast, showing the active reclamation activities taking place on site.

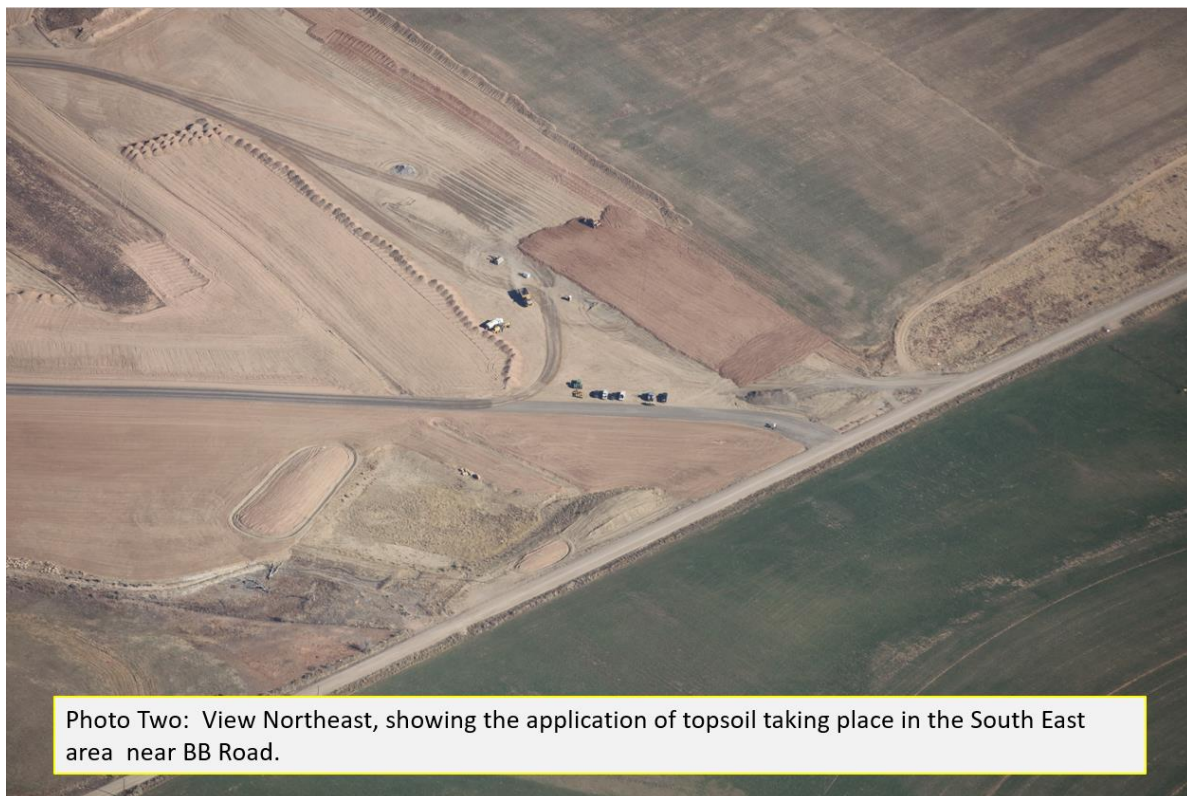
Photo Two: View Northeast, showing the application of topsoil taking place in the South East area near BB Road.

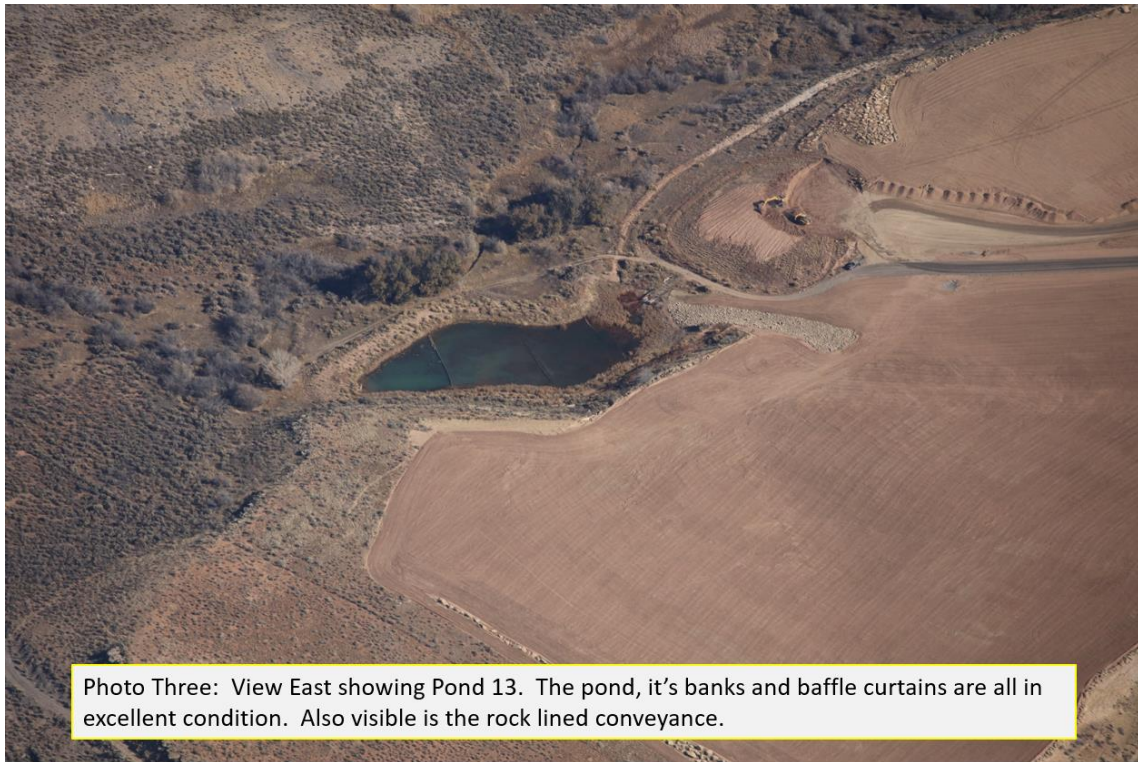
All ponds were observed during the inspection, with Pond 13 being the only pond retaining water. Pond 13, shown in Photo Three is in good condition, water was observed actively flowing into the pond by way of the piped inlet. The vegetation and baffle curtains are in good condition and no issues are noted in the area. Also visible in Photo Three, is the rock lined conveyance leading from the backfill area to the pond which is also in excellent condition.

Photo Three: View East showing Pond 13. The pond, it's banks and baffle curtains are all in excellent condition. Also visible is the rock lined conveyance.

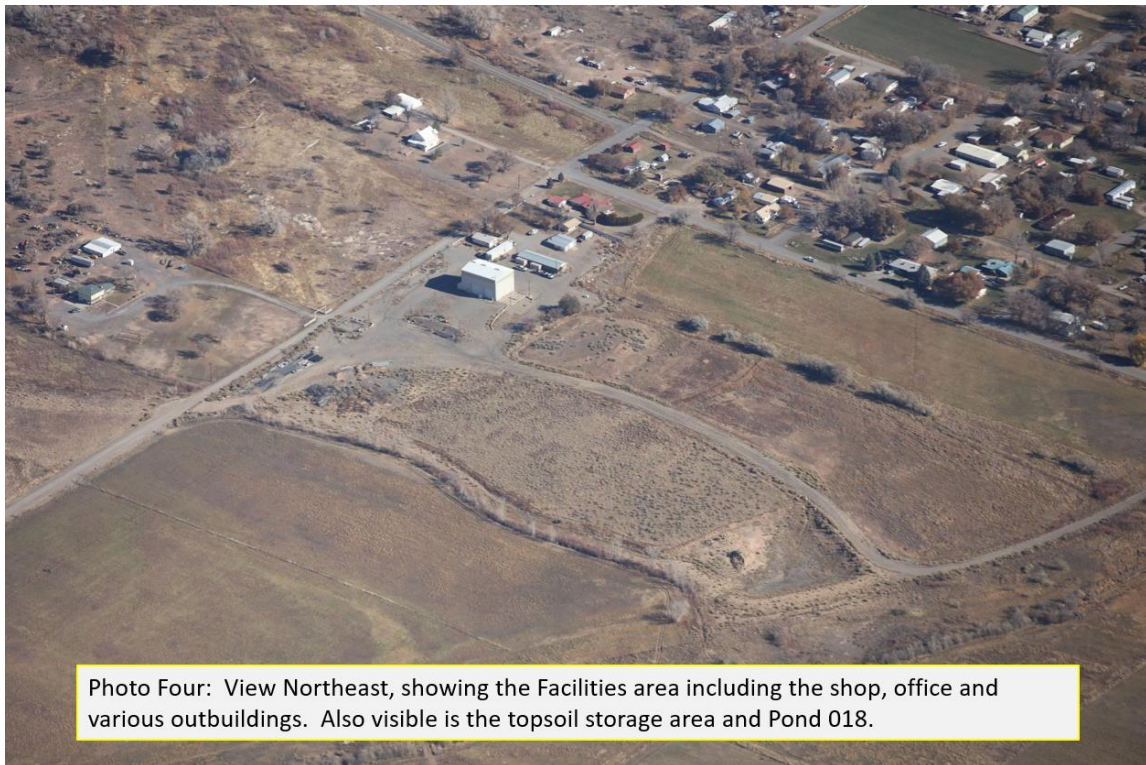
Located to the Southeast of the backfill area, where the activity is taking place, lies the facilities area that includes the shop, office and various out buildings. The facilities area can be seen in Photo Four. All buildings, equipment and items in this area are in excellent condition with no problems.

Photo Four: View Northeast, showing the Facilities area including the shop, office and various outbuildings. Also visible is the topsoil storage area and Pond 018.
