**MINERALS PROGRAM INSPECTION REPORT**  
**PHONE: (303) 866-3567**

<b>MINE NAME:</b> Soaring Eagle Gravel Pit	<b>MINE/PROSPECTING ID#:</b> M-1999-025	<b>MINERAL:</b> Sand and gravel	<b>COUNTY:</b> Mesa
<b>INSPECTION TYPE:</b> Monitoring	<b>WEATHER:</b> Clear	<b>INSP. DATE:</b> November 7, 2023	<b>INSP. TIME:</b> 10:00
<b>OPERATOR:</b> Grand Junction Pipe & Supply Co.	<b>OPERATOR REPRESENTATIVE:</b> Jim Doody	<b>TYPE OF OPERATION:</b> 112c - Construction Regular Operation	
<b>REASON FOR INSPECTION:</b> Normal I&E Program	<b>BOND CALCULATION TYPE:</b> Complete Bond	<b>BOND AMOUNT:</b> \$242,488.00	
<b>DATE OF COMPLAINT:</b> NA	<b>POST INSP. CONTACTS:</b> DRMS	<b>JOINT INSP. AGENCY:</b> None	
<b>INSPECTOR(S):</b> Amy Yeldell	<b>INSPECTOR'S SIGNATURE:</b>

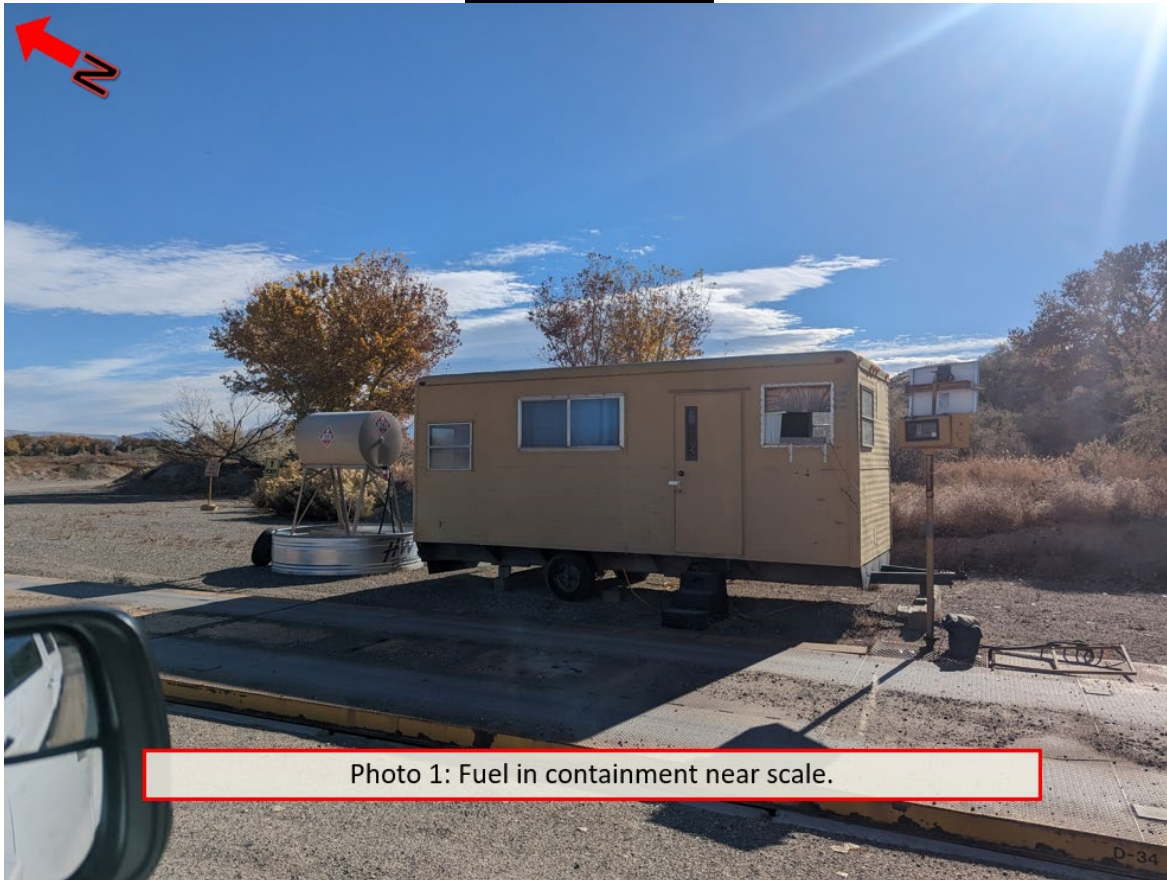
Fuel was located within secondary containment near the scale and office (Photo One). The landowner has batteries for their hot fence stored on the north side of the pit. The Operator is encouraged to work with the landowner to keep the site free of excess debris.

Photo 1: Fuel in containment near scale.

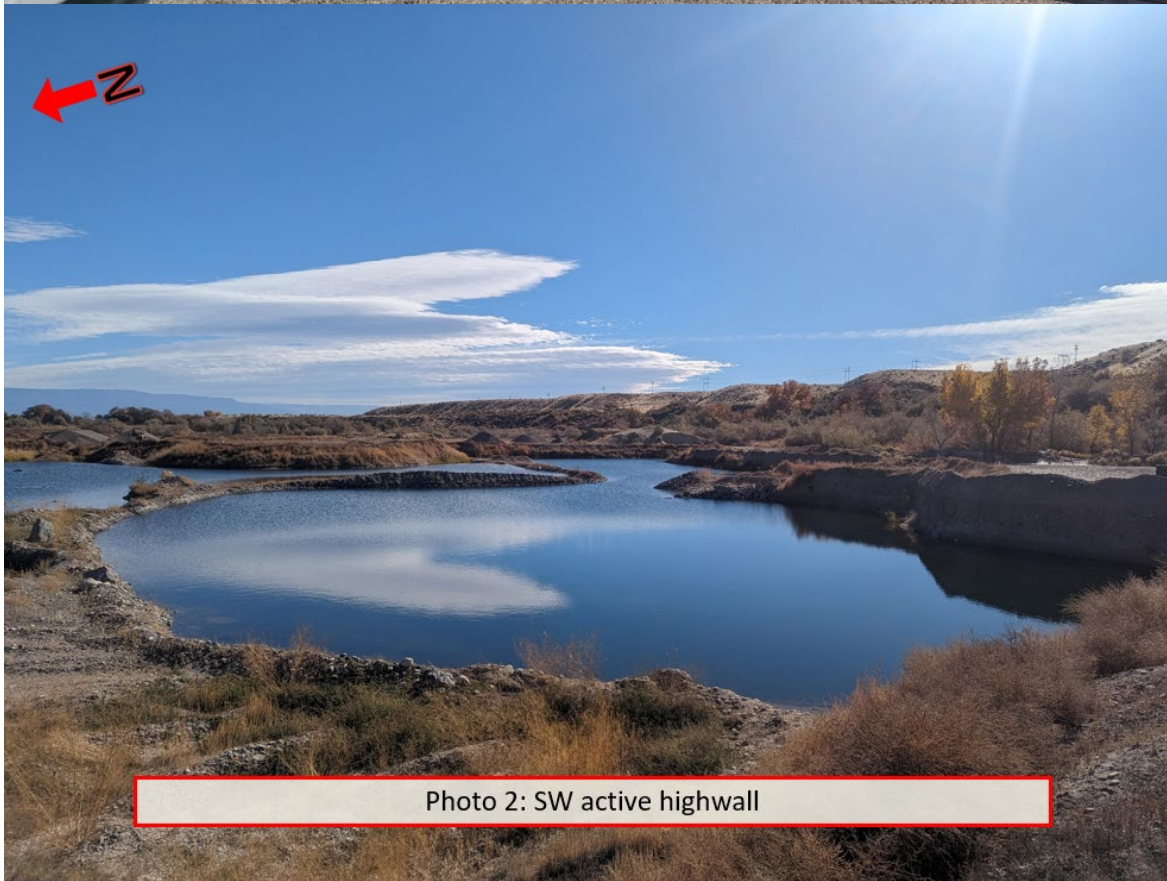
The north and east side of the pit has been recontoured to a 3H: 1V or less. The active highwalls are located along the south and west sides of the pond. Active high walls were generally near vertical and estimated to be 3000 LF and 20'H (Photos Two – Four). All highwalls can be cut/fill. Additionally, there are some misc. berms and general grading that remains on the pit (pond) floor that is visible even when the pit is inundated. The pond will have to be pumped to complete grading. The two main islands appear to be properly graded. There is a bench area along the northwest side of the pit that may be the wetlands bench. The area appears to be stripped but not yet mined. Some additional grading and smoothing out of stockpiles will be required if not consumed prior to final reclamation.

Photo 2: SW active highwall

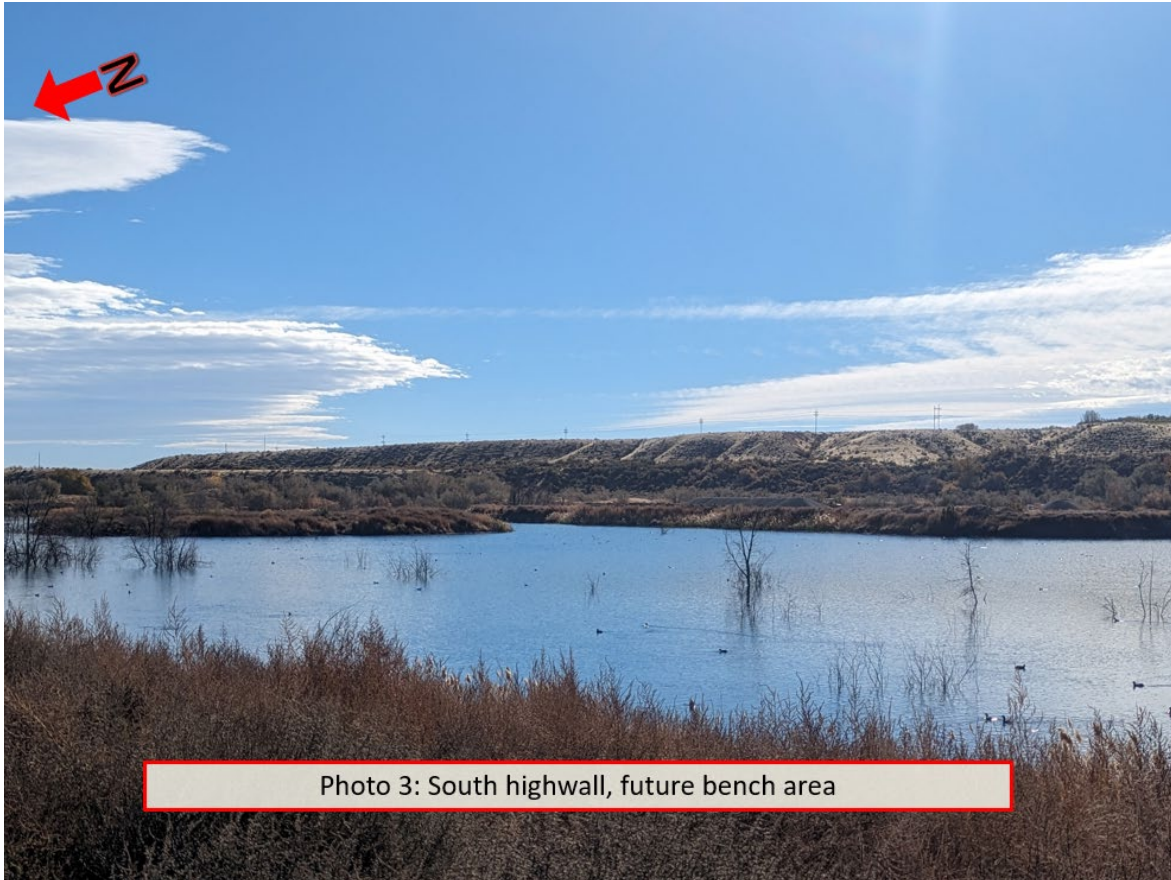
Photo 3: South highwall, future bench area

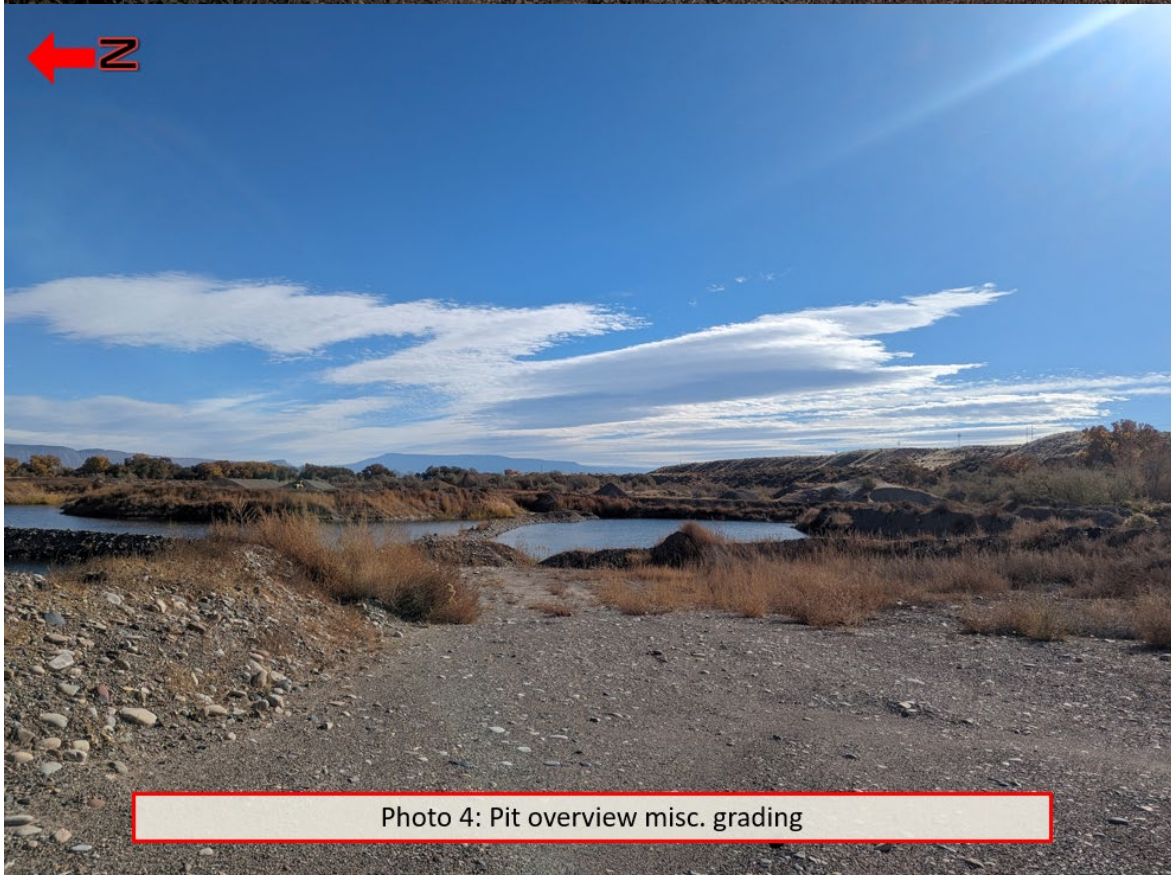
Photo 4: Pit overview misc. grading

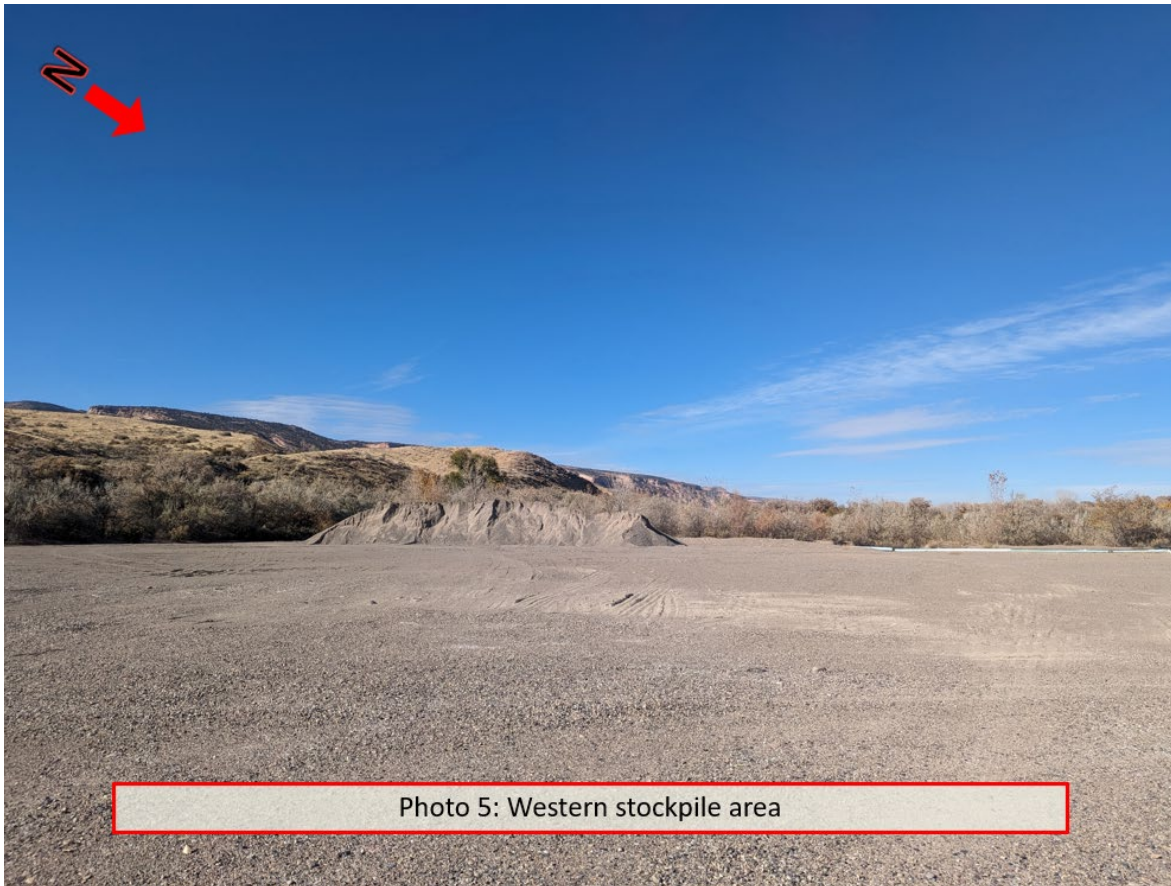
The site was inactive at the time of the inspection. This site is only permitted to crush during the winter months. The remainder of the year hauling occurs out of the existing stockpiles. There are several large stockpiles located throughout the southwestern side of the pit (Photo Five). All stockpiles appear stable and well organized. Mining is progressing to the south and west.

Photo 5: Western stockpile area

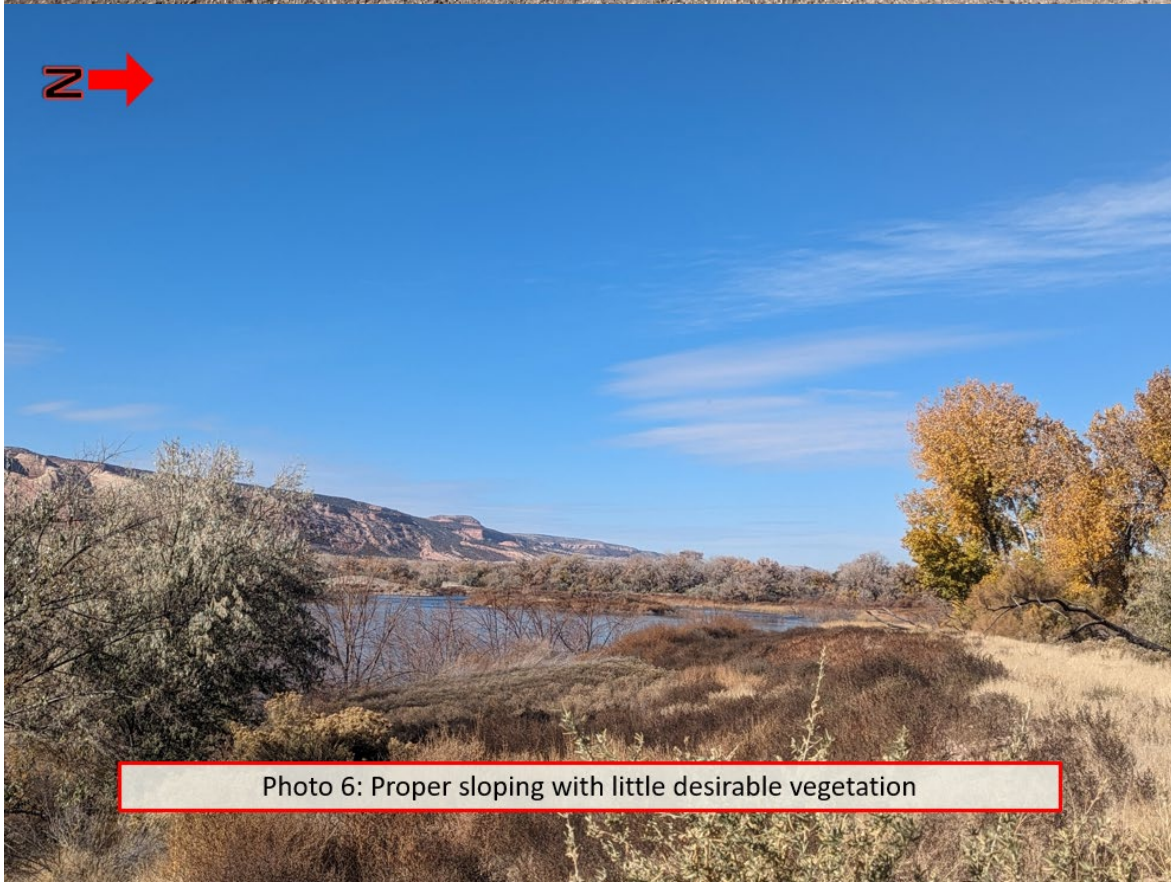
Approximately 100 acres have been affected by mining. The eastern half of the pit has largely self-reclaimed. There are lots of mature Russian Olive and Tamarisk trees on site. Because they are State listed Noxious-Weeds they must be controlled. Additionally it is unclear if the contoured slopes were ever seeded or if vegetation, primarily weeds have volunteered. Very little desirable vegetation was observed on the east side of the pit (Photos Six and Seven). The Operator is recommended to remove all noxious weeds prior to implementing reclamation per the approved Reclamation Plan. Then employ diligent noxious weed management. The Division notes that in 2005 under TR-1 a noxious weed management plan was approved. The Operator may wish to consult with Mesa County Weed and Pest to ensure that the plan is sufficient and implement/revise accordingly.

Photo 6: Proper sloping with little desirable vegetation
