MINERALS PROGRAM INSPECTION REPORT
PHONE: (303) 866-3567

MINE NAME: Parsons Mine	MINE/PROSPECTING ID#: M-2009-082	MINERAL: Sand, gravel and borrow material for construction	COUNTY: Weld
INSPECTION TYPE: Monitoring	WEATHER: Clear	INSP. DATE: November 1, 2023	INSP. TIME: 09:30
OPERATOR: Martin Marietta Materials, Inc.	OPERATOR REPRESENTATIVE: Julie Mikulas	TYPE OF OPERATION: 112c - Construction Regular Operation	
REASON FOR INSPECTION: Normal I&E Program	BOND CALCULATION TYPE: Complete	BOND AMOUNT: \$4,168,714.00	
DATE OF COMPLAINT: NA	POST INSP. CONTACTS: None	JOINT INSP. AGENCY: None	
INSPECTOR(S): Hunter Ridley	INSPECTOR'S SIGNATURE:

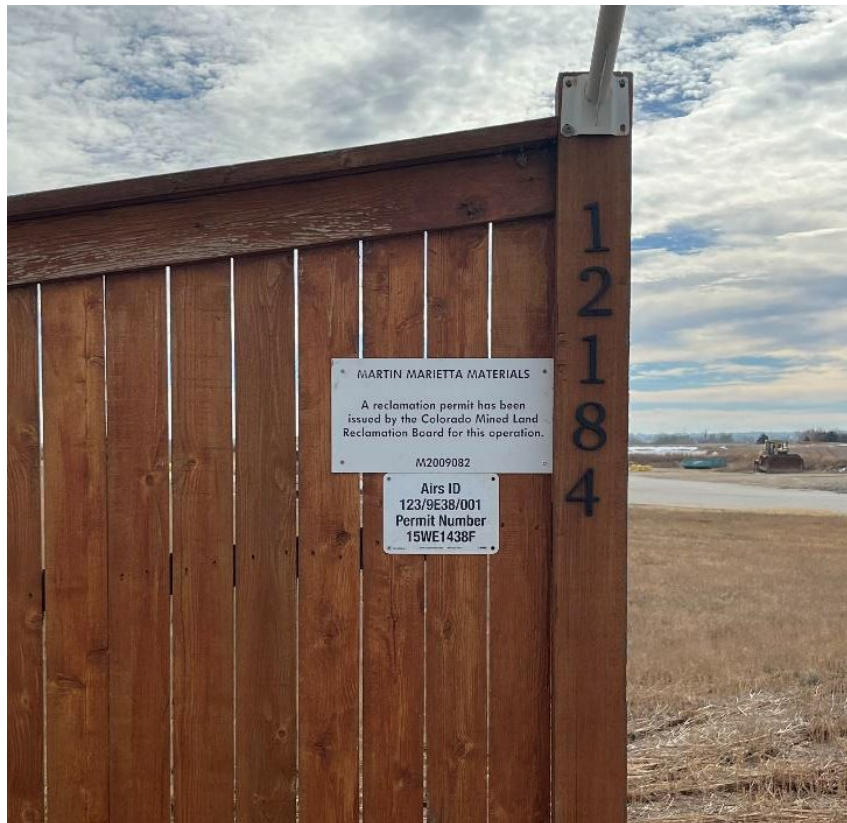
Boundary markers were observed as required by Rule 3.1.12. A mine identification sign was posted at the site entrance (Photo 1). The sign met all requirements of Rule 3.1.12 except section 3.1.12(1) which specifies a required sign size of 11 x 17. The Operator stated that when the current sign is damaged, the new replacement

Photo 1: Mine sign posted at the site entrance.

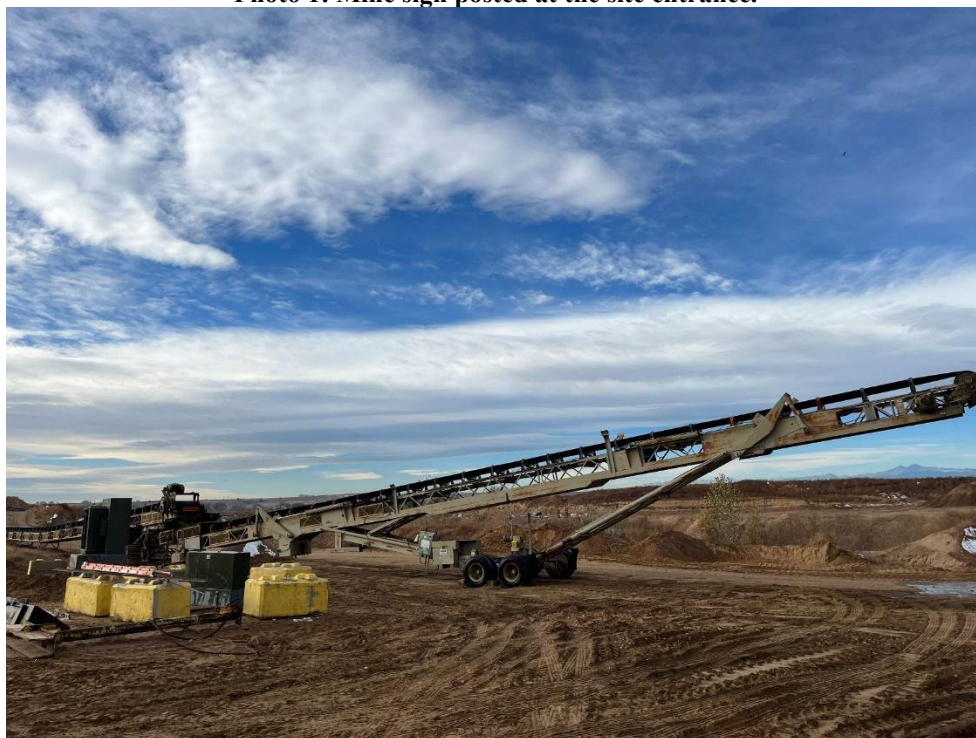
Photo 2: Processing equipment is stored onsite in Lot B of Phase 1A.

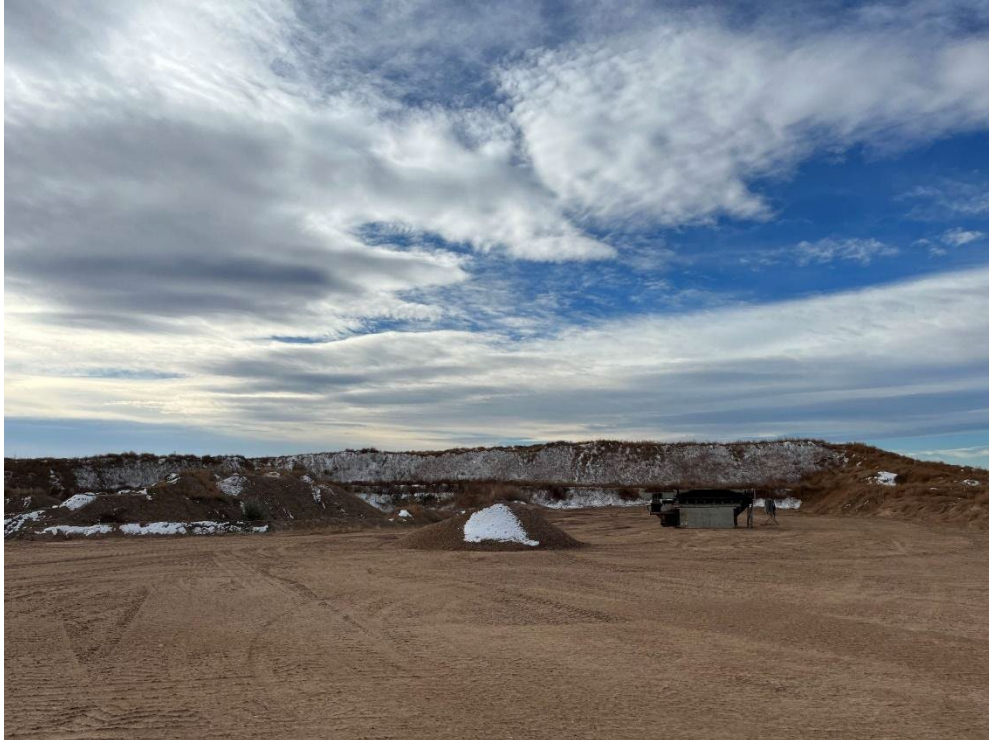
Photo 3: View south of existing area to be mined in Phase 1B, an overburden pile is located in the background.

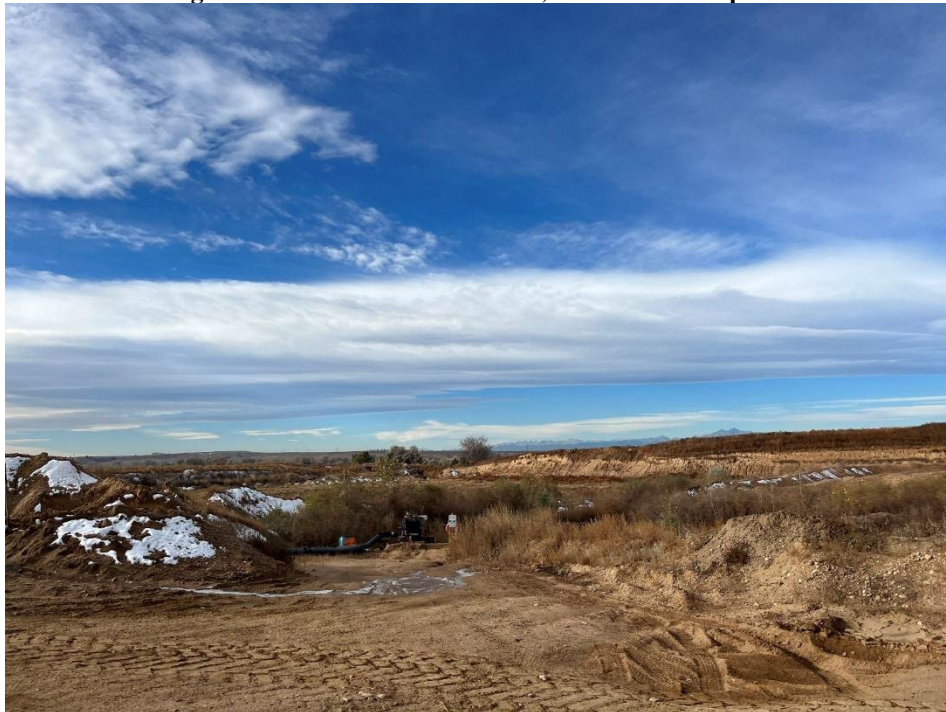
Photo 4: View southwest of Phase 1A.

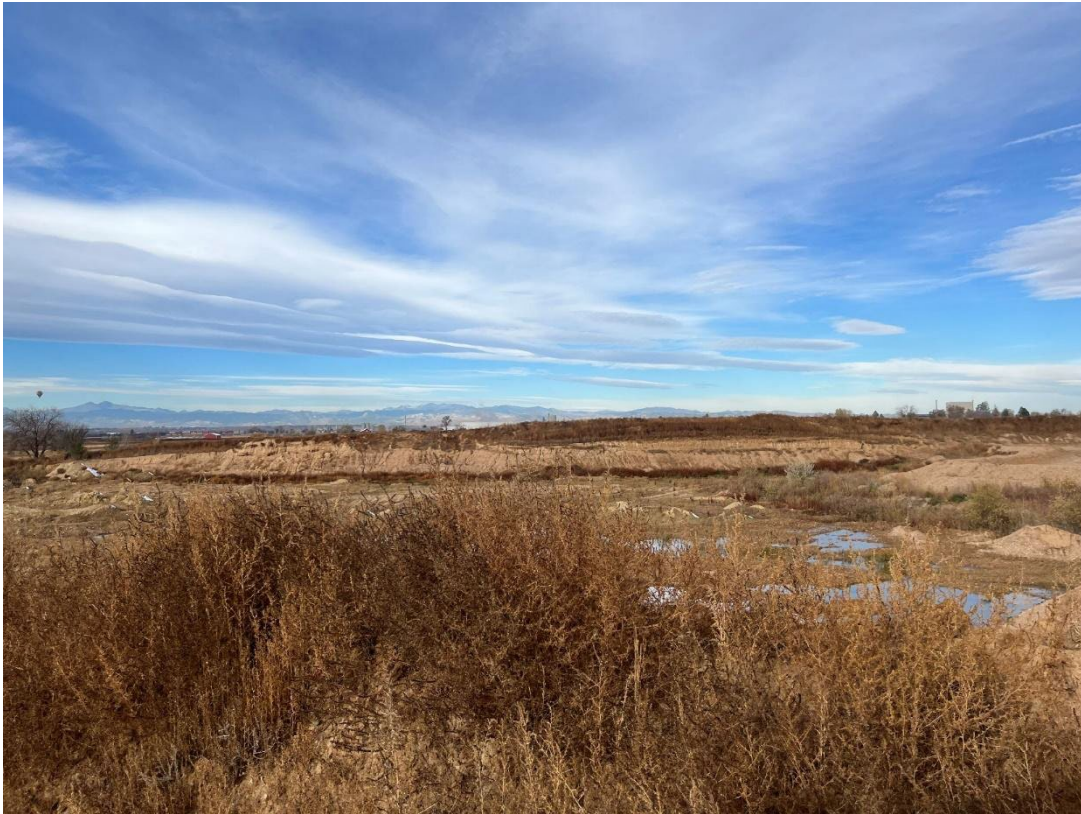
Photo 5: View west of Phase 1A.

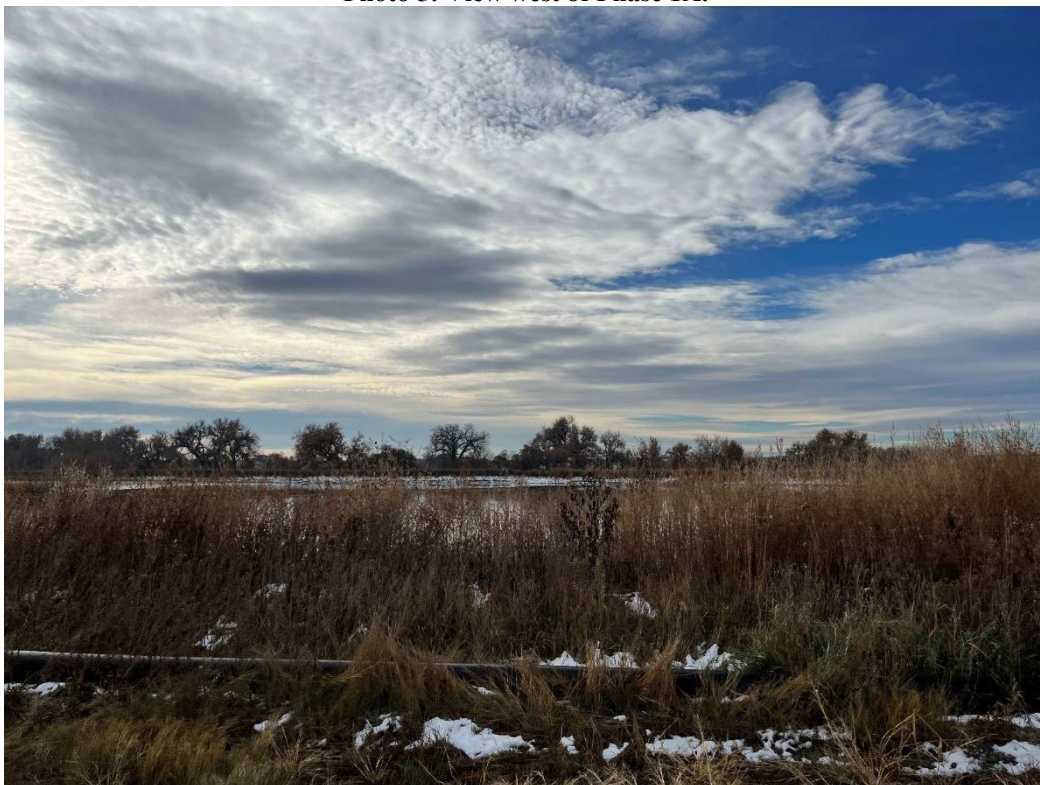
Photo 6: View south of Phase 1C, currently used as a sedimentation pond.

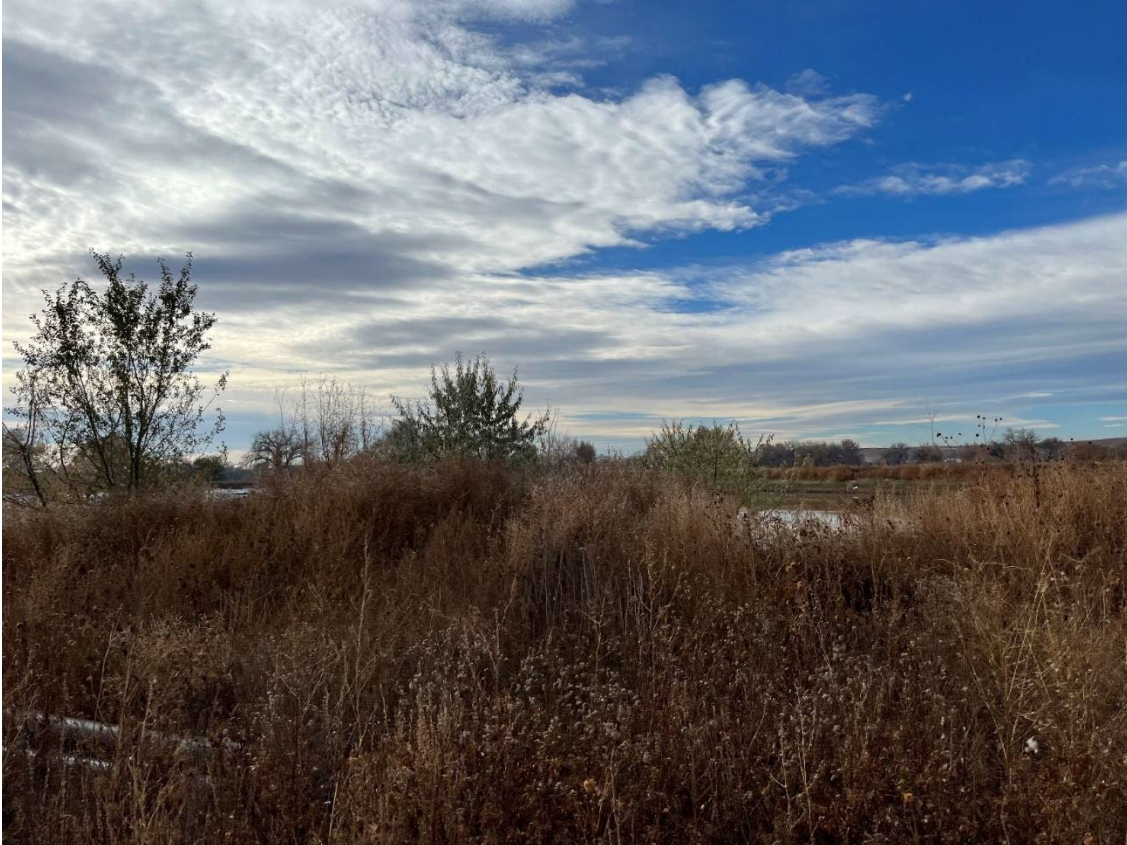
Photo 7: View southwest of the edge of Phase 1C and Phase 3, Russian olive is present in these areas.

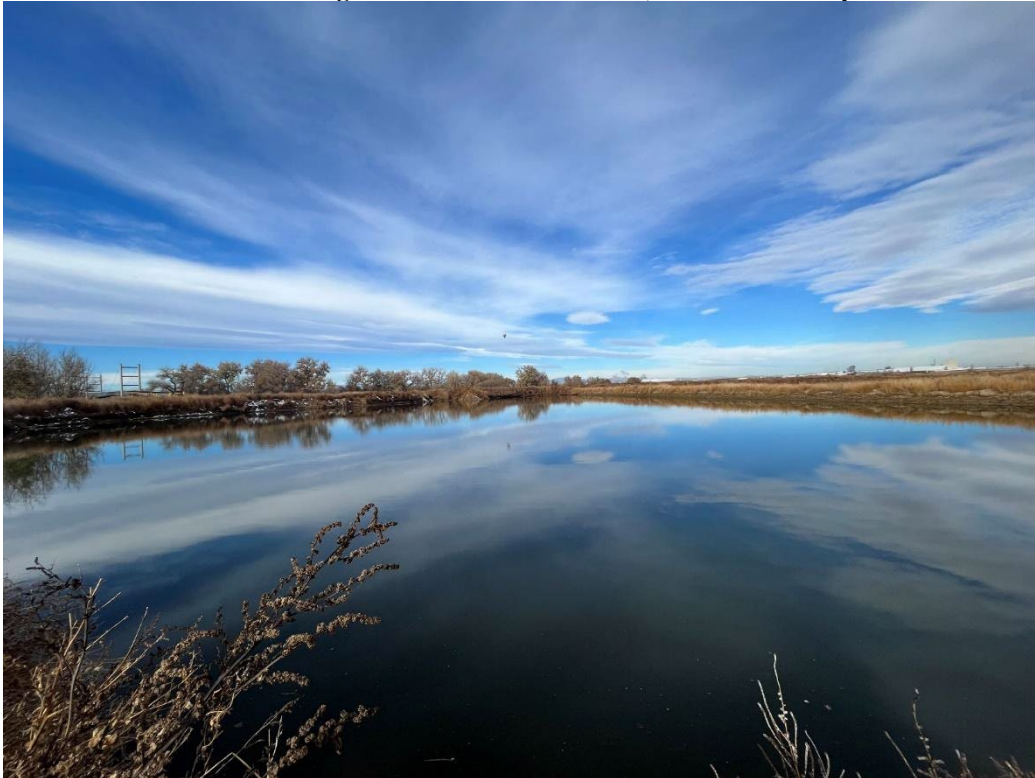
Phase 4B is completely mined out; kochia and other annual weeds currently line the pond slopes (Photos 8 and 9, and 14). Currently, there is about 1 mile of conveyor built at the site. This extends from the processing area, across CR25, between Phases 1A, 1B, Phase 3, Phase 4A and 4B, and over the Cache la Poudre River to Phases 5A and 5B. The Operator stated their intention to move a portion of the conveyor to extend into the adjacent Windsor East Pit site, also permitted by Martin Marietta Materials, Inc (Photo 14). The conveyor will be approximately 3 miles long in total once complete. Phases 4A and 4C are currently being mined out (Photos 10 – 13). Overburden is piled on the pit floor and topsoil has been segregated and vegetated in a berm to the north of Phase 4C (Photo 14). Phases 5A and 5B are located in the far southwest corner of the permit (Photo 15). These two Phases are in the process of being mined out. There is a large overburden pile located next to these Phases (Photo 16).

Photo 8: View northwest of Phase 4B.

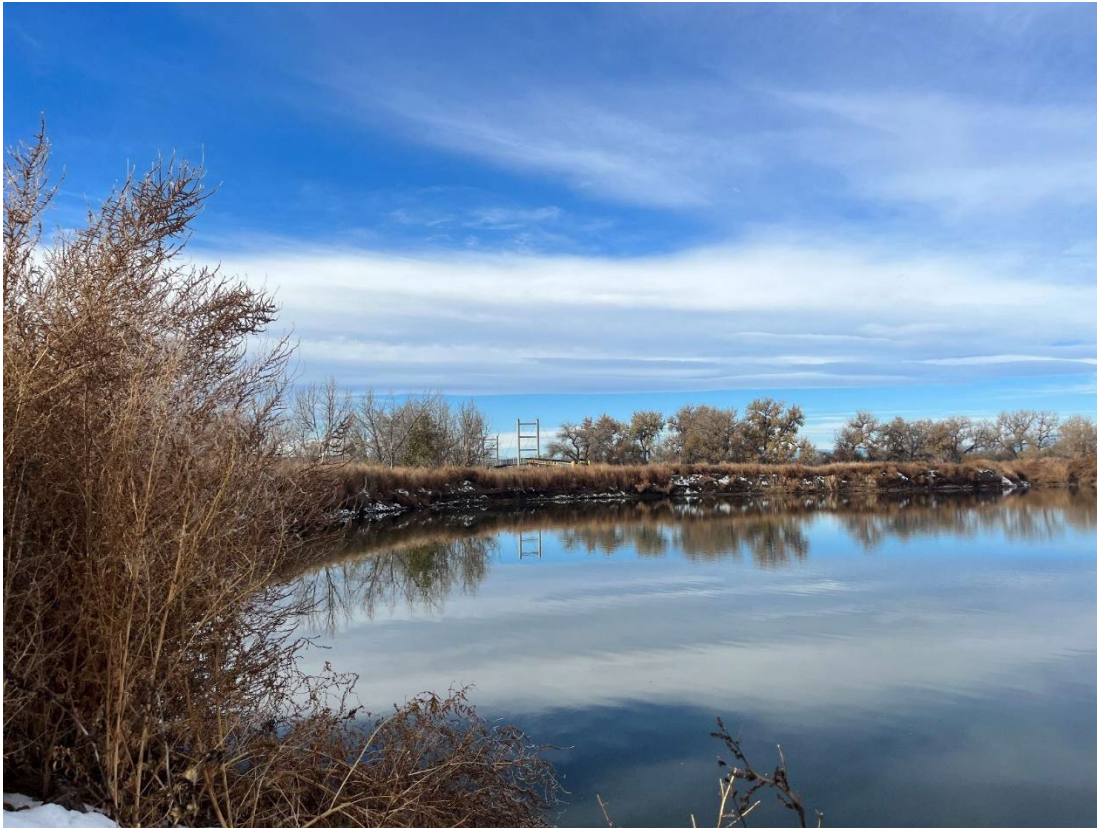
Photo 9: View south of completed Phase 4B, the conveyor to Phases 5A and 5B is visible.

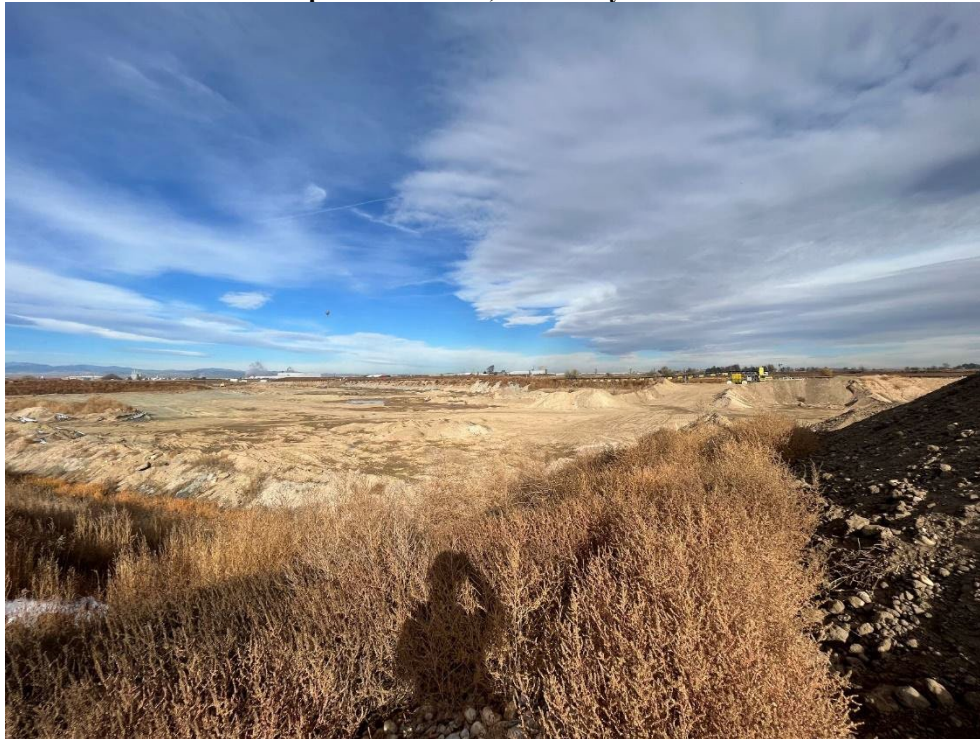
Photo 10: View north of Phase 4C, currently being mined.

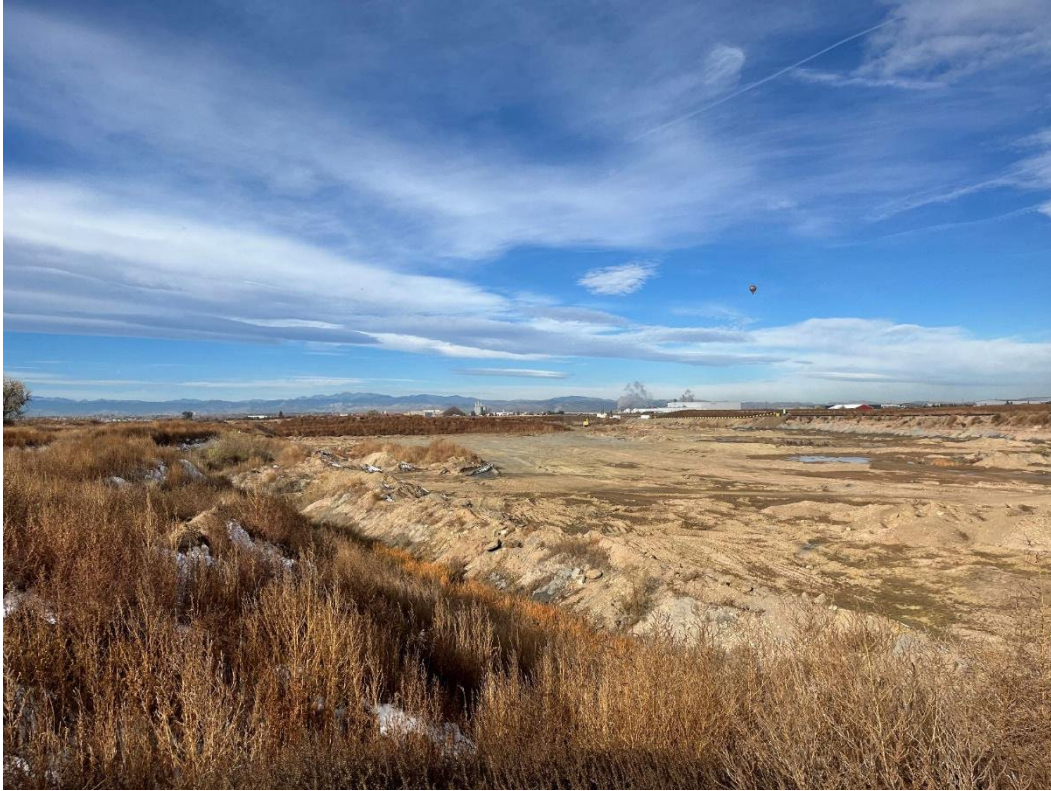
Photo 11: View west of Phase 4C, currently being mined.

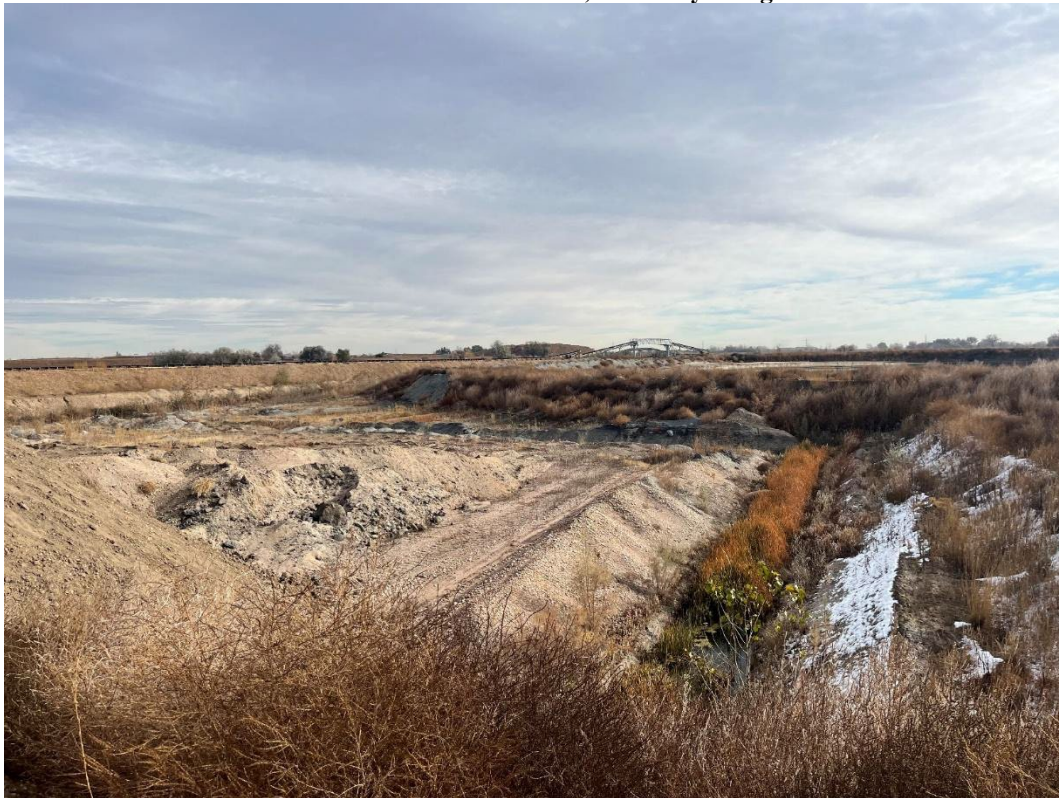
Photo 12: View northeast into Phase 4A.

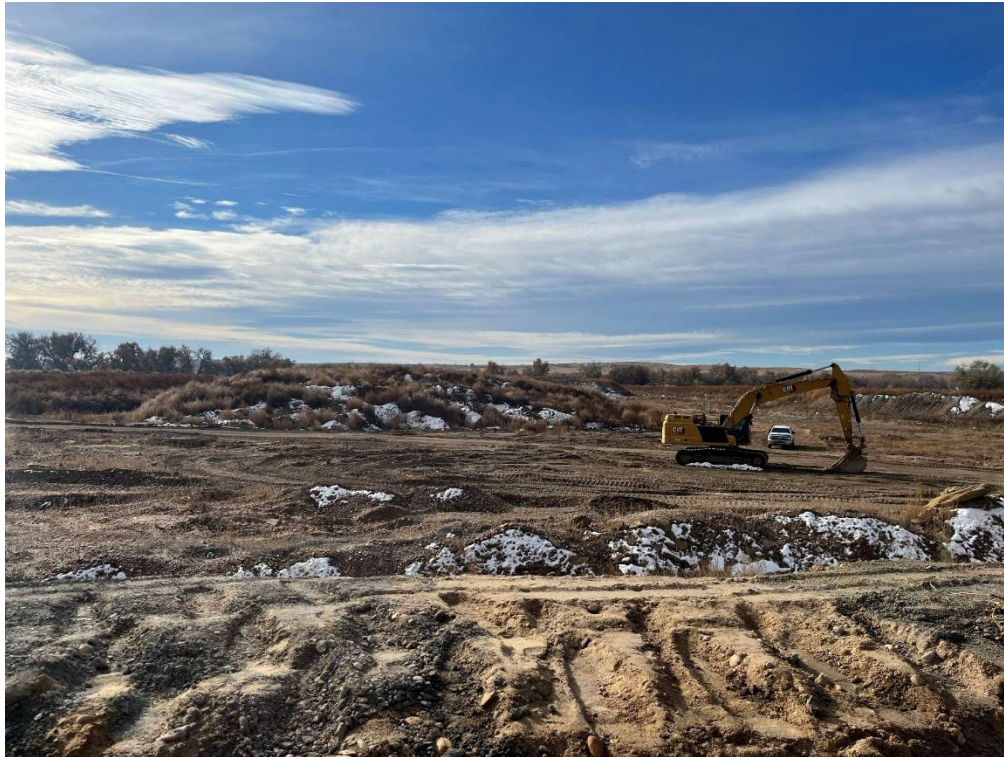
Photo 13: View south in Phase 4C, overburden is stored on the pit floor.

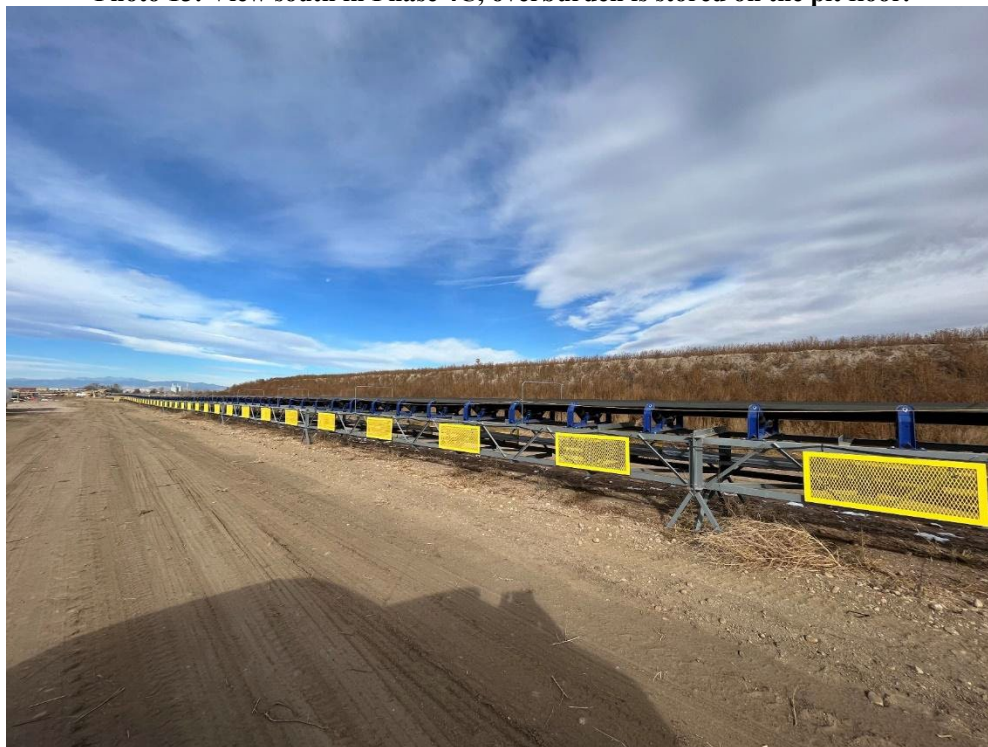
Photo 14: A section of new conveyor line which will extend into the Windsor East Pit site, topsoil for Phase 4C is stored in the berm pictured.

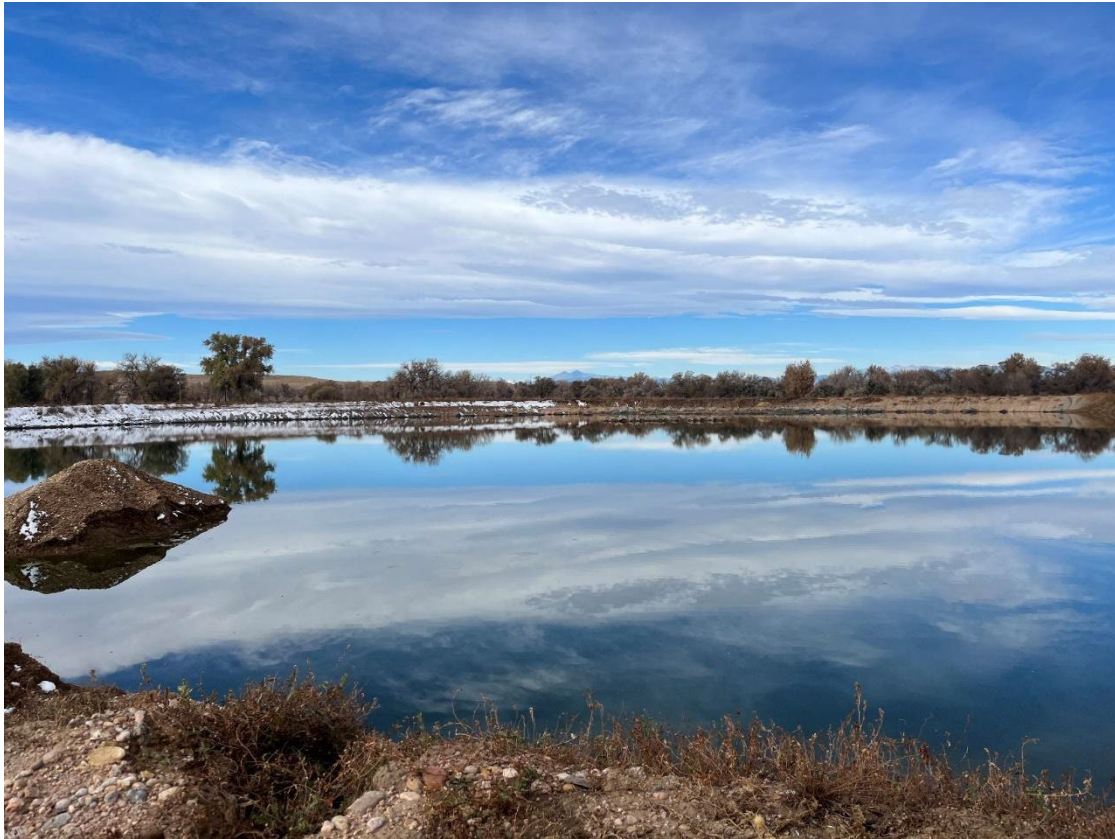
Photo 15: View west over Phase 5A.

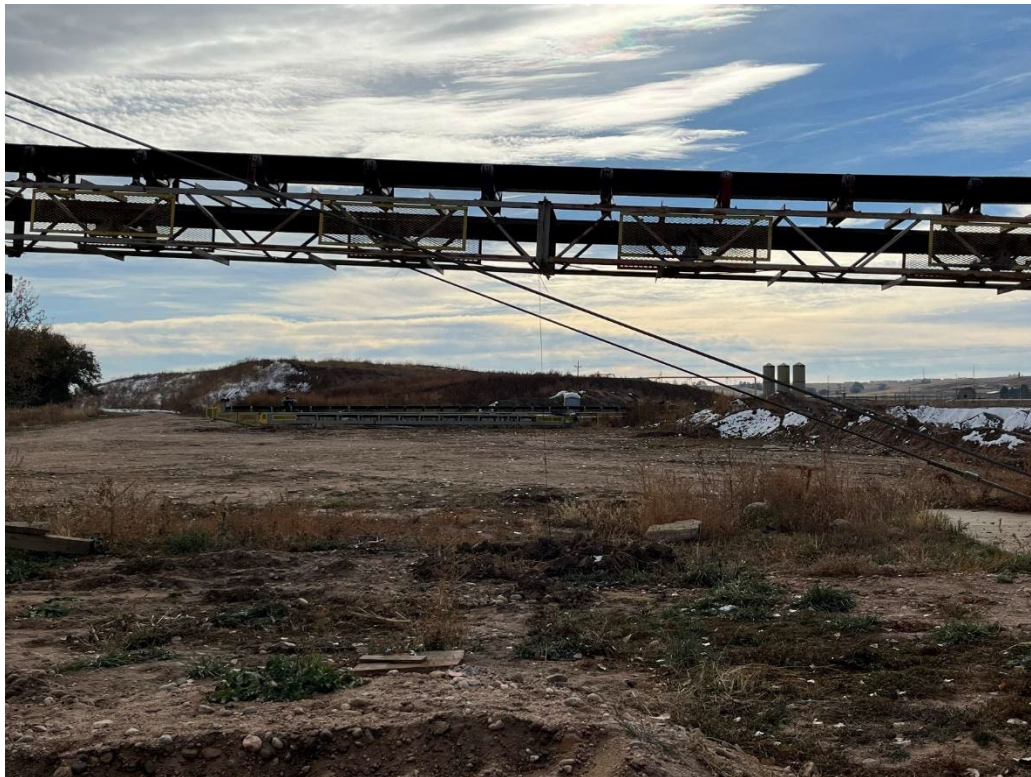
Photo 16: View southeast of the conveyor and overburden pile stored near Phases 5A and 5B.

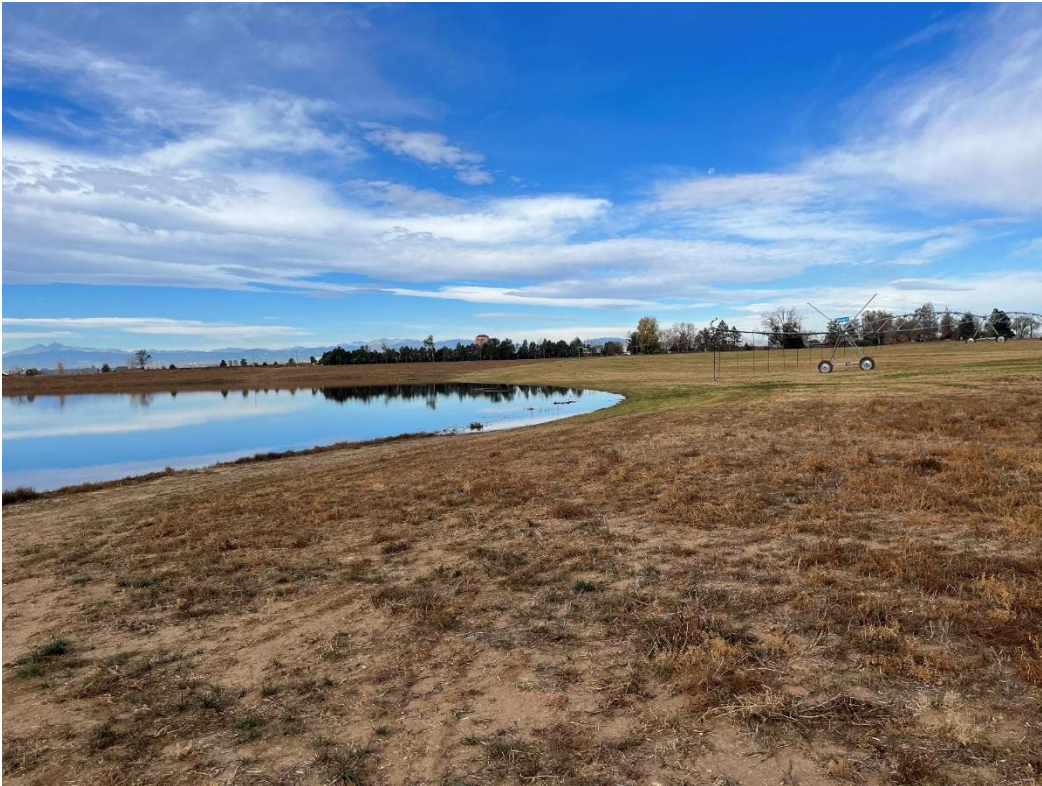
Phase 2 of the operation, located in the northwest corner of the site, is in final reclamation. The landowner has returned a section of this land back to an irrigated crop field (Photo 17) while the other half of the land serves as a recreational pond (Photo 18). The slopes have been put to final grade and the entire Phase is in the process of being reseeded. Once vegetation cover is better established, the Operator stated their intention to request formal release of this area.

Photo 17: Photo west of the reclaimed Phase 2 area.

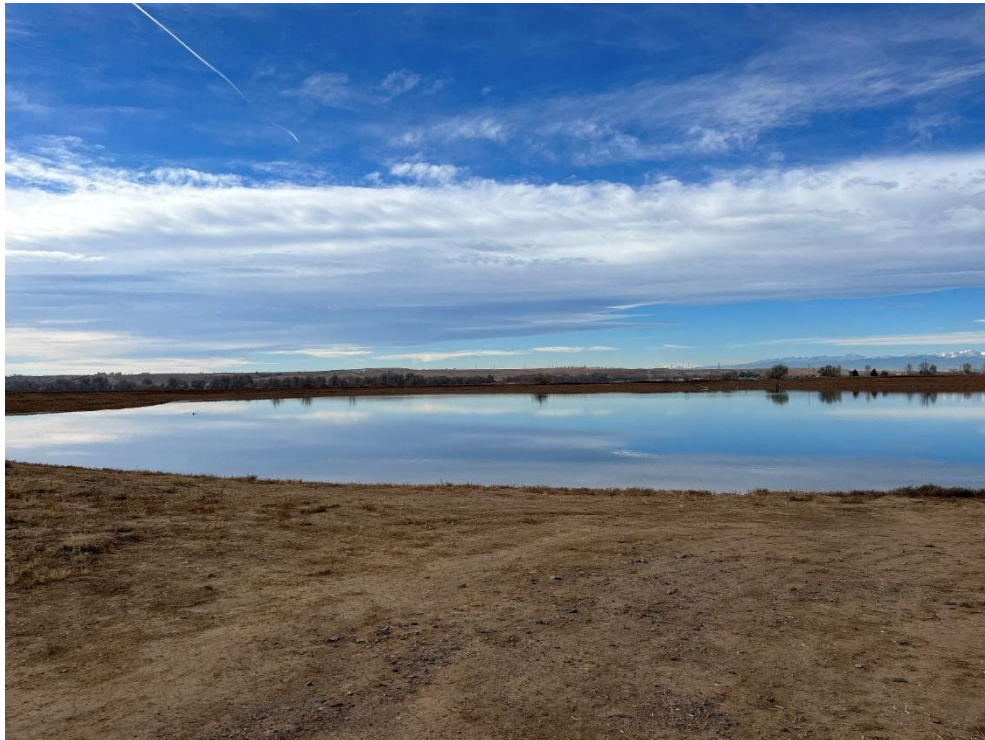
Photo 18: View southwest of the reclaimed Phase 2 area.
