MINERALS PROGRAM INSPECTION REPORT
PHONE: (303) 866-3567

MINE NAME: Cortner Pit	MINE/PROSPECTING ID#: M-1986-159	MINERAL: Sand and gravel	COUNTY: Pueblo
INSPECTION TYPE: Surety-Related Inspection	WEATHER: Clear	INSP. DATE: November 6, 2023	INSP. TIME: 10:00
OPERATOR: Martin Marietta Materials, Inc.	OPERATOR REPRESENTATIVE: Julie Mikulas	TYPE OF OPERATION: 112c - Construction Regular Operation	
REASON FOR INSPECTION: Surety Release Requested	BOND CALCULATION TYPE:	BOND AMOUNT: \$204,831.00	
DATE OF COMPLAINT: NA	POST INSP. CONTACTS: None	JOINT INSP. AGENCY: None	
INSPECTOR(S): Brock Bowles	INSPECTOR'S SIGNATURE:

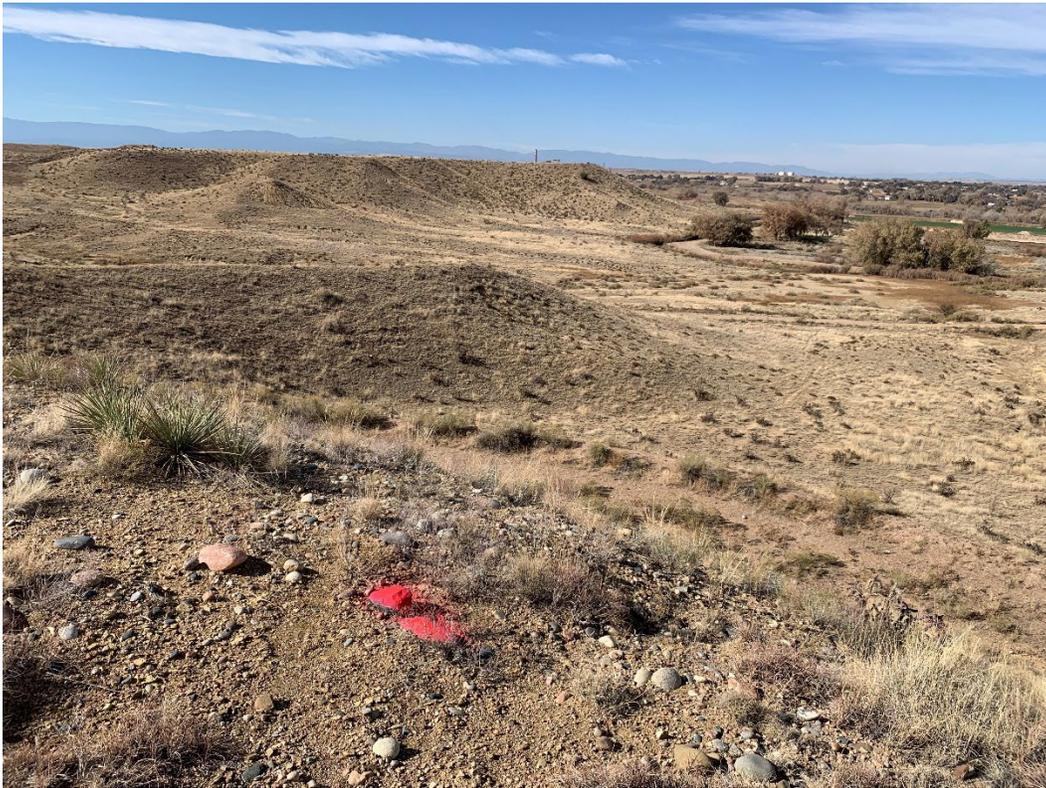
-The northwest area does not appear to have been disturbed by mining activities (photo 1). The vegetation is consistent in species composition and density as with the surrounding undisturbed areas outside the permitted area. The vegetation is dominated by grasses and yucca plants, which take a long time to get established. The section of the mine access road that crosses through the northwest section will remain in the permit boundary.

Photo 1 – Northwest area requested for release, at northwest corner marker facing southwest.

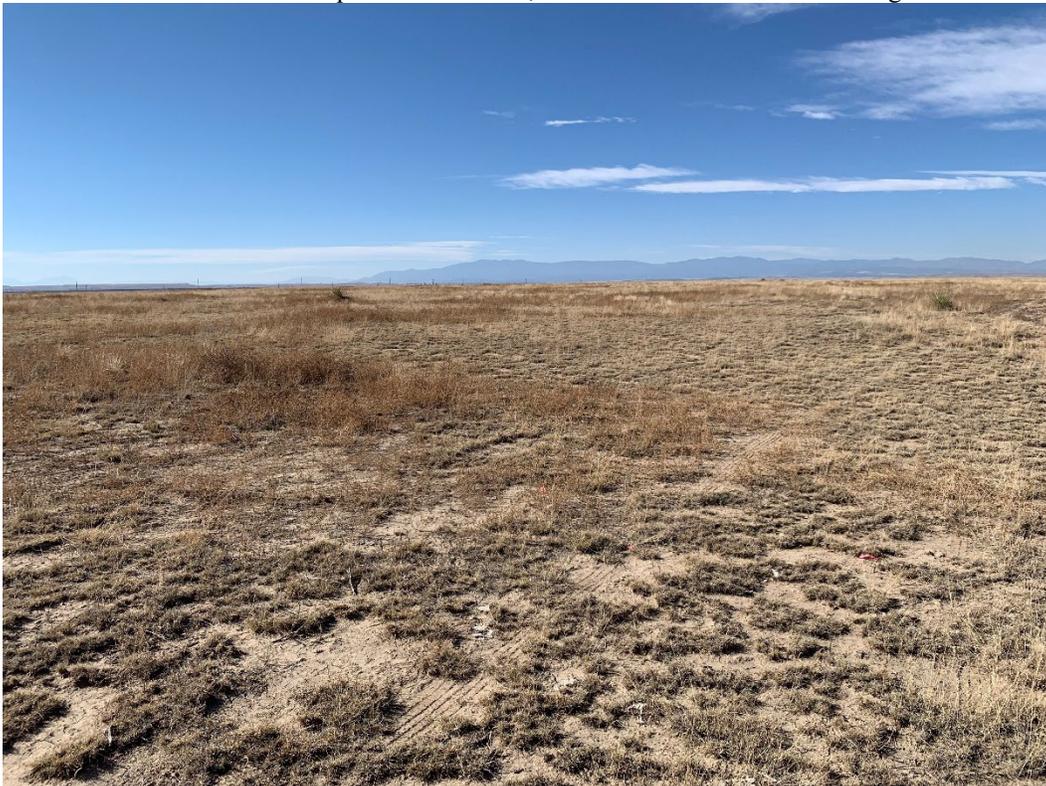
-The south area does not appear to have been disturbed by mining activities (photos 2 & 3). The vegetation is consistent in species composition and density as with the surrounding undisturbed areas outside the permitted area. The vegetation is also dominated by grasses with a few scattered yucca plants.

Photo 1 – Southern area requested for release, facing southwest.

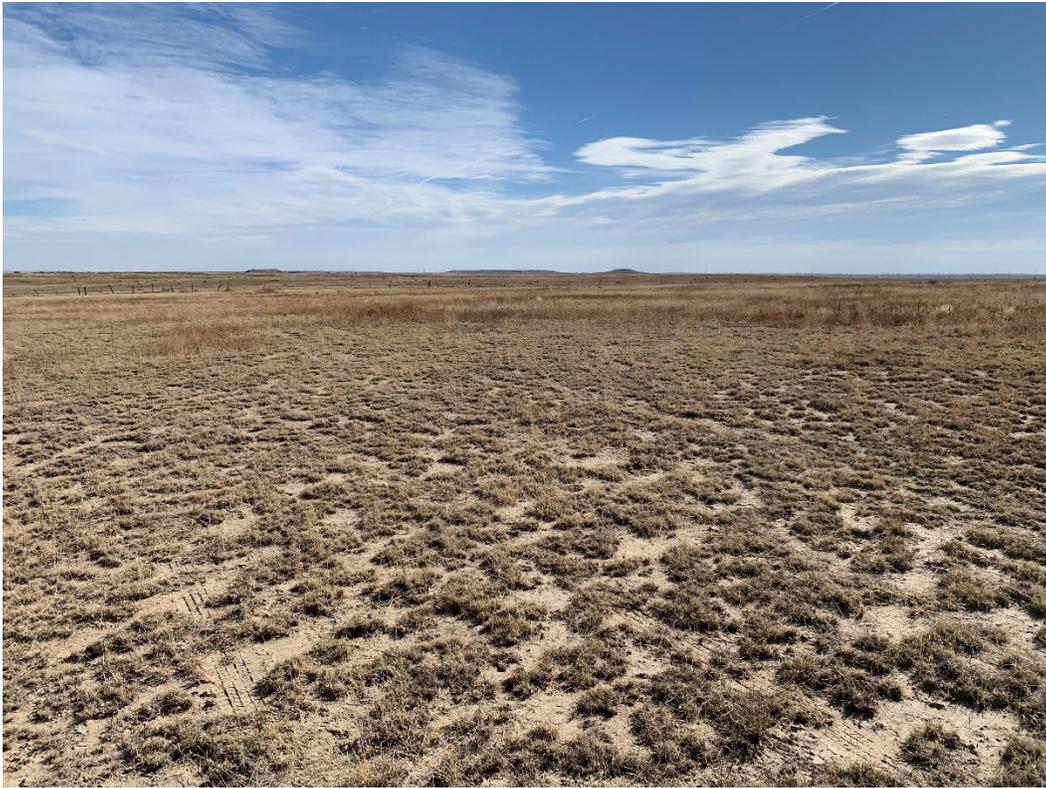
Photo 2- Southern area requested for release, facing southeast.

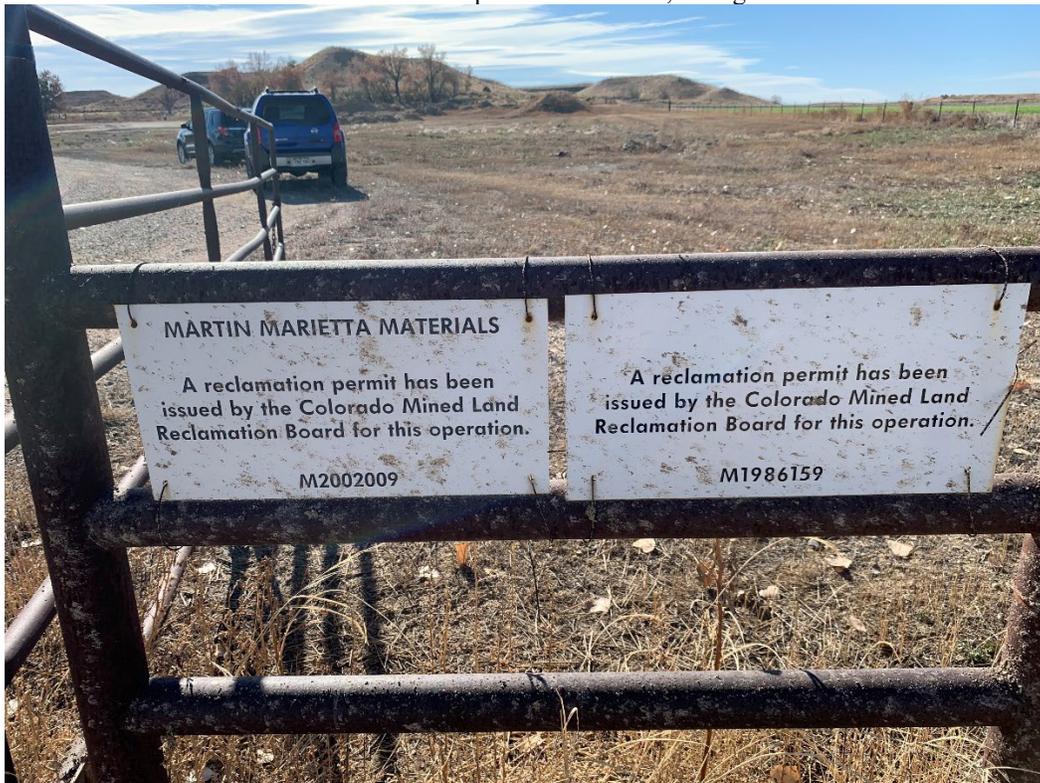
The mine entrance sign was in place facing Cortner Road (photo 4).

Photo 4 – Mine entrance sign facing Cortner Road

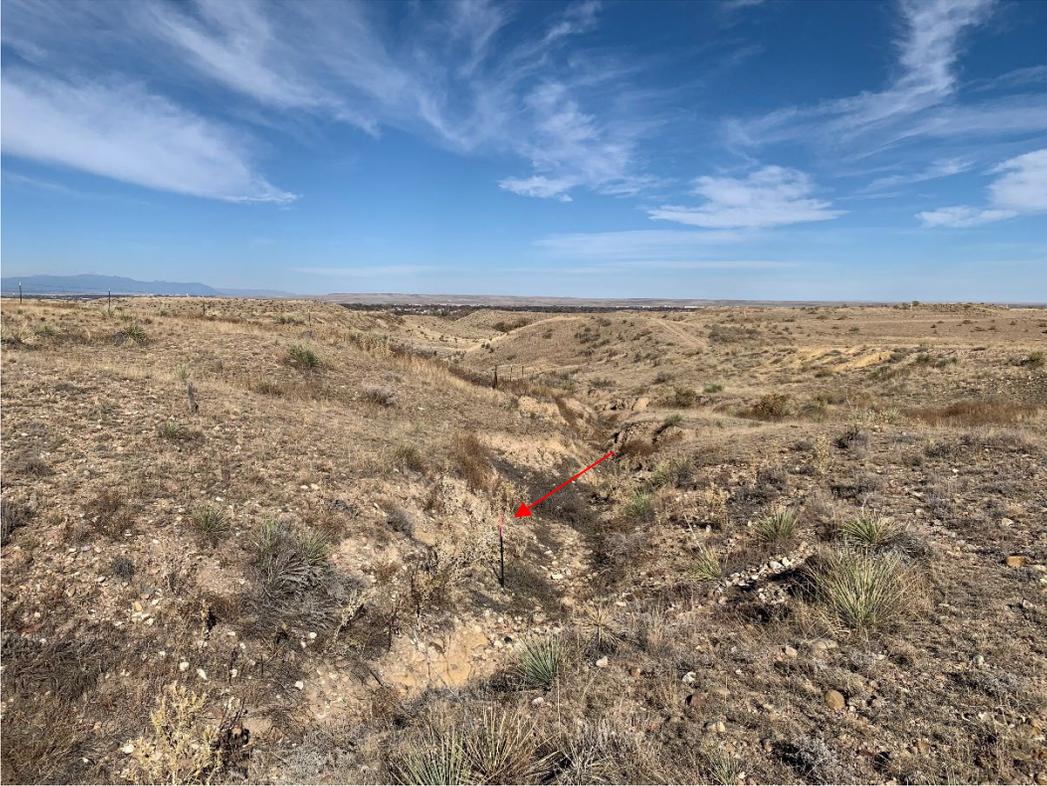
New permit boundary markers were installed to show the permit boundary proposed in the AR2 application. The new markers were painted orange (photos 5 & 6). All the corner markers were identified during the inspection.

Photo 5 – Southwest corner marker

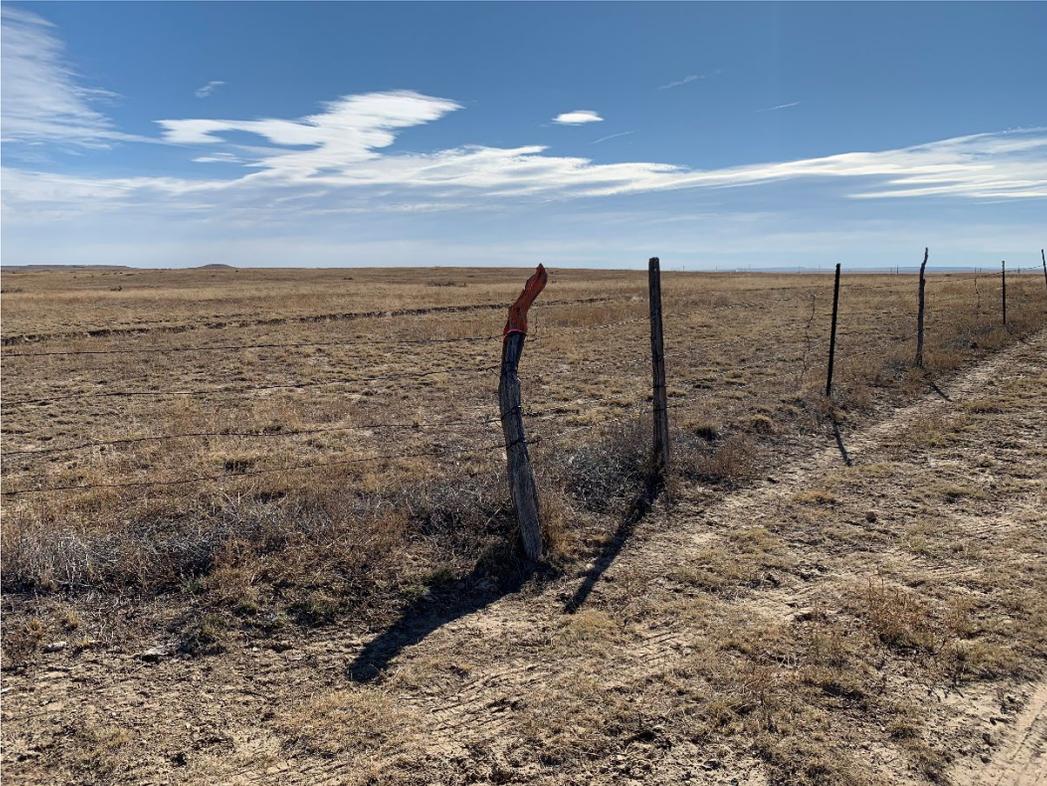
Photo 6 – South east corner marker
