Inspection Report, Foidel Creek Mine, C-1982-056

PERMIT INFORMATION

Permit Number: C-1982-056 Mine Name: Foidel Creek Mine Operator: Twentymile Coal, LLC Operator Address: Ms Miranda Kawcak 29515 Routt County Road No. 27 Oak Creek, CO 80467	County: Routt Operation Type: Underground Permit Status: Active Ownership: Private
	Operator Representative Present: Kevin Copeland
Operator Representative Signature: (Field Issuance Only)

Inspection Start Date: November 14, 2023 Inspection Start Time: 10:30 Inspection End Date: November 14, 2023 Inspection End Time: 15:30		Inspection Type: Coal Partial inspection (ground visit) with Aerial Inspection Reason: Normal I&E Program Weather: Windy	
Joint Inspection Agency: None		Joint Inspection Contacts: 	
Post Inspection Agency: None		Post Inspection Contacts: 	
Inspector(s): Hunter Ridley Leigh Simmons	Inspector's Signature: <i>Hunter Ridley</i> Signature Date: November 22, 2023

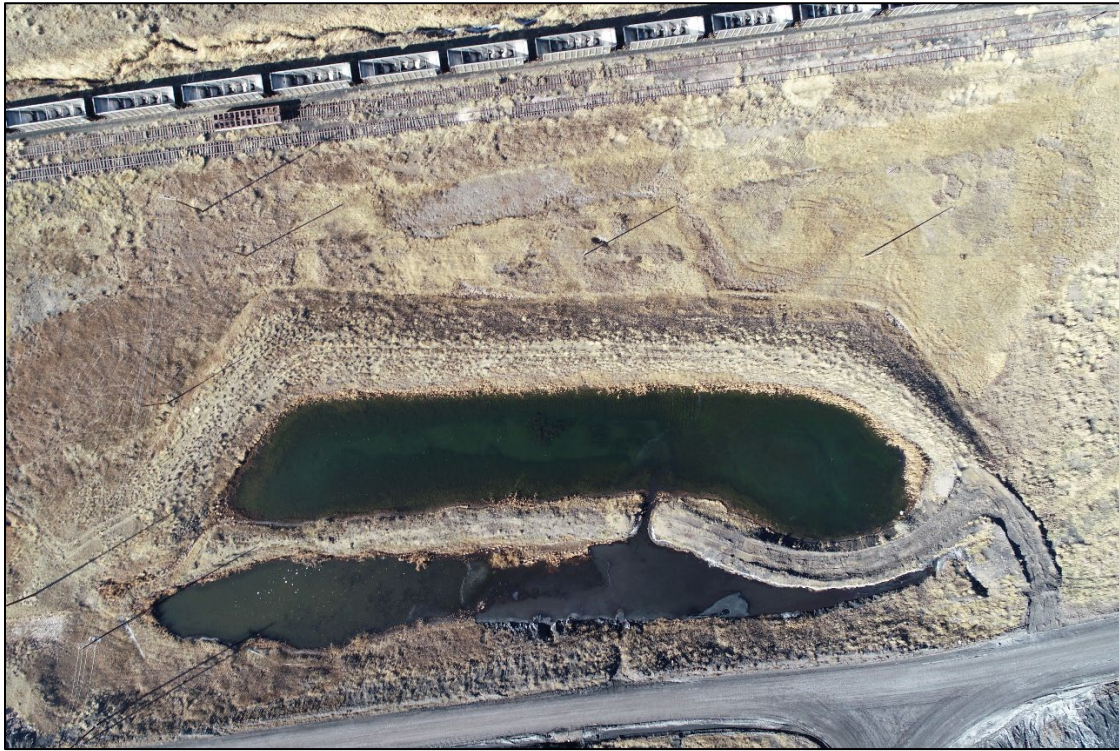
All ponds in the Main Facilities area, except Pond T, Pond F, Pond G, and the wastewater treatment ponds, were visible in the drone photographs. No problems with these features were observed. (Photos 2-6 and 9). All ponds have been cleaned out for the season.

Figure 5: Double celled Pond E.

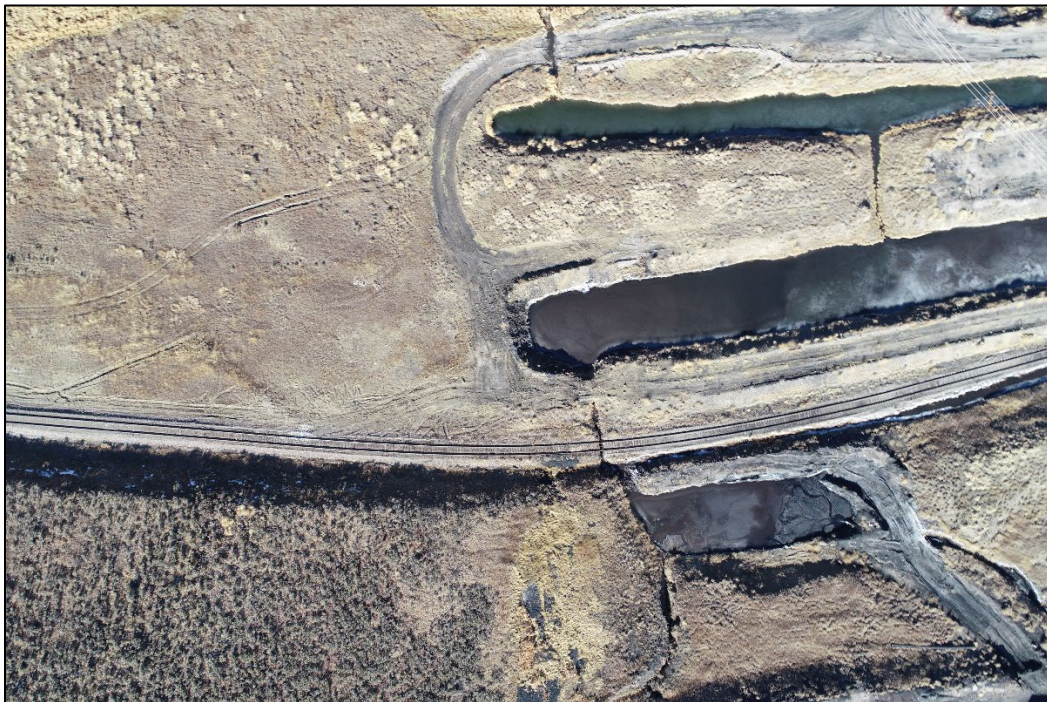
Figure 6: Double celled Ponds B and southern sump.
