C1980007, West Elk Mine, November Inspection Report

PERMIT INFORMATION

INSPECTION INFORMATION

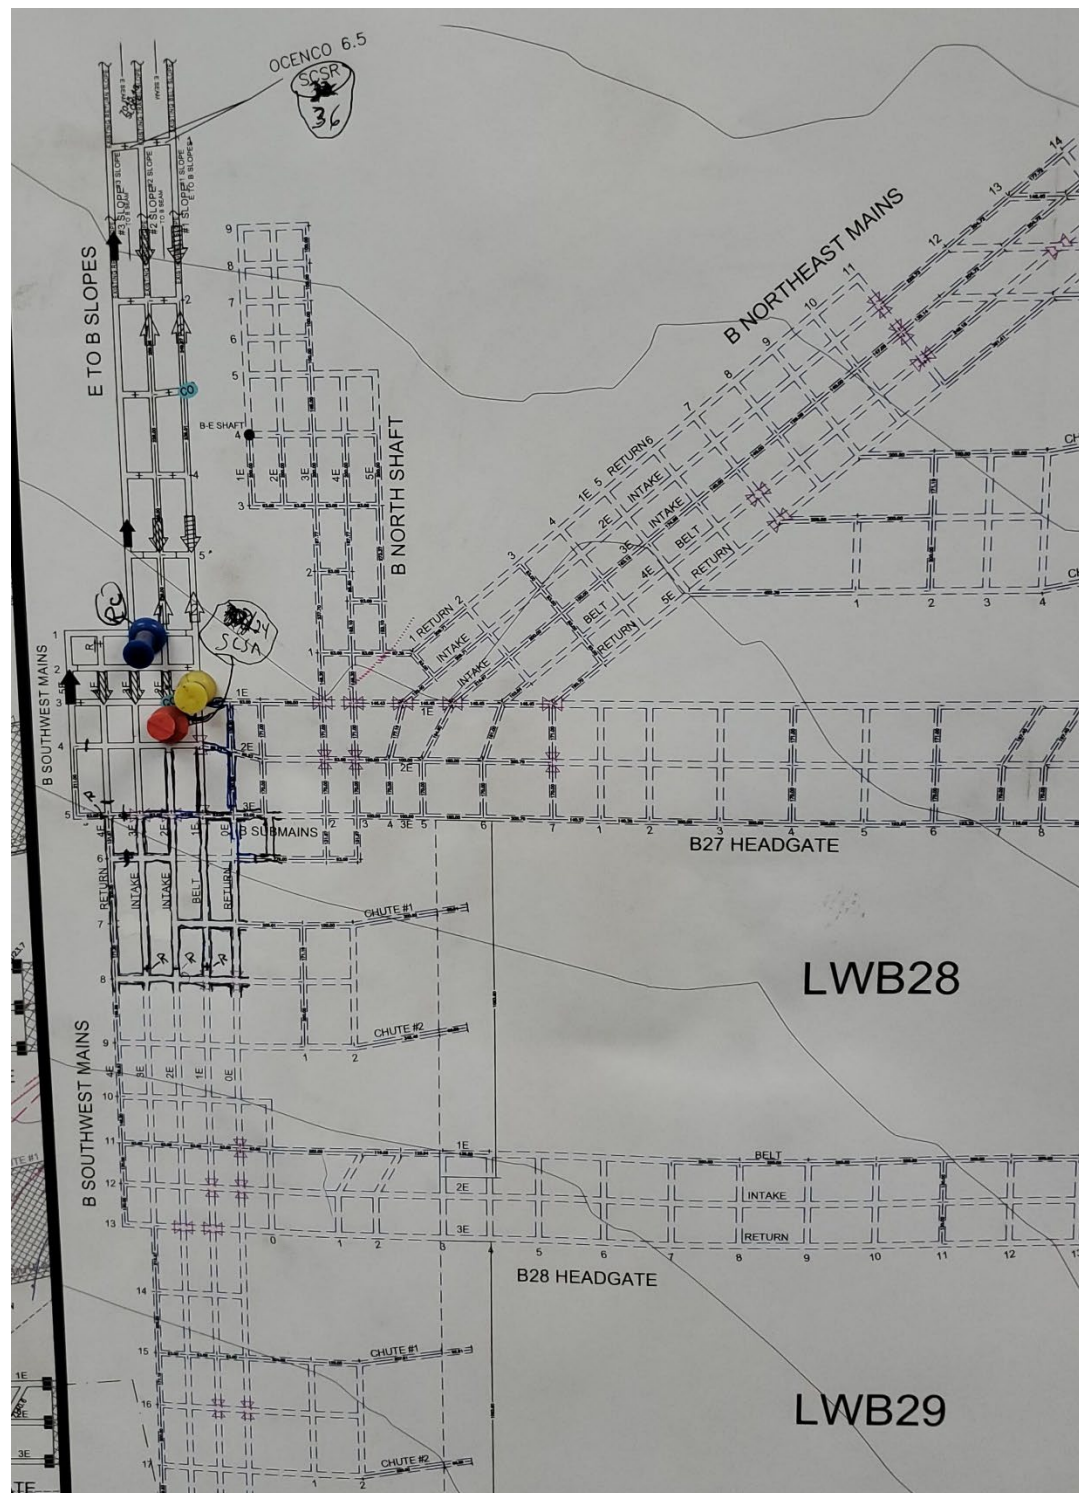
Development of the B Southwest Mains was in progress, at around crosscut 8.

Figure 3: Development progress in B southwest mains

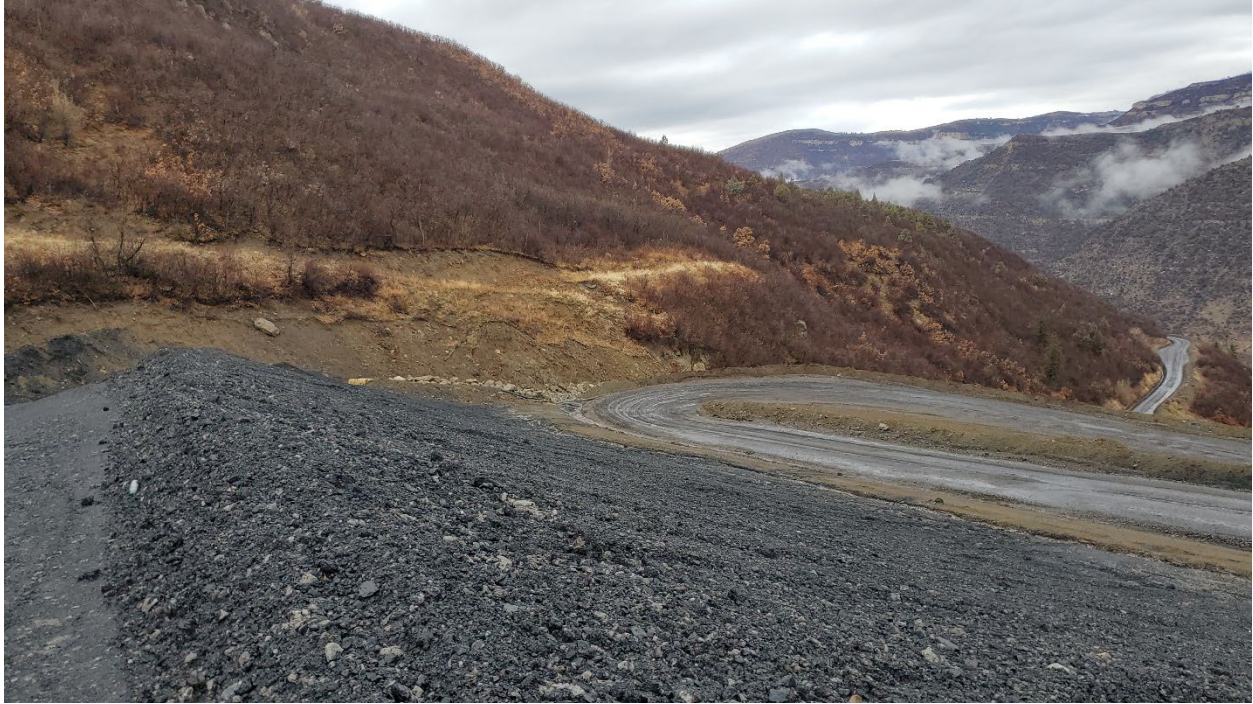
Figure 4: Entrance to RPEE (west)

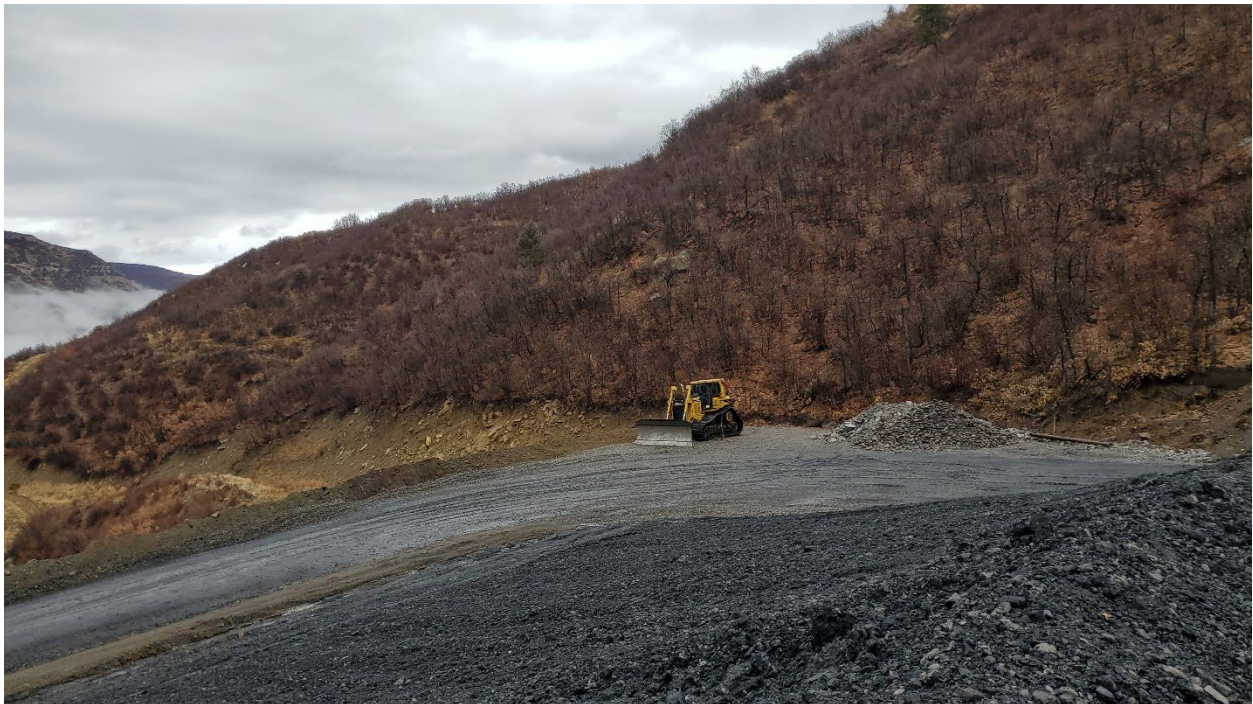
Figure 5: Entrance to RPEE (east)

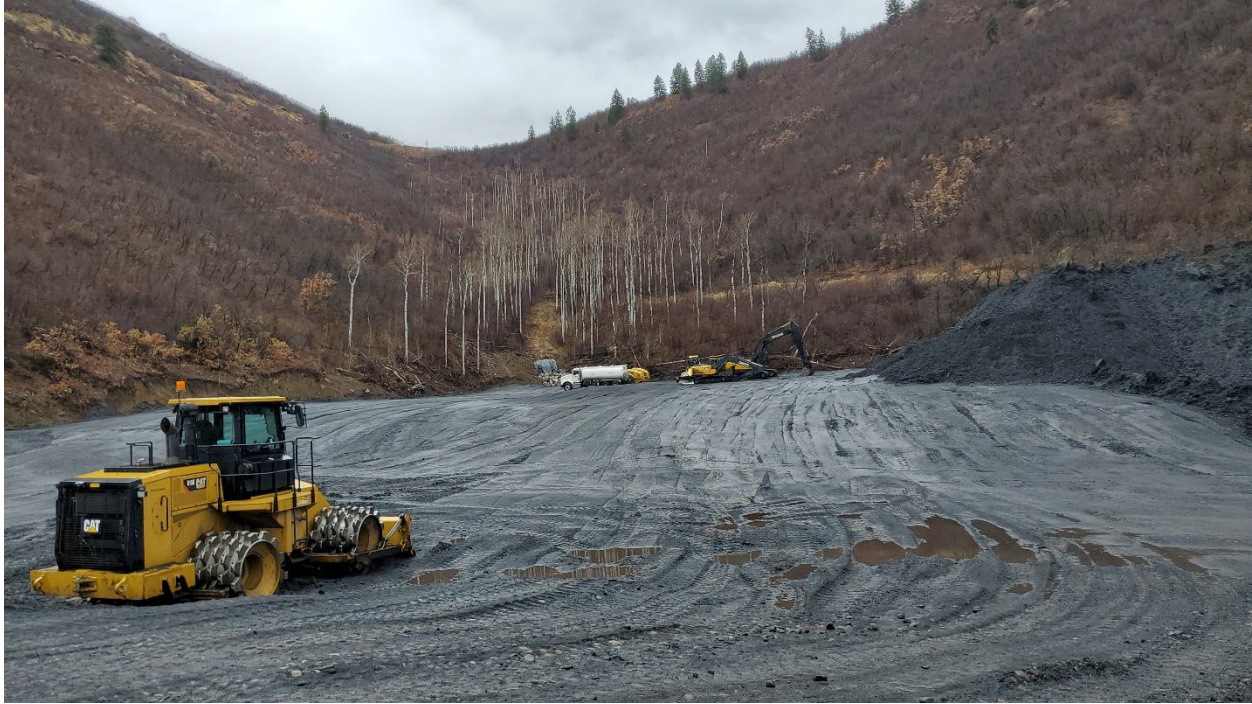
No refuse was being generated at the time of the inspection, and, as a result of the wet weather, none was being transported around the site either. The surface of the RPEE had been left smooth and fairly compact, sloped so as to drain to the northwest. Uncompacted material had been temporarily placed on the western edge of the RPEE. Refuse on the western edge was at the line where vegetation had been grubbed to; on the eastern edge of the pile several vertical feet of capacity remained, however vegetation and topsoil will need to be stripped and stockpiled respectively before the pile can grow significantly.

Figure 6: Compacted surface of RPEE, with uncompacted material on west side

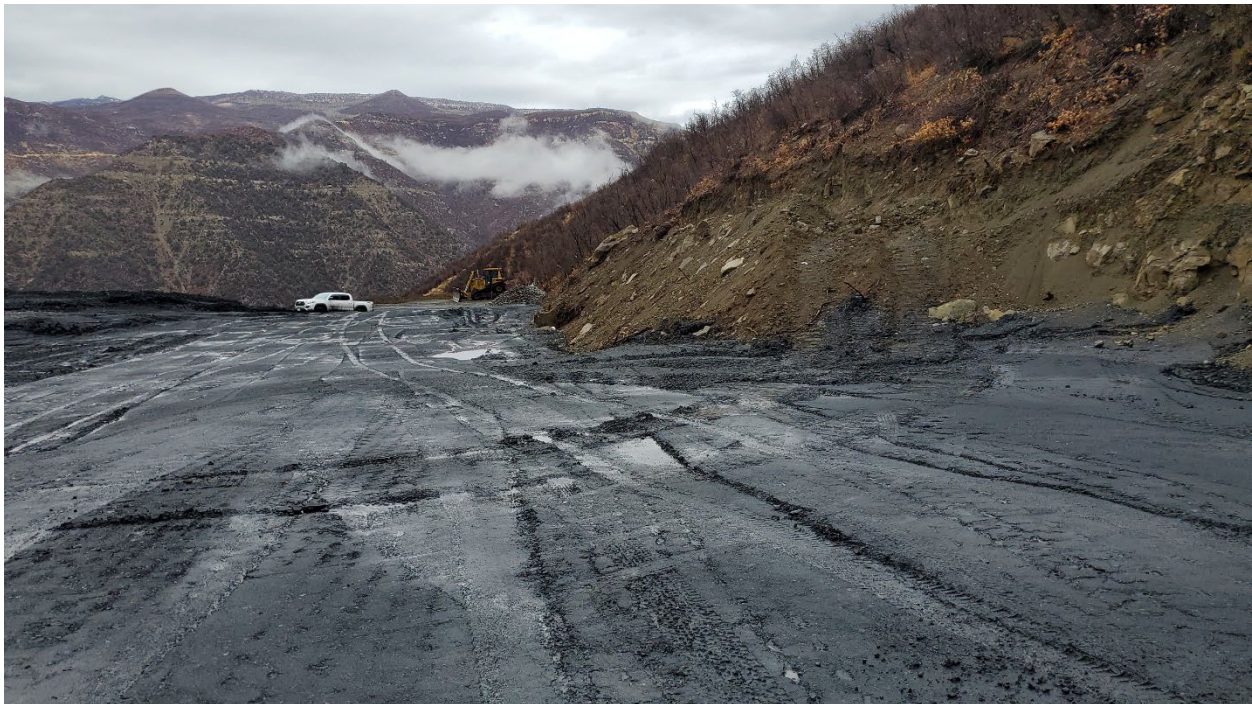
Figure 7: East side of RPEE, showing stripped topsoil

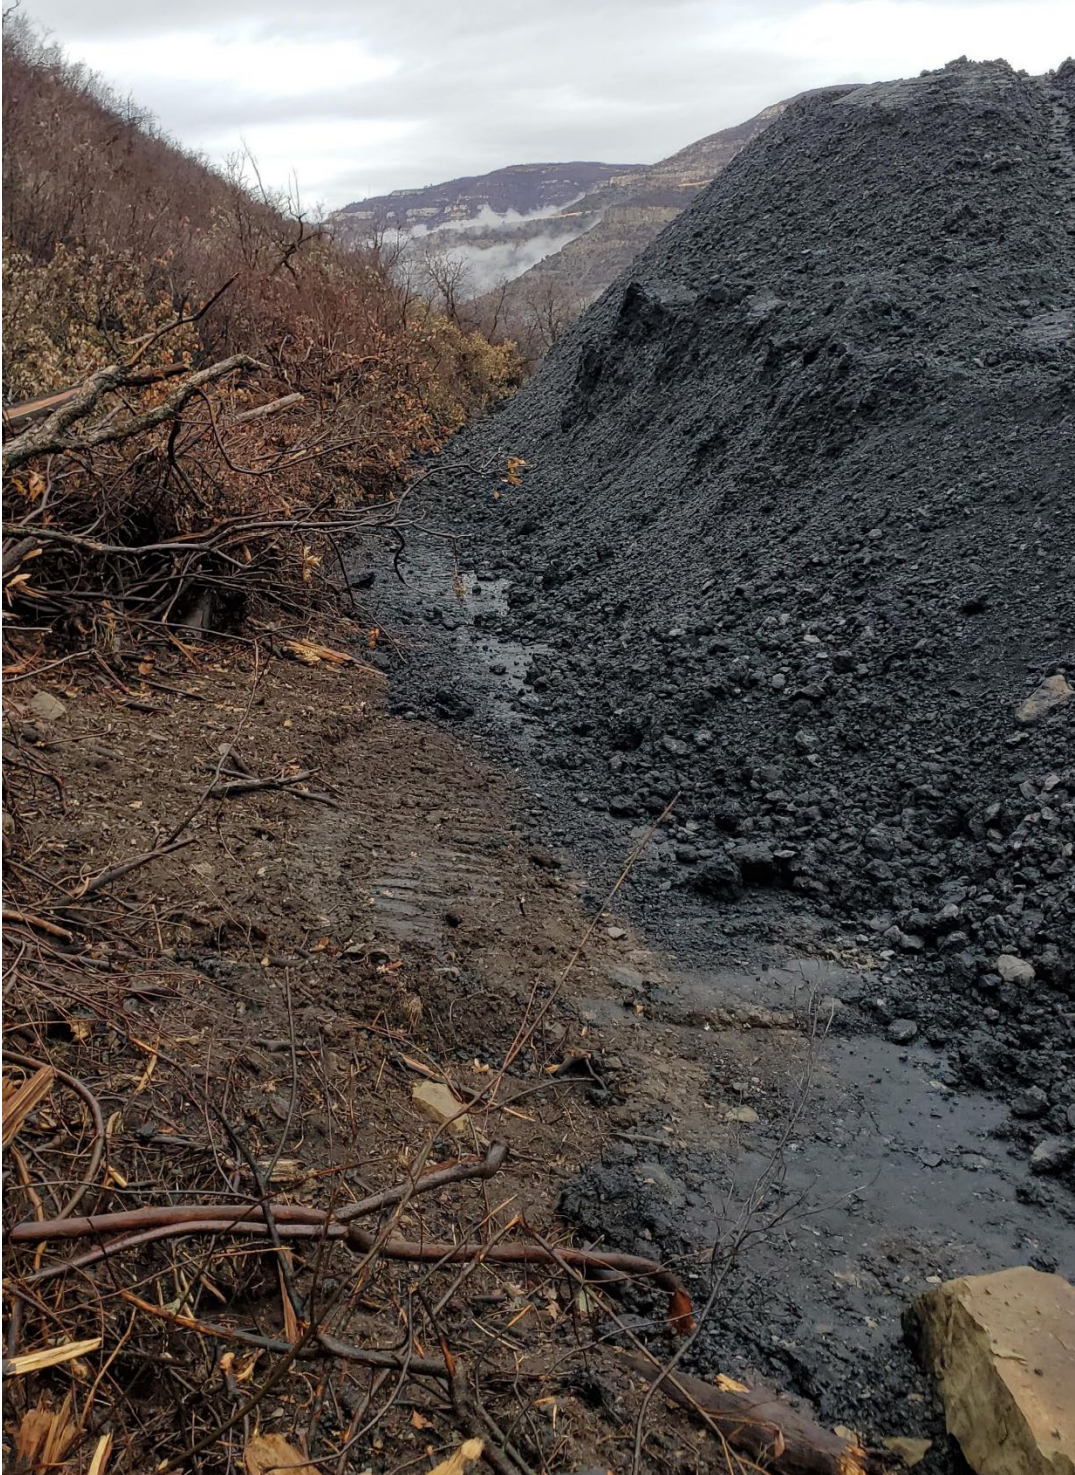
Figure 8: Refuse on west side of RPEE at upper limit

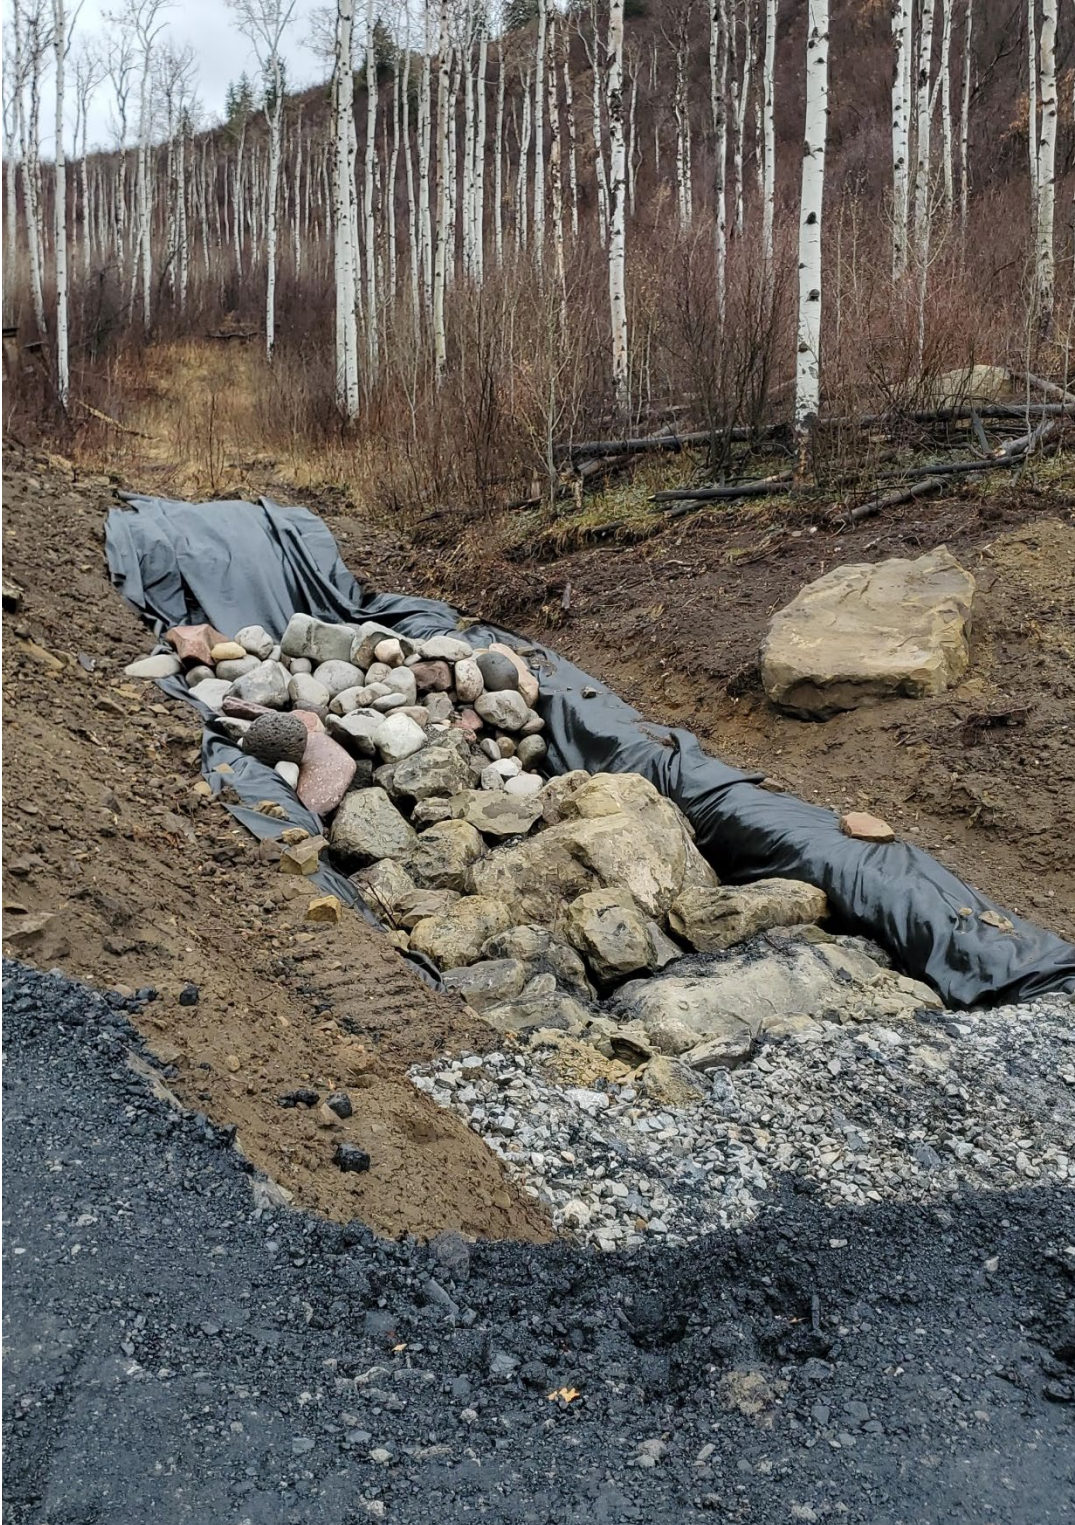
Figure 9: Underdrain on RPE

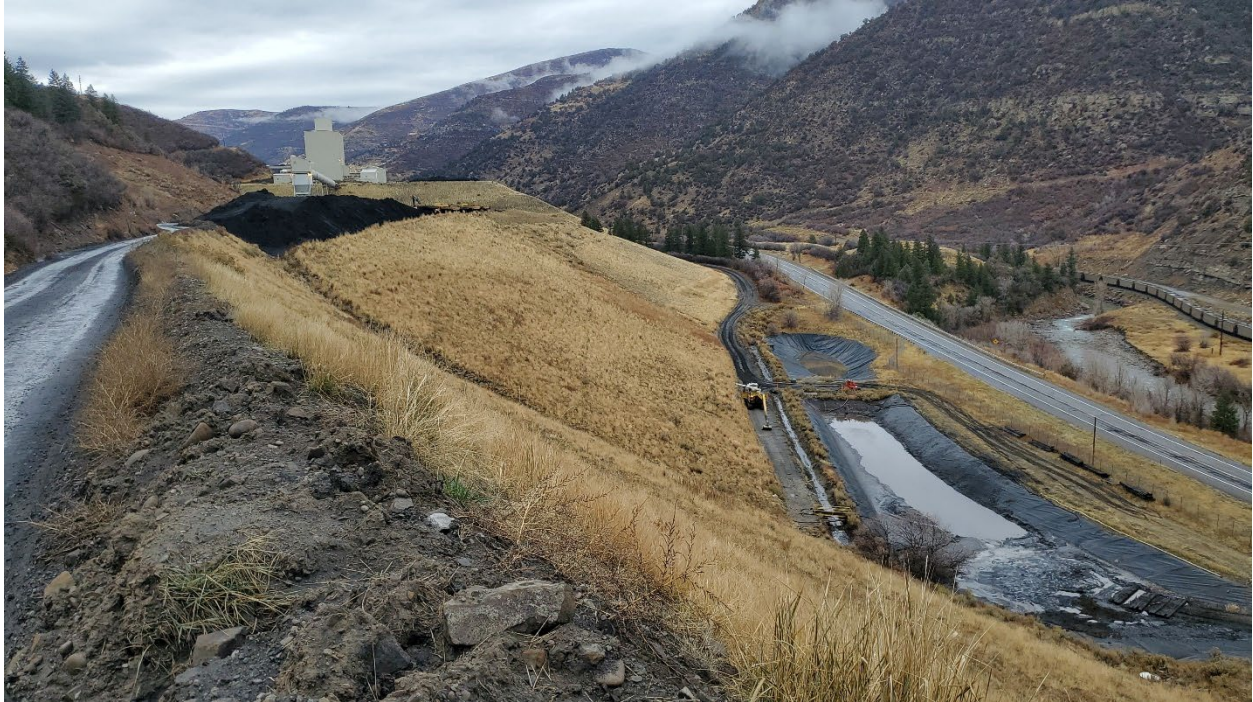
Cleaning of the RPE pond was halted while the long-arm excavator was being repaired.

Figure 10: RPE and RPE pond

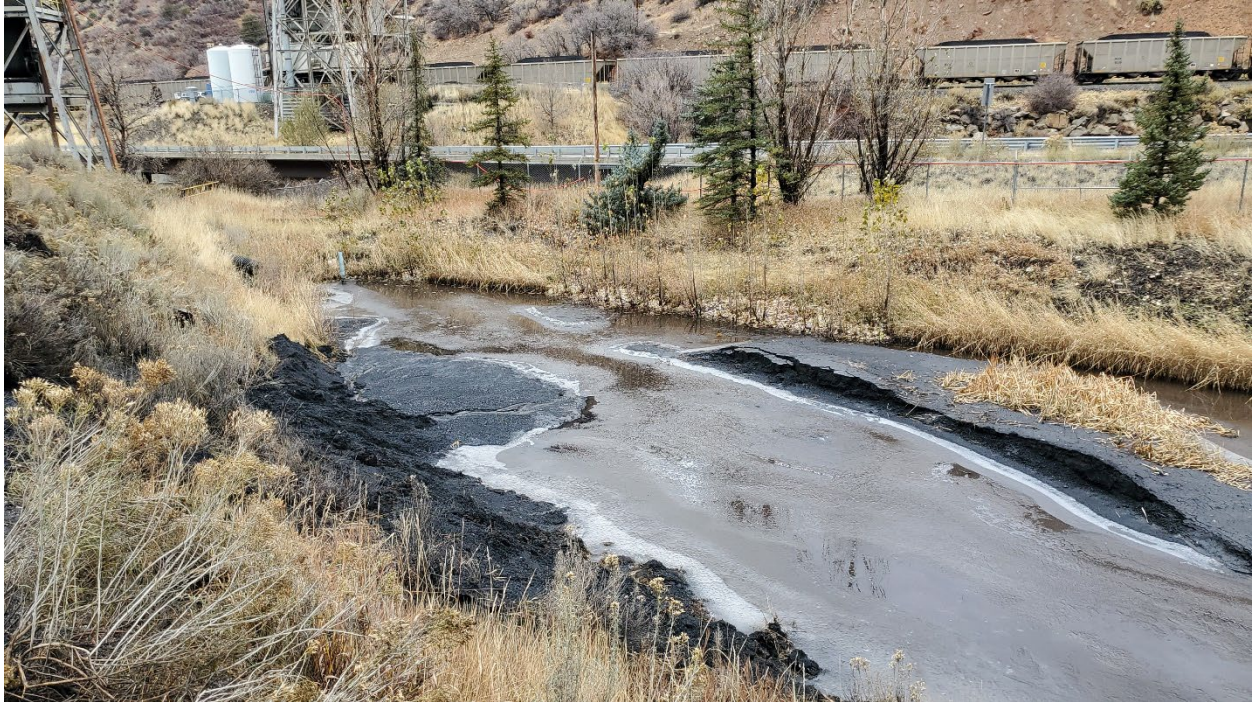
At the MB3 pond the pump was running to drain the water, ready for cleaning.

Figure 12: MB-3 pond (west)

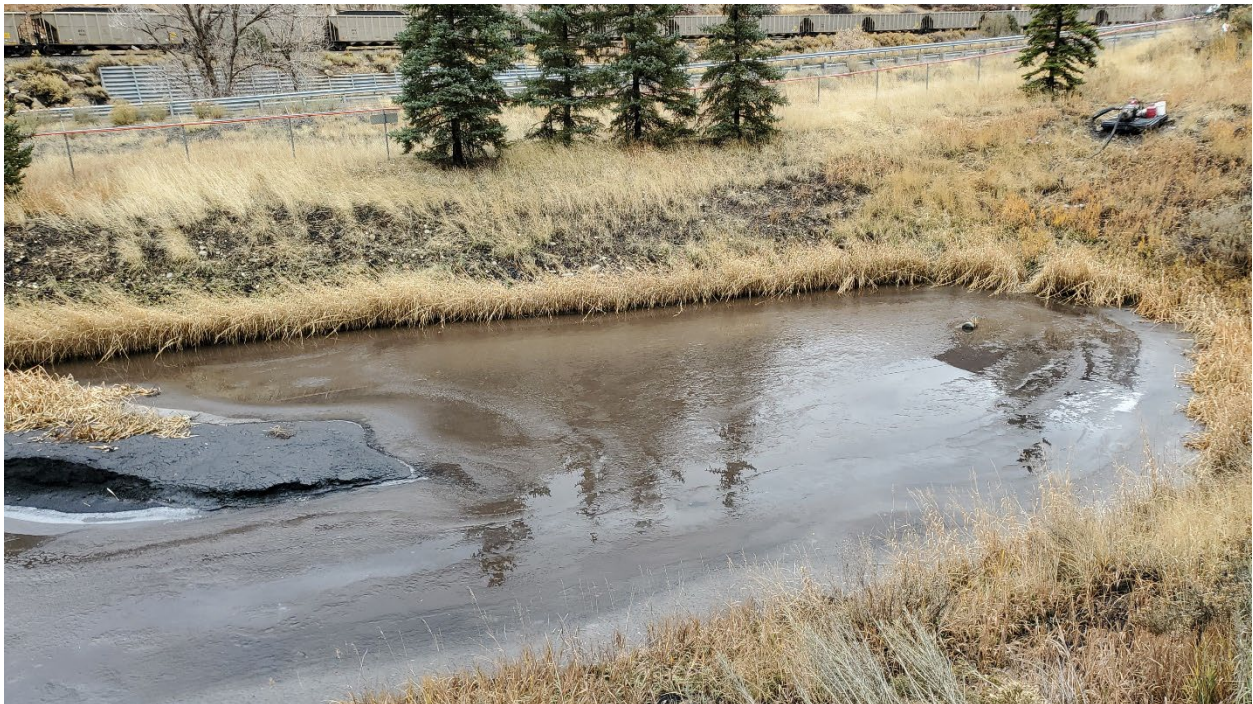
Figure 13: MB-3 pond (east)
