C1983059, Terror Creek Loadout, November Inspection Report

PERMIT INFORMATION

Permit Number: C-1983-059 Mine Name: Terror Creek Loadout Operator: Oxbow Mining, LLC Operator Address: Mr Doug Smith PO Box 535 Paonia, CO 81434	County: Delta Operation Type: Loadout Permit Status: Active Ownership: Private
	Operator Representative Present: Doug Smith
Operator Representative Signature: (Field Issuance Only)

Inspection Start Date: November 15, 2023 Inspection Start Time: 15:30 Inspection End Date: Inspection End Time:	Inspection Type: Coal Partial Inspection Inspection Reason: Normal I&E Program Weather: Clear
Joint Inspection Agency: None	Joint Inspection Contacts:
Post Inspection Agency: None	Post Inspection Contacts:
Inspector(s): Leigh Simmons	Inspector's Signature:

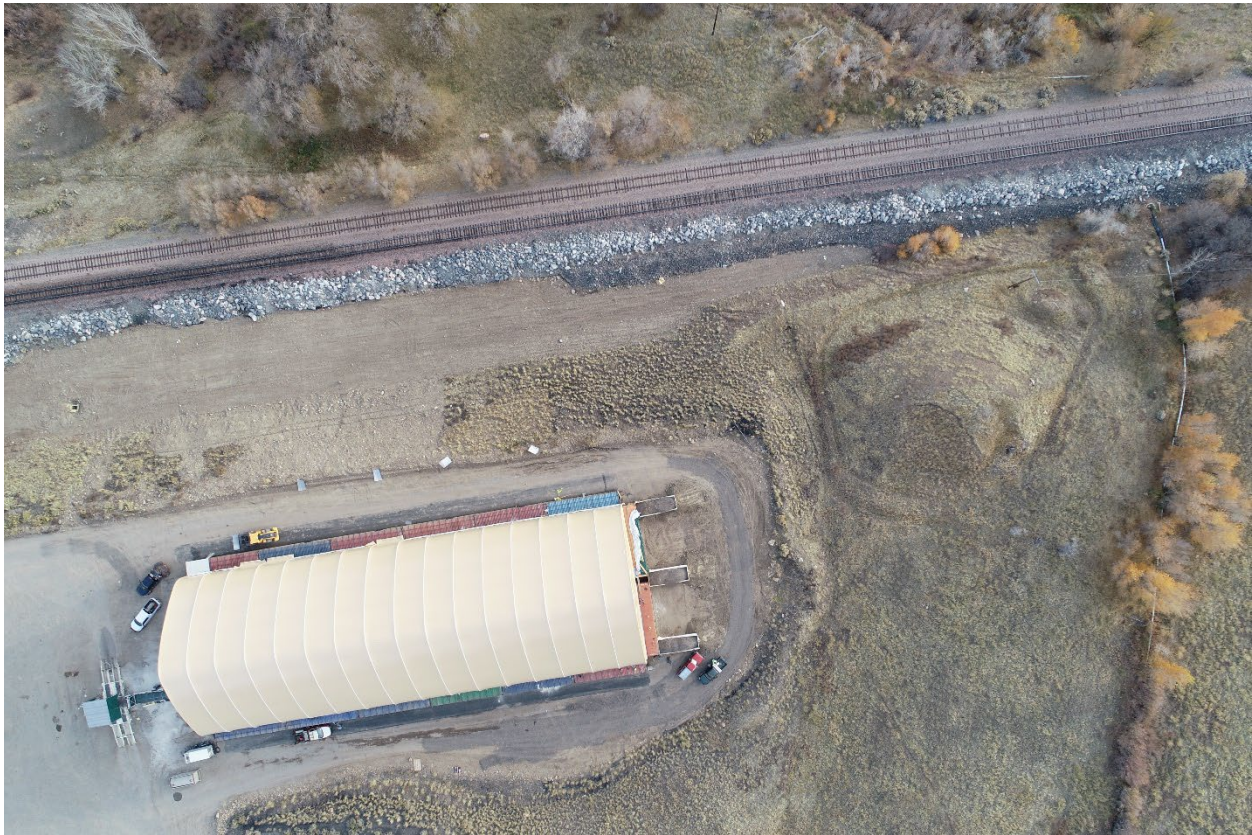
Figure 1: Drone image showing railroad track, topsoil stockpile, western end of lower pad and temporary building
