MINERALS PROGRAM INSPECTION REPORT
PHONE: (303) 866-3567

MINE NAME: Rocky Road Quarry	MINE/PROSPECTING ID#: M-1985-210	MINERAL: Sandstone (silica, st quartzite)	COUNTY: Larimer
INSPECTION TYPE: Monitoring	WEATHER: Clear	INSP. DATE: August 22, 2023	INSP. TIME: 09:30
OPERATOR: Rocky Road Investments, Inc.	OPERATOR REPRESENTATIVE: Douglas Bachli	TYPE OF OPERATION: 112c - Construction Regular Operation	
REASON FOR INSPECTION: Normal I&E Program	BOND CALCULATION TYPE: Complete Bond	BOND AMOUNT: \$76,054.56	
DATE OF COMPLAINT: NA	POST INSP. CONTACTS: None	JOINT INSP. AGENCY: None	
INSPECTOR(S): Patrick Lennberg	INSPECTOR'S SIGNATURE:

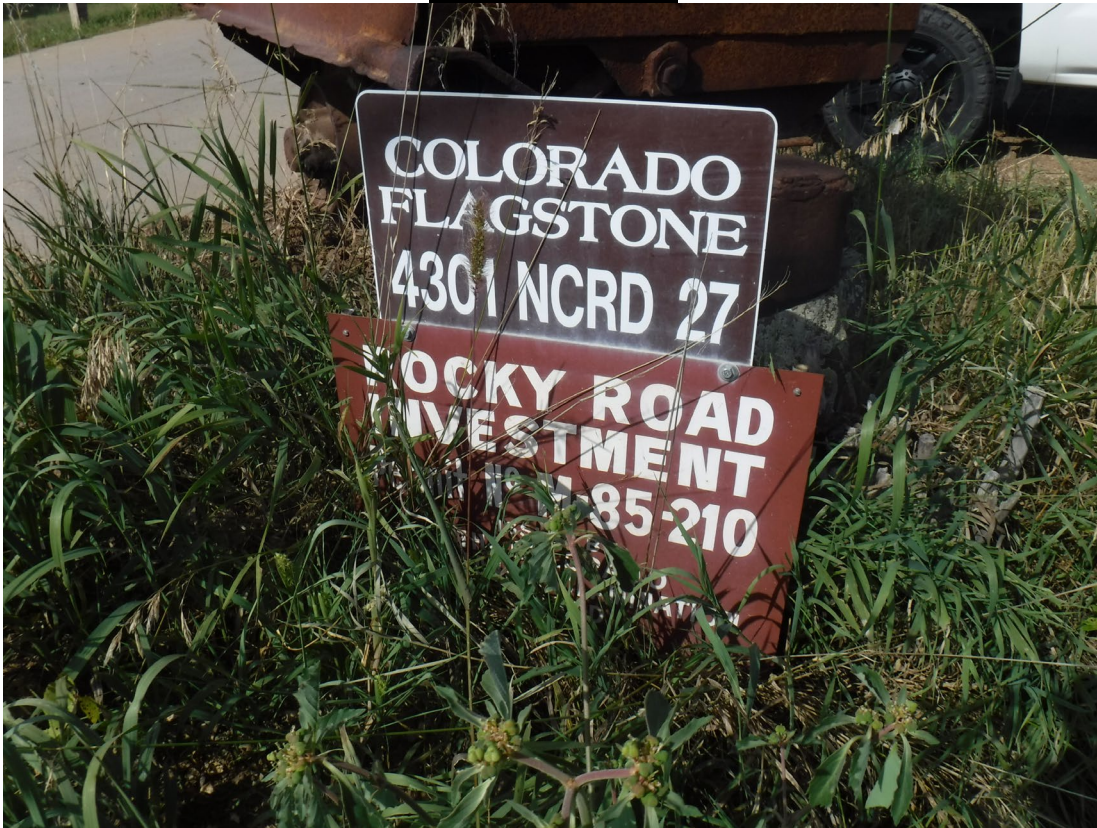
The Rocky Road Quarry permit is located in Larimer County approximately 7 miles northwest of Loveland, CO 1.4 miles north of the junction of US Hwy 34 and N Co Rd 27. The permit is located on land owned by Rocky Road Investments, Inc. which is the current Permittee and Operator. The approved permit is a 112c operation for 106.5 acres with 25 acres allowed to be disturbed at any one time. The approved post mining land use is rangeland with limited residential development. A mine sign was observed at the entrance to the mine as required by Rule 3.1.12.

Photo 1: Mine Sign at primary mine entrance

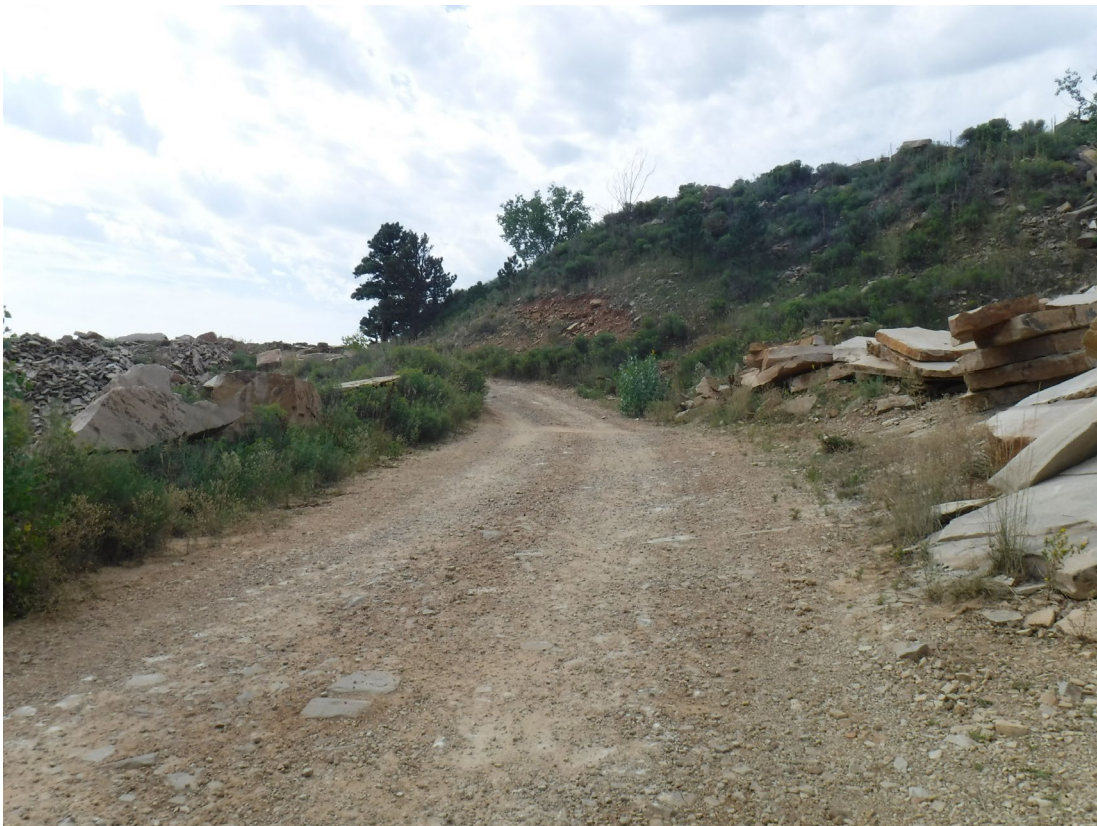
Photo 2: Typical road across the site

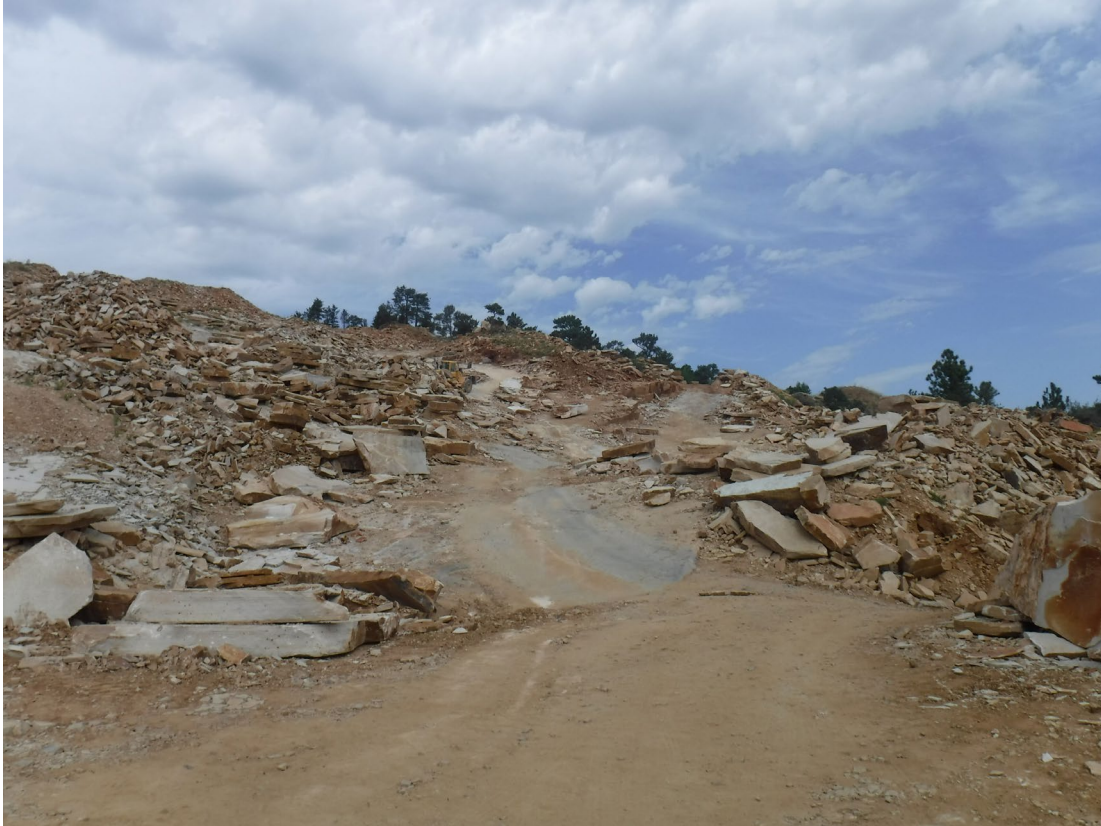
The mine progresses at a very slow rate as mining disturbance has not changed much over the years with the majority of activity confined to AL-6.

Photo 3: Typical active mining area disturbance, AL-6

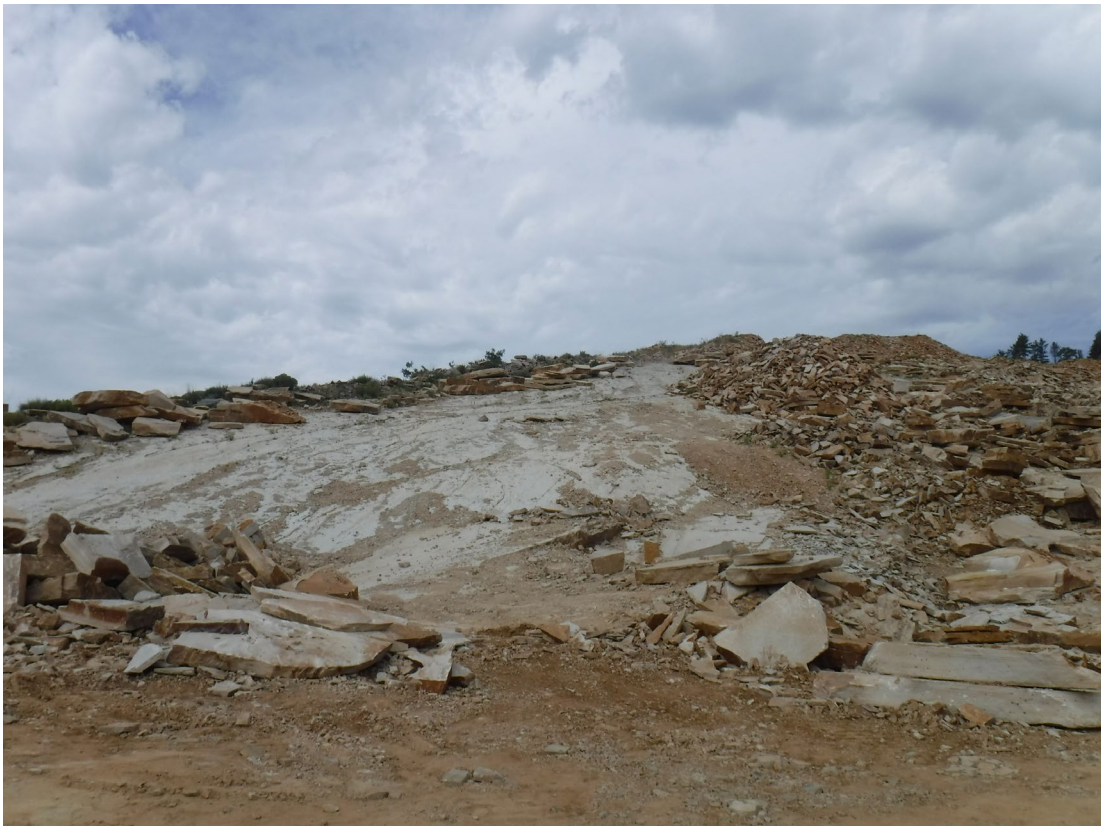
Photo 4: Southern mining disturbance area disturbance, AL-6

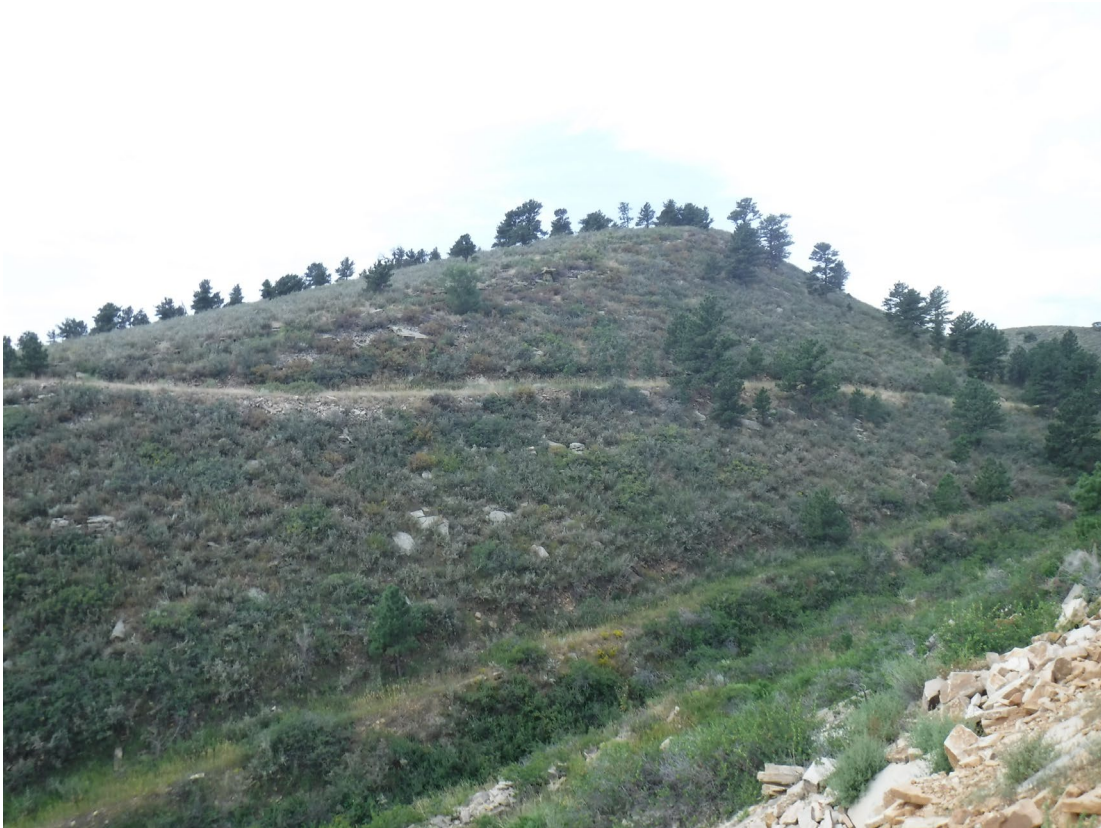
Photo 5: Looking south from AL-6 across the ravine to the Southern Mining Area

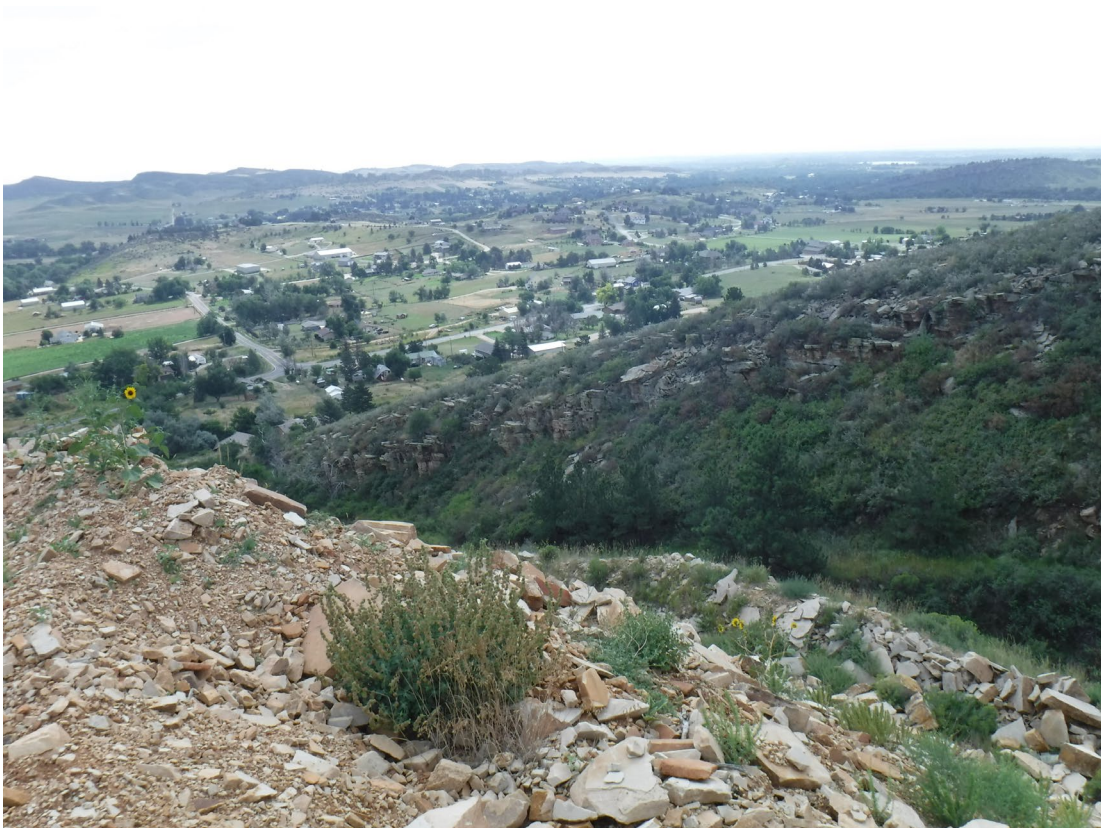
Photo 6: Looking southeast from AL-6 across the ravine to the Southern Mining Area and residences below

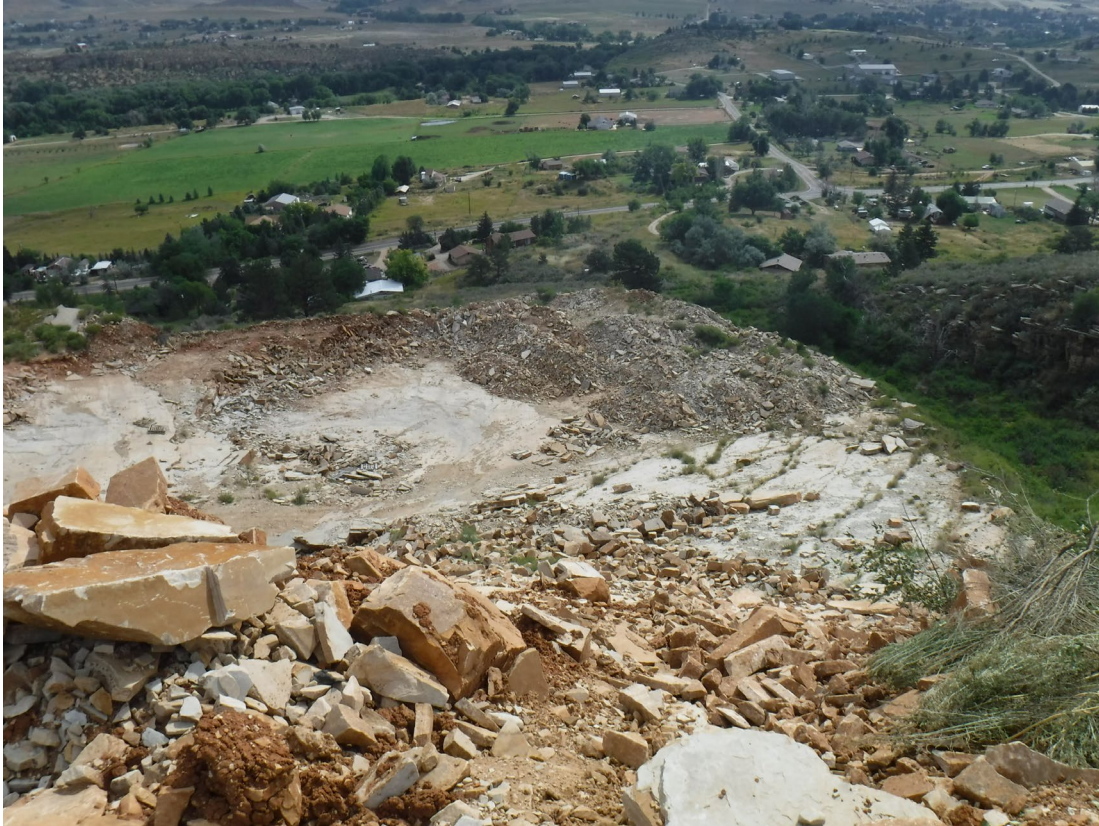
Photo 7: Looking east from the midpoint of AL-6 at top soil stockpiles

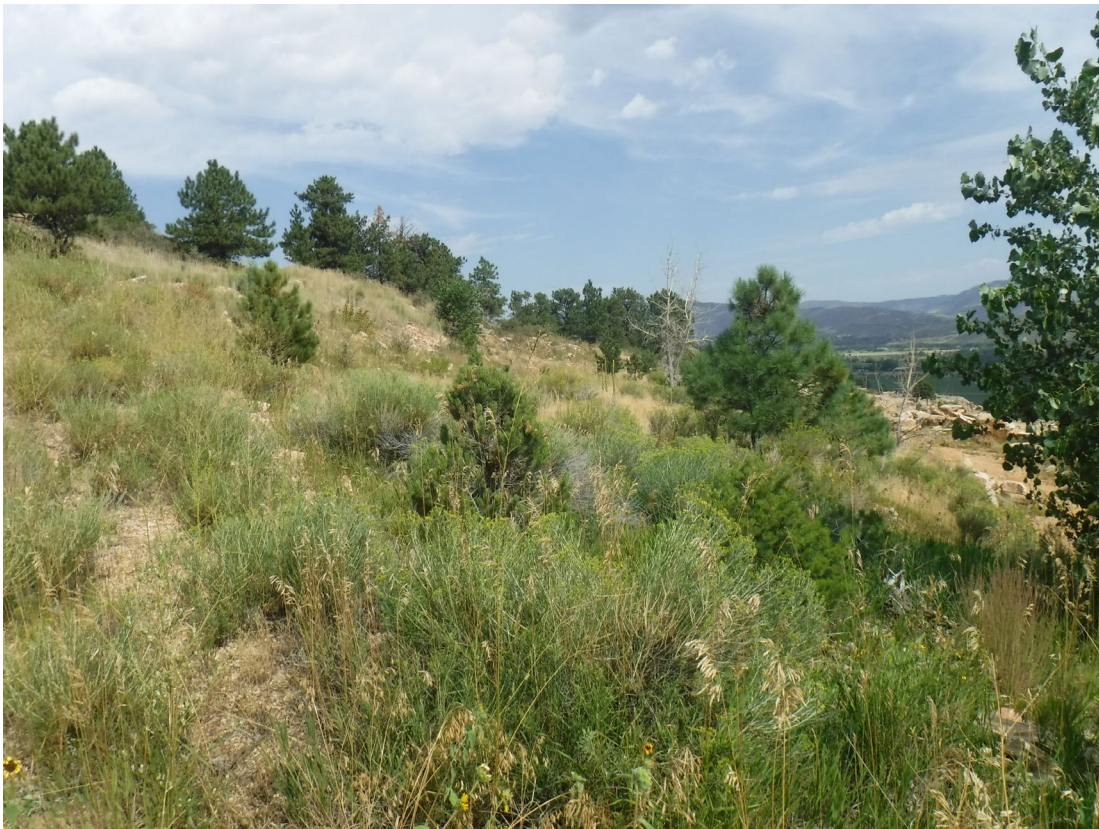
Photo 8: Typical reclaimed area, RL-1

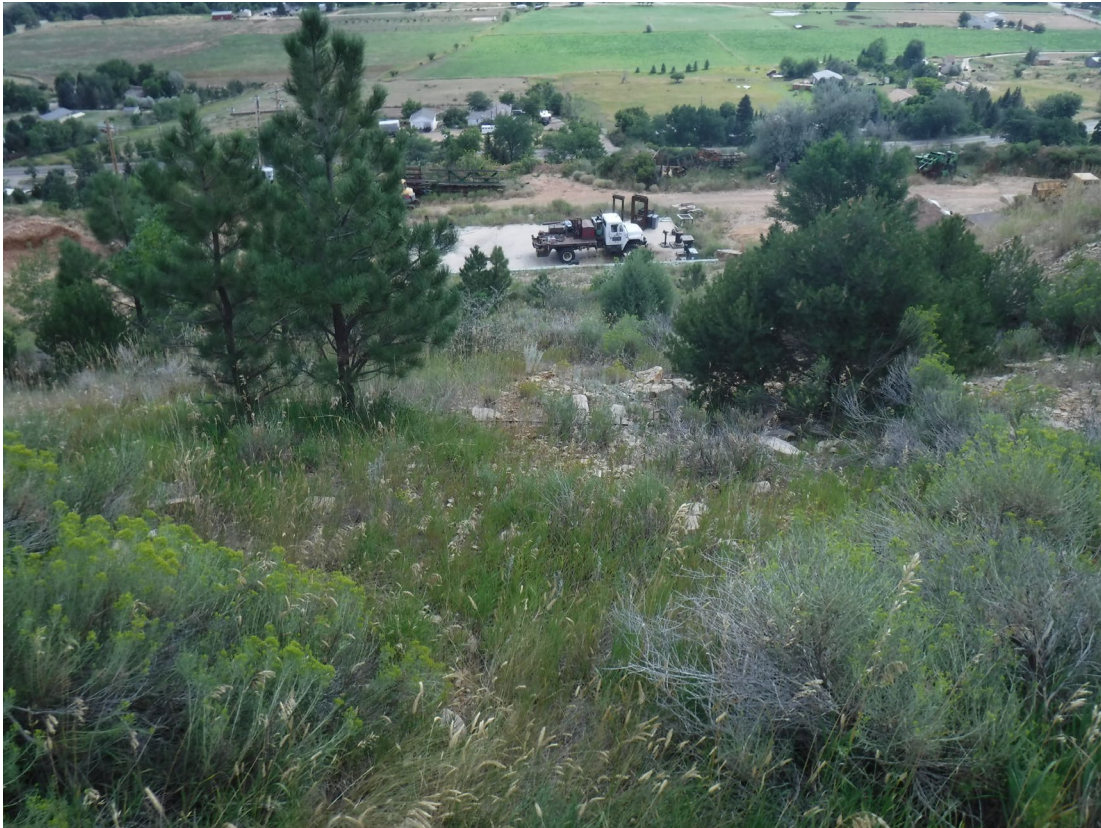
Photo 9: Typical reclaimed area, RL-2

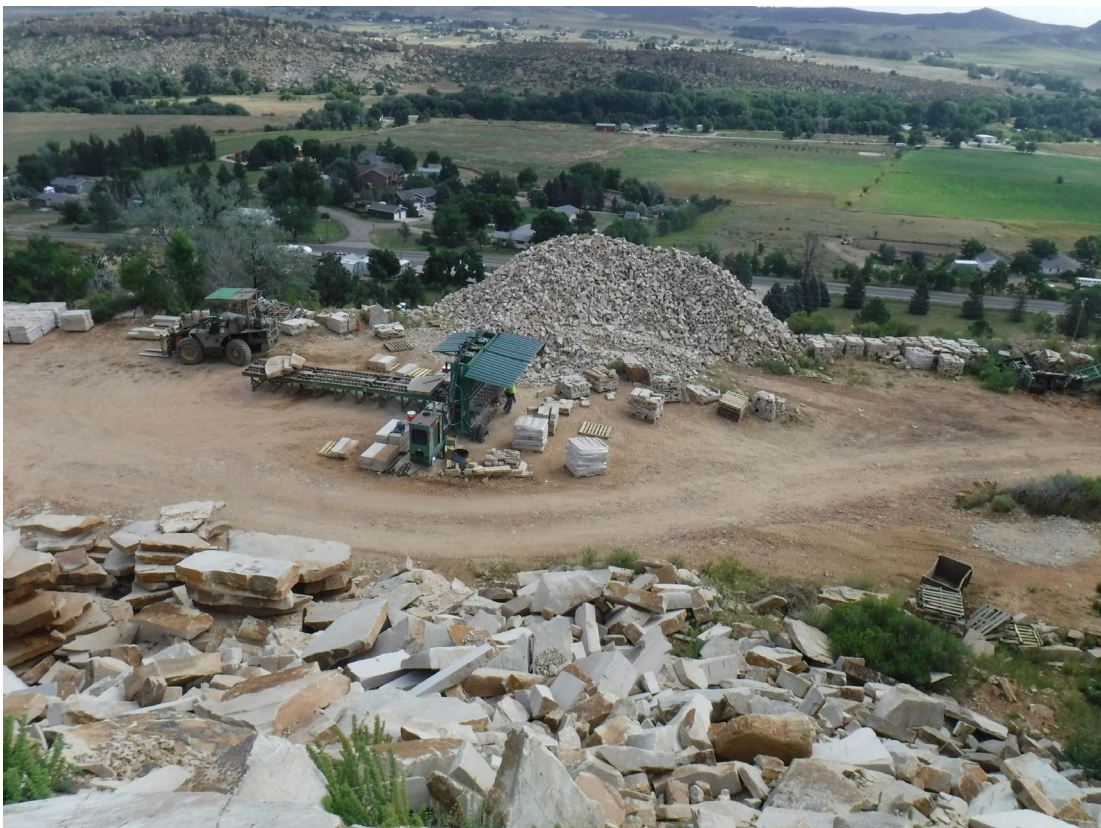
Photo 10: Typical stone cutter area
