King I and II Mine November Aerial Inspection

King Mine, C-1981-035, November 2023 Aerial Inspection Report_CCW.pdf
2054K

PERMIT INFORMATION

INSPECTION INFORMATION

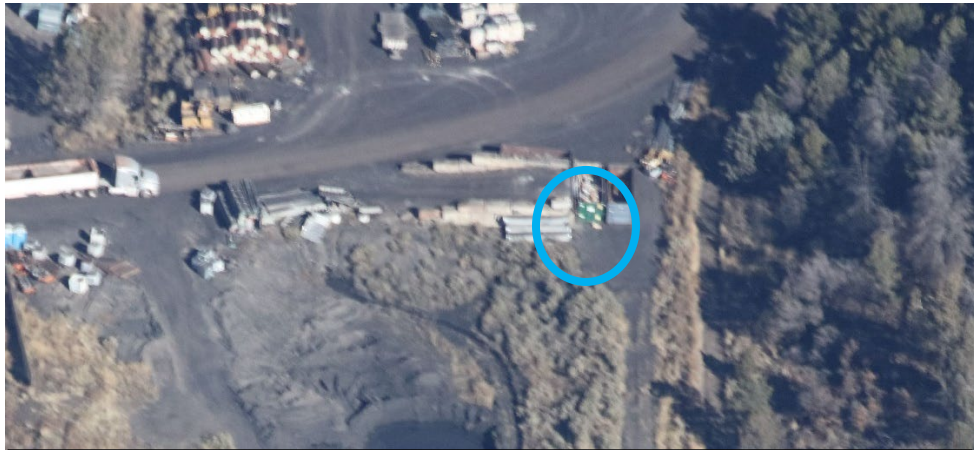
The area surrounding the Bath house at the King I area was well maintained and there was no loose trash or debris lying around the site. All trash within the King I area is placed in barrels at the bath house. Trash at the King II area was placed in roll-off dumpsters. The equipment laydown area was well kept and no trash or debris was observed. **The dumpsters located to the north of the sediment pond has a small amount of trash outside the Green roll-off dumpster (Photo 1). Please pick up the trash and place it in the dumpster.**

Photo 1: The maintenance item identified. Trash located outside the receptacle.

1. The dumpsters located to the north of the sediment pond at the King II Facilities Area has a small amount of trash outside the Green roll-off dumpster. Please pick up the trash and place it in the dumpster.

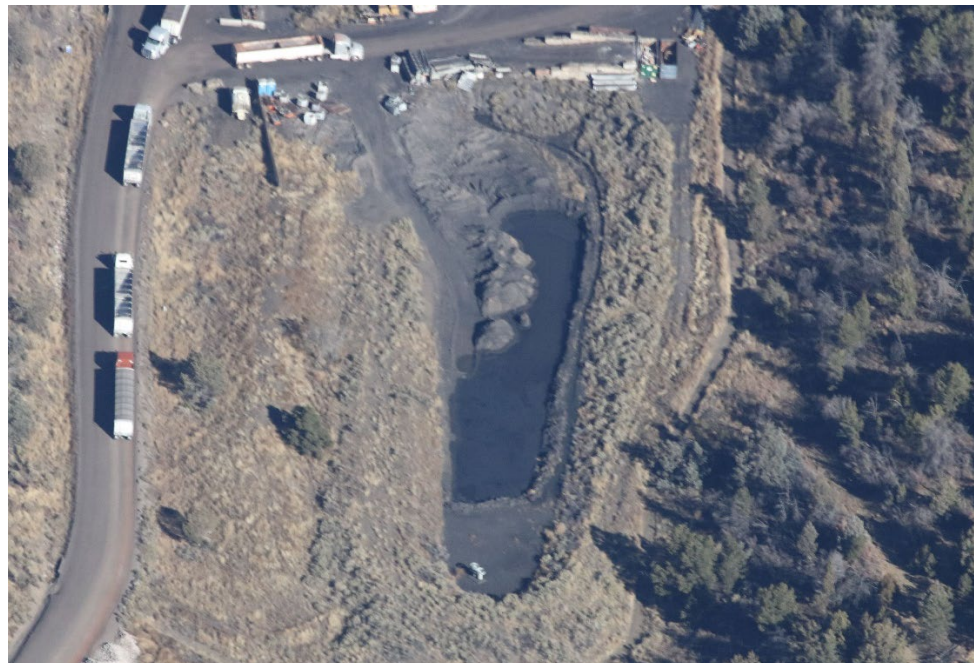
There is one sediment pond located at the south end of the King II Facilities Area (Photo 2). The pond was holding water during the inspection. The level of water impounded in the pond was below the primary discharge outlet. The outlet for the pond was clear of debris. The embankments for the pond were stable with vegetative cover. There were no erosional features identified. The sediment pond was undergoing cleaning. Piles of

material to be removed from the pond were seen at the north end of the pond. The piles of material were located in the pond so that the functionality of the pond was not impacted and sufficient capacity remained. These pond cleanings will be removed from the pond when ground conditions allow.

Photo 2: The King II Sediment Pond.

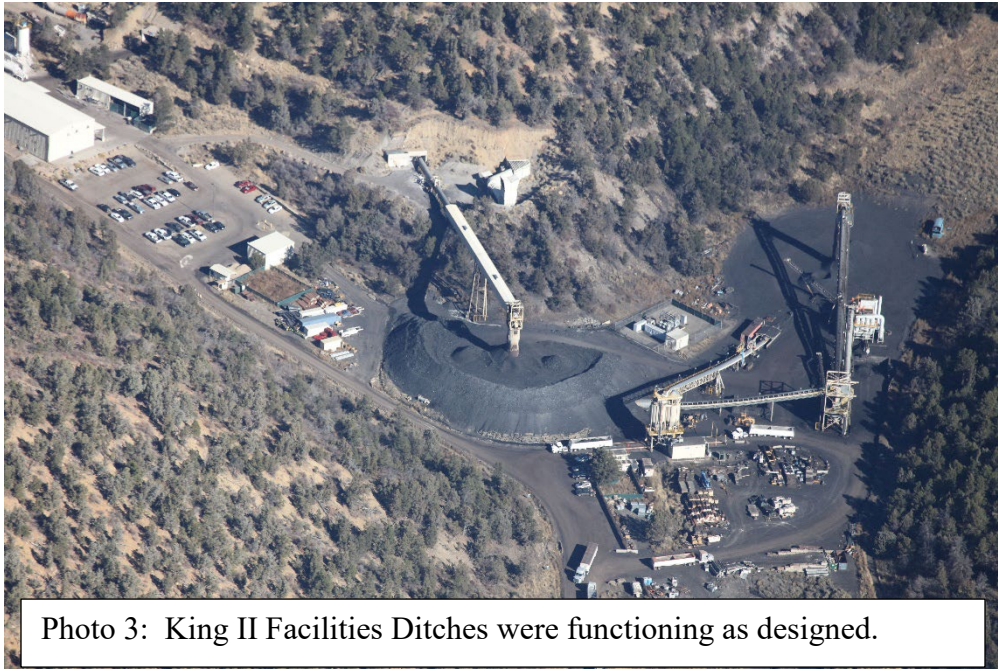
Drainage ditches throughout the King II area were observed to be unobstructed and functioning as designed (Photo 3). Ditches were transporting water to the sediment pond. There were no indications of channel instability or erosional issues.

The sump located behind the hydrocarbons storage shed was in a shadow of a tree at the time of the inspection (Photo 3). Water was likely impounded in the sump although the shadow made it difficult to determine.

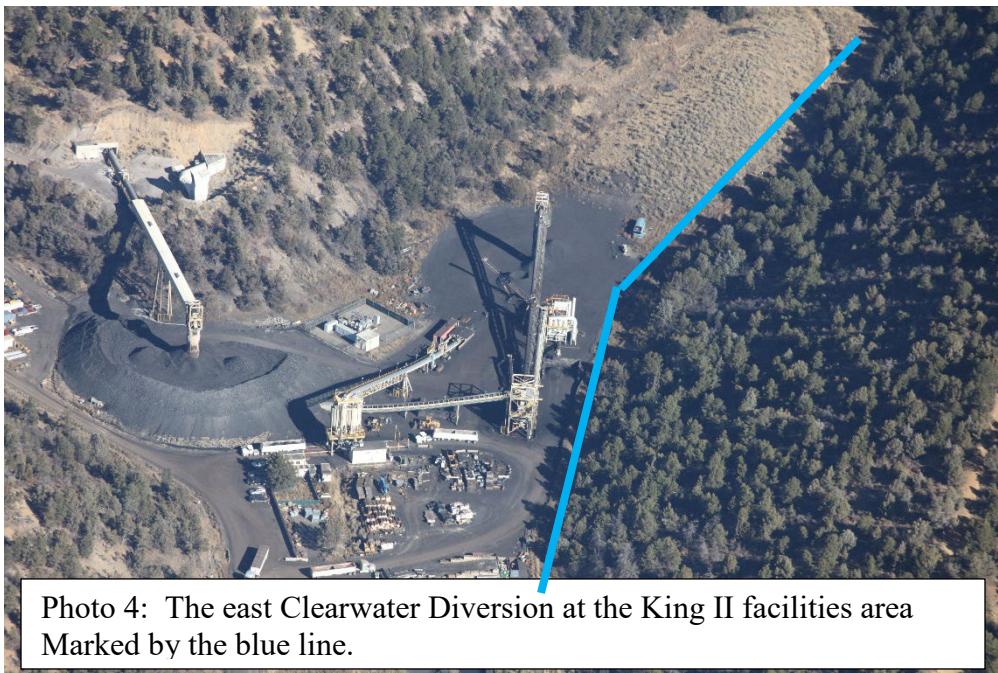
The east clearwater diversion ditch was dry at the time of the inspection (Photo 4). There were no indications of instability or erosion. The west Clearwater diversion ditch was also dry and stable. No erosional concerns were identified.

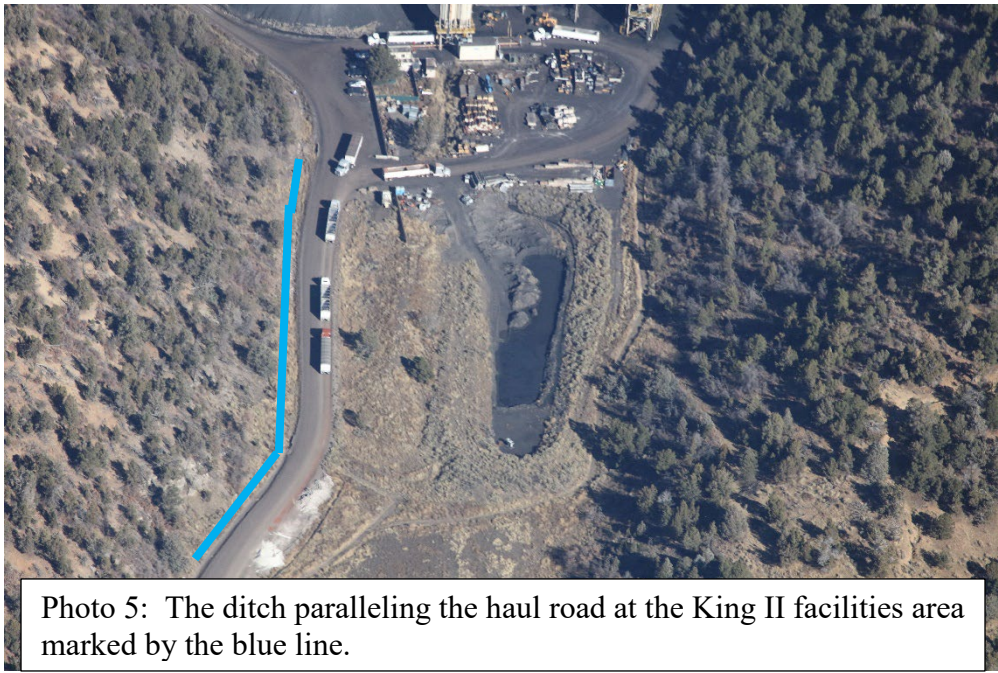
The ditch paralleling the haul road to the entrance of the King II Facilities Area was dry (Photo 5). There were no obstructions in the ditch. The ditch was stable and there were no erosional concerns. The Sump on the east side of the entrance cattle guard appeared to be dry.

Photo 5: The ditch paralleling the haul road at the King II facilities area marked by the blue line.

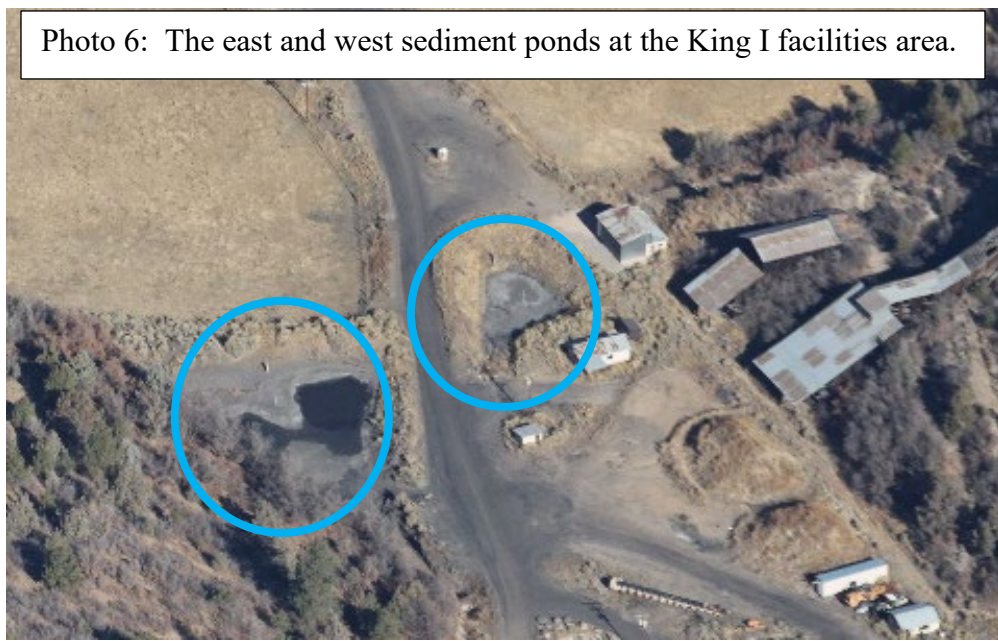
Two sediment ponds are located at the northern portion of the King I facilities area, the east pond and the west pond (Photo 6). The east pond was dry during the inspection. The embankment was covered with vegetation and stable. There were no erosional features identified. The outlet for the pond was unobstructed. In previous Division inspection reports, the inlet to the east pond had been down cutting. The operator in 2023 installed a riprap liner at the inlet to reduce the down cutting. The inlet during this inspection appeared to be stable and in similar to the previous Division Inspections. The West pond was holding water at a level below the primary spillway. The outlet for the pond was unobstructed. The inlet to the pond was stable with no erosional concerns. The pond's embankment was vegetated and stable. There were no indications of erosion.

Photo 6: The east and west sediment ponds at the King I facilities area.

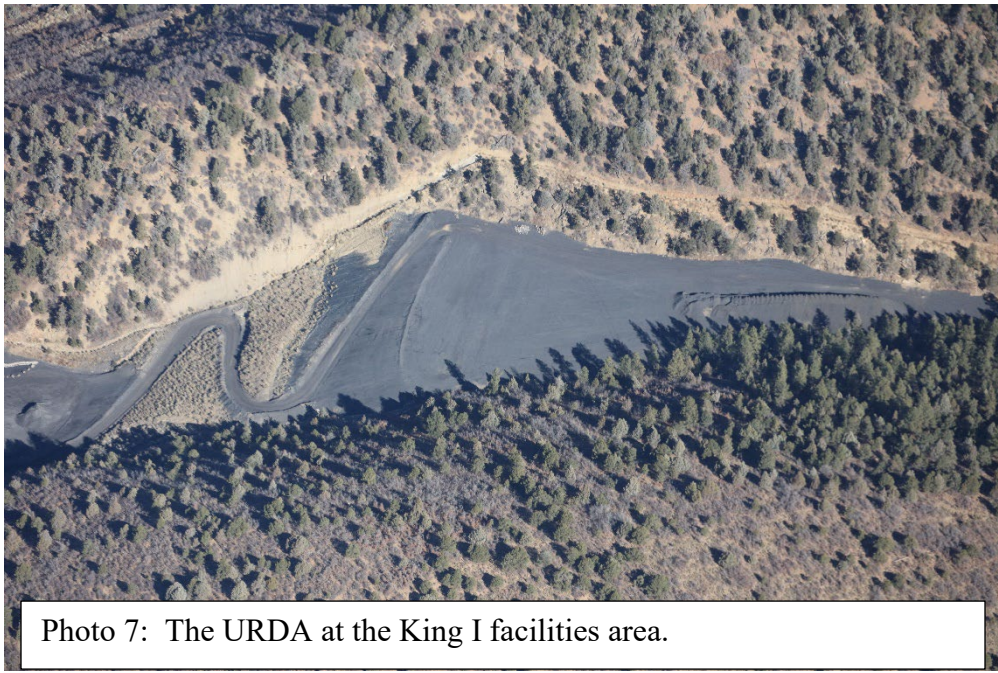
There are two refuse piles located at the King I facilities area, The Upper Refuse Disposal Area (URDA) and the Lower Refuse Disposal Area (LRDA). During the inspection refuse material on the URDA was placed in the southern section of the pile in a windrow (Photo 7). The top of the pile was stable with no erosional features identified. The face of the URDA was in good condition and there were no concerns of erosion observed. Reach 10 and The ditch paralleling the haul road were dry and stable. These ditches transport runoff from the URDA to the LRDA and eventually into the west sediment pond. The LRDA was also stable. Refuse material was observed stockpiled in two piles on top of the LRDA (Photo 8). The face of the LRDA was stable with no erosional features. Extensive work was completed in October 2023 on the northeastern portion of the LRDA. The northeastern corner was identified in the August 2023 Division inspection to not match the approved design with Technical Revision No. 27. Reach 13 is located adjacent to the LRDA's northeast corner and was observed to be covered over during August 2023. The northeastern corner of the pile was observed to match the TR-27 design and was stable with no erosion. Reach 13 was noted to be dry and stable. The reconstructed Reach 13 was in the correct location.

Photo 7: The URDA at the King I facilities area.

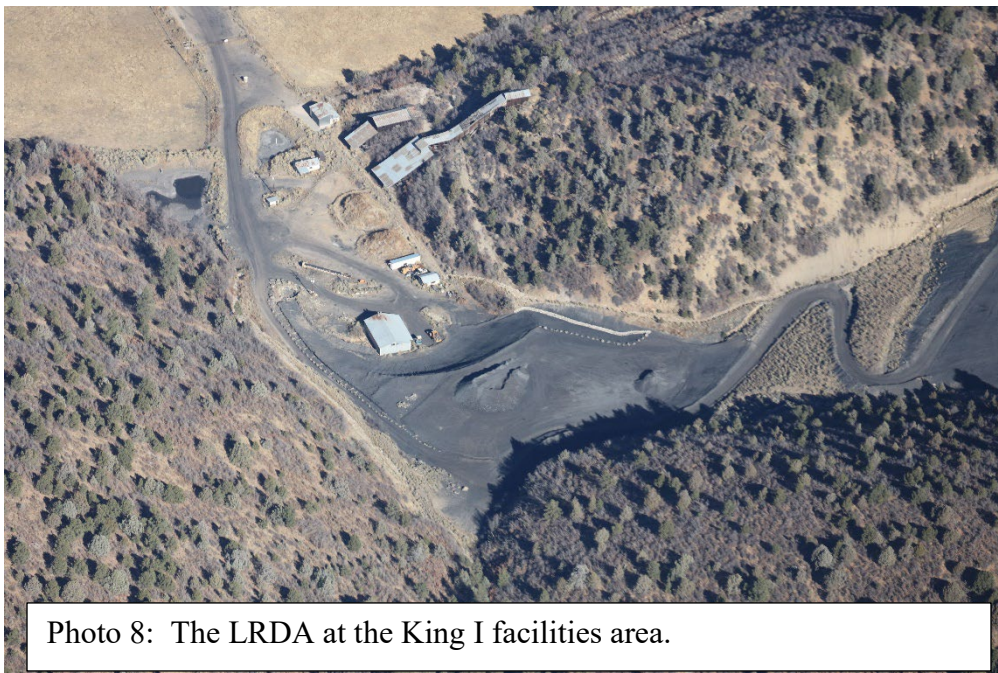
The Refuse Disposal Area and some support facilities remain at the King I facilities area. The bath house, old sales office, pump houses and a storage shed remain on the pad below and to the north of the Lower Refuse Disposal Area (Photo 8). The pad was well kept and stable. There were no indications or erosional features observed.

Photo 8: The LRDA at the King I facilities area.

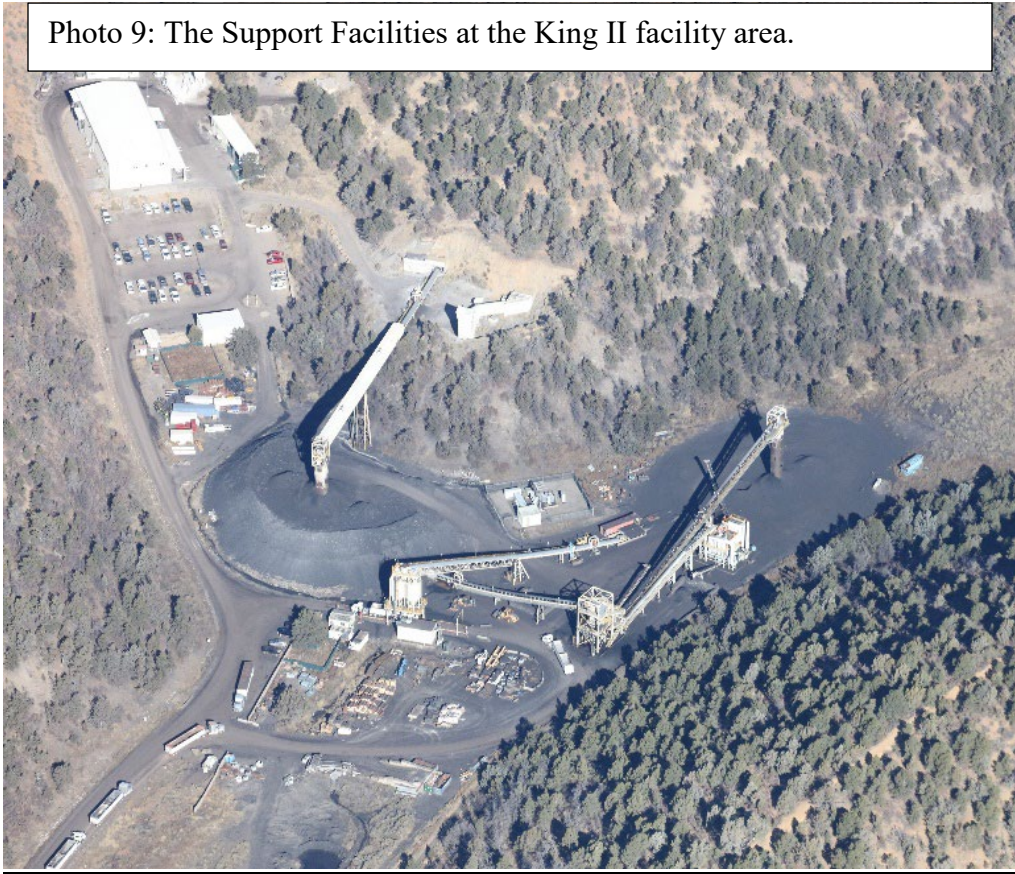
The majority of the support facilities are currently located at the King II facilities area (Photo 9). The portals bench was stable with no erosional features observed. The parking lot by the mine office was stable with no erosional concerns. Coal throughout the processing area was observed to be properly contained in the designated areas. No off-site impacts were observed. The equipment and materials laydown area is located to the south of the coal processing stackers. The Laydown area was well kept and there was no excess trash observed.

Photo 9: The Support Facilities at the King II facility area.
