## **Lorencito Canyon Mine C-1996-084, November 17, 2023 Partial Inspection Report**

**PERMIT INFORMATION**

<b>Inspection Start Date:</b> November 17, 2023 <b>Inspection Start Time:</b> 12:00 <b>Inspection End Date:</b> November 17, 2023 <b>Inspection End Time:</b> 01:20		<b>Inspection Type:</b> Coal Partial Inspection <b>Inspection Reason:</b> Normal I&E Program <b>Weather:</b> Clear	
<b>Joint Inspection Agency:</b>  None		<b>Joint Inspection Contacts:</b>	
<b>Post Inspection Agency:</b>  None		<b>Post Inspection Contacts:</b>	
<b>Inspector(s):</b>  Amber Gibson Jared Ebert	<b>Inspector's Signature:</b>

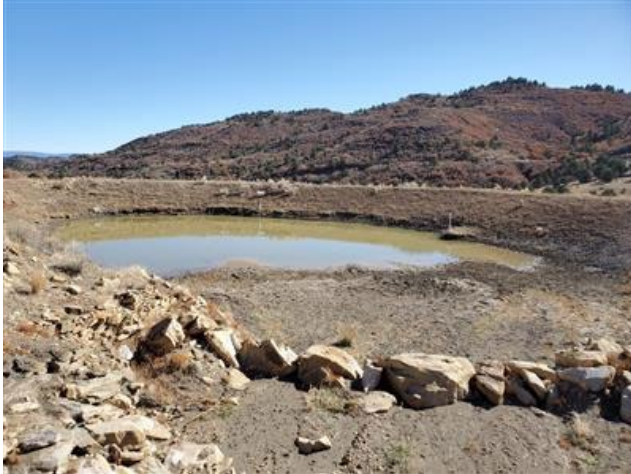
- Pond 006a was holding water but was not discharging. The pond embankment was stable and vegetated, and the primary and emergency spillways appeared clear and functional.

**Photo 1:** Pond 006

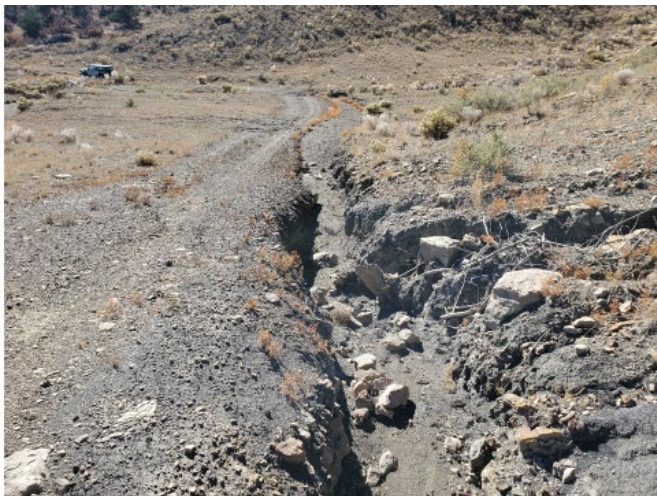
- The reclaimed area above Pond 006a has many gullies which have undercut the wattles. This area has not stabilized and needs to be reconstructed and revegetated. NECC is required to provide a plan to stabilize this area through the Permit Renewal No. 5 (RN5) process. DRMS is waiting for NECC's response to this issue. **The ditch along the road leading to Pond 006a is also eroding and is nearly full of sediment and needs to be cleaned out and repaired.**

**Photo 2:** Erosion along south-east side of the reclaimed area above Pond 006a and along the road that's located between this area and Pond 006a.

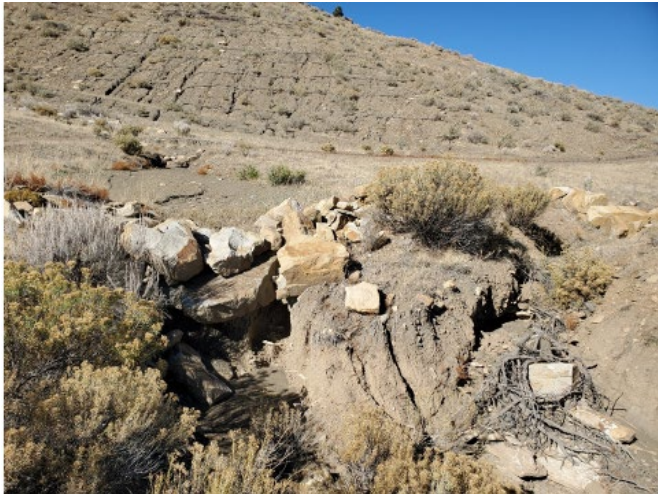
- The first check dam, located east of this road and above Pond 006a, is nearly full of sediment and at risk of being over-run. **Due to this, the area above the check dam in Photo 3 needs to be cleaned out to prevent damage to the dam, and to prevent excess sediment from entering Pond 006.**

**Photo 3:** Check dam within D64, to the east of the road near the reclaimed area above Pond 006a leading to Pond 006a.

- The reclaimed land above Pond 006a, reported to have been seeded in 2007, is still eroded (see Photo 3). NECC is required to provide a plan to stabilize this area through the RN5 process. DRMS is waiting for NECC's response to this issue.
- The Division observed Fill 7 from the access road along the fill's northern border. Fill 7 was well vegetated and appeared stable.
- The Division used ArcGIS Field Maps software to trace the path walked along D5, up to the top of 'The Knob', and down through D2 into D3 (see blue lines on reference map below). The ditches were mostly clear of debris, and appear to be functioning adequately (Photo 10). Erosion was noted along the slopes around "The Knob" (Photos 11 and 12). NECC is required to provide a plan to stabilize this area through

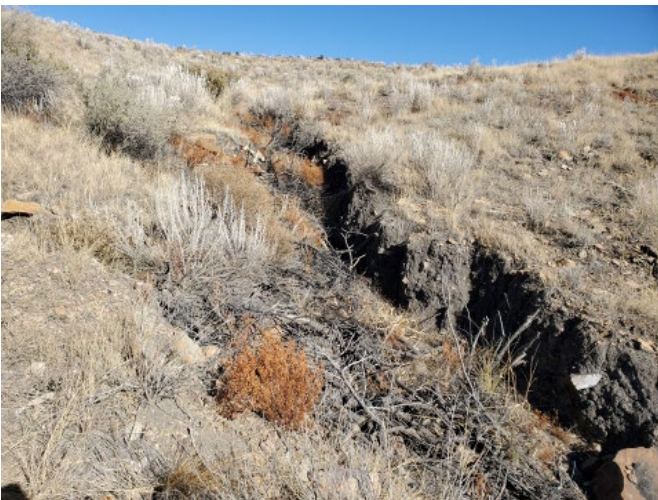
- The Division walked along ditches 7 and 8 (D7 and D8) and noted erosion control efforts such as added brush and rebar from BMP construction. However, some of the check dams in D7 appear to have failed and require repair (Photos 5 and 6), and the BMP's around the ditches also need to be repaired (Photo 7). D8 appears to be stable at this time (Photos 8 and 9).

**Photo 4:** Looking north along the top of D7.

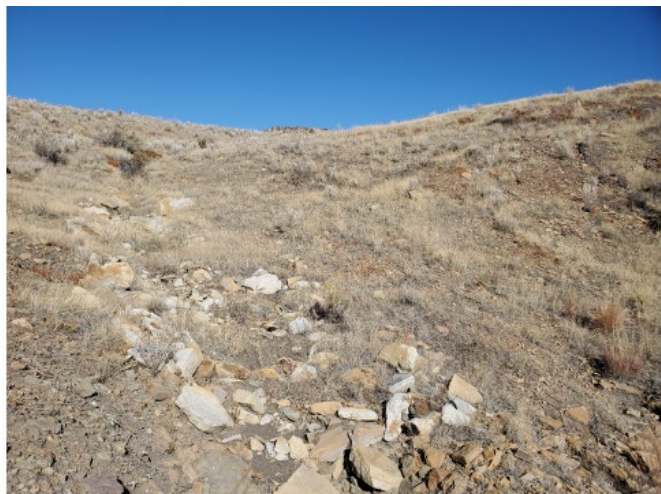
**Photo 5:** Looking north along D7.

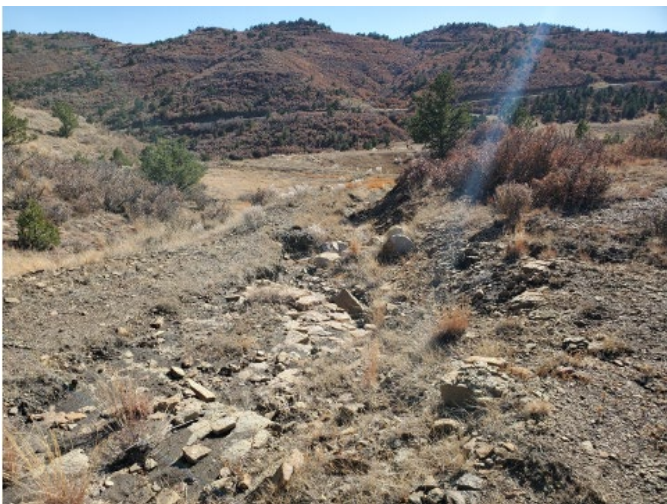
**Photo 6:** Looking south in D7 at check dams that need repairs.

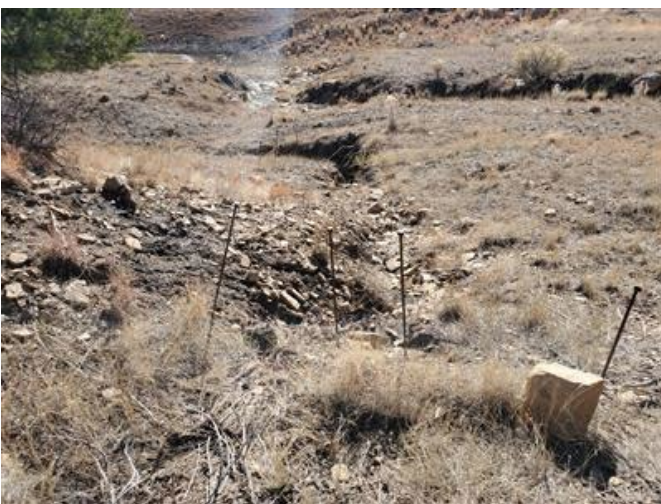
**Photo 7:** Remains of BMPs north of Pond 006a.

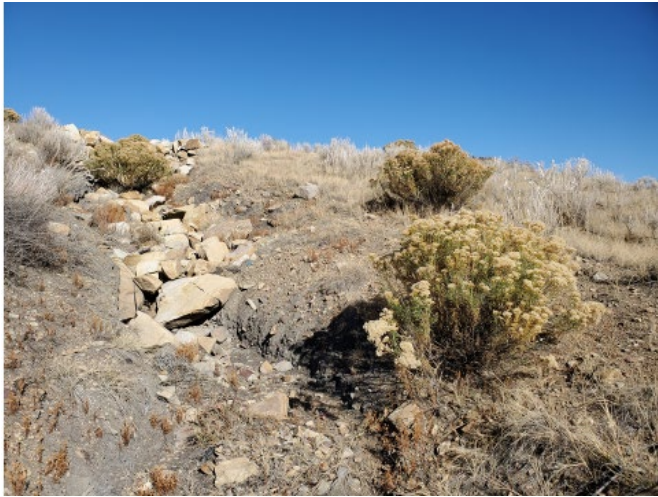
**Photo 8:** Looking north in D8.

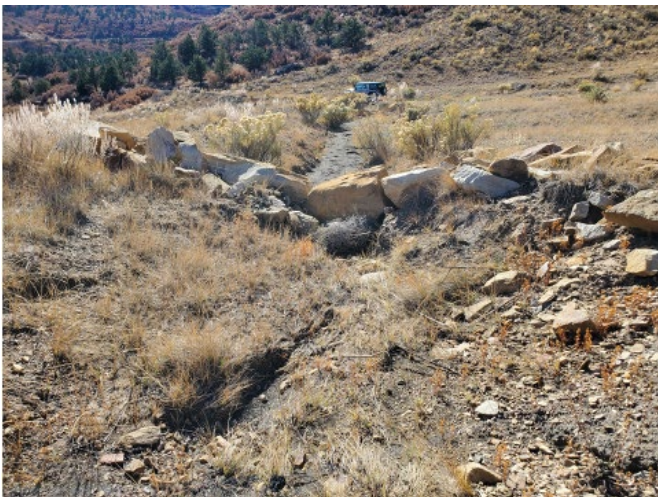
**Photo 9:** Looking south in D8.

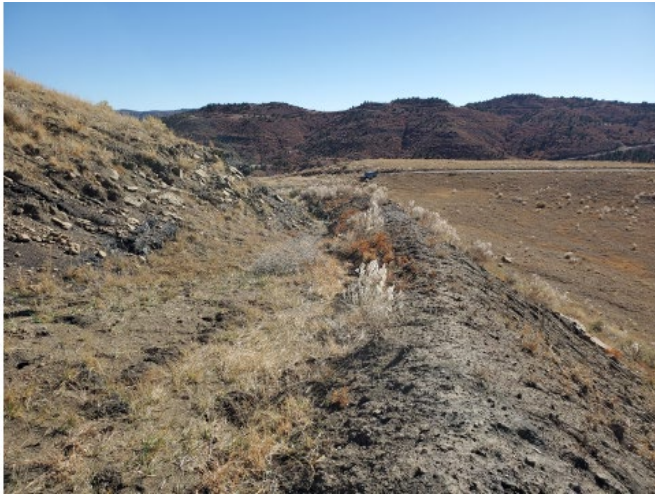
**Photo 10:** D5 along western side of The Knob.

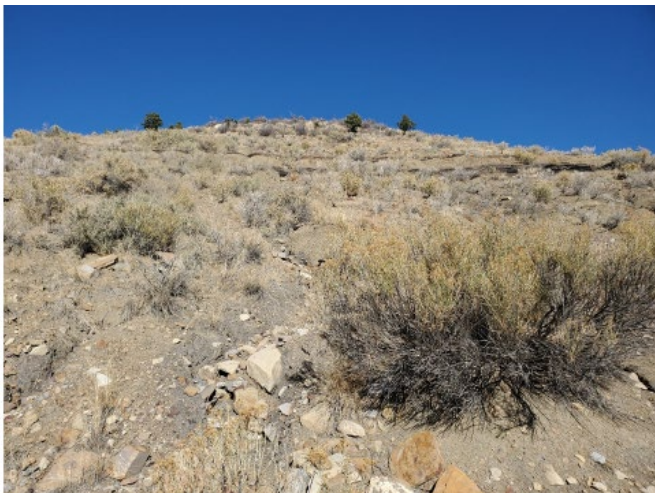
**Photo 11:** Looking upslope on the north side of The Knob.

the RN5 process. DRMS is waiting for NECC's response to this issue.

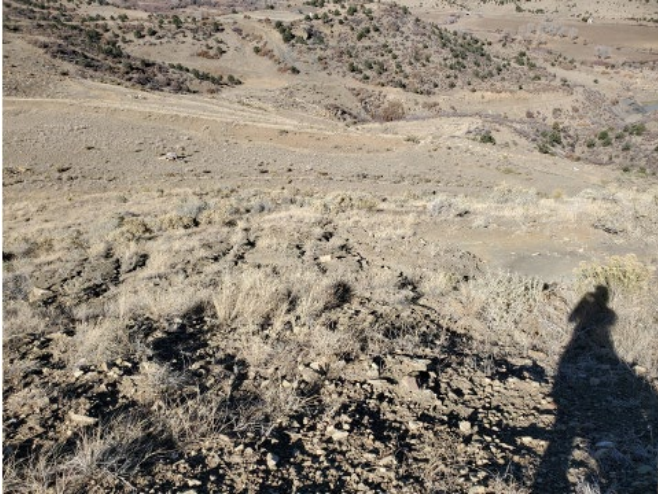
**Photo 12:** Looking downslope on the northeast side of The Knob.

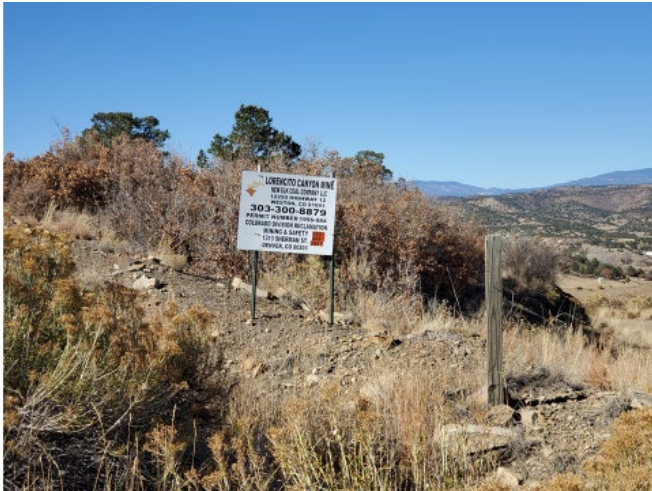
- Mine signs were posted at road entrances and at the entrance to permit boundary in compliance with Rule 4.02.

**Photo 13:** Mine sign posted at east permit boundary entrance.
