Division of Reclamation,
Mining and Safety

MINERALS PROGRAM INSPECTION REPORT

MINE NAME: Sprague Stone	MINE/PROSPECTING ID#: M-2015-006	MINERAL: Sandstone (silica, stone quartzite)	COUNTY: Larimer
INSPECTION TYPE: Monitoring	WEATHER: Clear	INSP. DATE: August 22, 2023	INSP. TIME: 11:00
OPERATOR: Sprague Stone LLC	OPERATOR REPRESENTATIVE: Michael Lang	TYPE OF OPERATION: 112c - Construction Regular Operation

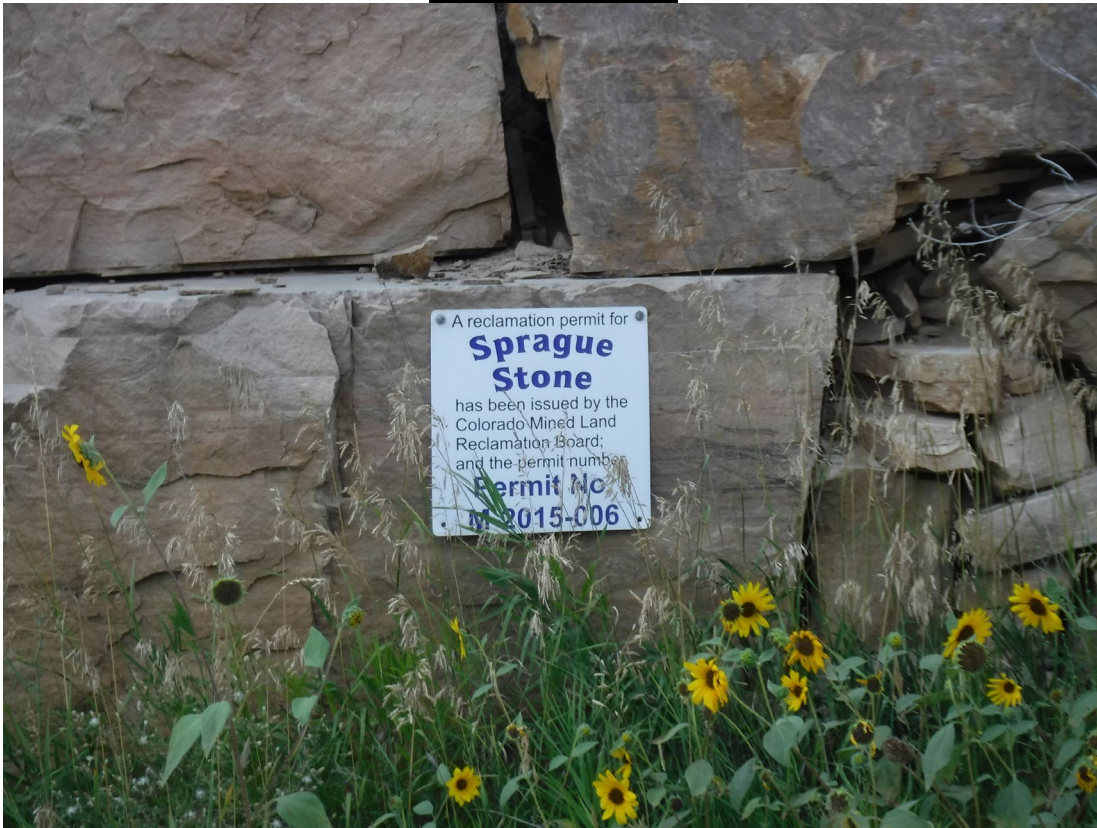
Photo 1: Mine Sign at primary mine entrance

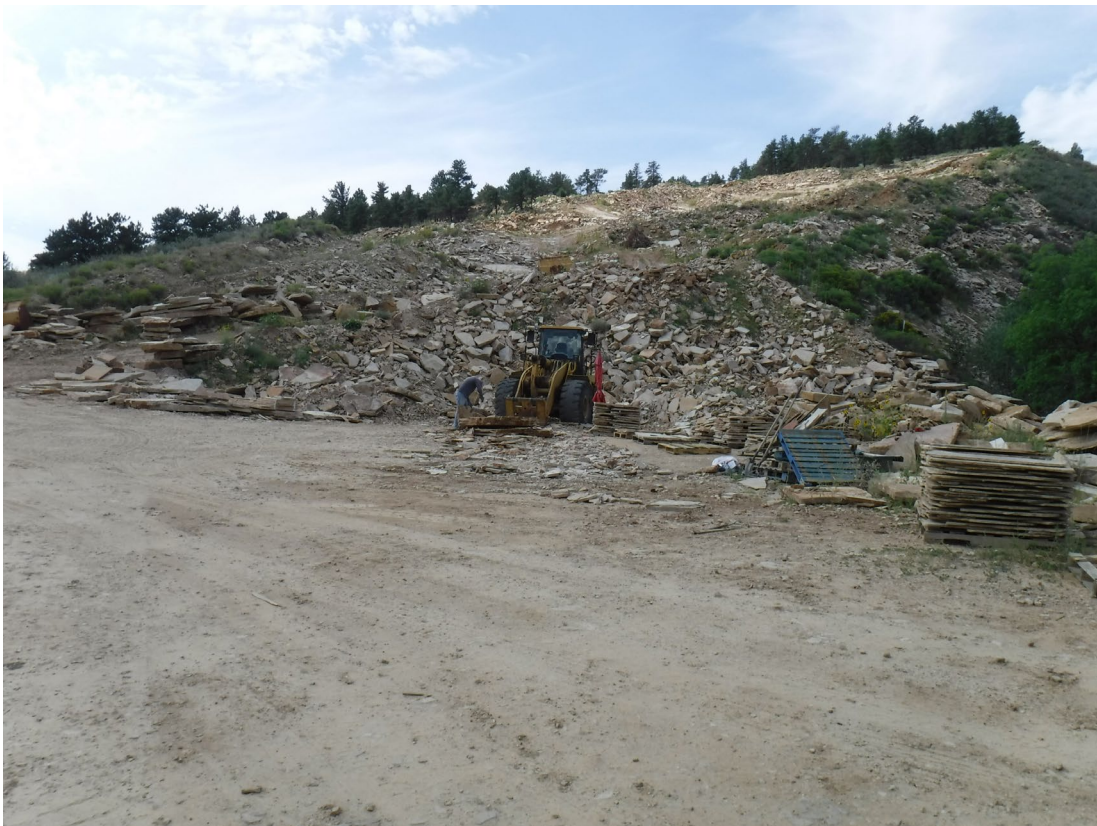
Photo 2: North Pit mine area

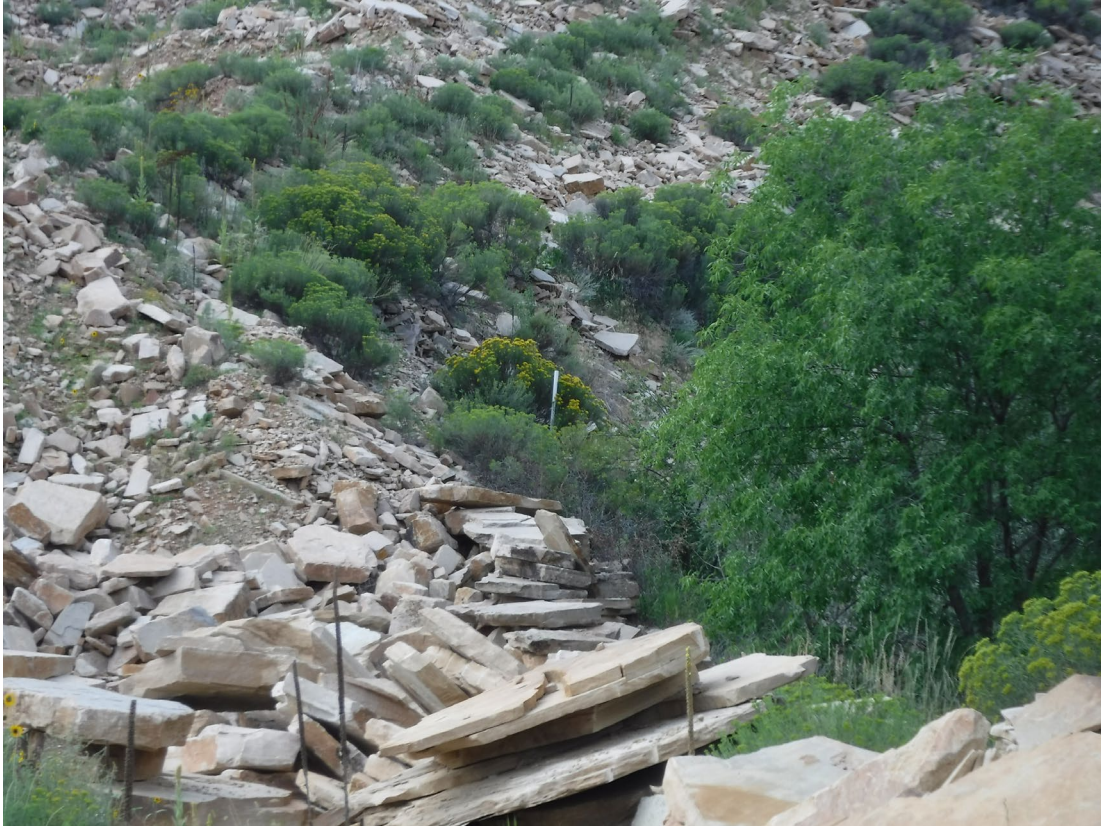
Photo 3: Typical permit boundary marker

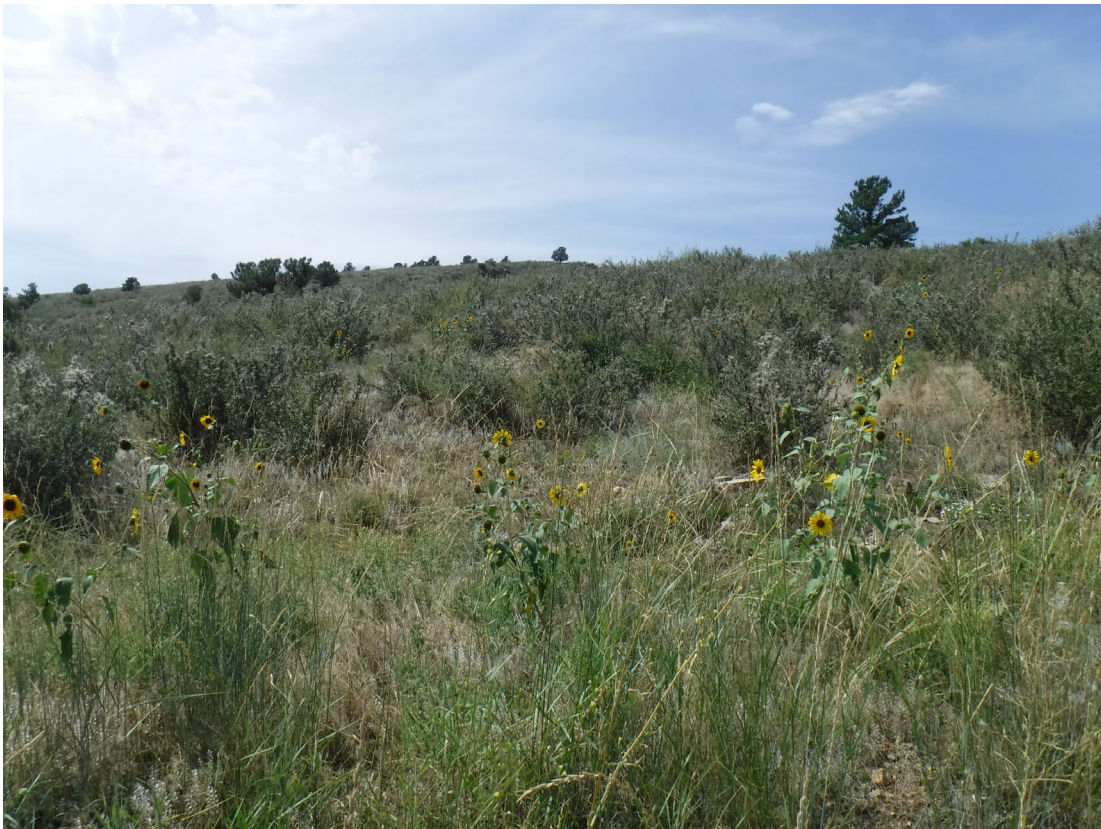
Photo 4: Reclaimed area conditions in the southern portion of the permit

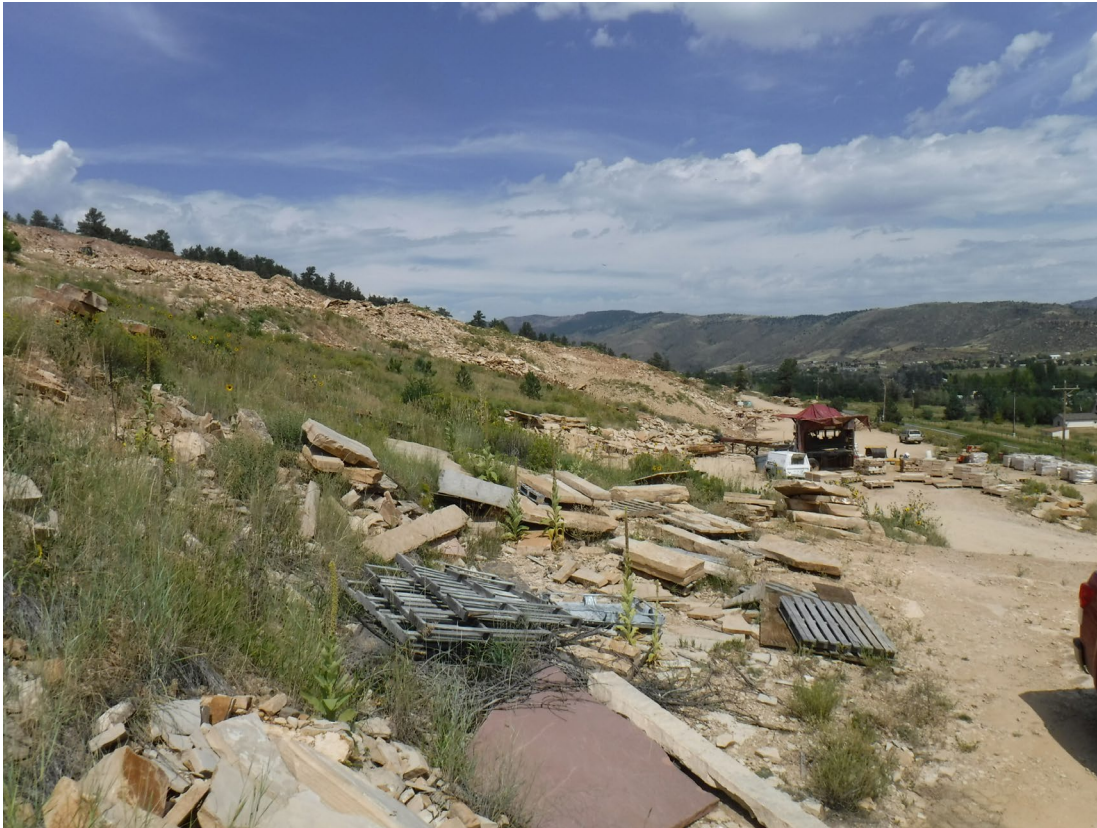
Photo 5: Southern mine area processing and storage area

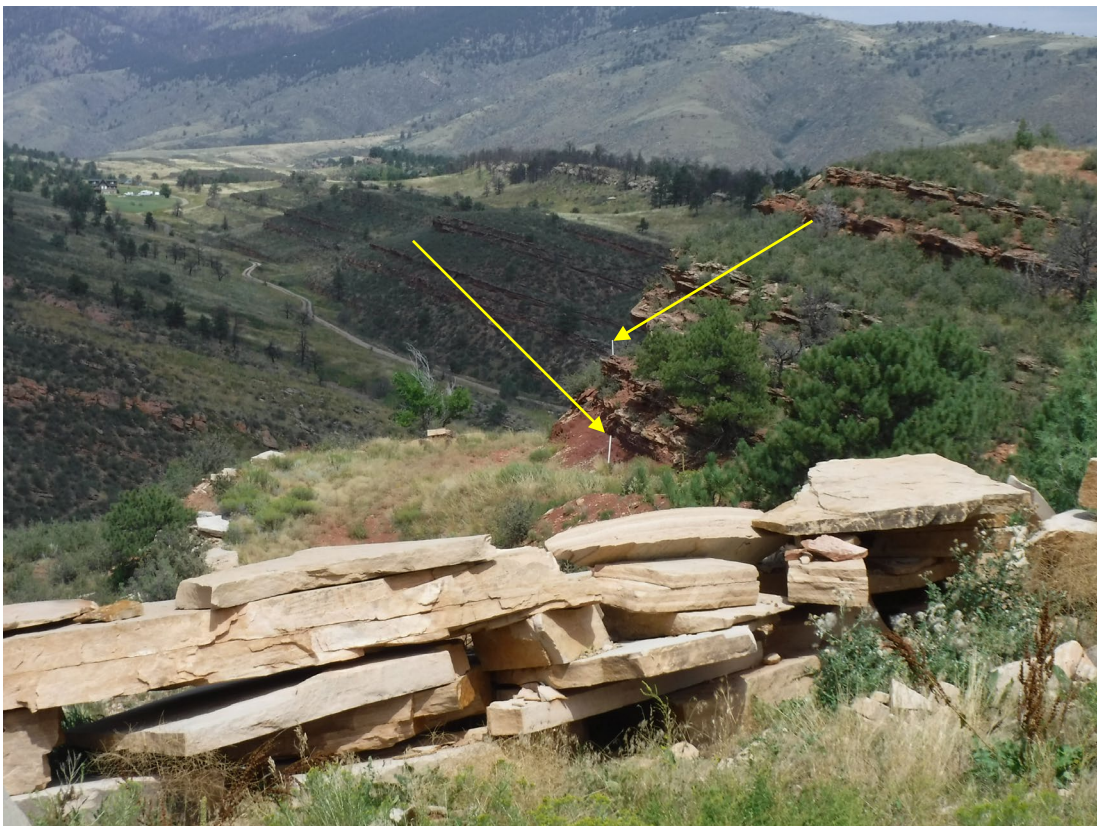
Photo 6: Western permit boundary looking north, yellow arrows denote boundary markers

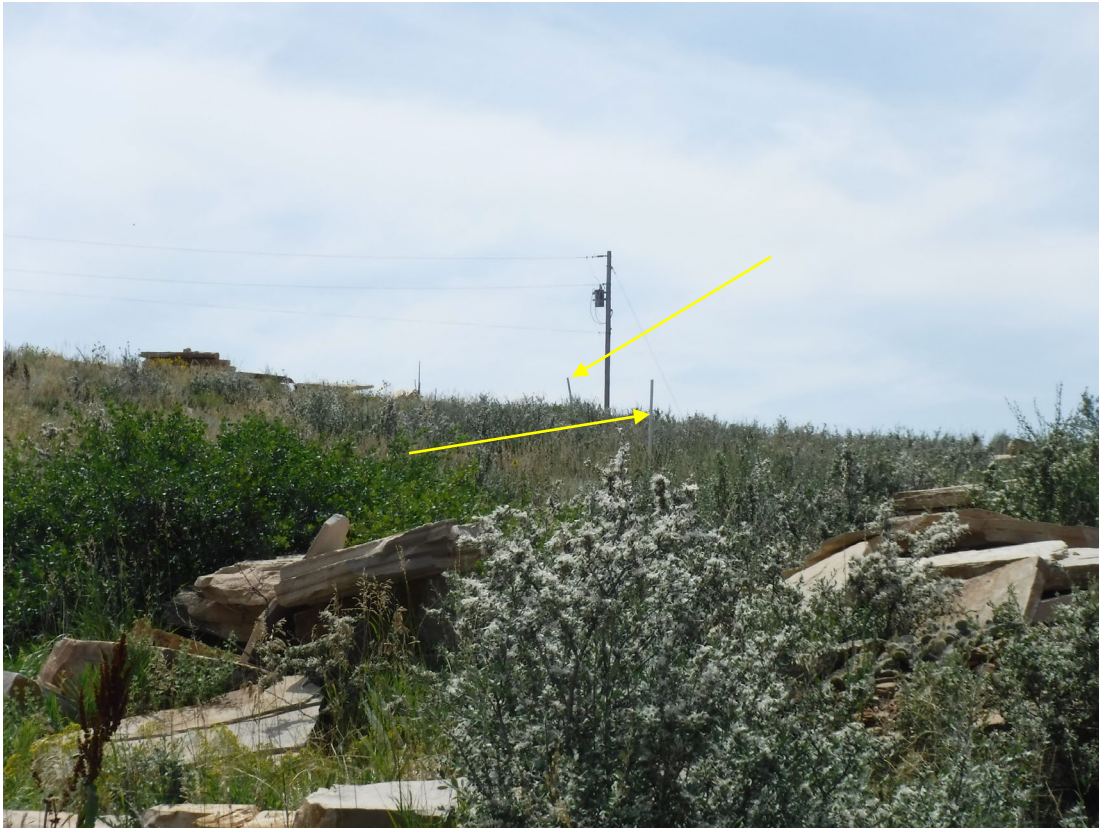
Photo 7: Western permit boundary looking south, yellow arrows denote boundary markers

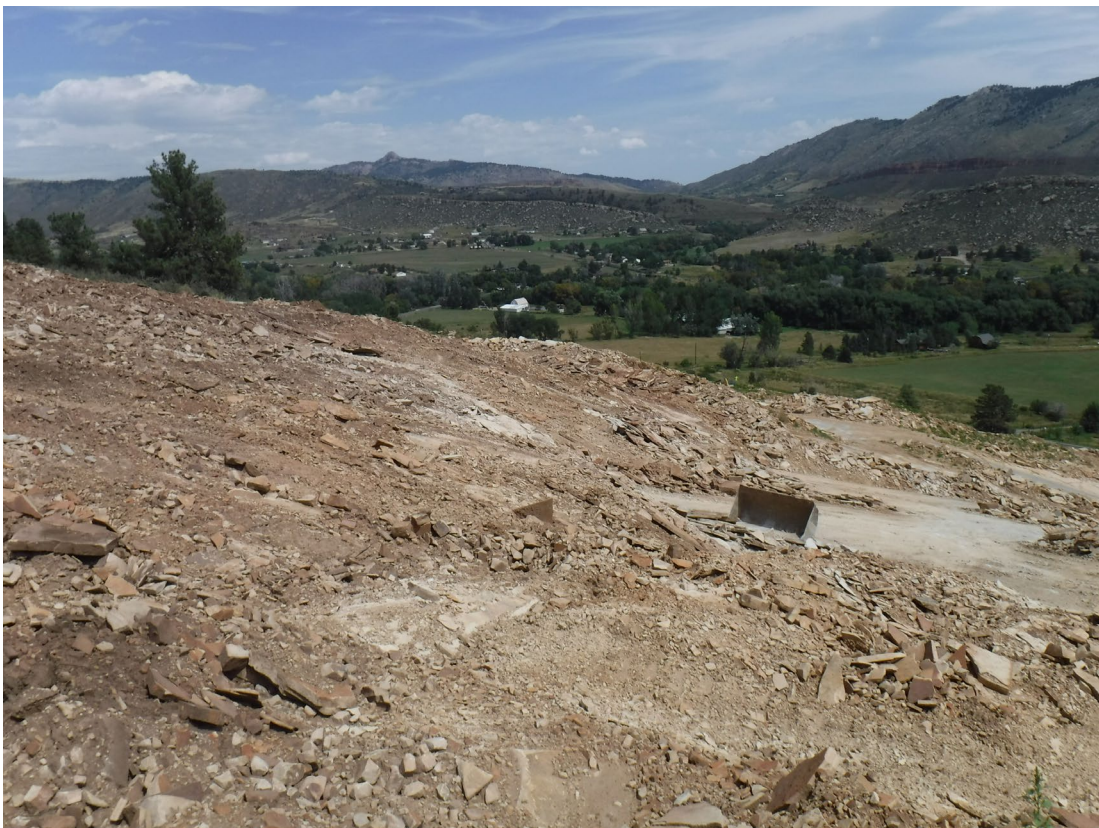
Photo 8: Looking northeast across the southern mining area

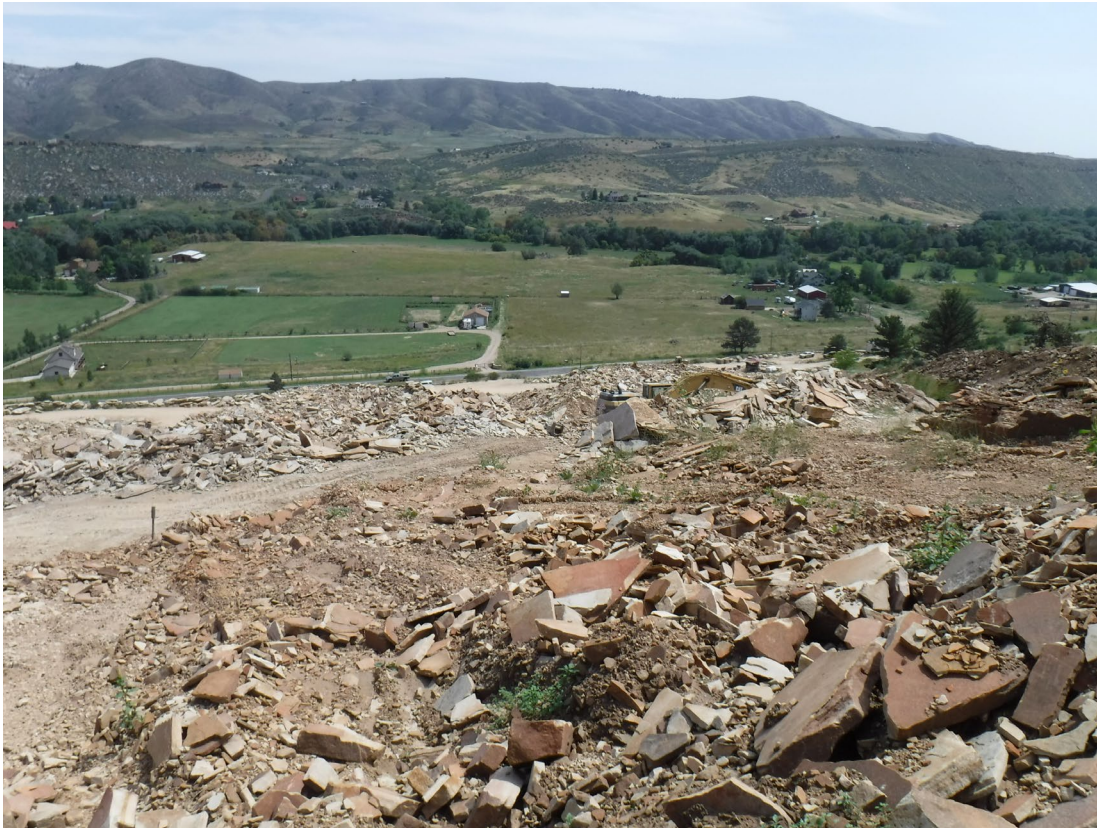
Photo 9: Looking east across the southern mining area

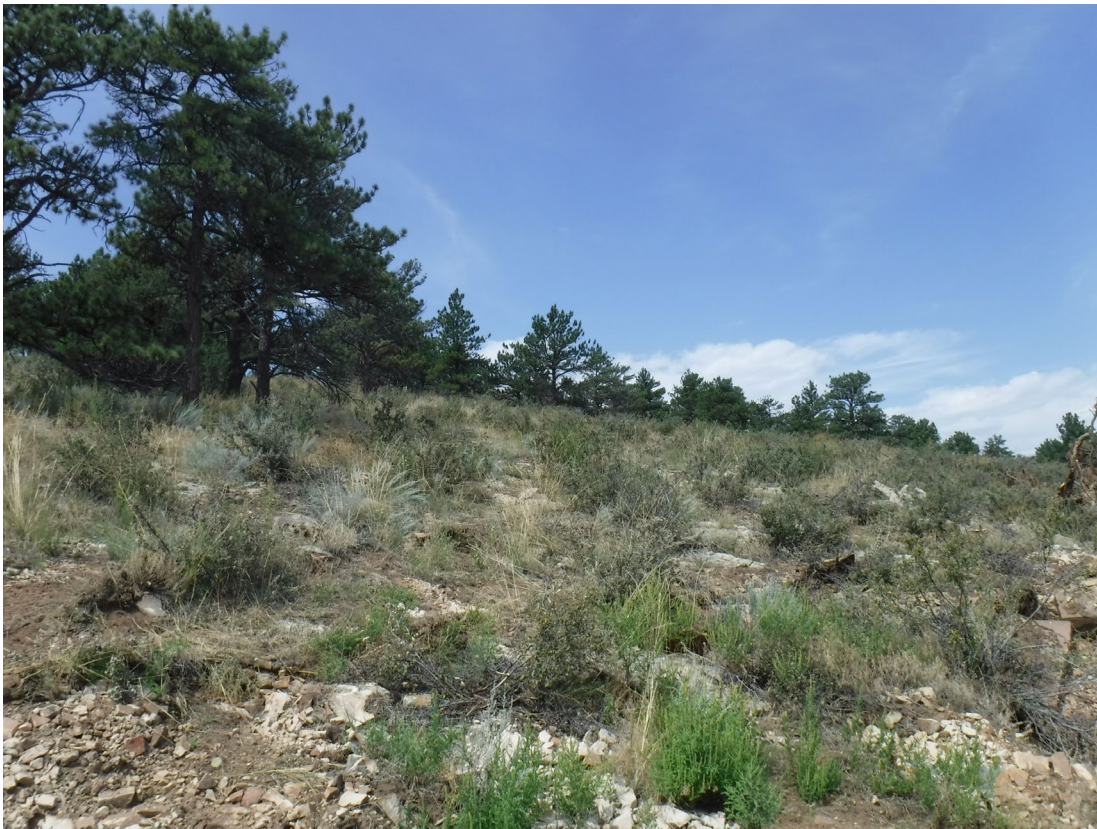
Photo 10: Area unaffected by mining

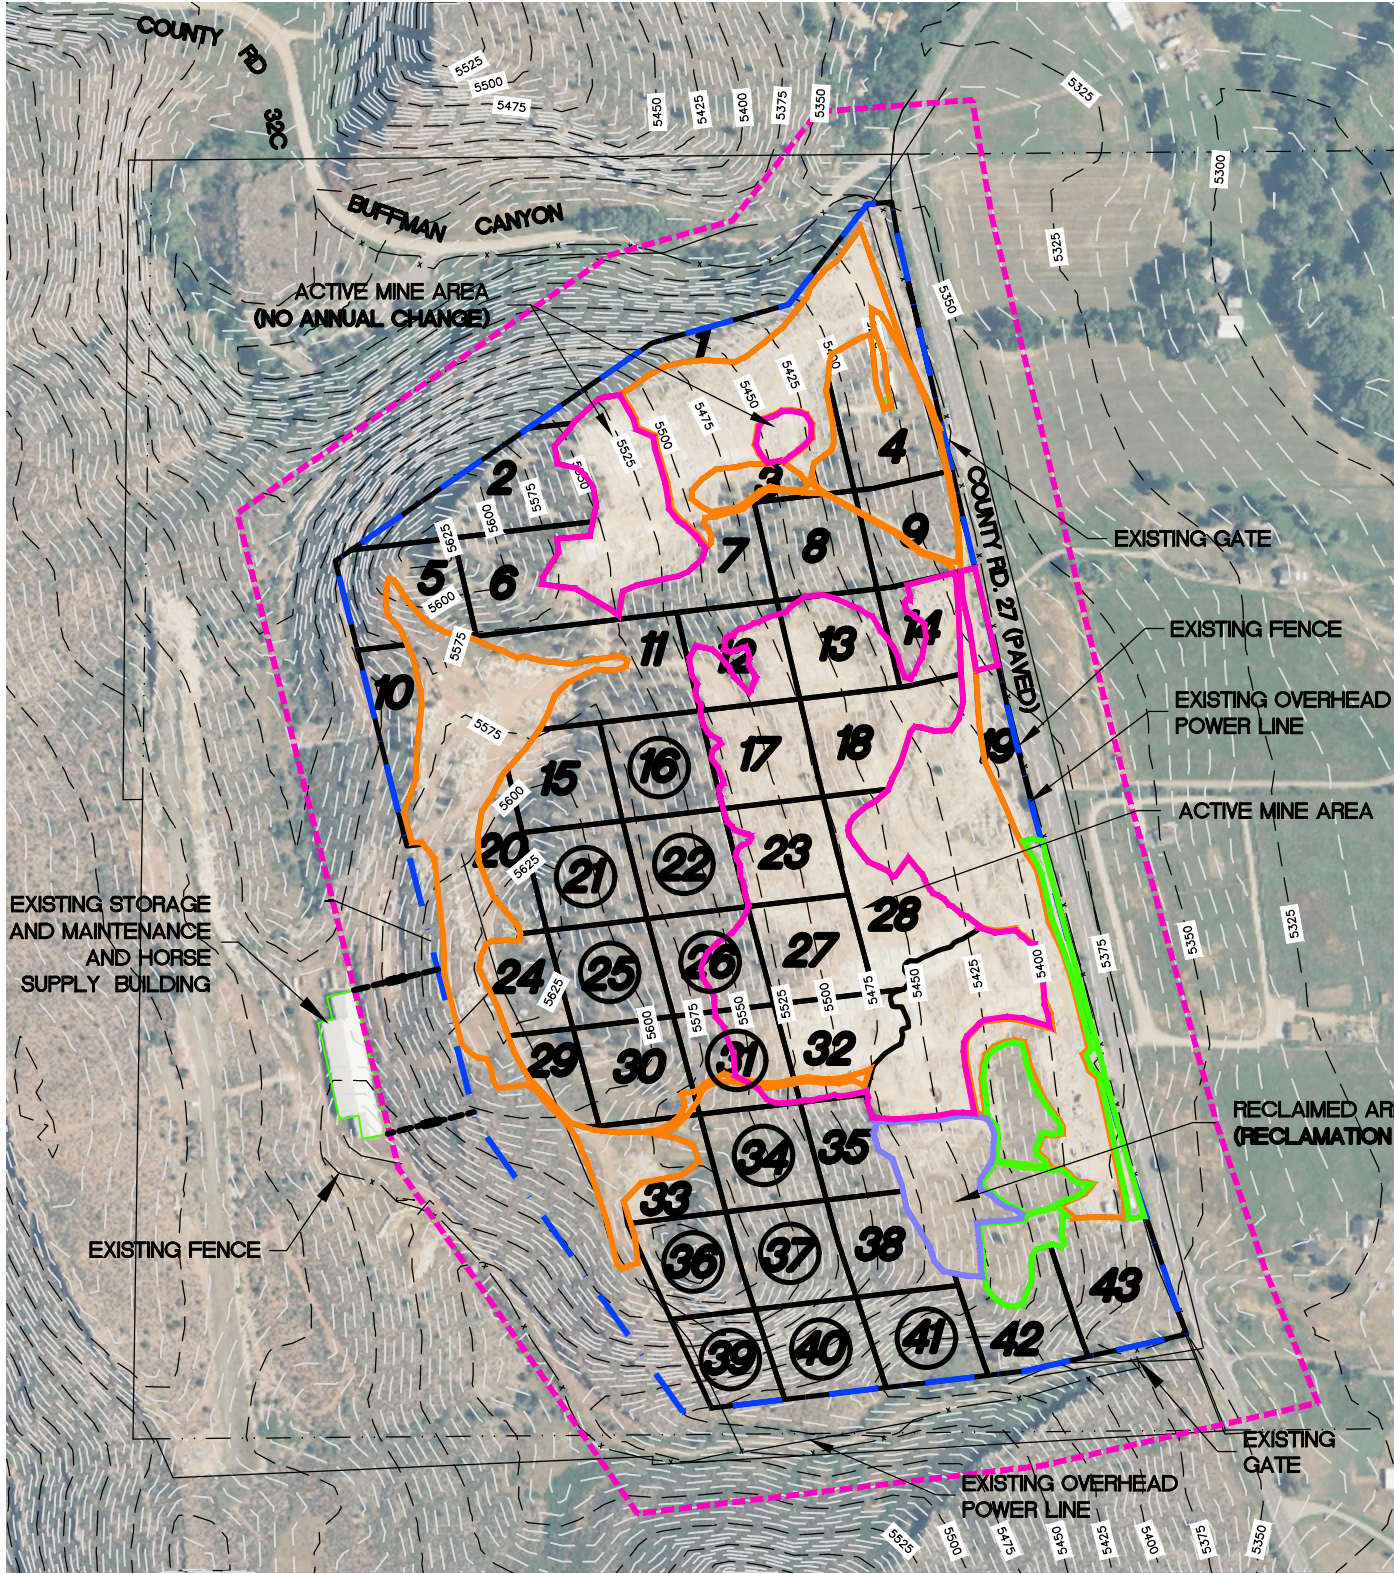
Attachment 2

PROBLEM: The financial warranty is not adequate to reclaim the site in accordance with the approved reclamation plan. This is a failure to maintain the proper financial warranty amount to complete reclamation of the affected lands pursuant to C.R.S. 34-32.5-117(4)(b) of the Act.

The Annual Report Map submitted in October 2023, Attachment 2, indicates there are at least two parcels, 26 and 31, that have been affected but not yet approved for disturbance. The disturbed parcels total to an increase of 2 acres. Failure to maintain the appropriate financial warranty as required by the approved permit has been cited as a problem within this report.

CORRECTIVE ACTIONS: The operator shall submit adequate financial warranty, per the approved plan, to the Division for review.
