MINERALS PROGRAM INSPECTION REPORT

MINE NAME: Schmidt Gravel Pit	MINE/PROSPECTING ID#: M-2000-048	MINERAL: Gravel	COUNTY: Kiowa
INSPECTION TYPE: Monitoring	WEATHER: Clear	INSP. DATE: October 5, 2023	INSP. TIME: 11:15
OPERATOR: Kiowa County	OPERATOR REPRESENTATIVE: Allen Watts	TYPE OF OPERATION: 110c - Construction Limited Impact

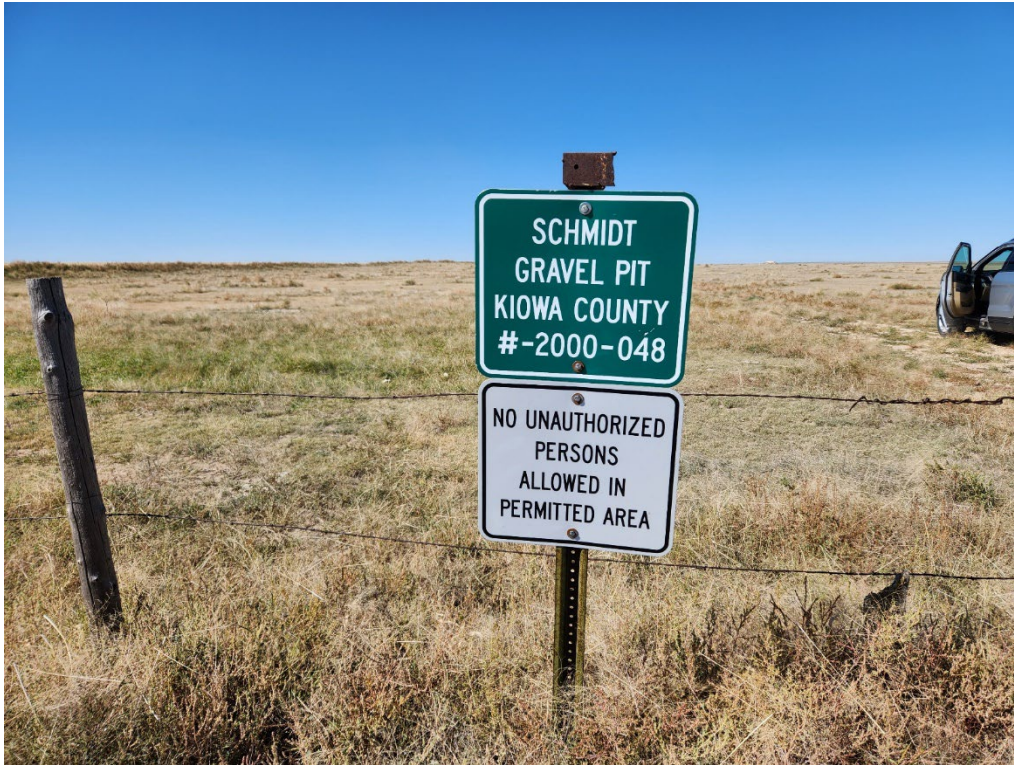
PROBLEM/POSSIBLE VIOLATION: Problem: The sign does not include a statement that the reclamation permit for the operation has been issued by the Colorado Mined Land Reclamation Board (CMLRB). This is a problem for failure to meet all requirements of a mine identification sign per Rule 3.1.12(1).

There is no statement on the mine entrance sign that a reclamation permit for the operation has been issued by the Colorado Mined Land Reclamation Board (CMLRB), therefore the sign does not include all information required by Rule 3.1.12(1). This is cited as a problem in the report (see page 1). The operator will need to submit photo documentation that a proper sign has been posted by the corrective action due date.

Photo 1. Mine entrance sign, looking west. The sign does not state "A reclamation permit for the operation has been issued by the Colorado Mined Land Reclamation Board (CMLRB)".

CORRECTIVE ACTIONS: The operator shall, at the entrance of the mine site post a sign, which shall be clearly visible from the access road, with a minimum size equaling one hundred and eighty-seven (187) square inches, such as eleven (11) inches in height and seventeen (17) inches in width, with appropriate font size, with the following: the name of the operator, the operation name, a statement that a reclamation permit for the operation has been issued by the CMLRB, and the permit number. The operator shall submit photo documentation that a proper sign has been posted by the corrective action due date.

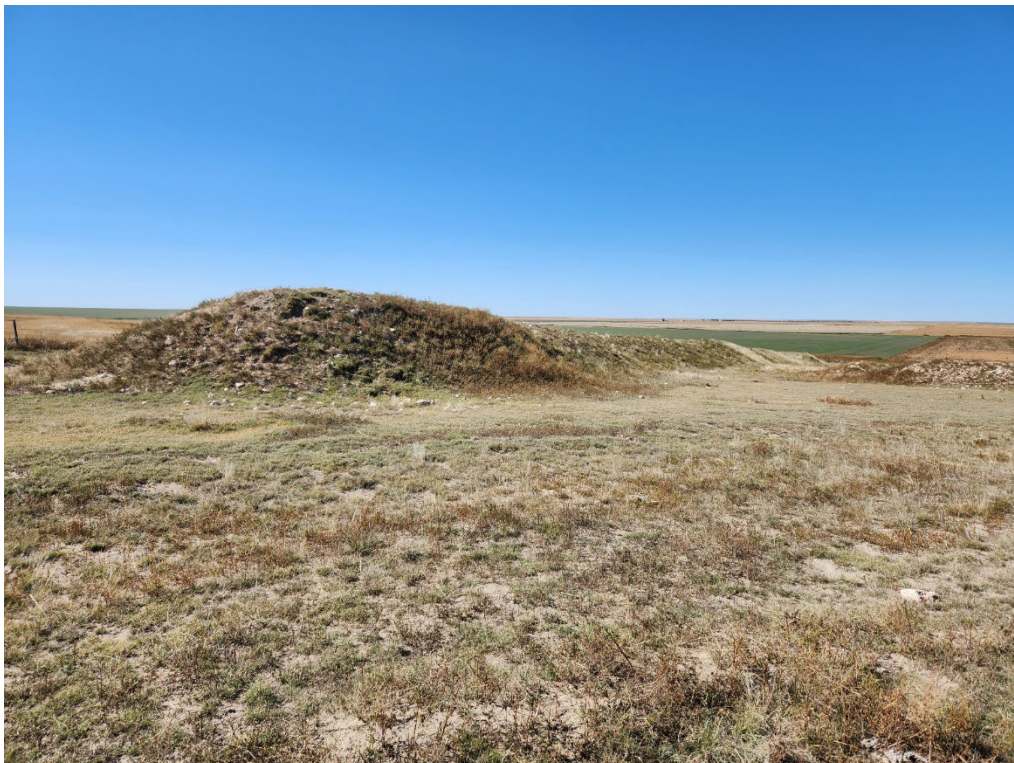
Photo 2. Topsoil stockpile, looking west.

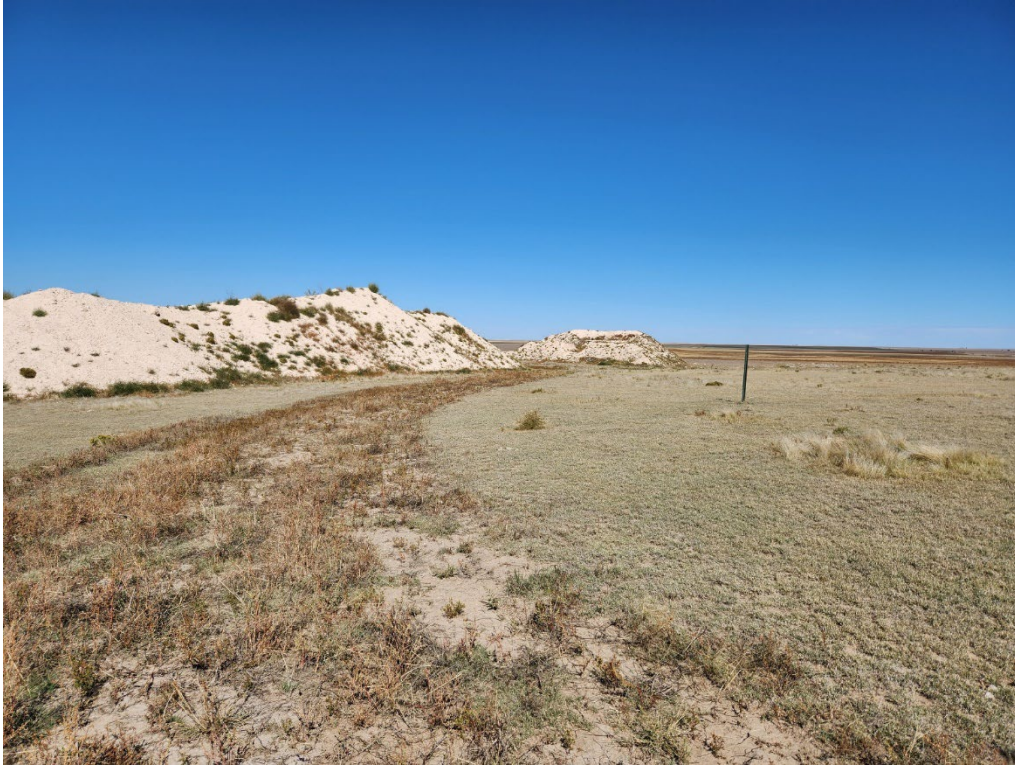
Photo 3. Overburden stockpile located east of newest pit, looking north.

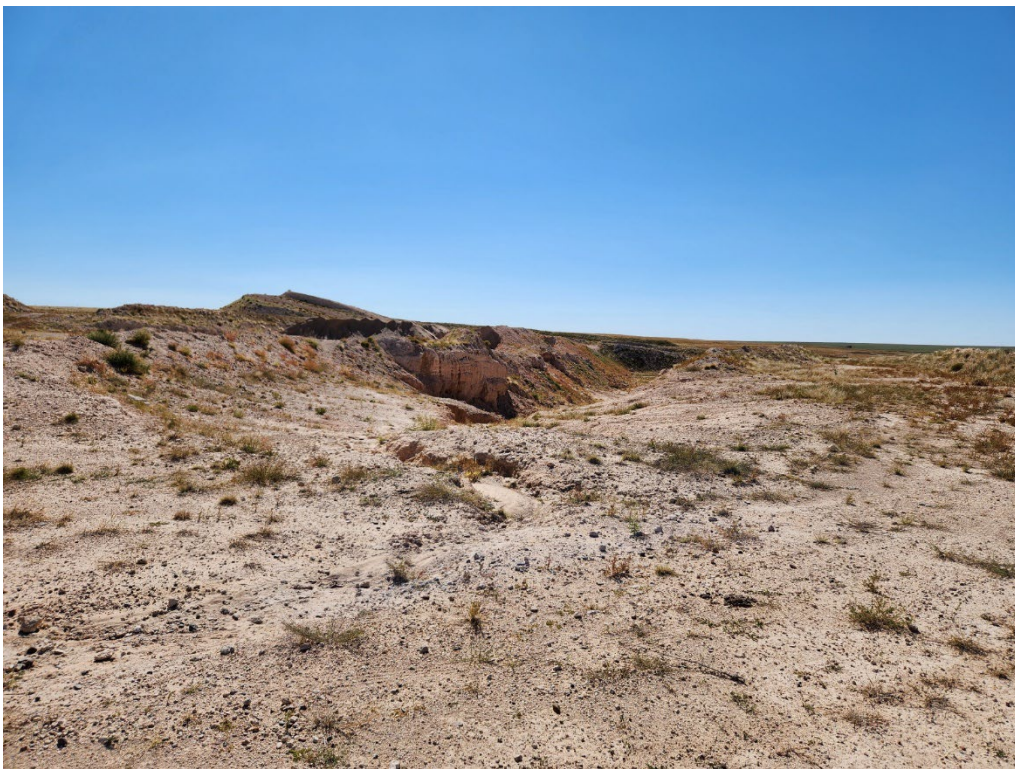
Photo 4. The old mining pit is in the center of the image, looking south. A new mining pit is being excavated to the left. The operator plans to connect these pits by digging out the highwall in between the pits.

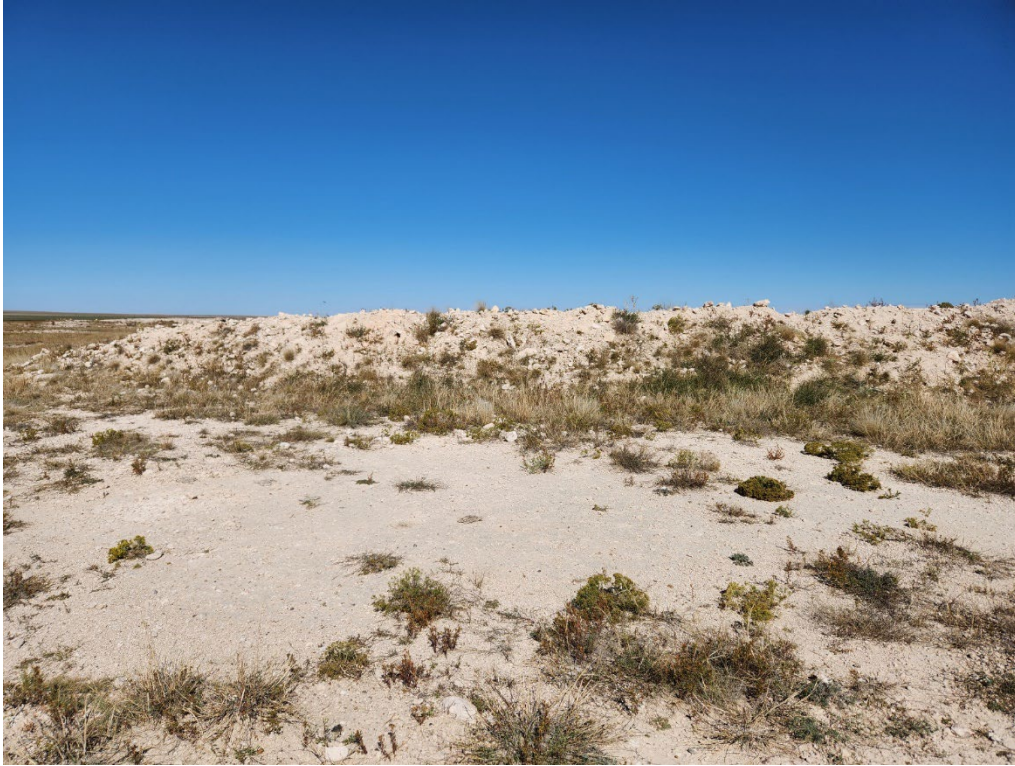
Photo 5. Overburden stockpile, looking east.

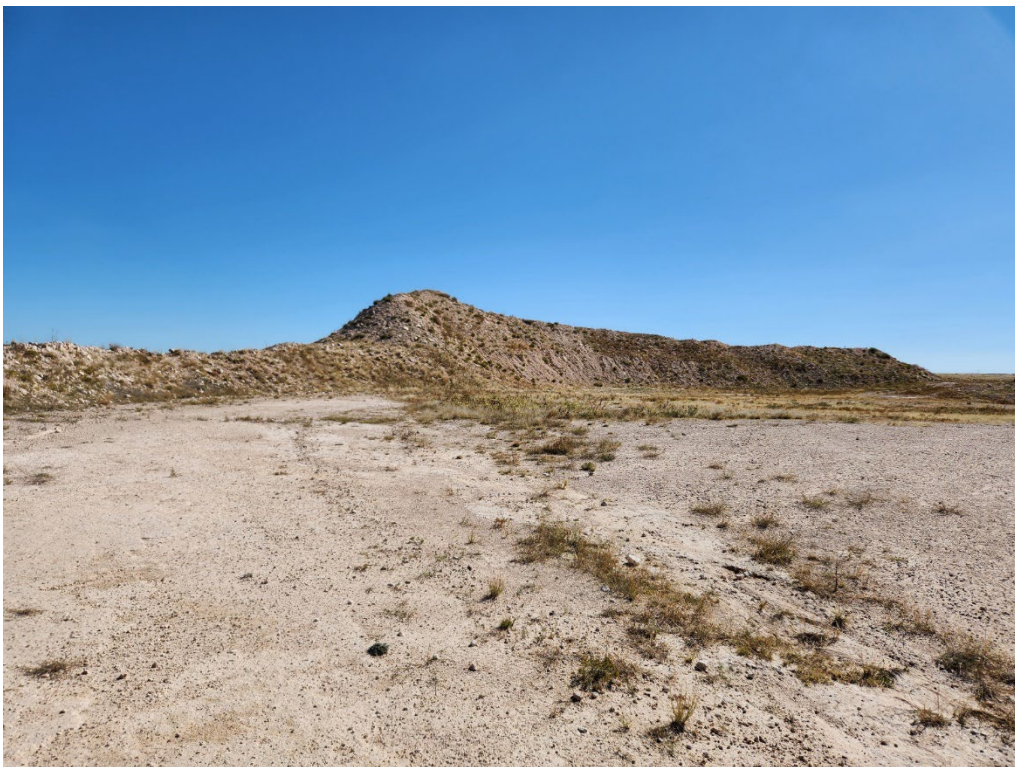
Photo 6. Overburden stockpile located north of the pits, looking north.

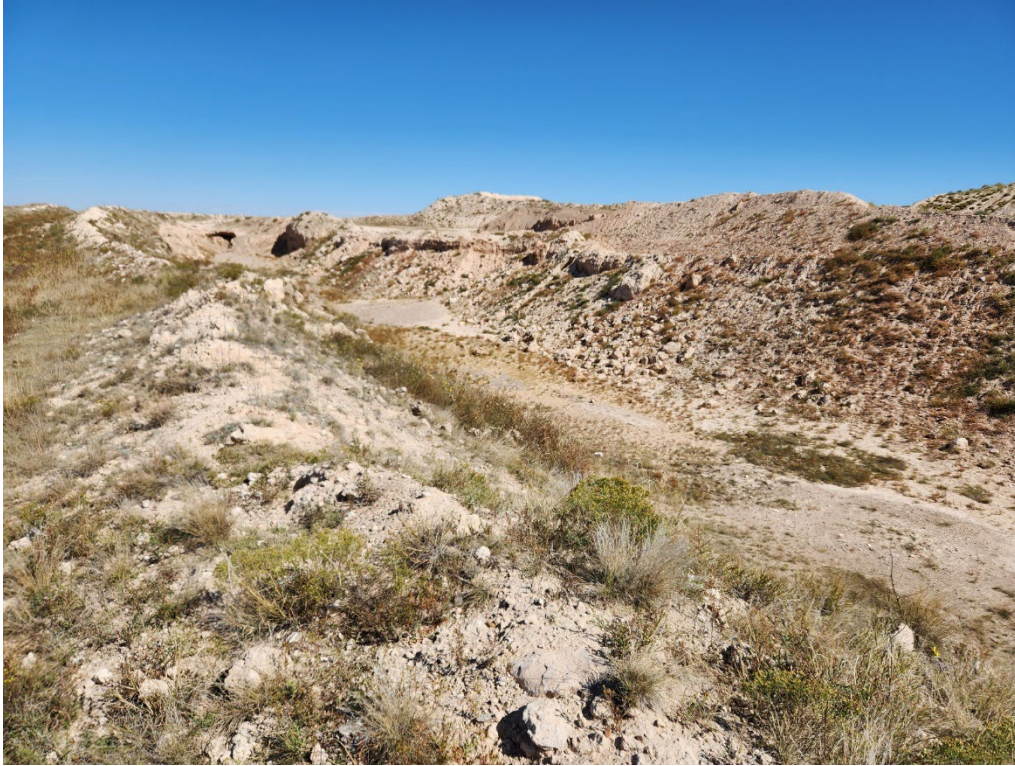
Photo 7. Original mining pit, looking north.

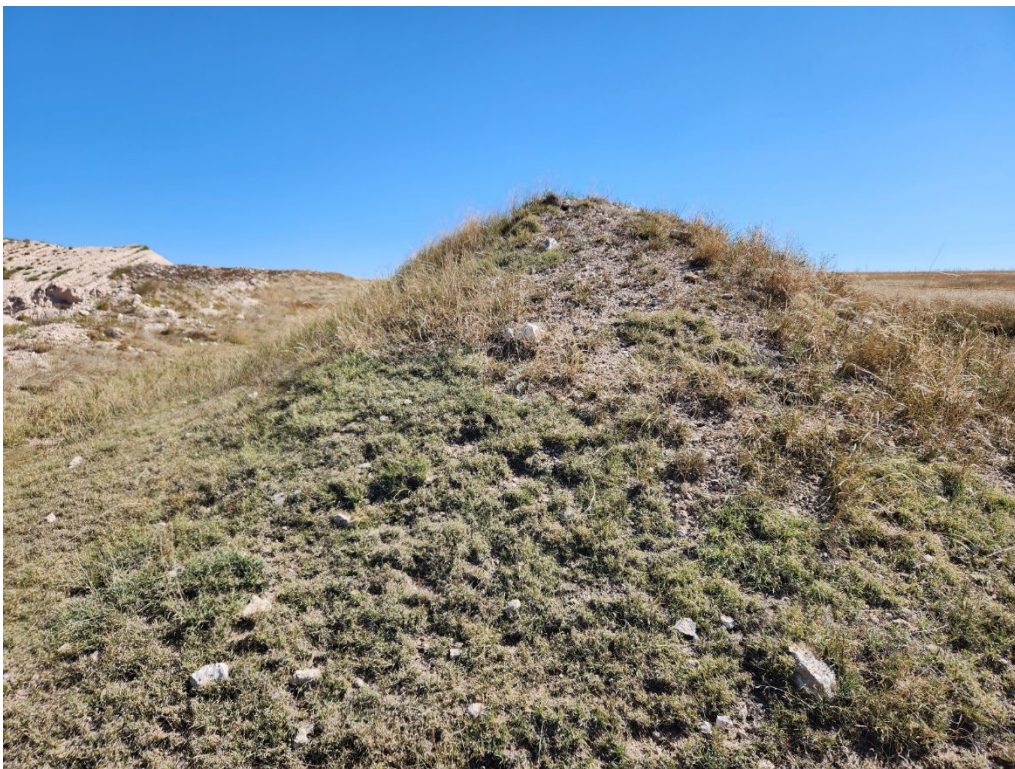
Photo 8. Topsoil stockpile located south of mining pits, looking east.

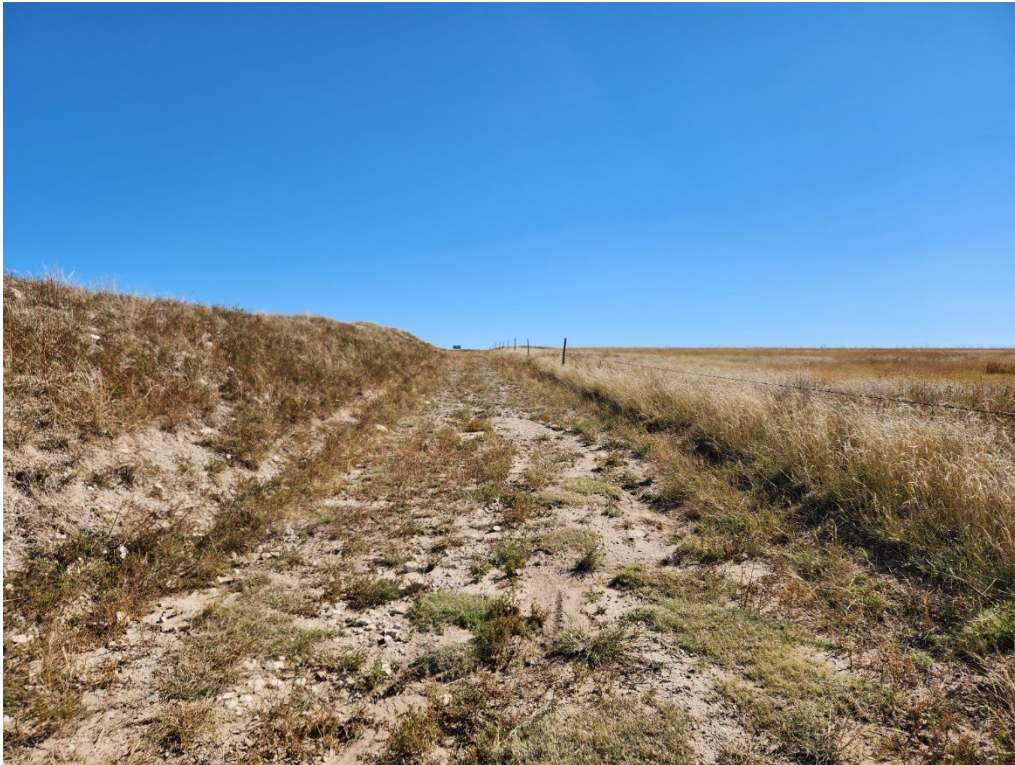
Photo 9. South of the topsoil stockpile, the southern permit boundary is marked by the fence on the right, looking east.

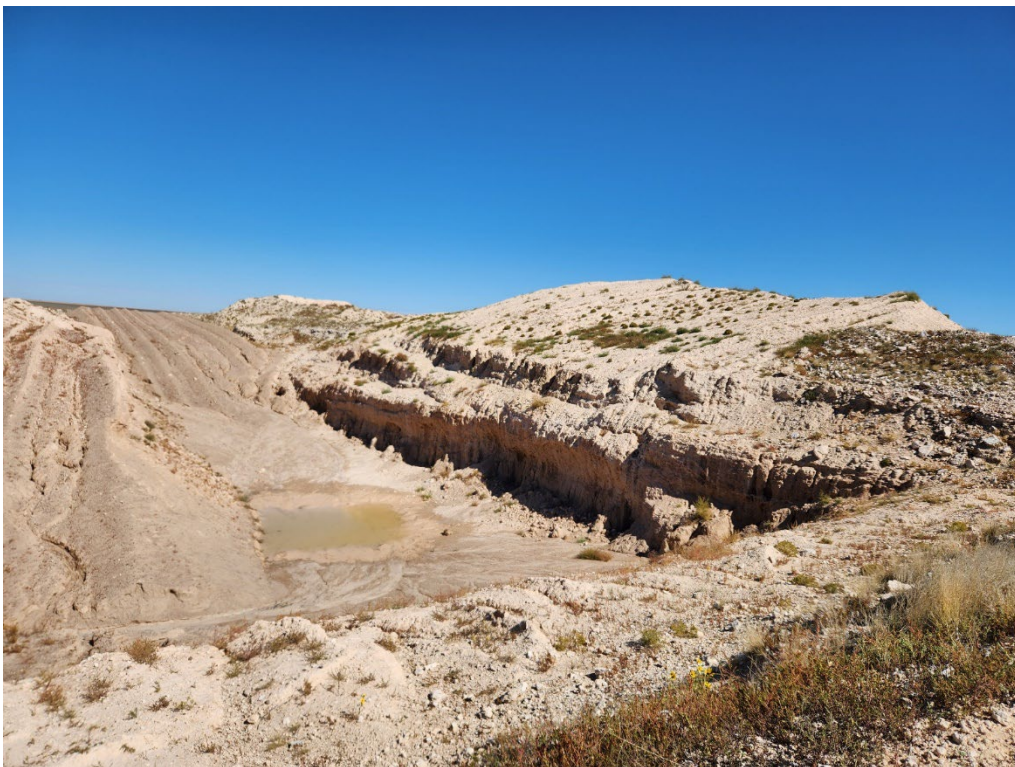
Photo 10. New mining pit, looking north.
