### MINERALS PROGRAM INSPECTION REPORT

<b>MINE NAME:</b> Barnes Pit	<b>MINE/PROSPECTING ID#:</b> M-1991-075	<b>MINERAL:</b> Gravel	<b>COUNTY:</b> Kiowa
<b>INSPECTION TYPE:</b> Monitoring	<b>WEATHER:</b> Clear	<b>INSP. DATE:</b> October 5, 2023	<b>INSP. TIME:</b> 10:00
<b>OPERATOR:</b> Kiowa County	<b>OPERATOR REPRESENTATIVE:</b> Allen Watts	<b>TYPE OF OPERATION:</b> 112c - Construction Regular Operation

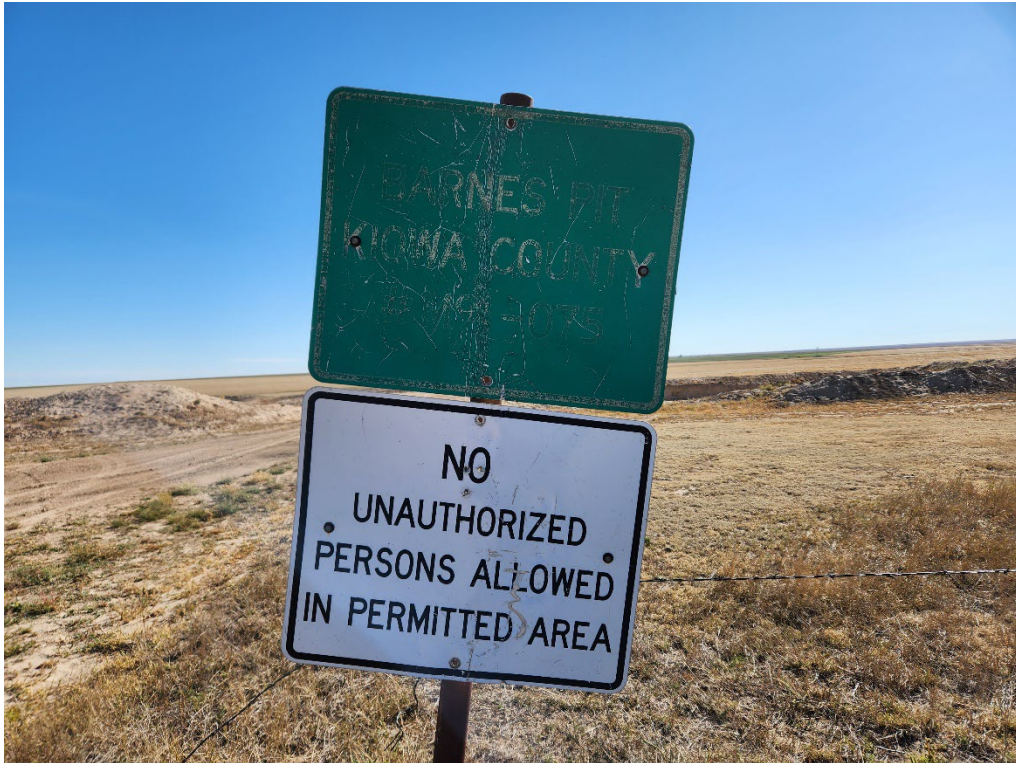
**PROBLEM/POSSIBLE VIOLATION:** Problem: The current mine identification sign posted at the entrance of the mine site is weathered and the permit number is no longer readable. The sign also does not include a statement that the reclamation permit for the operation has been issued by the Colorado Mined Land Reclamation Board (CMLRB). This is a problem for failure to meet all requirements of a mine identification sign per Rule 3.1.12(1).

The mine identification sign located at the site entrance has been weathered over time and the permit number is no longer readable. Also, the sign does not include all information required by Rule 3.1.12(1). This is cited as a problem in the report (see page 1). The operator will need to submit photo documentation that a proper sign has been posted by the corrective action due date.

**Photo 1.** Mine entrance sign, looking east. The sign is weathered away and needs to be replaced.

**CORRECTIVE ACTIONS:** The operator shall, at the entrance of the mine site post a sign, which shall be clearly visible from the access road, with a minimum size equaling one hundred and eighty-seven (187) square inches, such as eleven (11) inches in height and seventeen (17) inches in width, with appropriate font size, with the following: the name of the operator, the operation name, a statement that a reclamation permit for the operation has been issued by the CMLRB, and the permit number. The operator shall submit photo documentation that a proper sign has been posted by the corrective action due date.

**CORRECTIVE ACTION DUE DATE:** 12/28/23

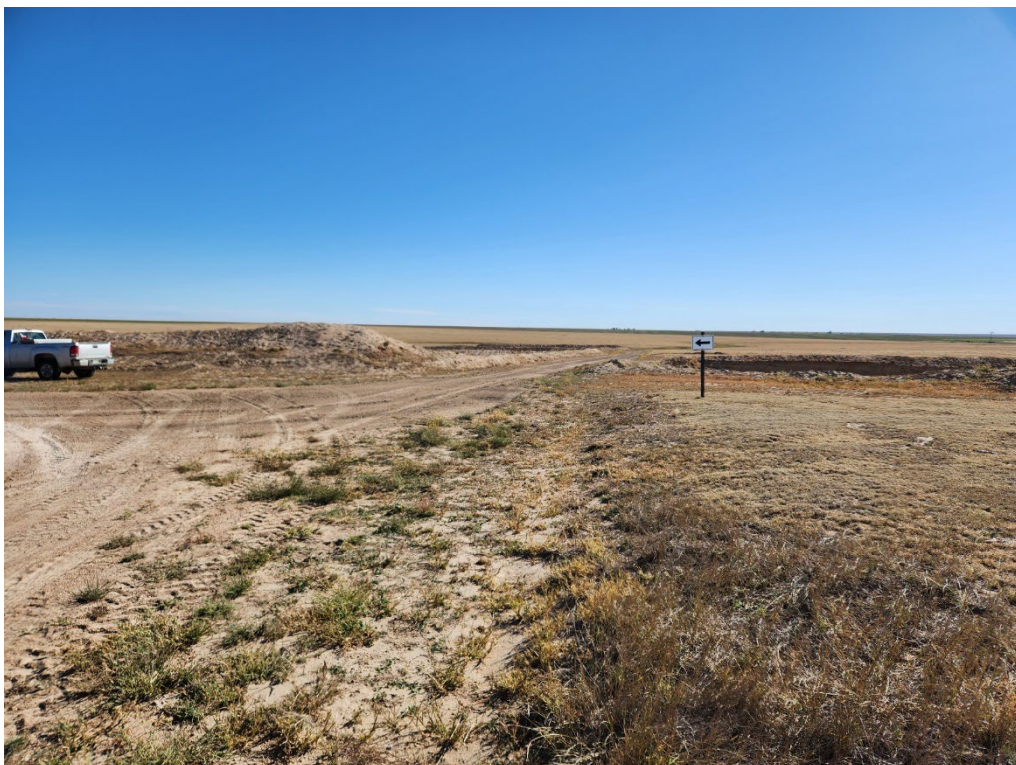
**Photo 2.** Mine entrance, looking east.

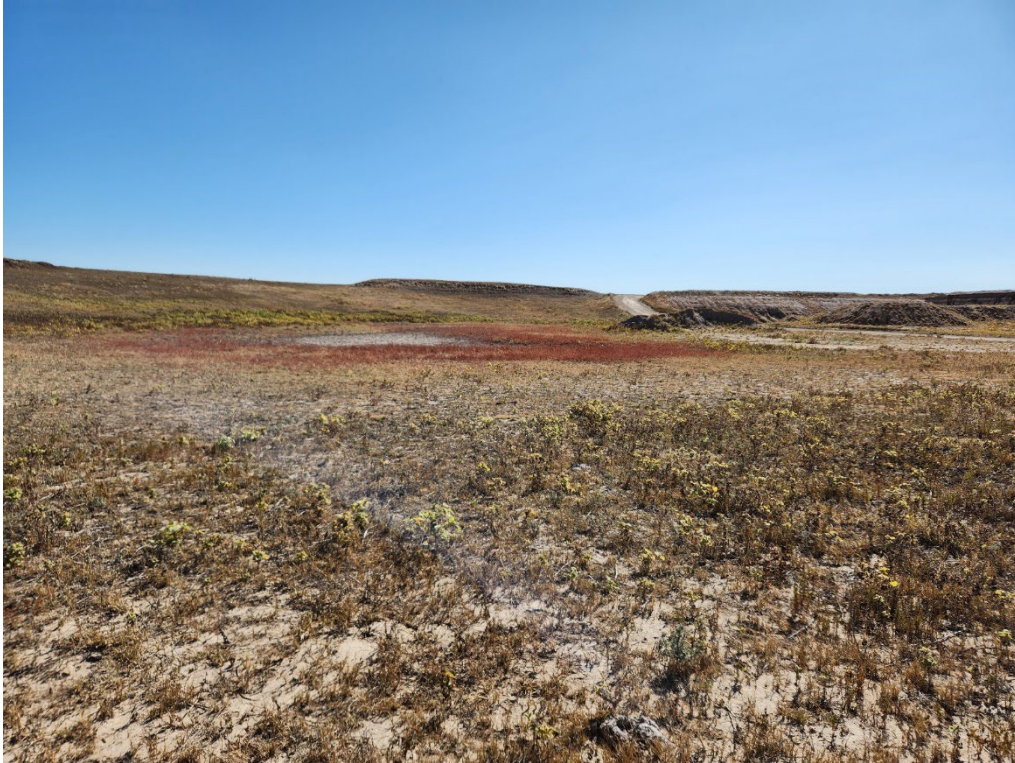
**Photo 3.** Northern pit flood that has been graded, backfilled, and reseeded.

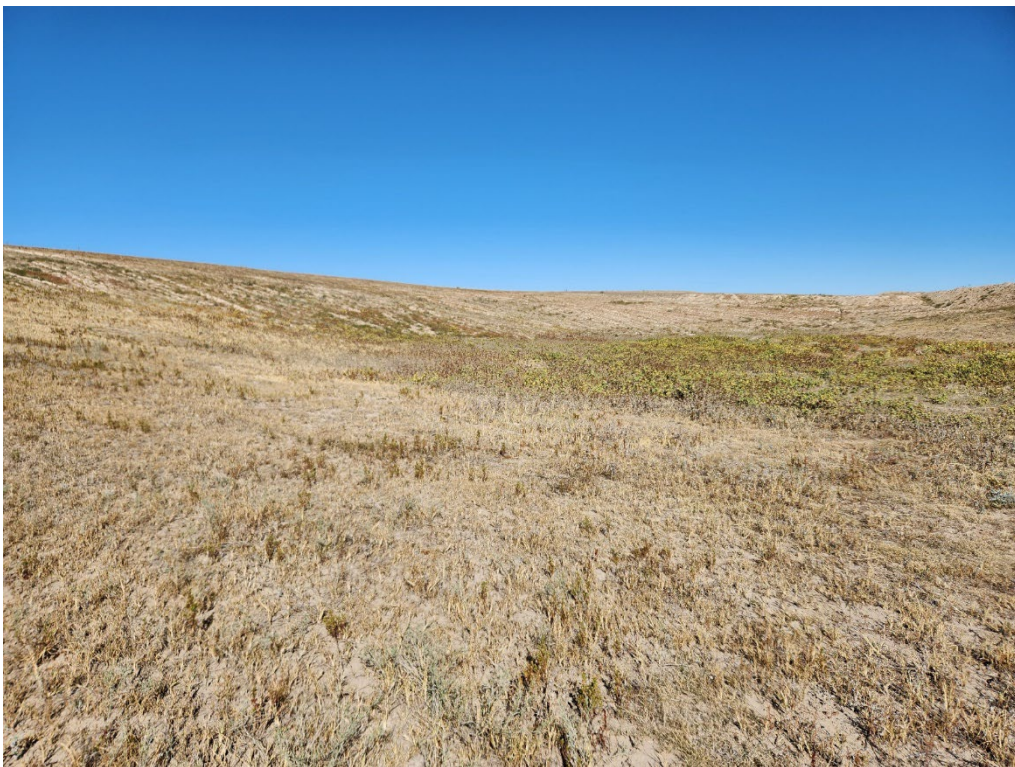
**Photo 4.** Vegetation cover in the northern portion of the mining pit, looking north.

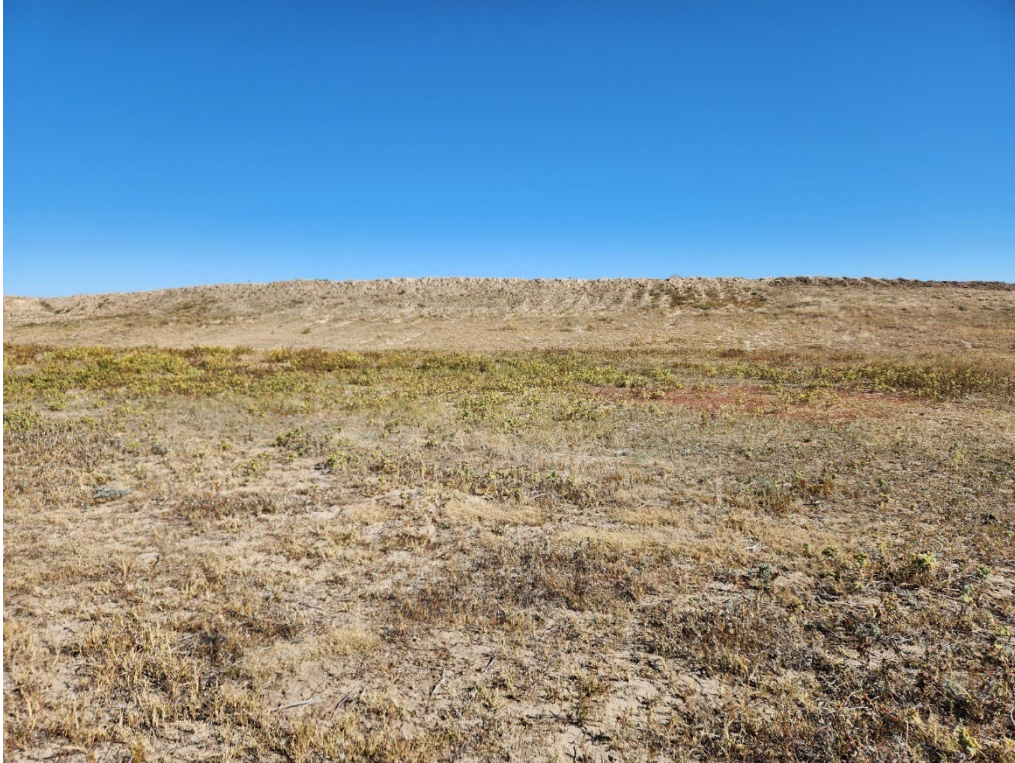
**Photo 5.** Vegetation cover in the northern portion of the mining pit, looking north. Topsoil is stockpiled still on top of the ridge.

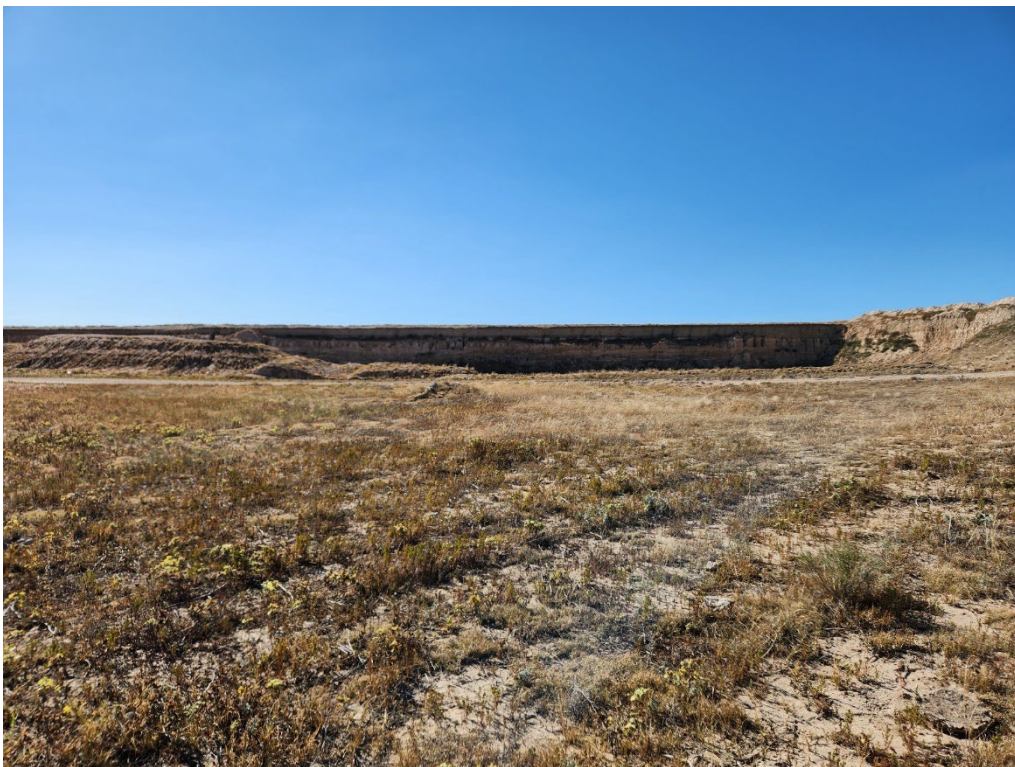
**Photo 6.** Mining pit highwall, standing on top of the revegetated area looking south.

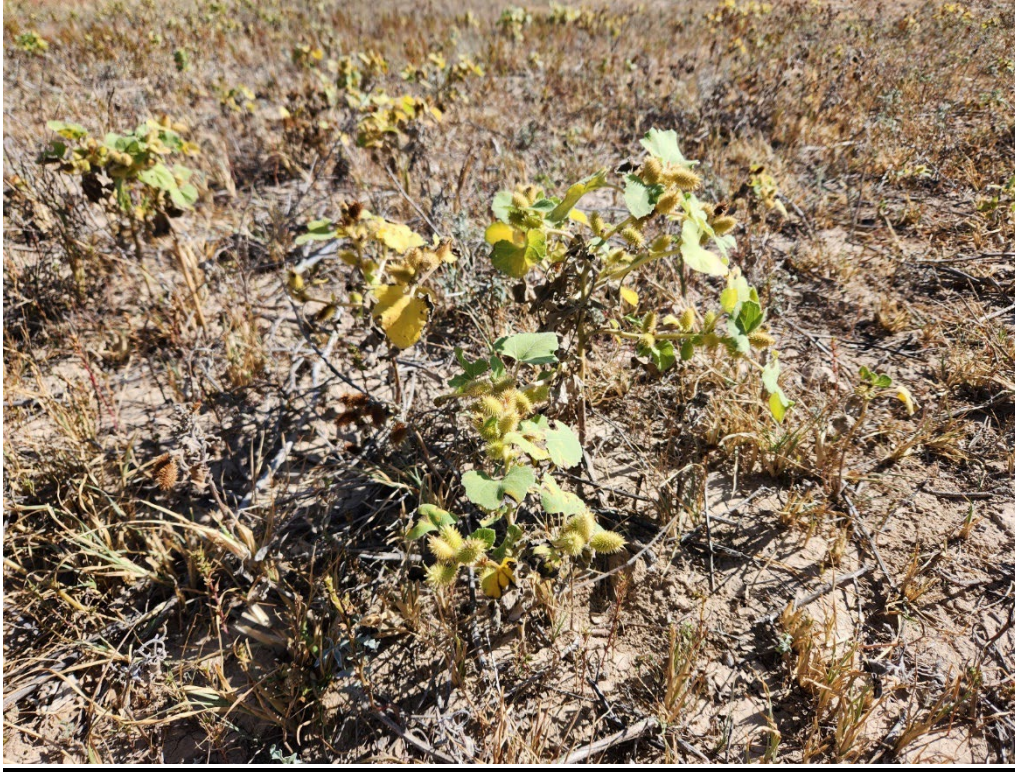
**Photo 7.** Cocklebur was found throughout the revegetated area.

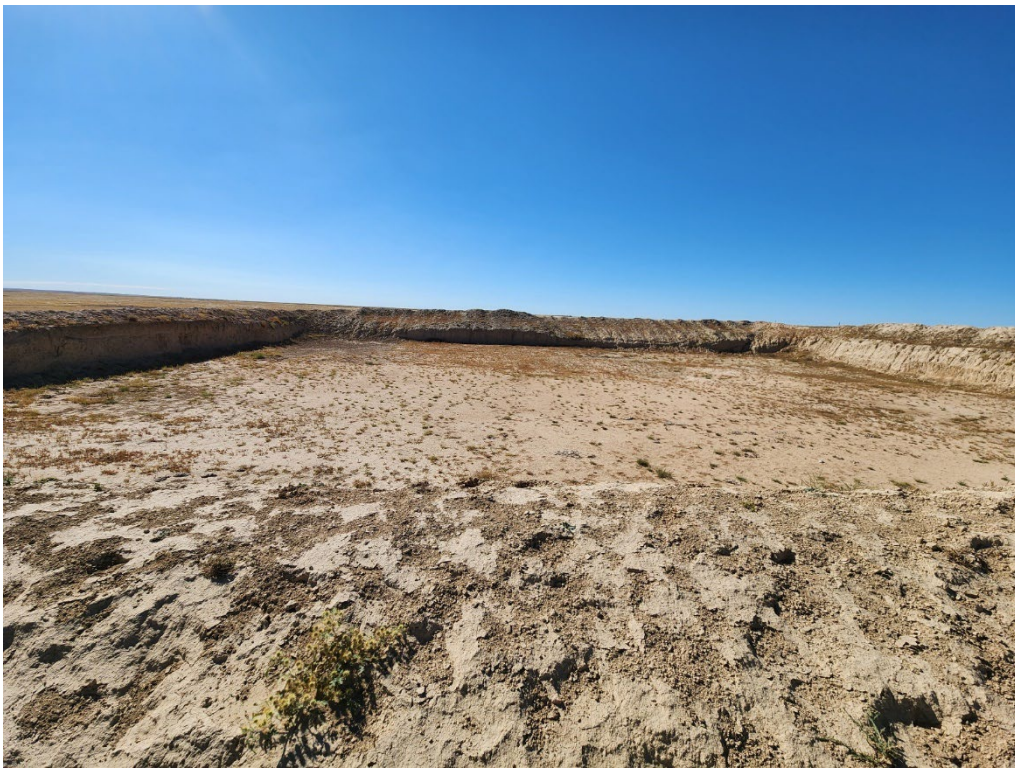
**Photo 8.** New mining pit south of the original pit, looking south.

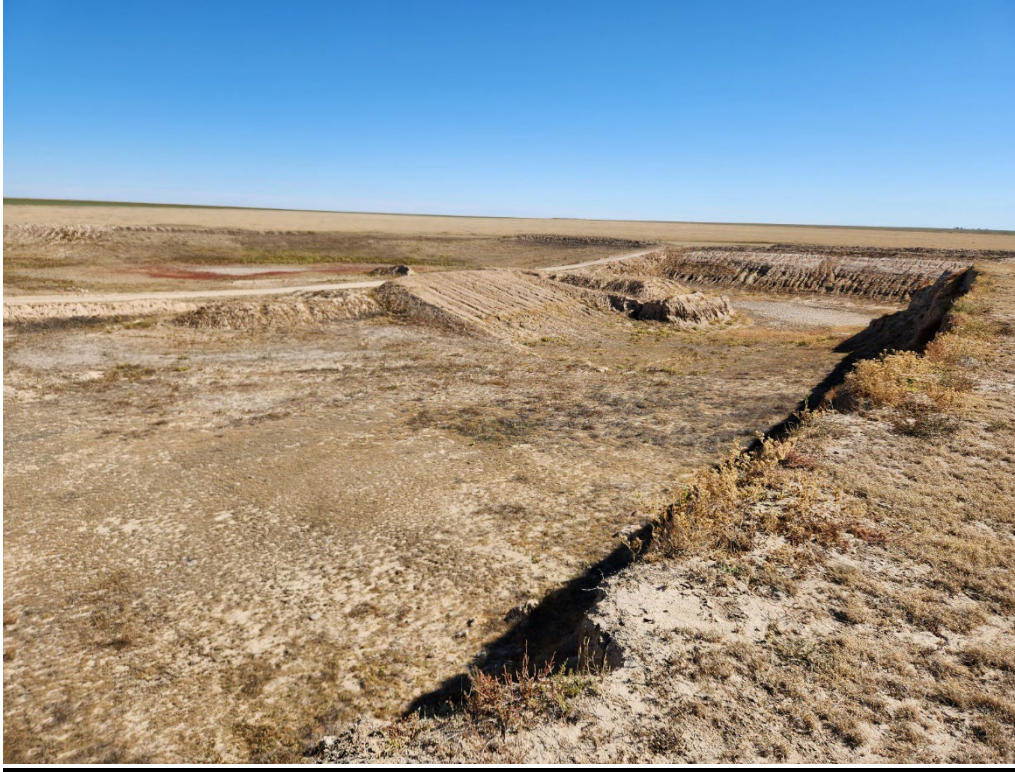
**Photo 9.** New mining pit, looking northeast.

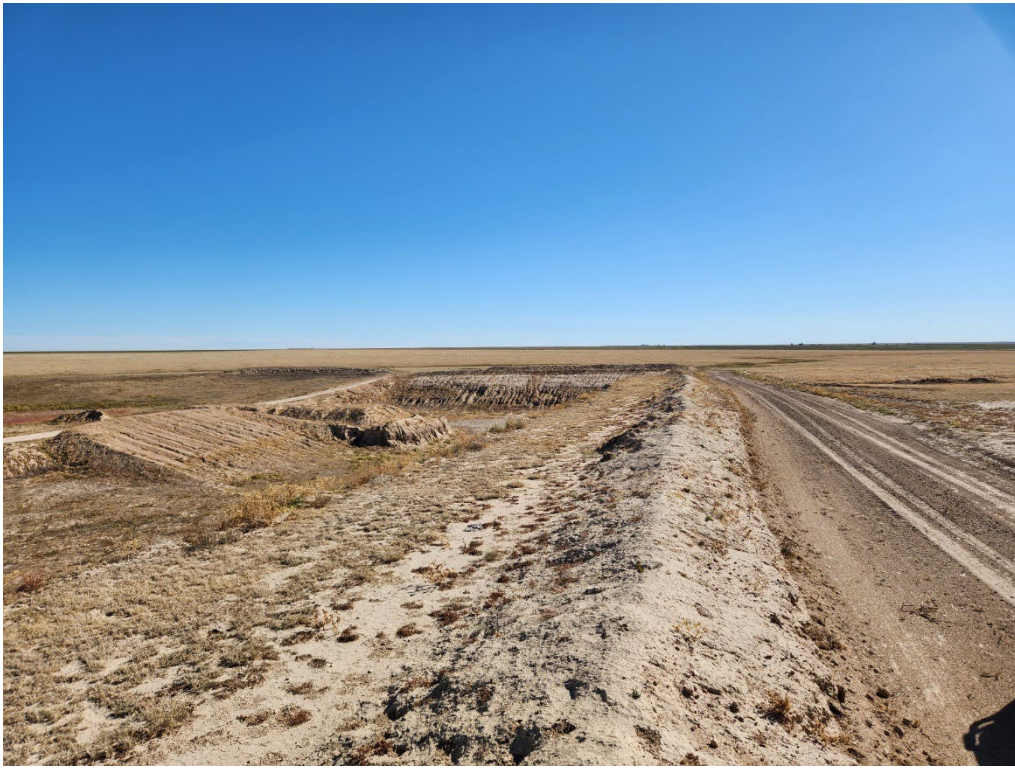
**Photo 10.** New mining pit, looking east.

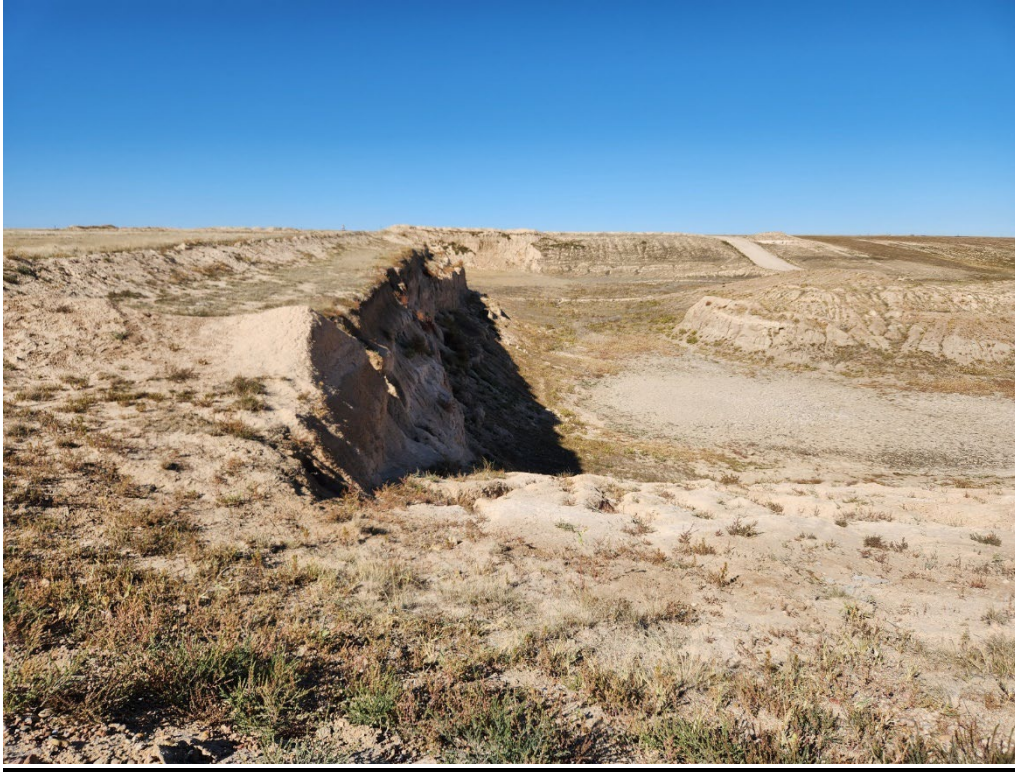
**Photo 11.** The original mining pit to the right and the new mining pit to the left, are separated by a highwall that will be mined down eventually to connect the pits. Looking west.

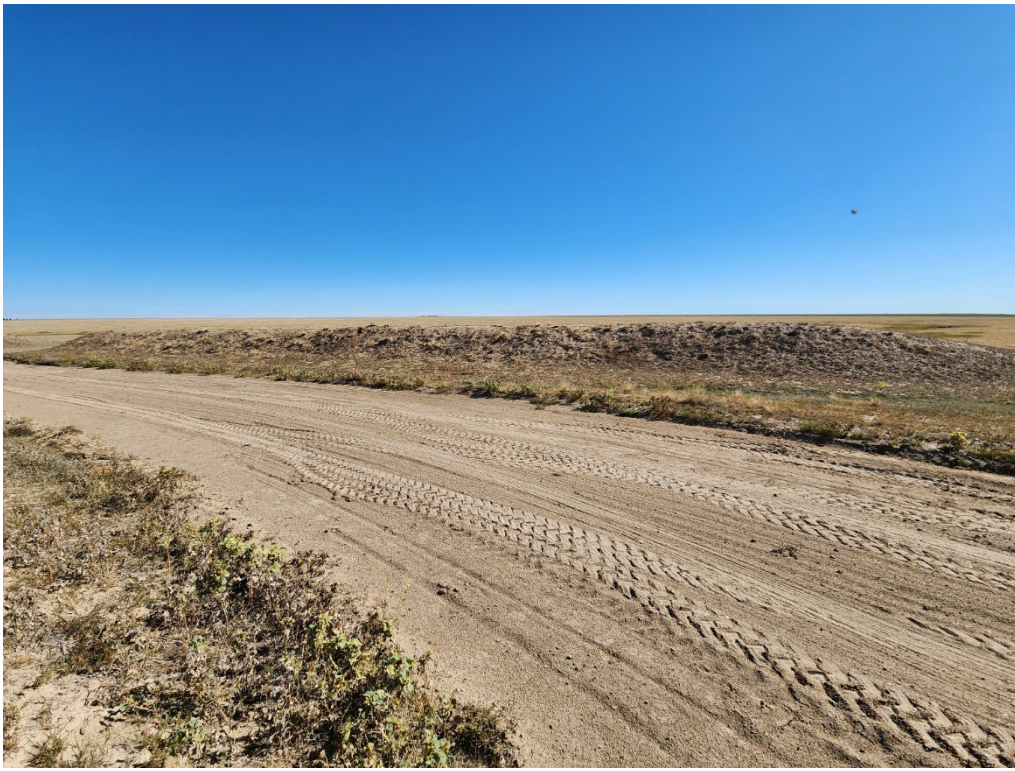
**Photo 12.** Access road along the eastern edge of the mining pits, looking north. A topsoil stockpile is photographed above the road.

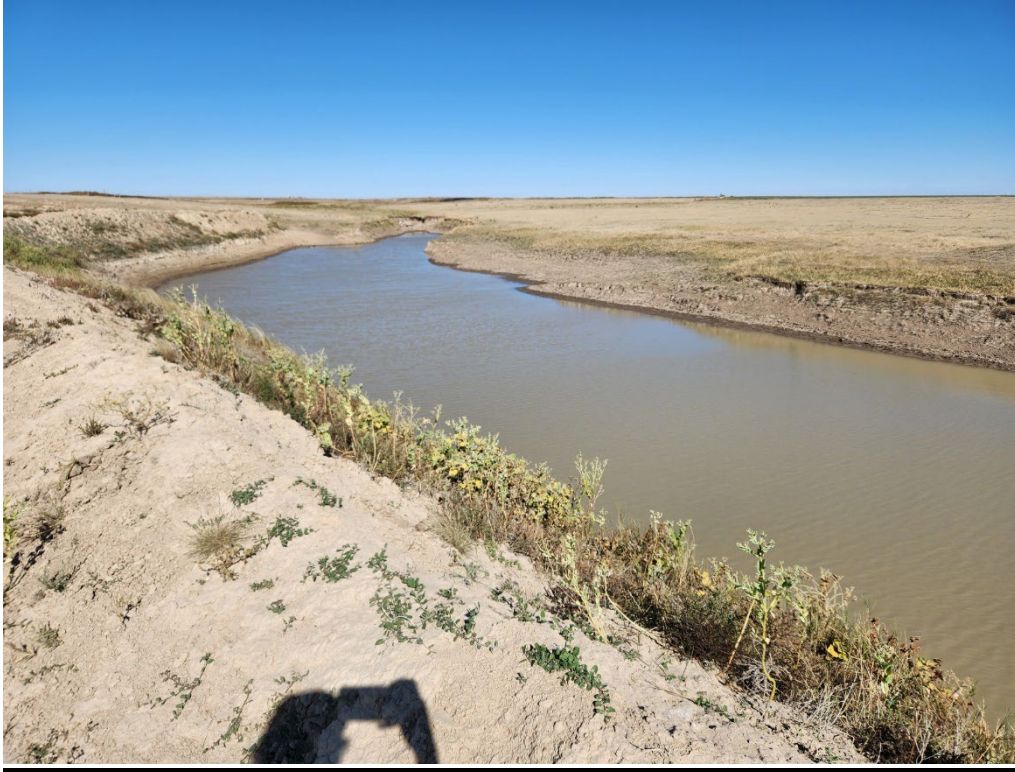
**Photo 13.** An unnamed drainage that runs east to west, located north of the permit boundary, looking northwest.

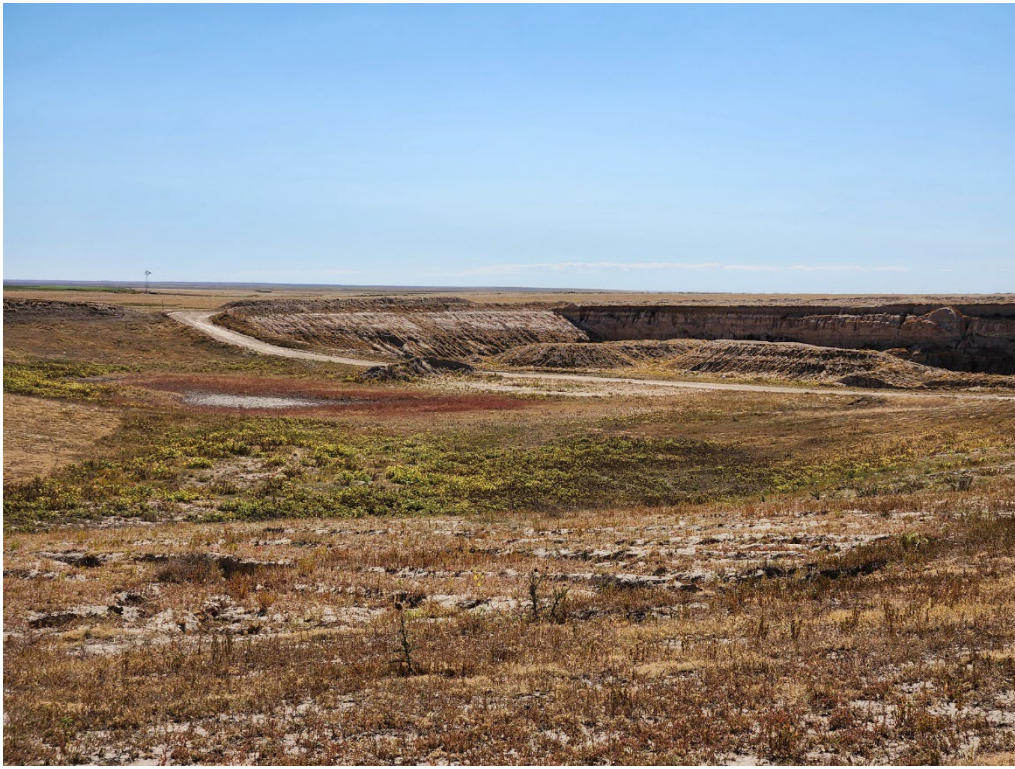
**Photo 14.** The original mining pit is seen above the access road, along with product stockpiles. A revegetated area is seen below the access road. Looking southeast.
