MINERALS PROGRAM INSPECTION REPORT

MINE NAME: Rother Gravel Pit	MINE/PROSPECTING ID#: M-1985-173	MINERAL: Sand and gravel	COUNTY: Kiowa
INSPECTION TYPE: Monitoring	WEATHER: Clear	INSP. DATE: October 5, 2023	INSP. TIME: 12:10
OPERATOR: Kiowa County	OPERATOR REPRESENTATIVE: Allen Watts	TYPE OF OPERATION: 112c - Construction Regular Operation

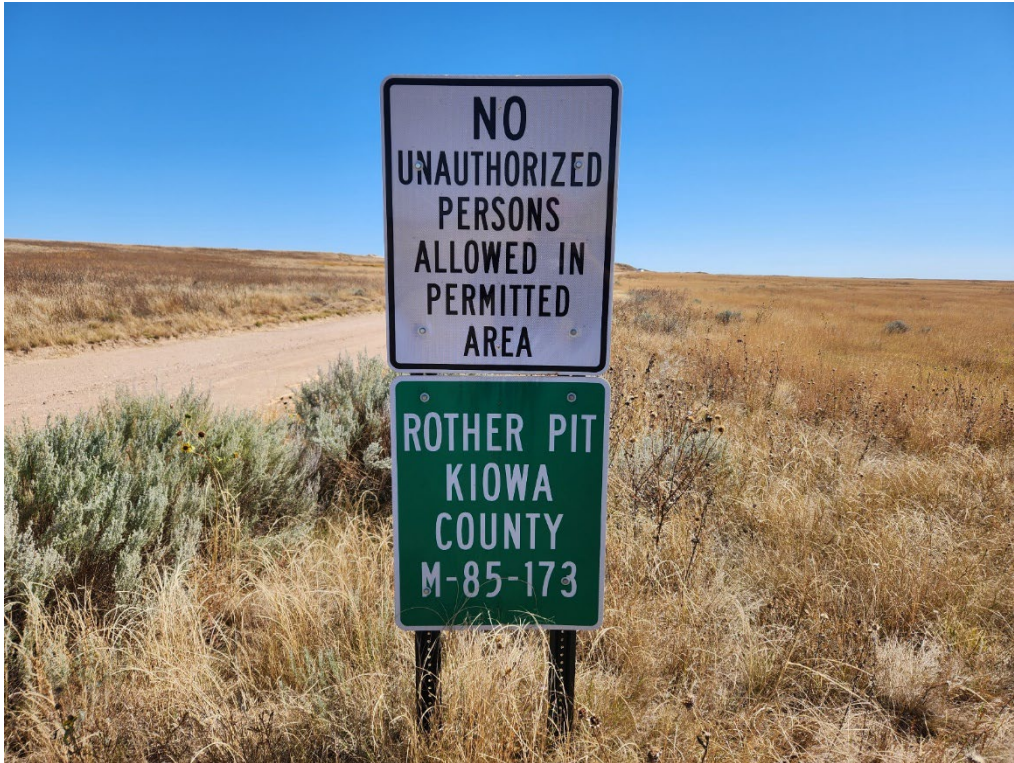
PROBLEM/POSSIBLE VIOLATION: Problem: Problem: The sign does not include a statement that the reclamation permit for the operation has been issued by the Colorado Mined Land Reclamation Board (CMLRB). This is a problem for failure to meet all requirements of a mine identification sign per Rule 3.1.12(1).

There is no statement on the mine entrance sign that a reclamation permit for the operation has been issued by the Colorado Mined Land Reclamation Board (CMLRB), therefore the sign does not include all information required by Rule 3.1.12(1). This is cited as a problem in the report (see page 1). The operator will need to submit photo documentation that a proper sign has been posted by the corrective action due date.

Photo 1. Mine entrance sign, looking east. The sign does not state "A reclamation permit for the operation has been issued by the Colorado Mined Land Reclamation Board (CMLRB)".

CORRECTIVE ACTIONS: The operator shall, at the entrance of the mine site post a sign, which shall be clearly visible from the access road, with a minimum size equaling one hundred and eighty-seven (187) square inches, such as eleven (11) inches in height and seventeen (17) inches in width, with appropriate font size, with the following: the name of the operator, the operation name, a statement that a reclamation permit for the operation has been issued by the CMLRB, and the permit number. The operator shall submit photo documentation that a proper sign has been posted by the corrective action due date.

CORRECTIVE ACTION DUE DATE: 12/28/23

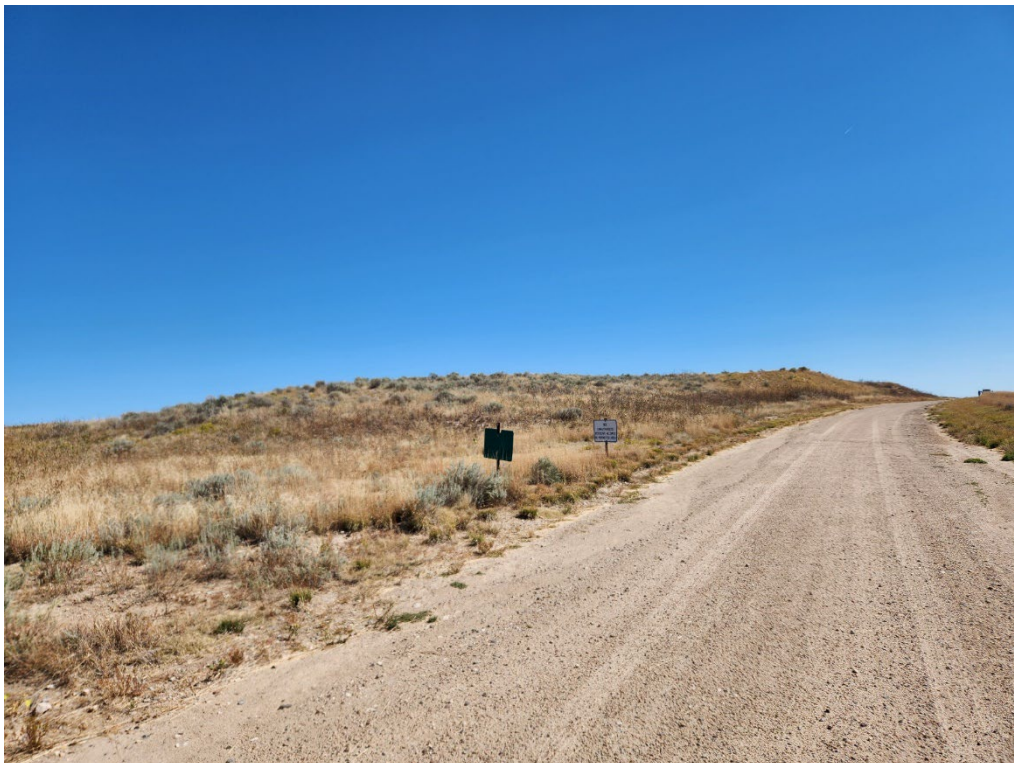
Photo 2. The access road into mine, looking east.

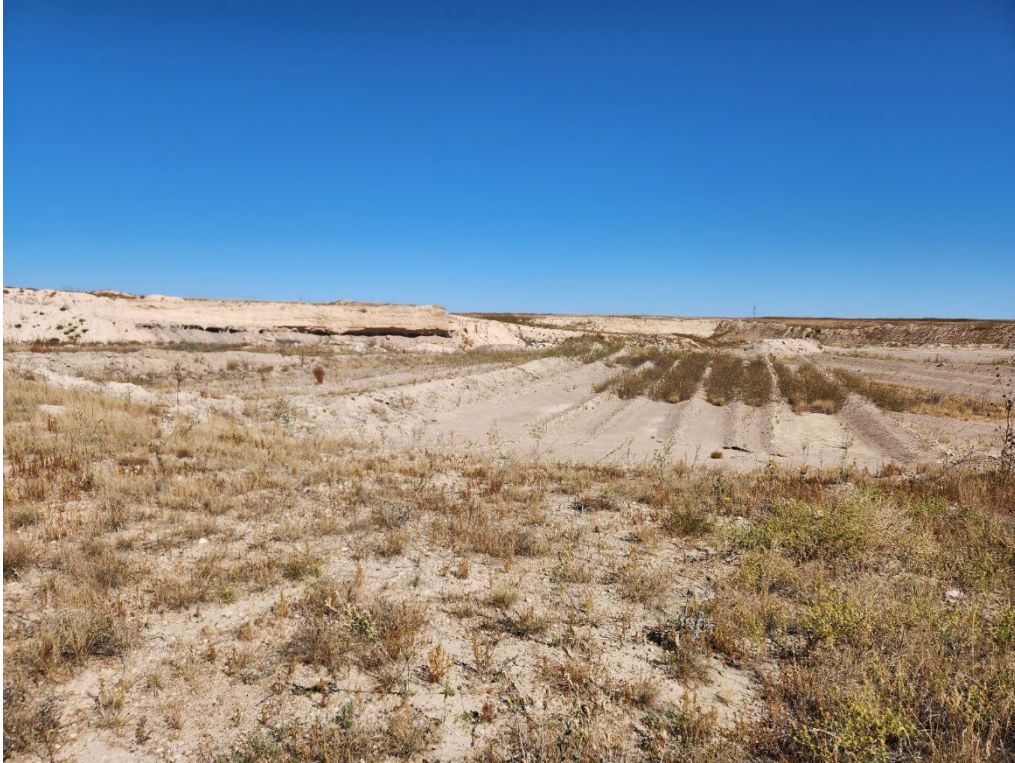
Photo 3. Mining pit, standing on top of the entrance access road, looking north.

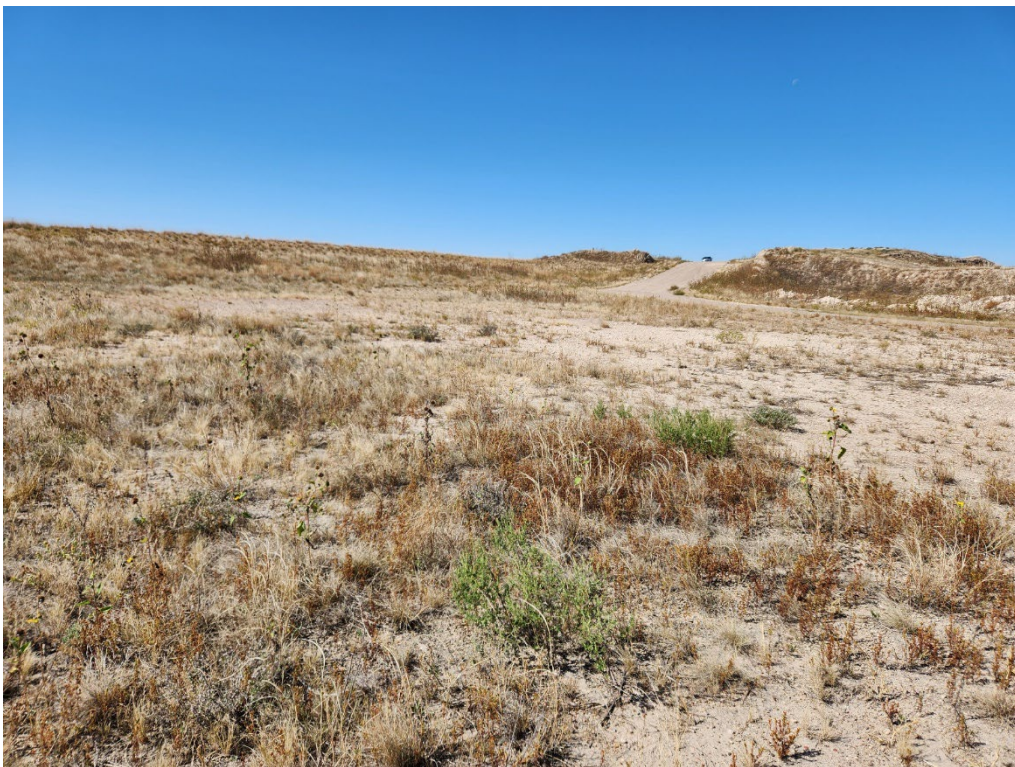
Photo 4. Looking back at the mine entrance, standing on top of the area in reclamation, looking west.

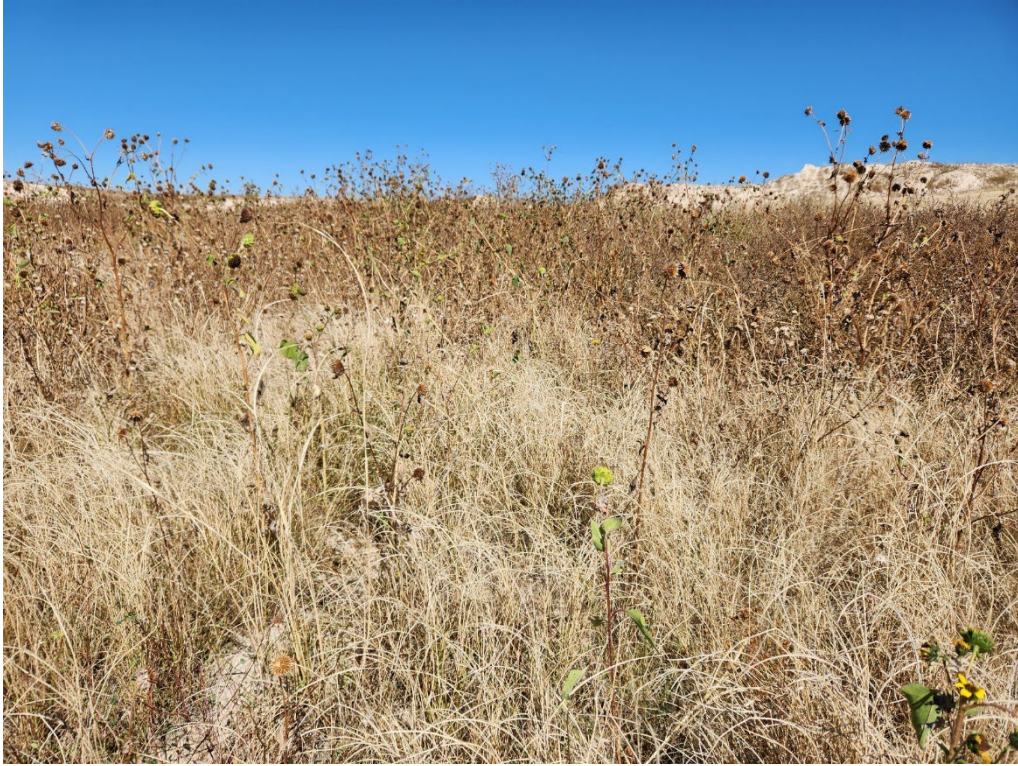
Photo 5. Current vegetative regrowth.

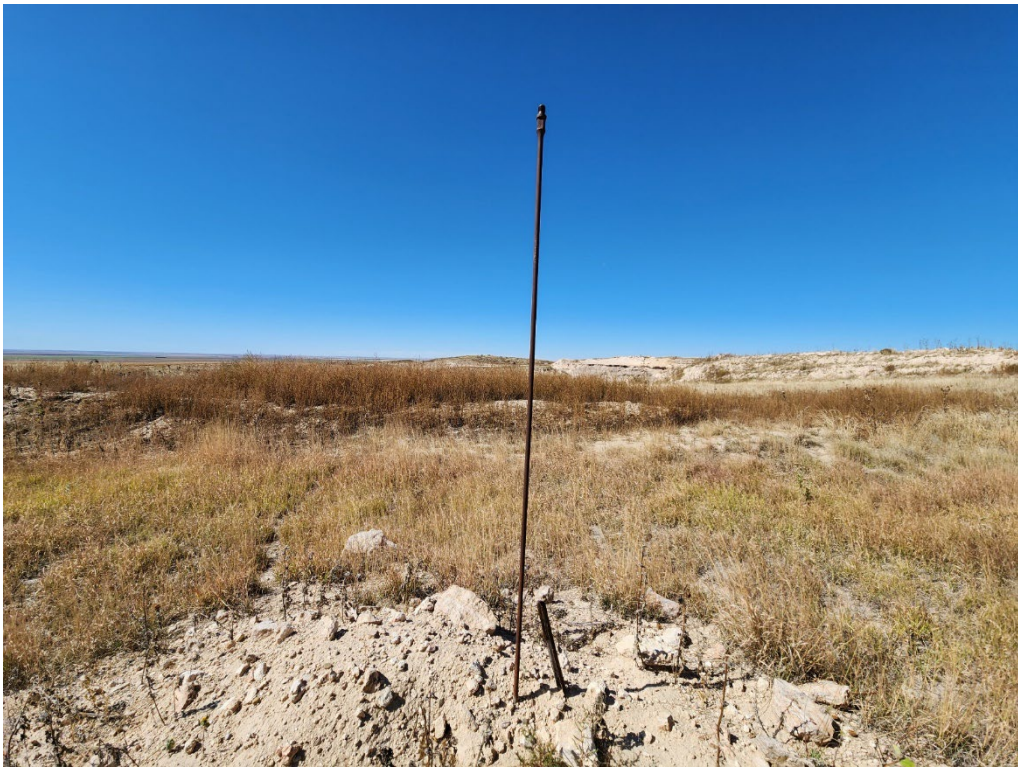
Photo 6. Permit boundary marker located southeast of the site, looking northwest.

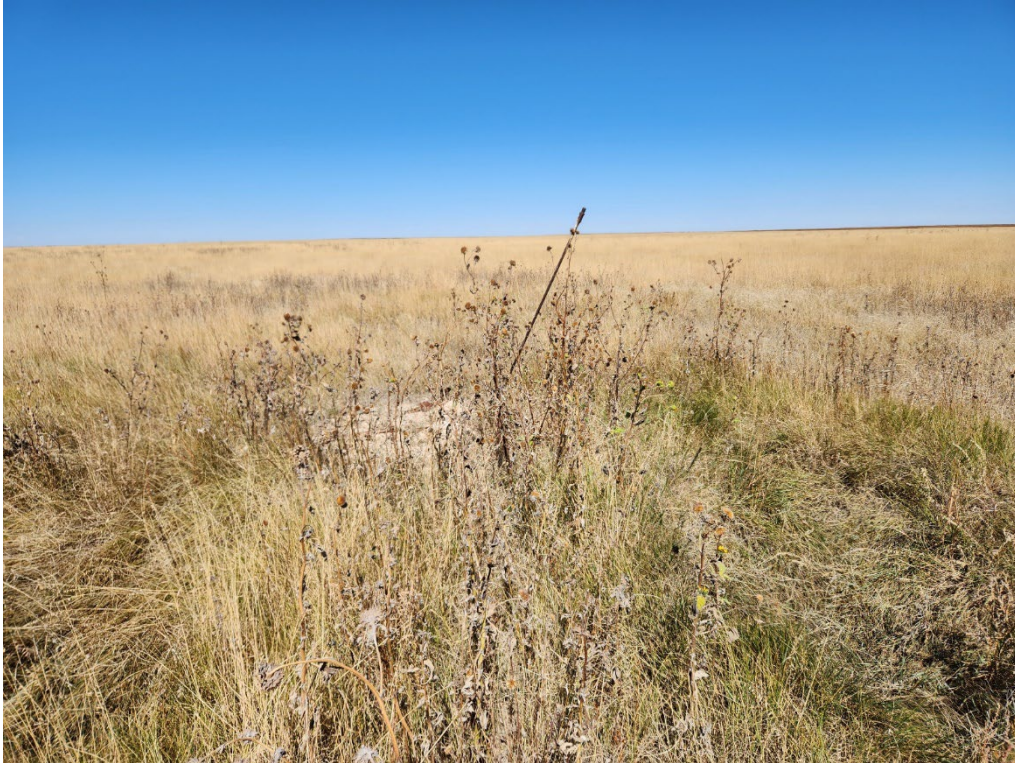
Photo 7. Permit boundary maker along the eastern edge of the site, looking north.

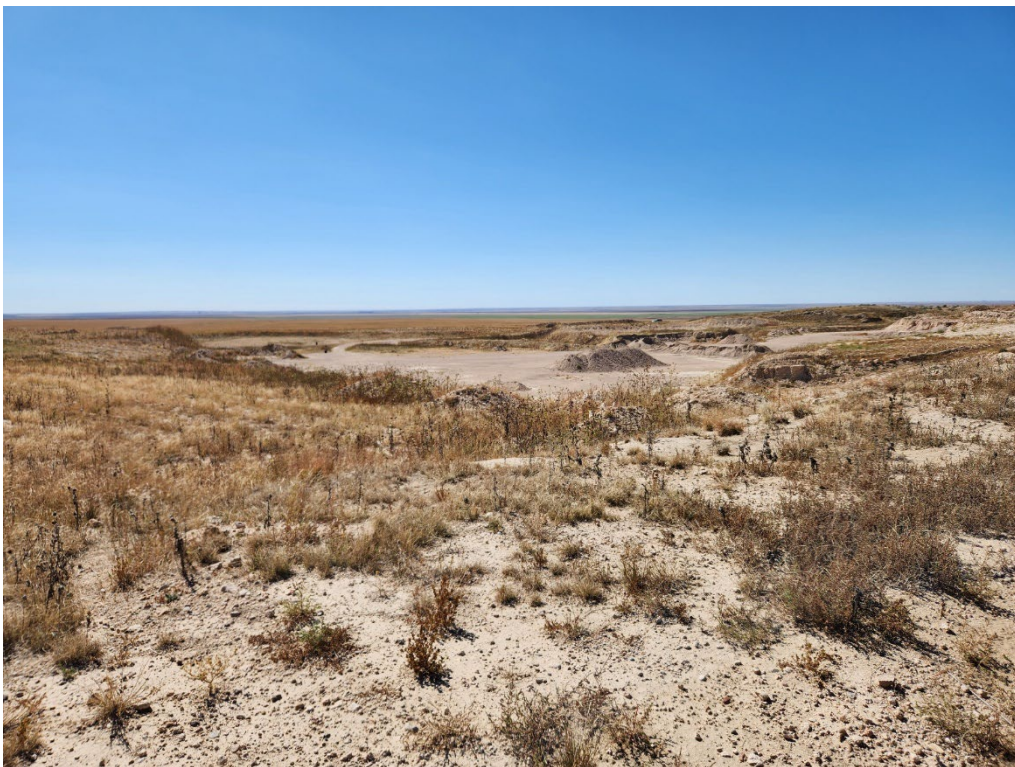
Photo 8. The mining pit from above, looking northwest.

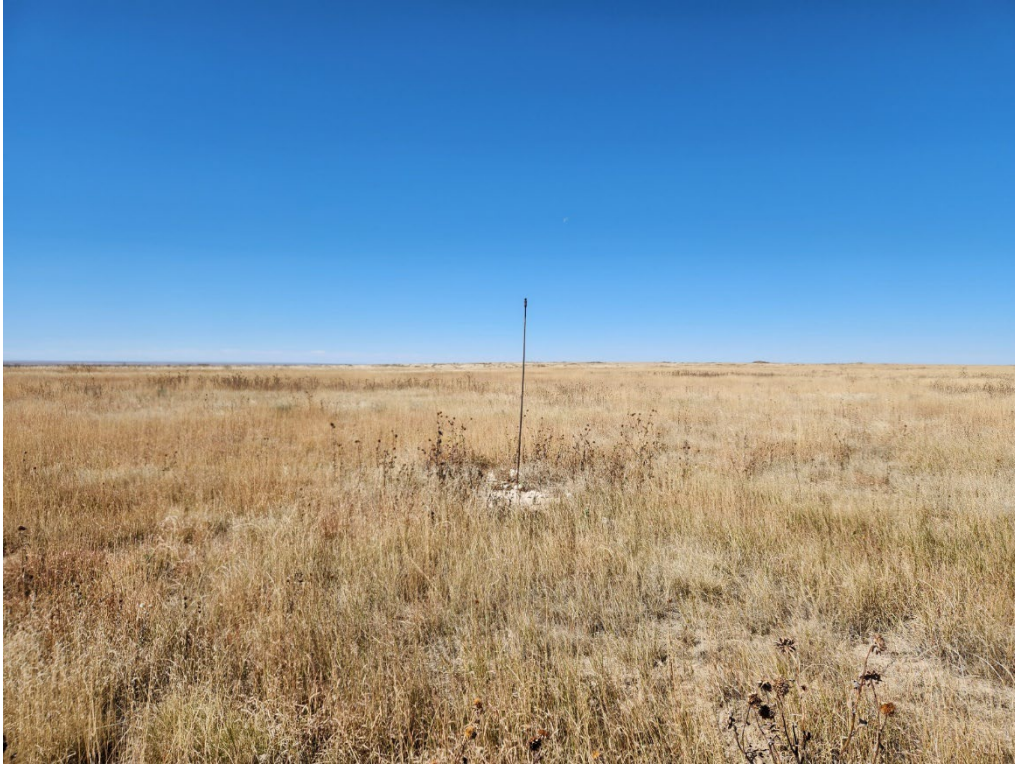
Photo 9. The permit boundary marker is located in the northwest corner of the mining pit, looking north.

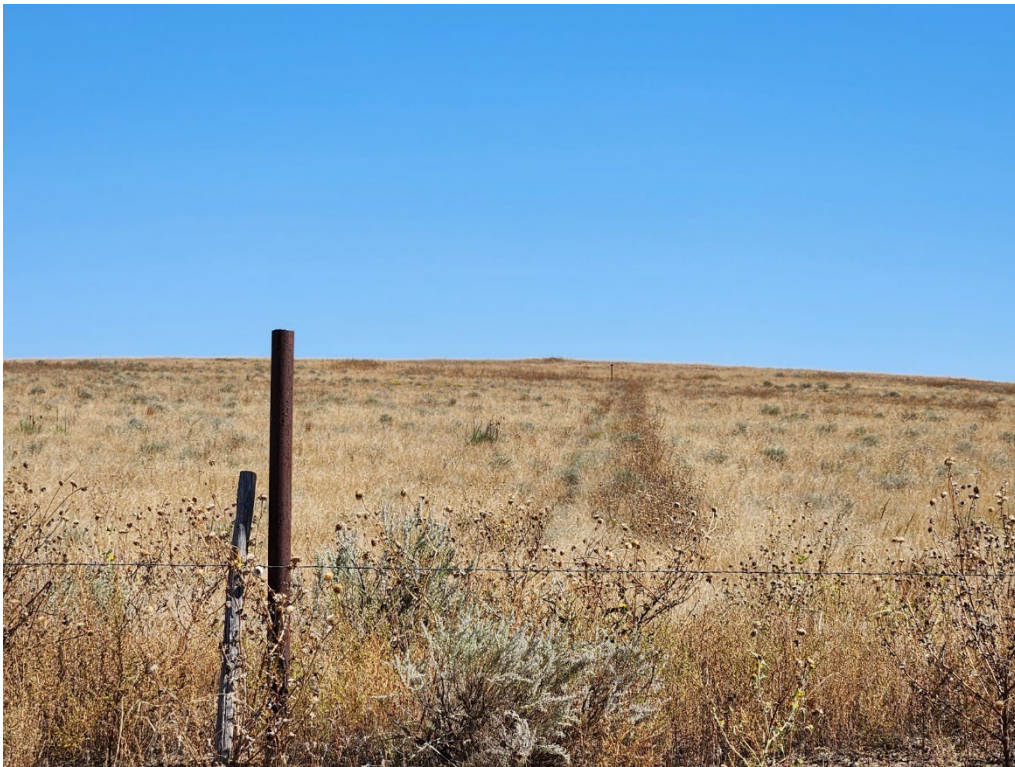
Photo 10. Permit boundary marker along the northern edge of the permit boundary, looking south, standing on Co Rd Z.

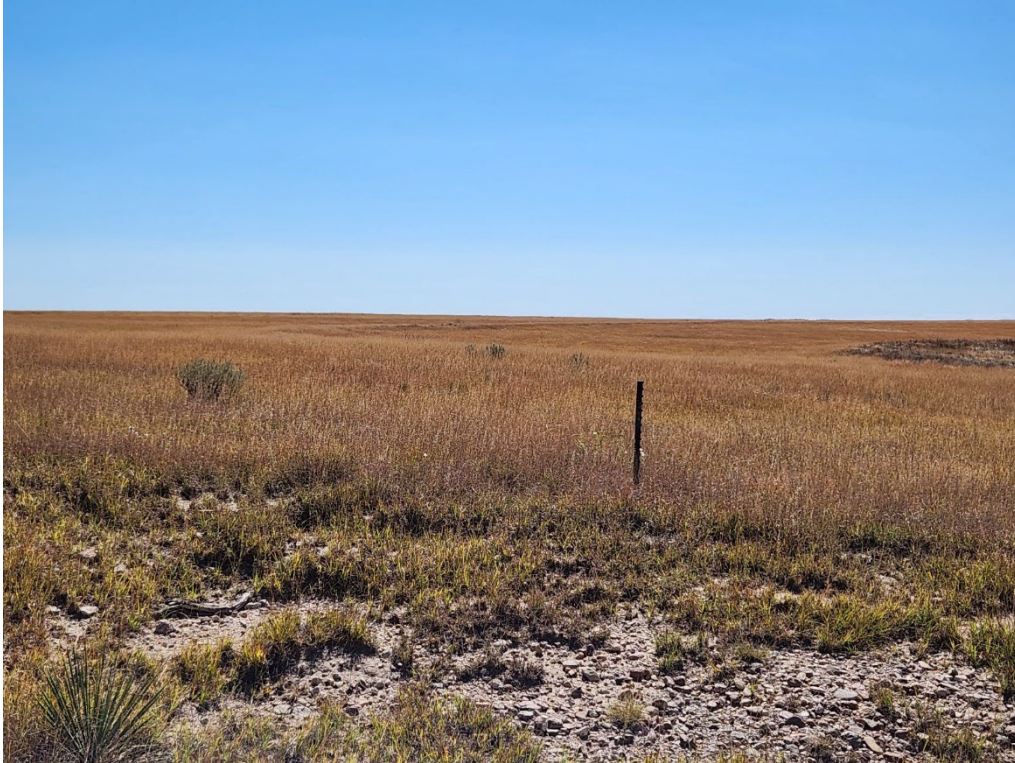
Photo 11. Permit boundary marker for the northeasternmost corner, looking south, standing on Co Rd Z.
