## Inspection Report, Foidel Creek Mine, C-1982-056

**PERMIT INFORMATION**

**INSPECTION INFORMATION**

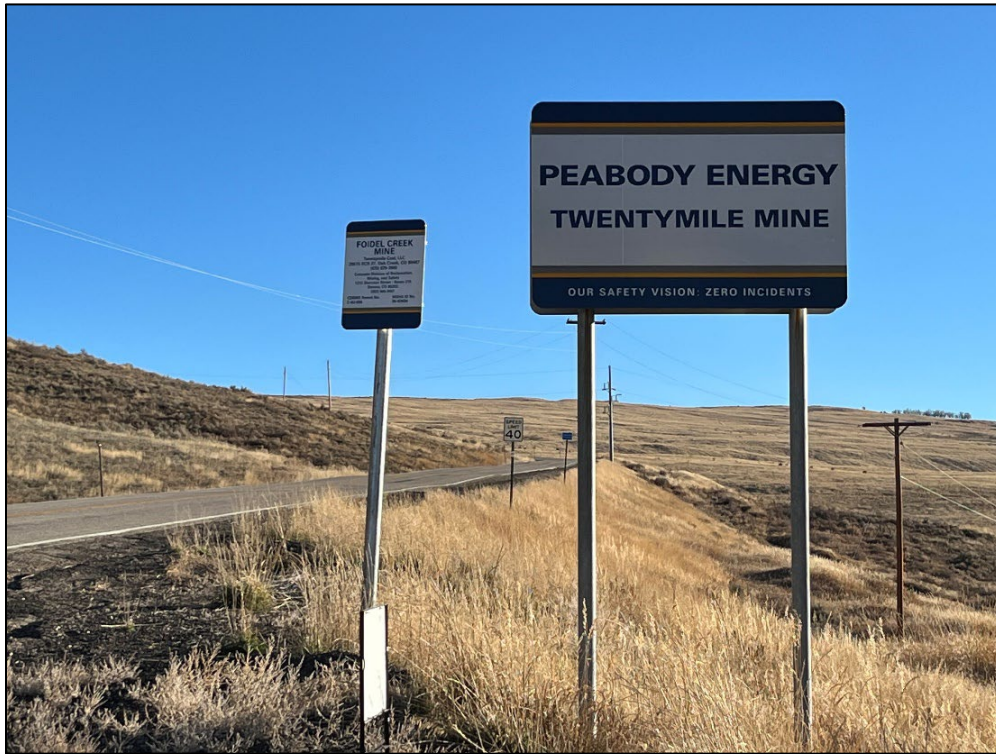
Appropriate mine identification signs were observed throughout the site (Photo 1). All information required for compliance was present on signs.

Photo 1: Mine identification sign located at the site entrance road.

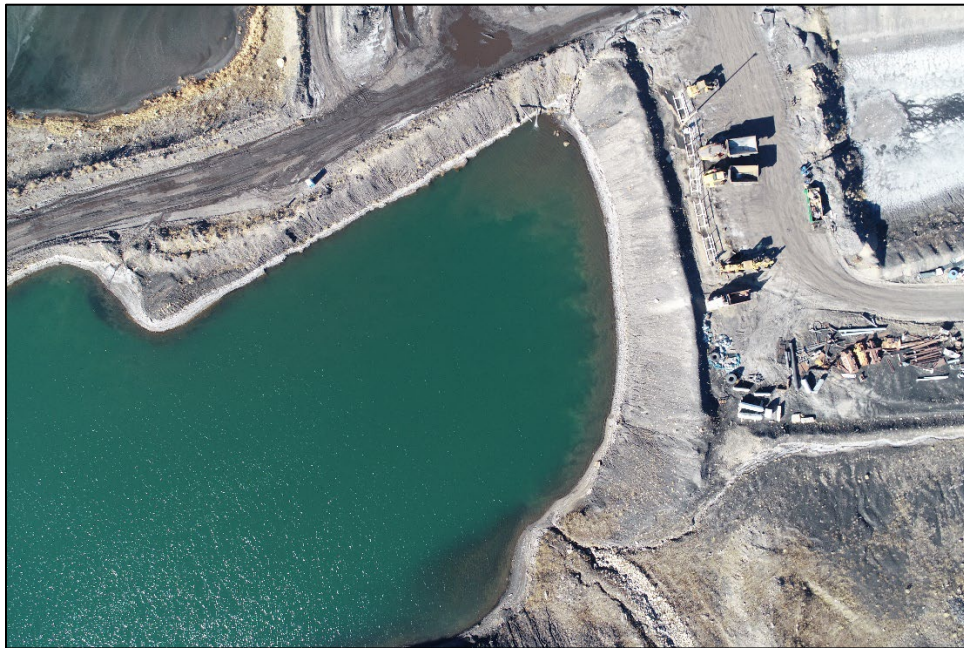
All ponds in the Main Facilities area, except Pond T, Pond F, Pond G, and the wastewater treatment ponds, were visible in the drone photographs. No problems with these features were observed. (Photos 2-6 and 9). All ponds have been cleaned out for the season.

Figure 2: Northeastern end of the Pit Pond.

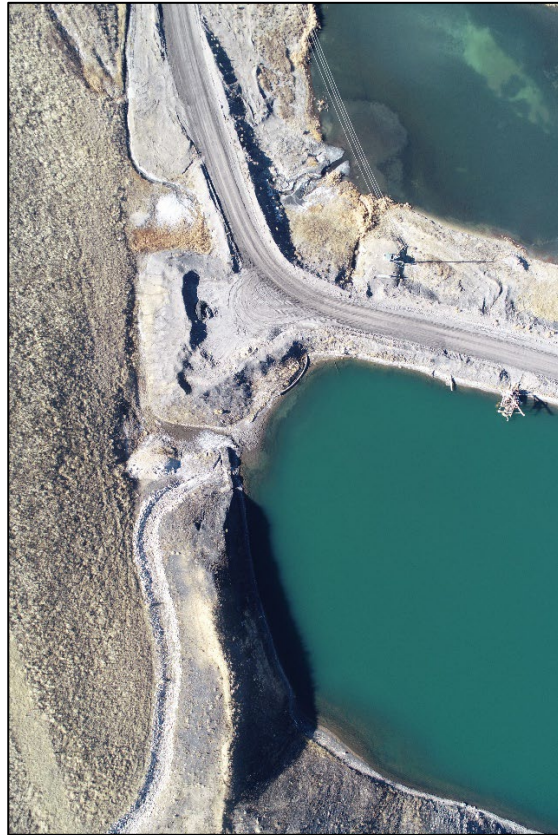
Figure 3: Southwestern end of Pond D and the Pit Pond.

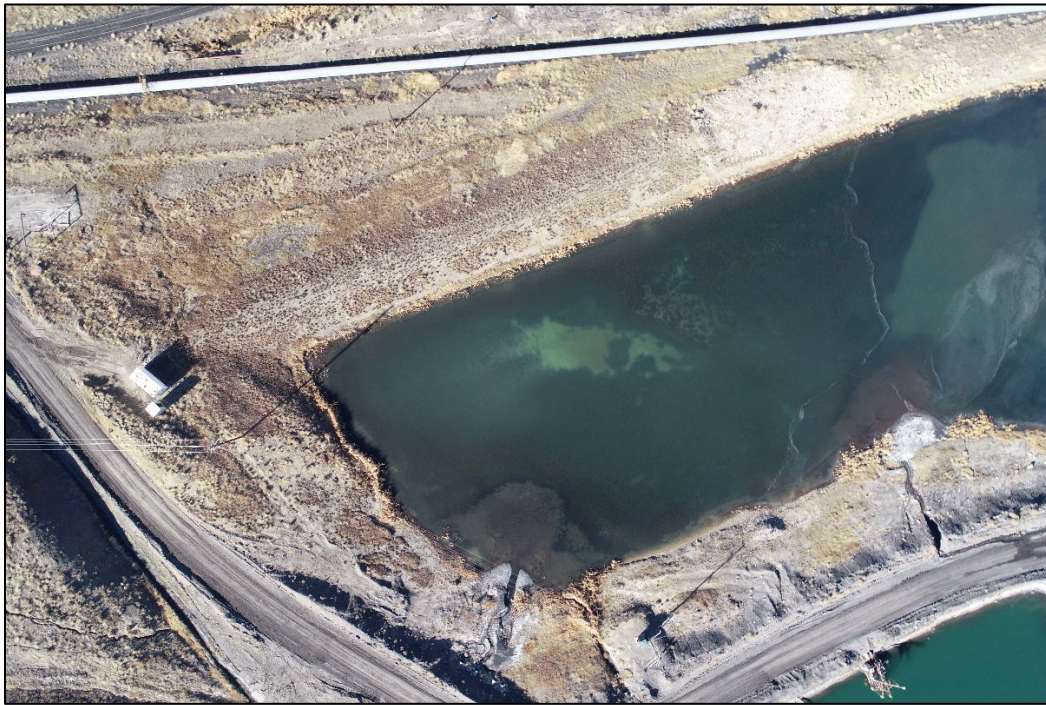
Figure 4: Northern extent of Pond D.

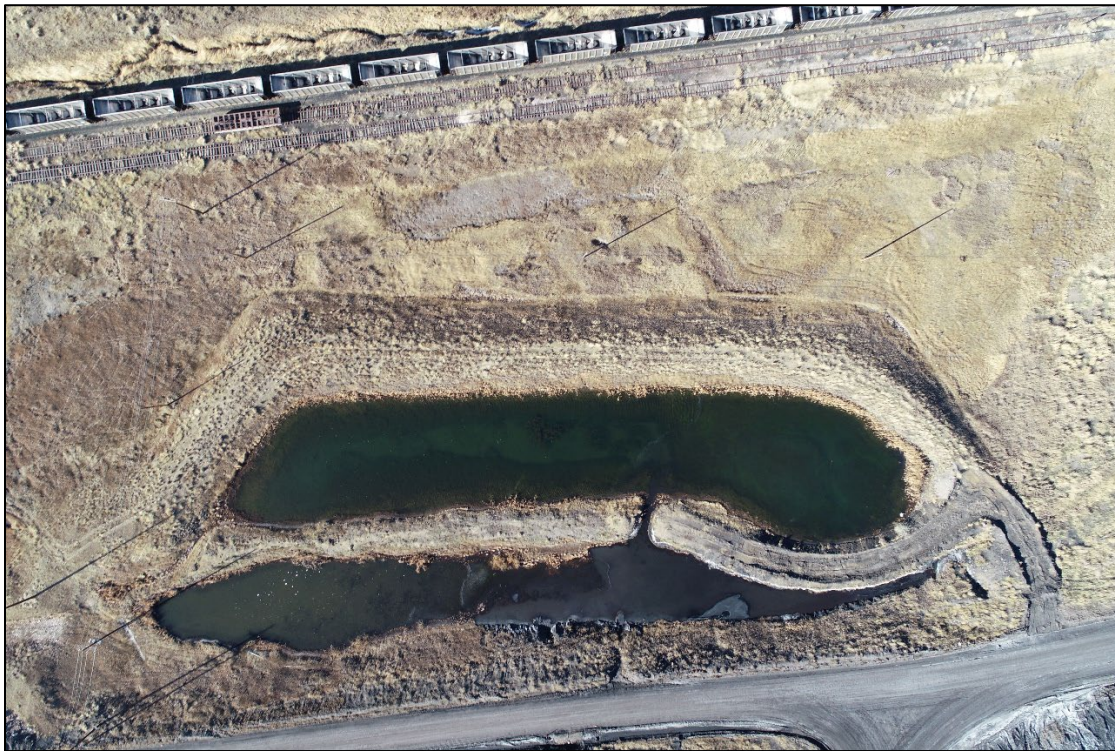
Figure 5: Double celled Pond E.

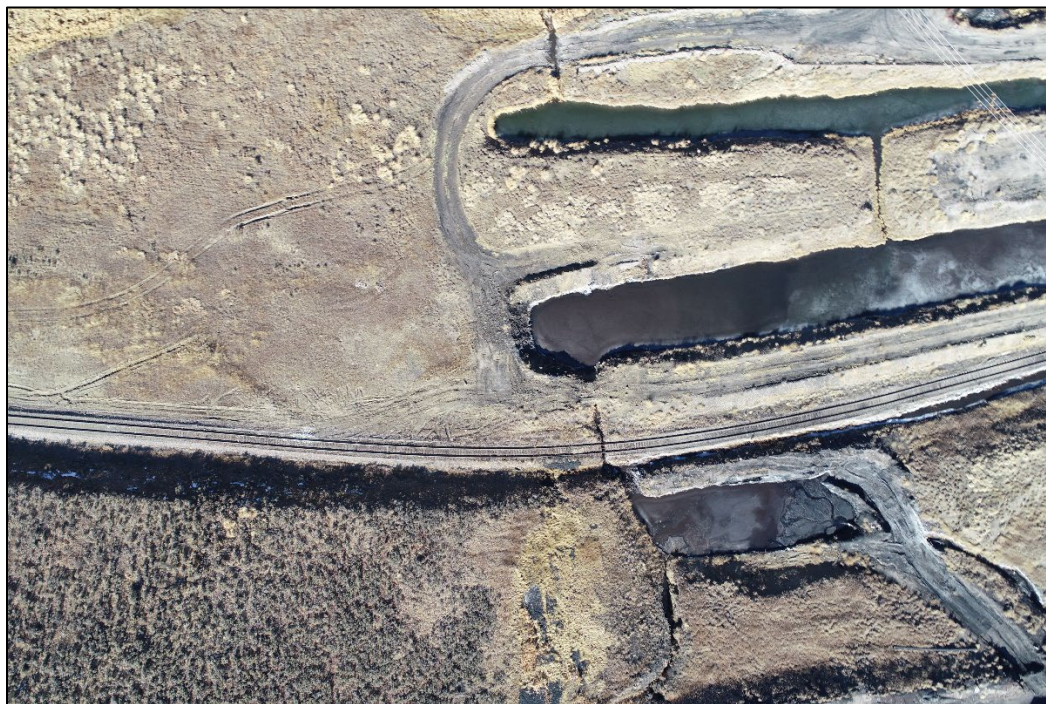
Figure 6: Double celled Ponds B and southern sump.

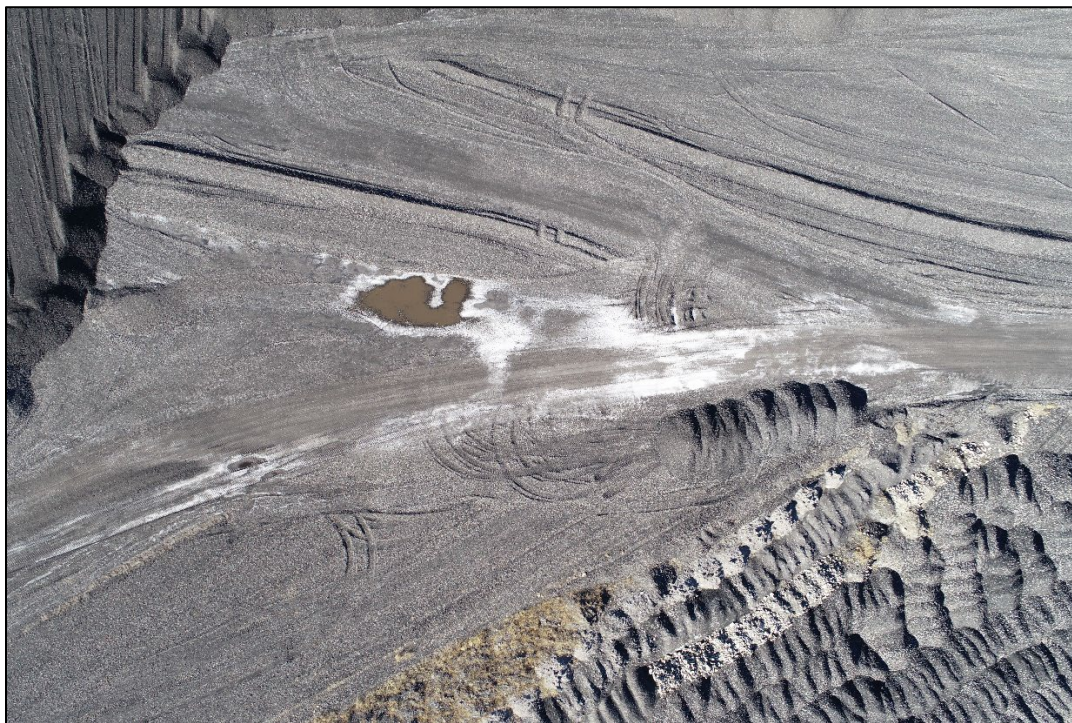
The refuse pile was inspected from above via the aerial. Trucks were actively hauling material at the time of inspection. A drag bar connected to a dozer is used to compact refuse material atop the pile and was seen on the western side of the pile (Photo 12). The pile appeared to be stable with a small amount of standing water visible on the eastern side of the pile (Photo 7). Construction of lift three is currently underway and will continue throughout the winter season as weather allows.

Figure 7: View atop the Refuse pile on the eastern side, a small amount of standing water is visible.

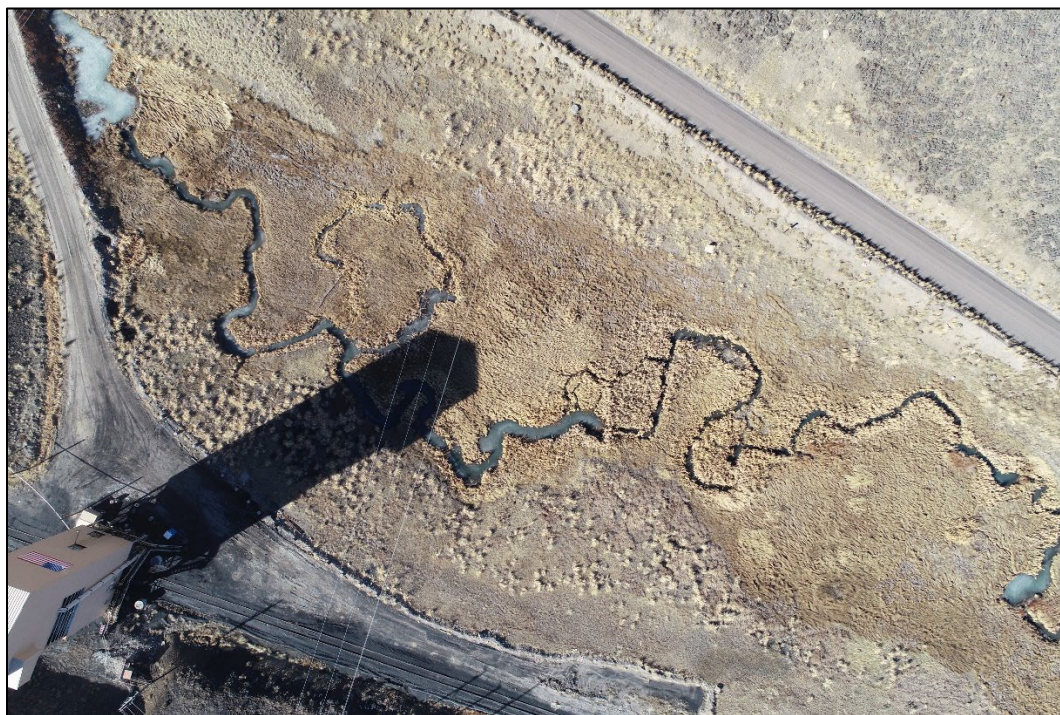
The buffer zone for Foidel Creek was being maintained in all areas, e.g. the Train Loadout area (Photo 8).

Figure 8: Train Loadout area and Foidel Creek.

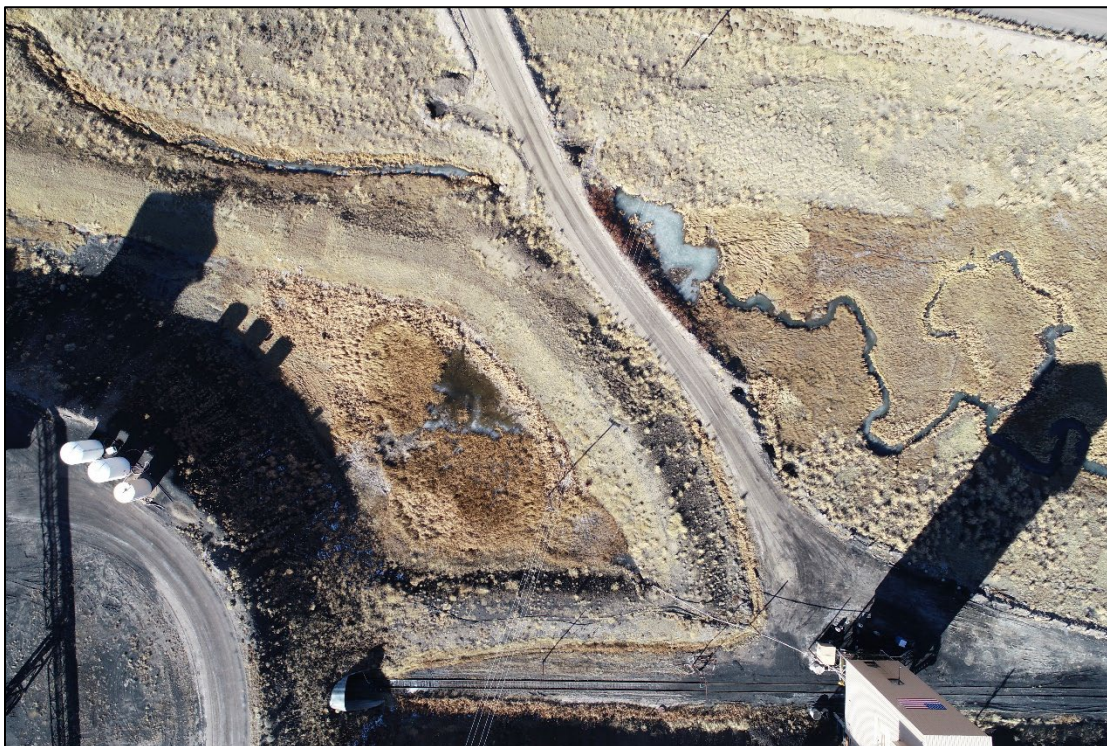
Figure 9: Pond C near the Train Loadout.

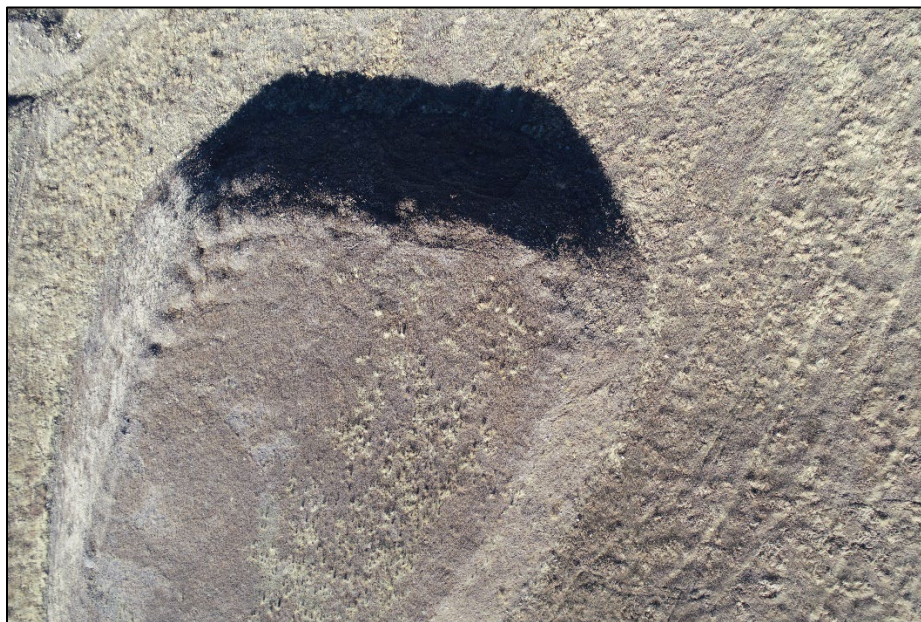
The two main topsoil piles to be used for reclaiming the refuse pile and main facilities area were visible in the drone photos. The piles appeared stable and vegetated (Photos 10 and 11).

Figure 10: Topsoil stockpile located to the northeast of the Refuse Pile.

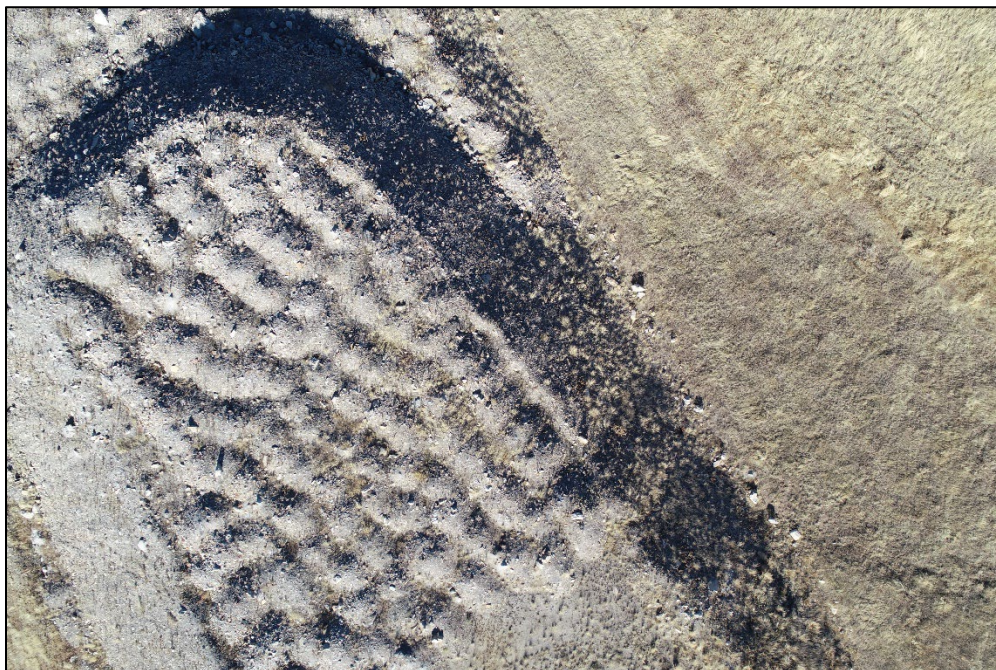
Figure 11: Topsoil stockpile located to the east of the Refuse Pile.

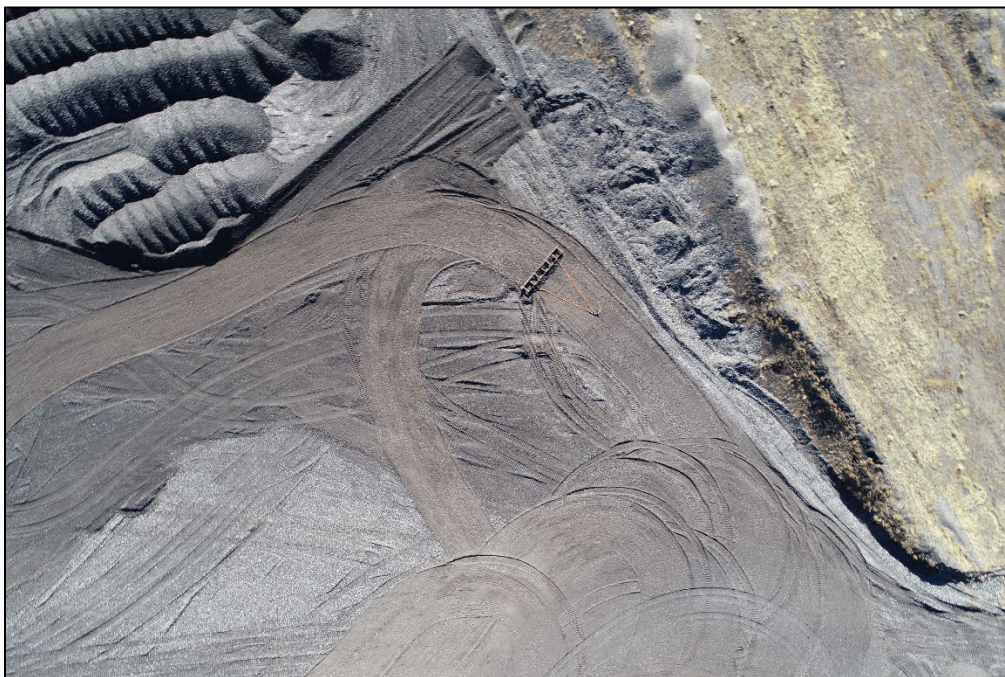
Figure 12: A drag bar is used to compact material on the Refuse Pile.

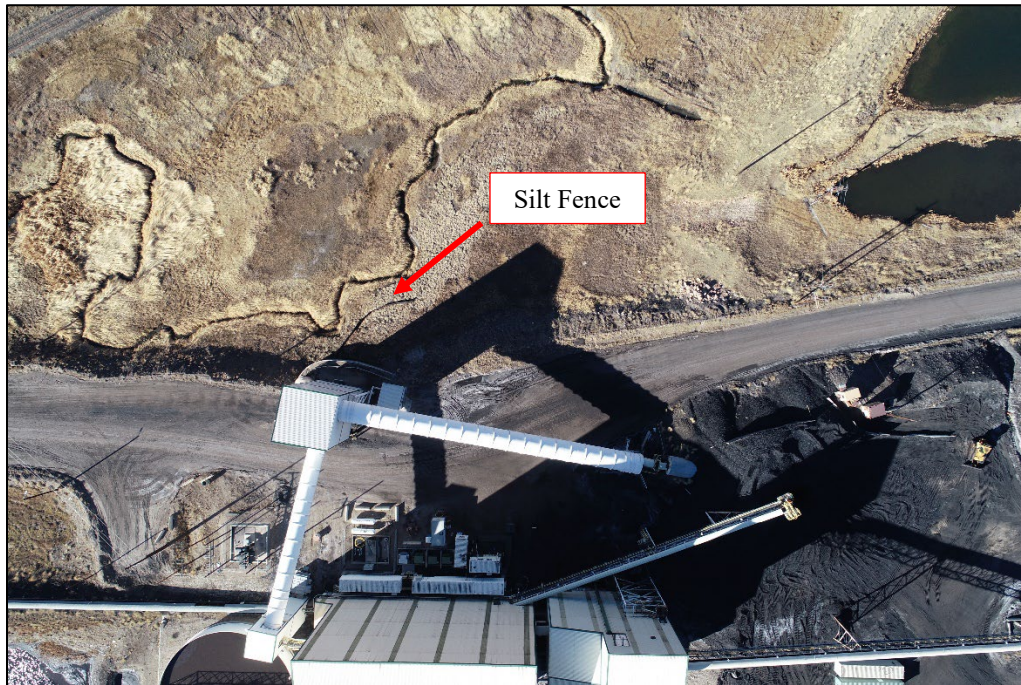
Recently placed BMPs at the stoker coal loadout facility were also noted to still be in place with no signs of erosion occurring around the newly sealed wash plant facility (Photo 12). These BMPs include a silt

fence, an additional sediment fence located on the western side of the stoker building, and hay bales located at the back of the stoker building.

Figure 12: Stoker Coal Loadout Facility and BMPS.
