Inspection Report, Peabody Sage Creek Mine, C-2009-087

PERMIT INFORMATION

INSPECTION INFORMATION

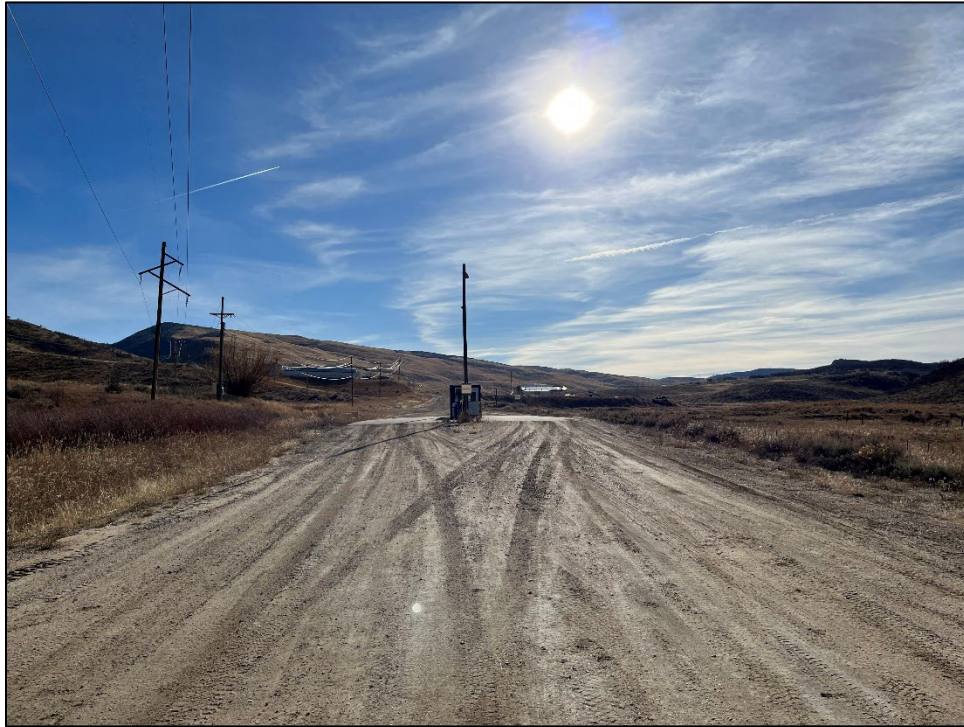
Mine identification markers were observed throughout the site. A scale, scale house, and office buildings are near the site entrance (Photo 1).

Photo 1: View south of the scale and scale house area.

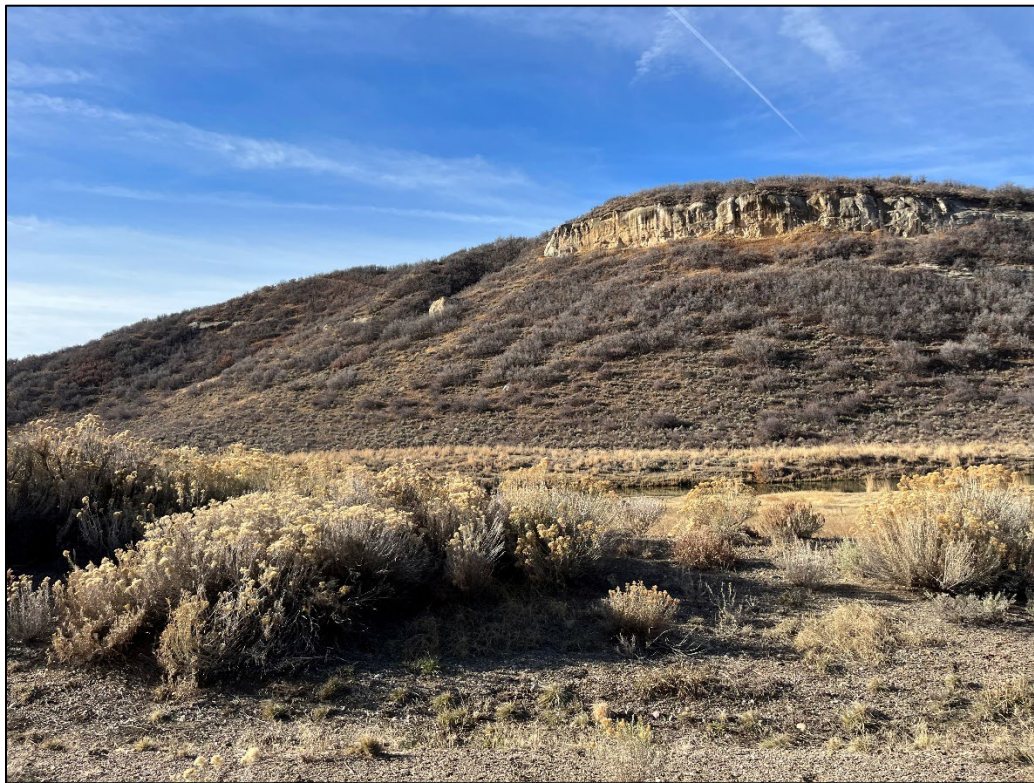
All ponds and sumps at the site were discharging at the time of inspection with no erosional features noted (Photos 2, 4, 5, 10, and 11). NPDES #7, located by the site’s main office buildings, was also discharging. However, the southeastern culvert of NPDES #7 needs repair (Photo 12). Flow was not completely blocked off from this point, but repair of the crushed culvert is required for full function. This has been added as a maintenance item. **Please inform the Division when the appropriate repairs have been completed.**

Photo 2: View west of Pond 003 near the site entrance.

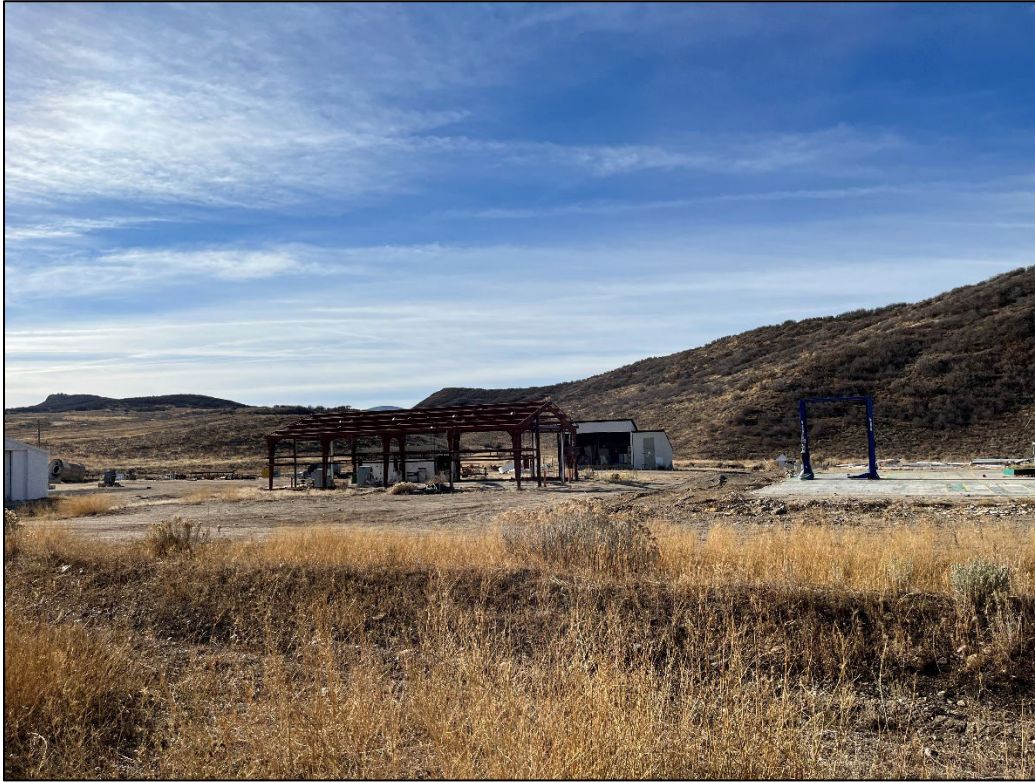
As this site is in temporary cessation, many of the on-site support facilities are unused. This includes storage buildings, a water tank located along Road B, and other unused storage areas (Photos 3 and 6). These areas remain organized and contained.

Photo 3: Storage area located along Haul Road B.

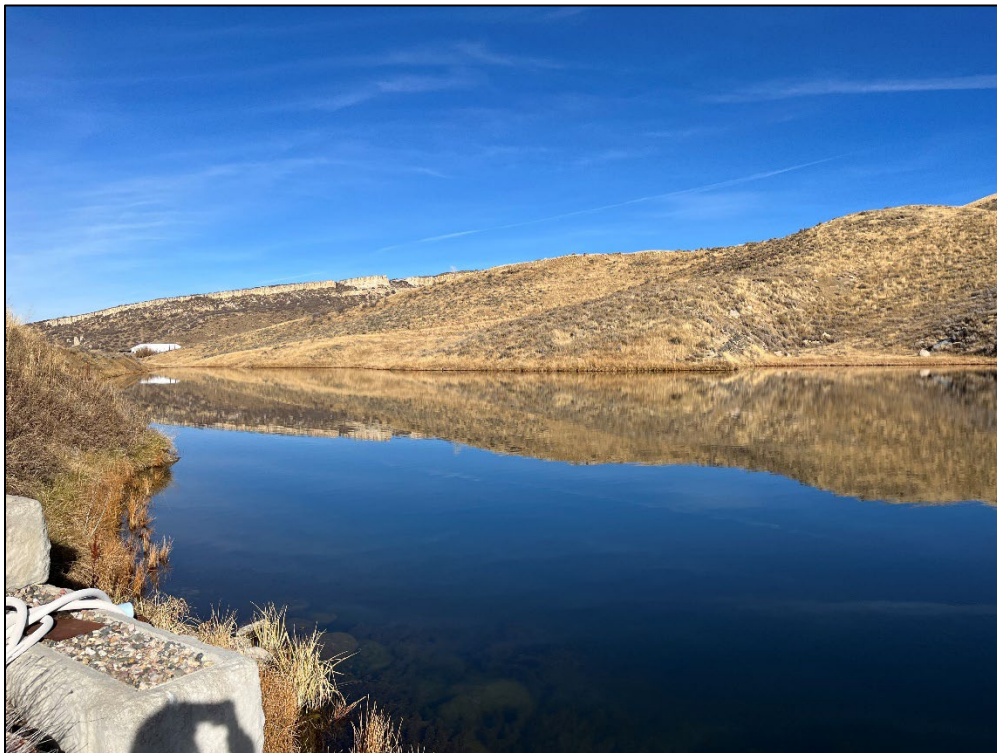
Photo 4: View north of Pond 002.

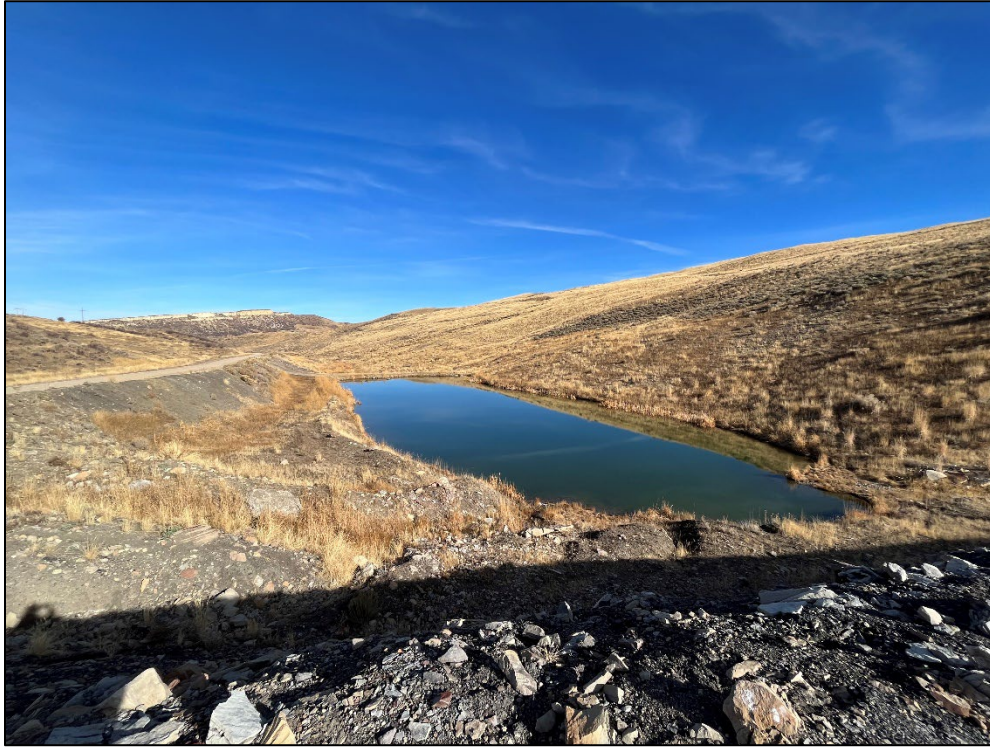
Photo 5: View north of the pond south of Pond 002 which acts as a sump for mine water.

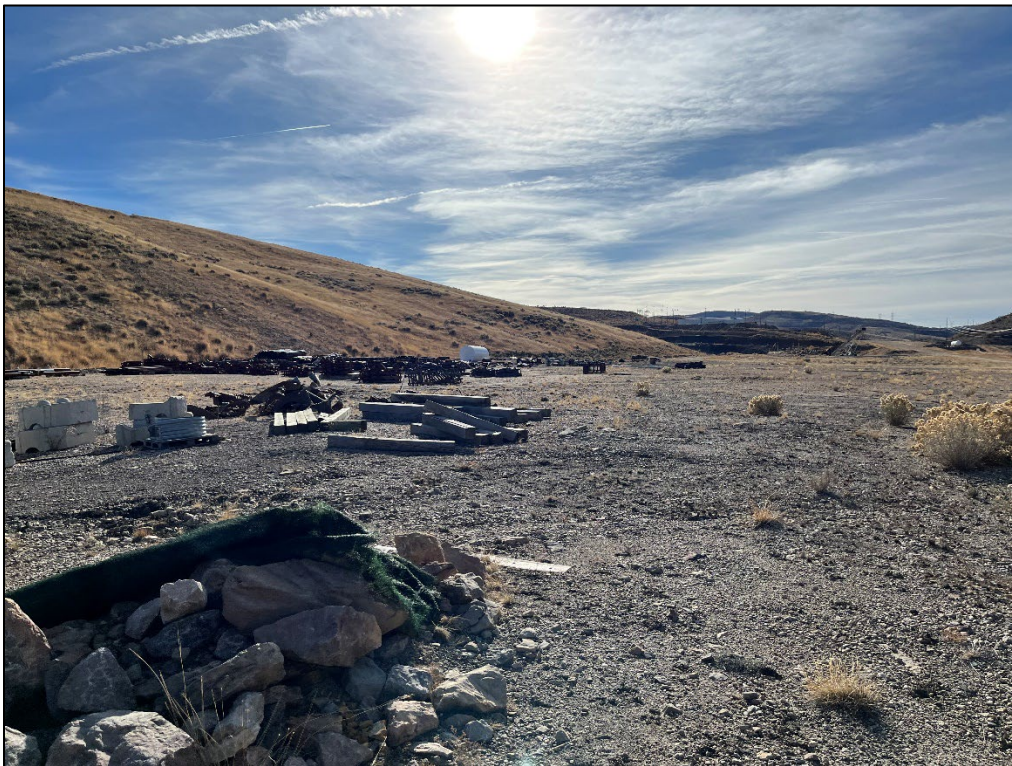
Photo 6: Storage area located to the south of the Pond 002 Pump Facility.

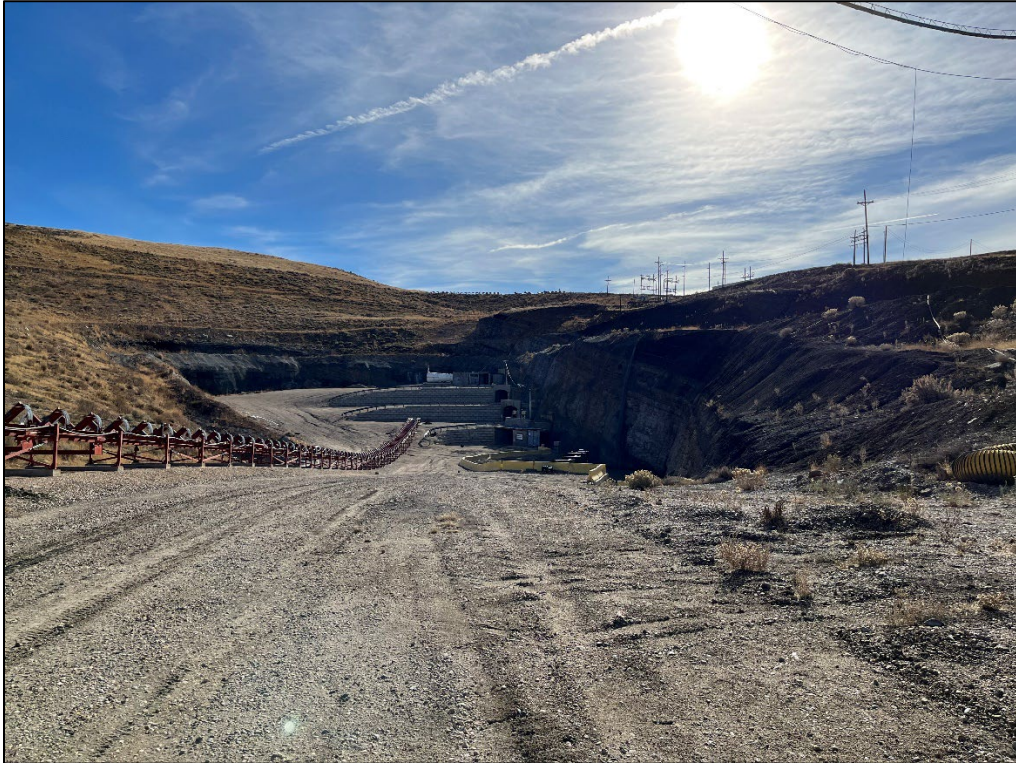
Mine water and snowmelt are no longer being continually pumped at the portal entrance (Photo 7). The float system which automatically turns on pumps when needed at the portal entry is still in place. A natural spring

Photo 7: View east of the portal entries.

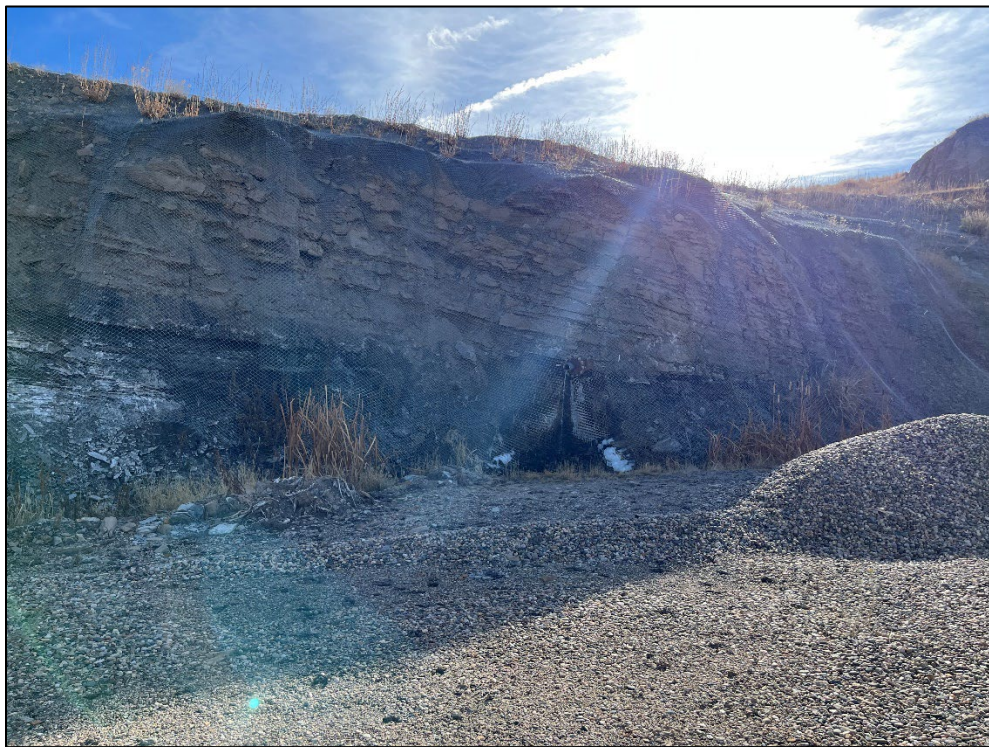
leeches from the walls at the portal entries. A series of ditches capture and carry this water to be pumped back out of the portal area (Photos 8 and 9).

Photo 8: A natural spring leeches from a wall at the portal entries. Ditches capture and carry this water to be pumped back out of the portal area.

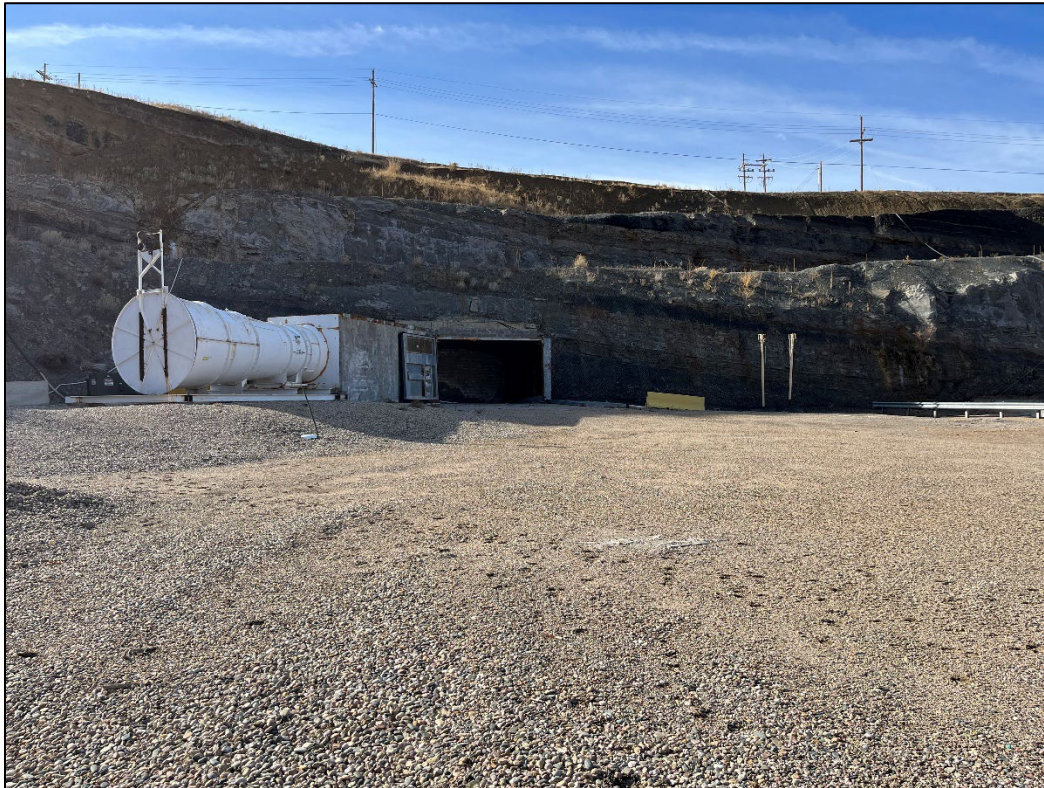
Photo 9: View south of one of three portal entries.

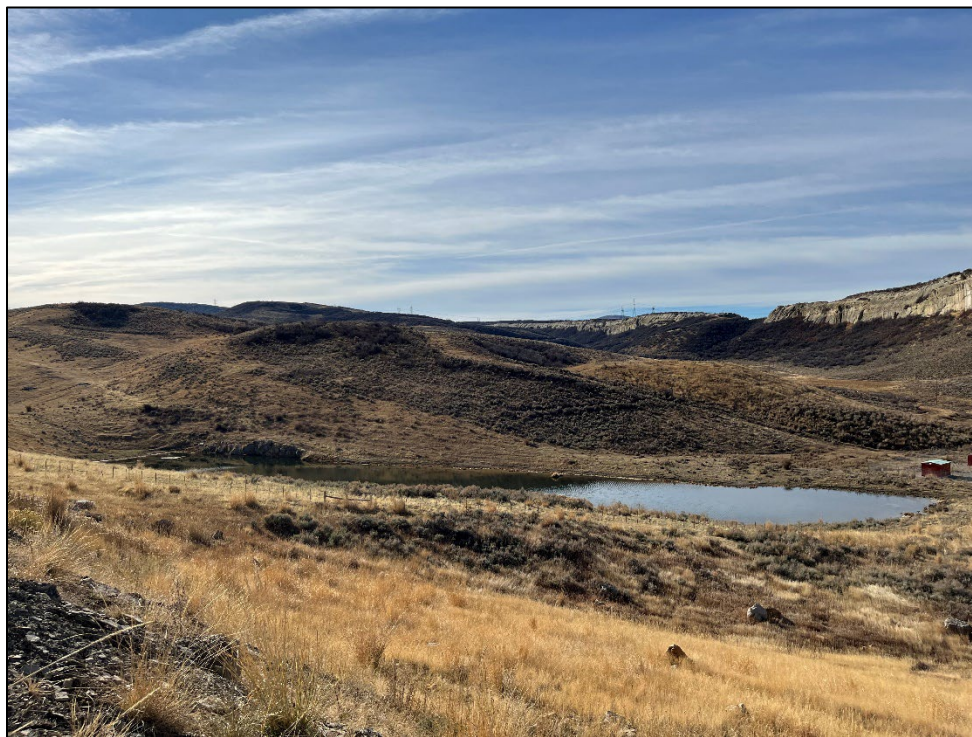
There is one large topsoil pile onsite located adjacent to the Pecoco pond (Photo 10). The pile appears stable, well vegetated and undisturbed. A small, orange flag marks this pile as topsoil.

Photo 10: View southwest of Pecoco Pond and Topsoil Pile A.

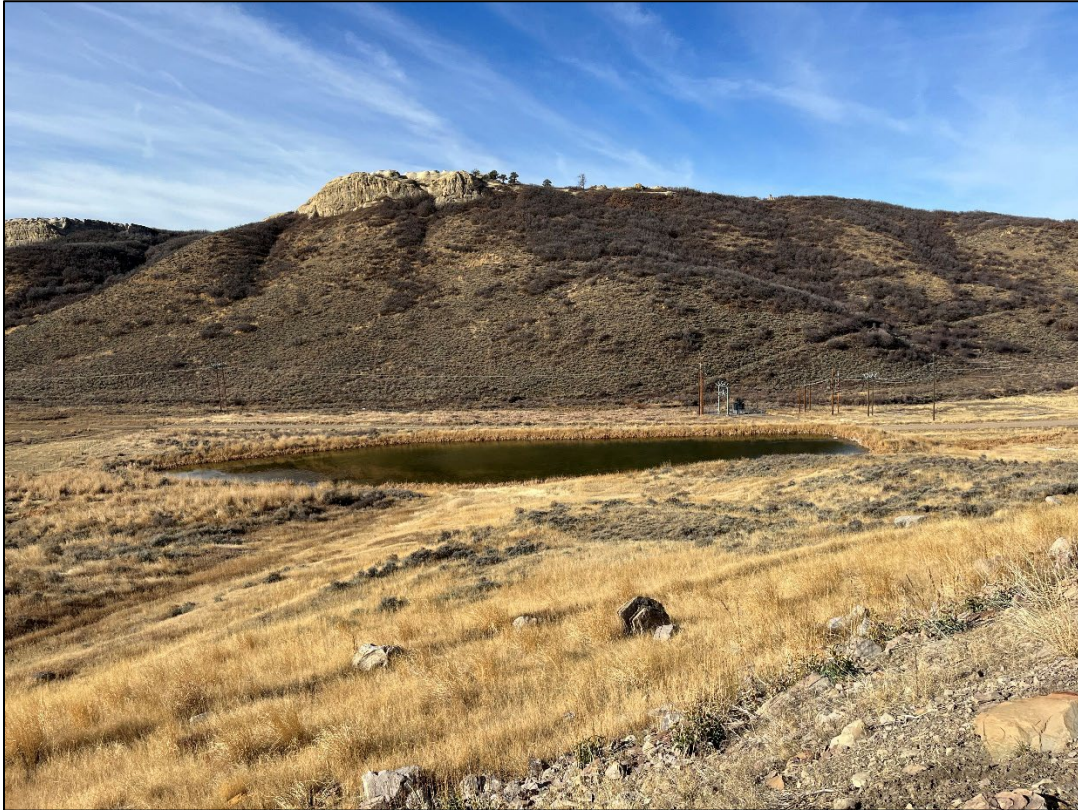
Photo 11: View west of the Upper Sump Area, located north of Pecoco Pond.

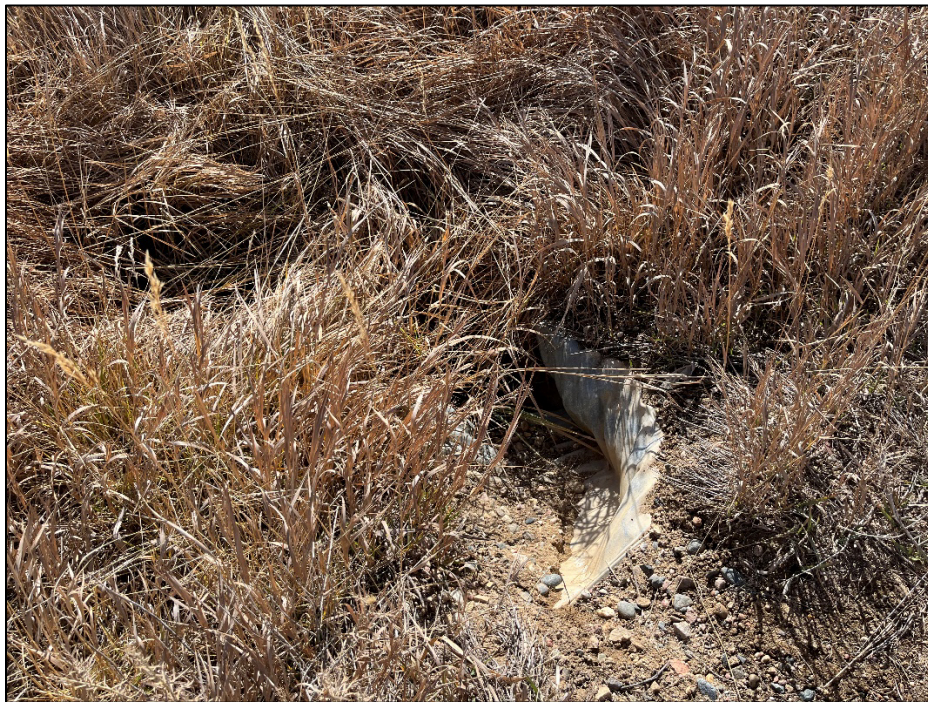
Photo 12: Crushed culvert at the southern end of the NPDES #7 discharge point, in need of repair.

- The ditch around the portal area needs to be cleared of cattail growth to maintain proper drainage in the area.
- Additional disturbance markers are recommended.
- Culvert at NPDES #7 needs to be repaired.
- Continue to monitor the pipe below Pond 002 for leakage or blowout.
