Permit Number: C-1981-012 Mine Name: New Elk Mine Operator: New Elk Coal Company, LLC Operator Address: Mr. Nick Mason 12250 Highway 12 Weston, CO 81091	County: Las Animas Operation Type: Underground Permit Status: Active Ownership: Private
Operator Representative Present: Nick Mason and John Terry	
Operator Representative Signature: (Field Issuance Only)

Inspection Start Date: November 16, 2023 Inspection Start Time: 12:30 Inspection End Date: November 17, 2023 Inspection End Time: 11:40		Inspection Type: Coal Complete Inspection Inspection Reason: Normal I&E Program Weather: Clear	
Joint Inspection Agency: None		Joint Inspection Contacts: 	
Post Inspection Agency: None		Post Inspection Contacts: 	
Inspector(s): Amber Gibson Jared Ebert	Inspector's Signature:

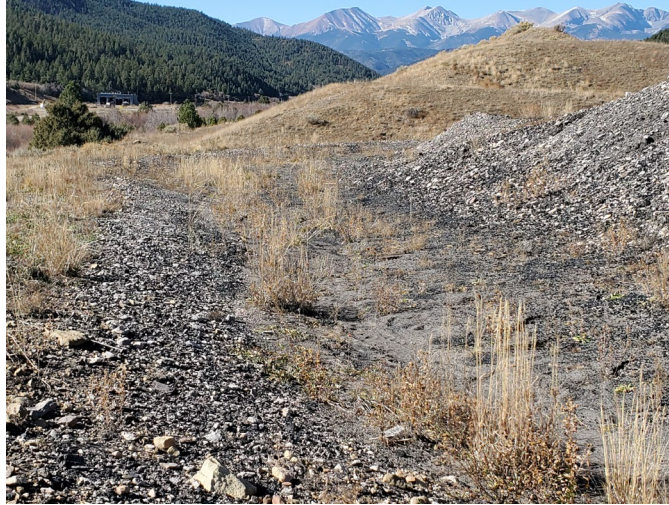
- The berm around the drying area on the west side of DWDA #2 is functioning at this time but has a lower profile than desired (Photo 1). **The berm will require additional material to be placed to raise the profile between the basin and the river to ensure prevention of untreated water leaving the basin and entering the river.** Besides the southwest corner, the rest of the berm along ditch D15 is stable and clear.

Photo 1: East side of the berm around D15 that needs to be raised.

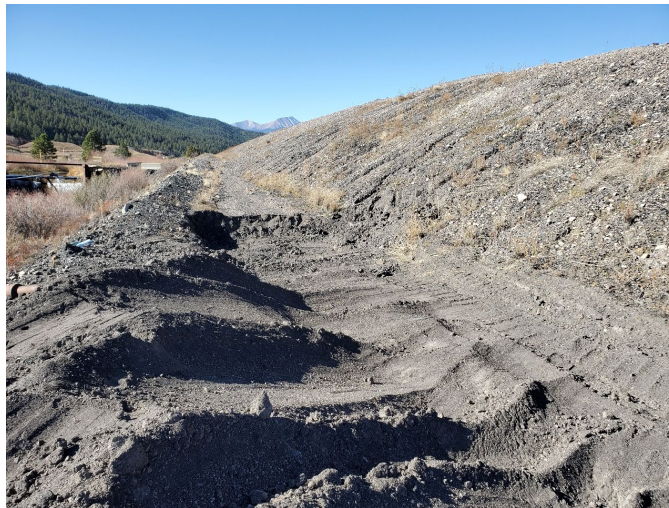
- The sediment basin at the east end of DWDA #2 was dry. The berm around the basin appeared to be stable and has recently been improved. The check dams in the ditches around the DWDA #2 have recently been cleaned, and ditch D14 leading into the basin has been cleaned as well (Photo 2). Culvert C13 was free of obstructions.

Photo 2: Recently cleaned west side of D15. Berm in good condition along majority of southern border of D15.

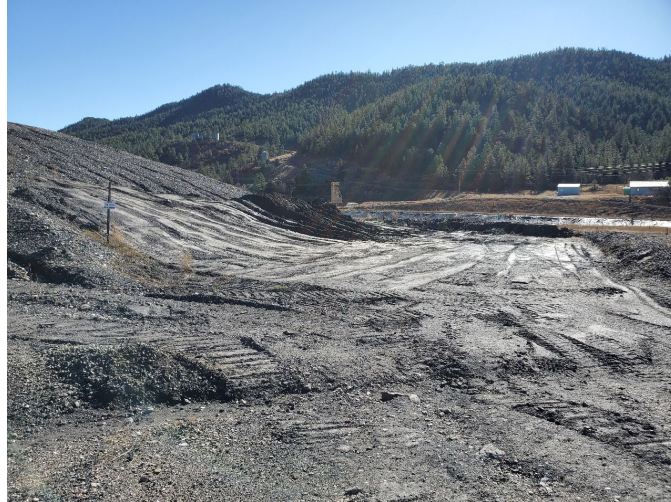
- D3, the ditch around DWDA #1, is clear and free of obstructions.
- Material from pond and ditch cleanings has recently been placed in the east side of DWDA #2. This area appears stable at this time.

Photo 3: East side of DWDA #2 where ditch and pond cleanings are placed to dry.

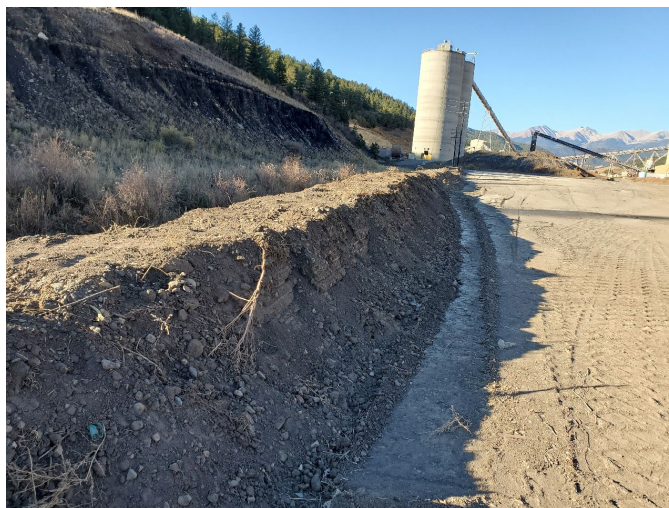
- Pond 007A contained a small amount of water but was not discharging. The emergency spillway was free of obstructions and the embankment appeared to be stable.
- Ditch D58, south of Pond 007A, is clear and free of obstructions. The berm has recently been built up along the haul road south of Pond 007A (Photo 4), within the S.A.E.

Photo 4: Operator's reconstructed the berm to be taller, wider, and more stable along the haul road south of Pond 007A within the S.A.E.

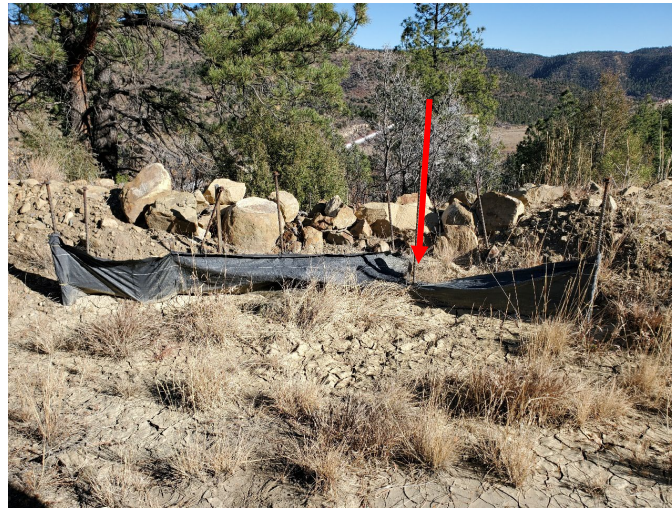
- The silt fences lining the north and south sides of the haul road within the S.A.E, near Pond 007A, were clear. The outfall, No. 010, was also free of obstructions.
- The S.A.Es along the southern portion of the permit, along Ditch D18, appeared stable. However, **the silt fence on the western border of the S.A.E. on the top of the hill needs to be repaired** (Photo 5).

Photo 5: Damaged silt fence on western side of S.A.E.

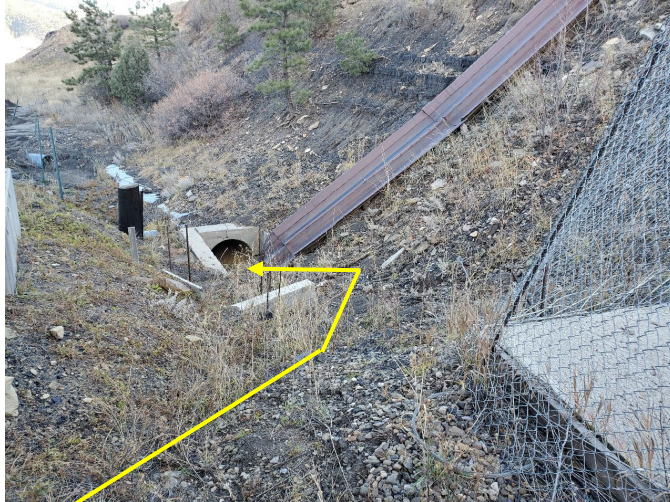
- Water from the processing areas that flow south under the fan near the East Portal, seem to not be separated from where water enters into the base of the clean water flume and into culvert C48 (Photo 6). **A berm, or another separating structure, needs to be constructed to divert processed water from entering C48.**

Photo 6: Arrow indicates water direction of water flowing south of the Fan, into the base of the Clean Water Flume, and into C48.

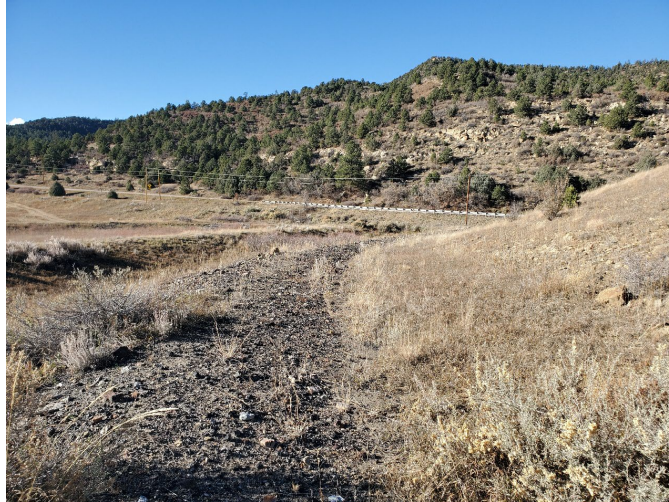
- Containment Area 1 contained some water. The embankment appeared to be stable.
- Pond 004A contains water, pumped from Pond 006A. Pond 004A is not discharging. The embankment appears stable. The emergency and primary spillways were clear of obstructions. The Division walked along ditch D3 on the west side of DWDA #1. D3 appeared to be stable and clear. However, the berm along the southeast corner of the DWDA #1 is getting low (Photo 7), and **needs to be built up again to prevent water from the processed area entering the basin between Pond 004A and DWDA#1.**

Photo 7: Berm along east side of DWDA #1.

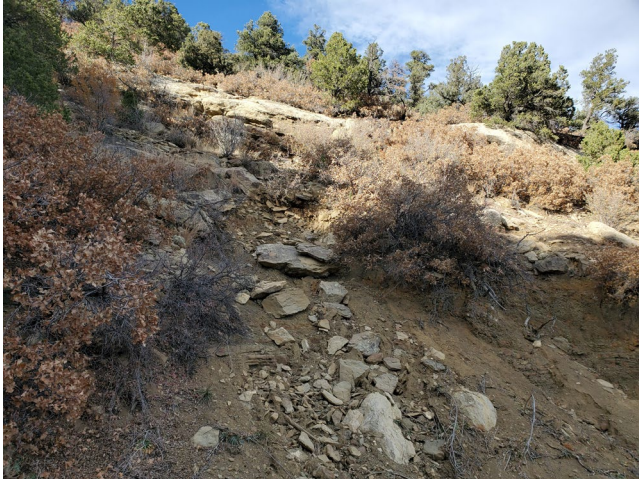
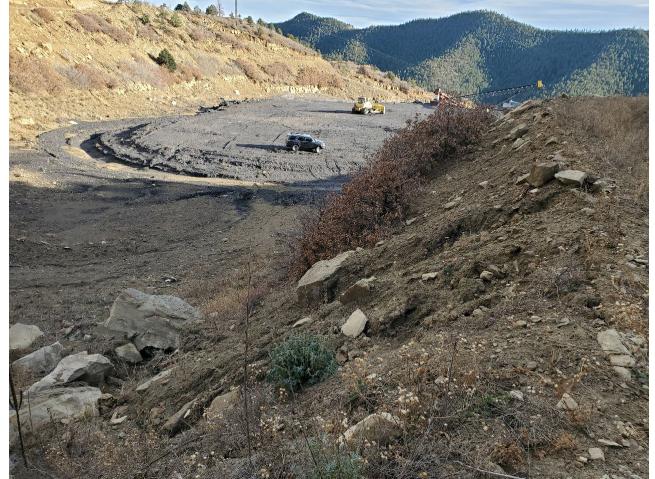
Photos 8A & 8B: Areas along D55 that are exhibiting failure. 8A – Slide up-slope of D55. 8B – Slide down-slope of D55.

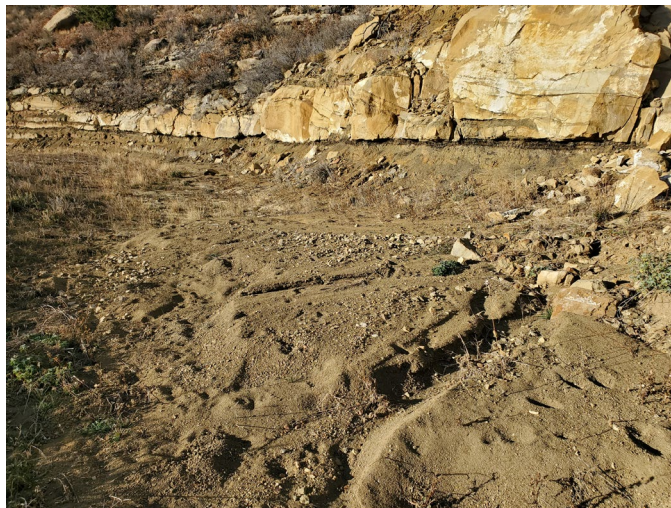
- The mine was idle at the time of the inspection. Therefore, the wash plant was not processing coal at the time of the inspection. The RDA appears to exhibit positive drainage at this time. The underdrains in the northeast and northwest corners appear to be clear of obstructions, and appear to be functioning as intended.
- The Division walked the extent of ditch D55 starting at the northeast corner of the RDA to the western extent of the ditch. There are a few areas up-slope and down-slope of D55 that **exhibit some slumping/sliding that need to be stabilized** (Photo 8A&B) and a few areas within D55 where **sediment has accumulated in the ditch and needs to be removed** (Photo 9). However, most of the ditch is clear of debris and appears to be functional.

Photo 9: Sediment accumulating in D55.

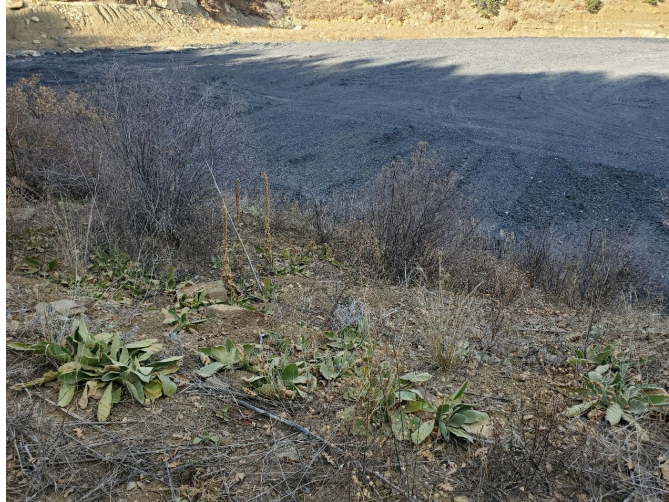
- The state listed noxious weed Mullein was present in small quantities within D55. A higher concentration was located in the northeast corner of D55 (Photo 10). **The Operator shall treat these areas with the approved weed control measures.**

Photo 10: Mullein within and downslope of D55.

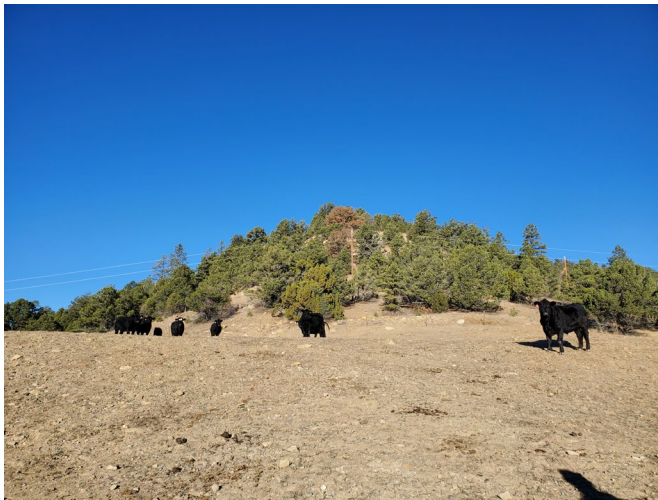
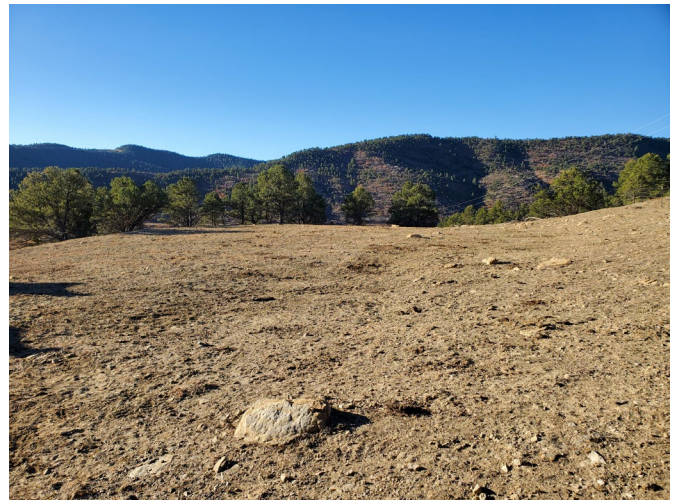
- The former Golden Eagle ventilation shaft area has been grazed. The grazing and cattle occupancy at the vent shaft area have significantly impacted the revegetation reclamation efforts within this area (Photos 11A&B). The Operator may need to re-vegetate this area prior to consideration of its release.

Photo 11A&B: Grazed and destroyed Golden Eagle ventilation area.

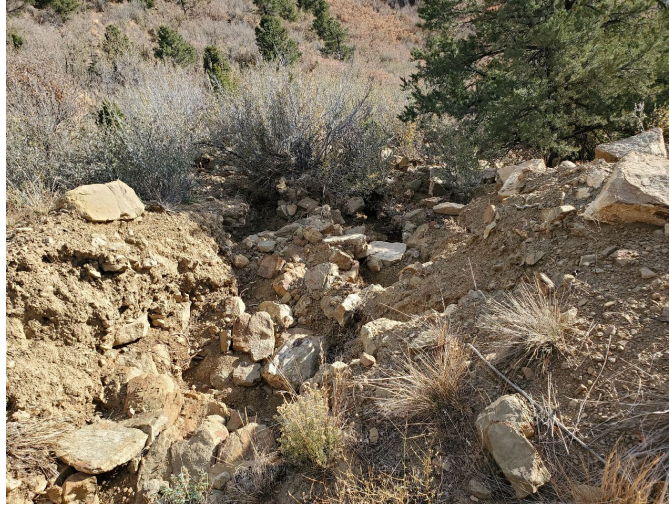
- At the western extent of D55, debris has fallen within the ditch (Photo 12). The slope within this ditch, leading down, has started to slide. **The ditch and slope need to be repaired and stabilized.**

Photo 12: Debris sliding down D55 towards the RDA area.

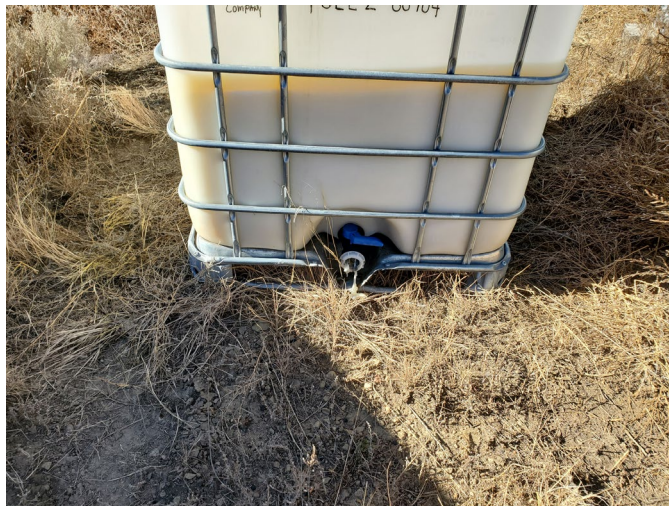
- The old equipment and debris that was located in the yard area around the C&W Train Shop is being salvaged, and the berm separating the yard from the Purgatoire River is stable.
- The Portable Explosives and Chemical Storage area was overall stable. However, the Division observed leaking from one of the tanks (Photo 13). **The Operator stated that they will either repair or replace this tank.**

Photo 13: Single tank with noticeable leak.

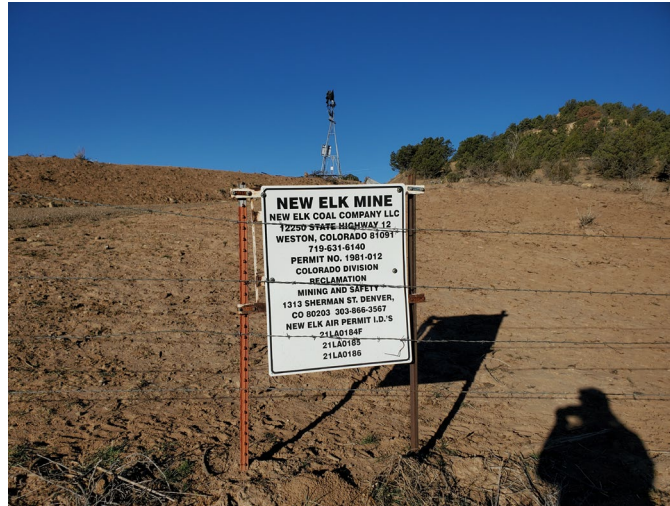
- A mine sign was also posted at the entrance to the Golden Eagle ventilation shaft area (Photo 14).

Photo 14: Mine sign posted at entrance to Golden Eagle ventilation shaft area.

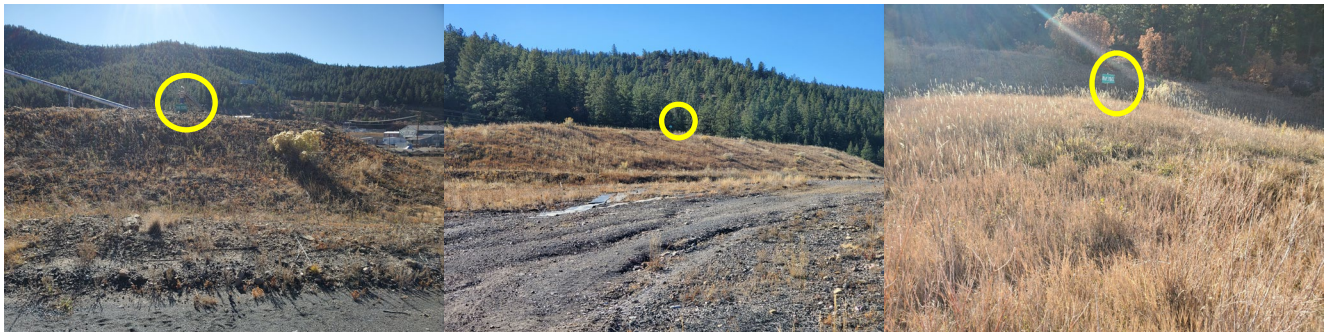
- The three topsoil piles were segregated, vegetated, and were marked with signs pursuant to Rule 4.02.7. The topsoil piles appeared to be stable at this time (Photo 15A, B, & C).

Photo 15A, B, & C: Vegetated and stable topsoil piles. Signs displaying “Topsoil” circled in yellow.
