**MINERALS PROGRAM INSPECTION REPORT**  
**PHONE: (303) 866-3567**

| <b>MINE NAME:</b><br>Climax Mine | <b>MINE/PROSPECTING ID#:</b><br>M-1977-493 | <b>MINERAL:</b><br>Molybdenum | <b>COUNTY:</b><br>Lake, Summit |
| <b>INSPECTION TYPE:</b><br>Monitoring | <b>WEATHER:</b> Clear | <b>INSP. DATE:</b><br>November 15, 2023 | <b>INSP. TIME:</b><br>10:03 |

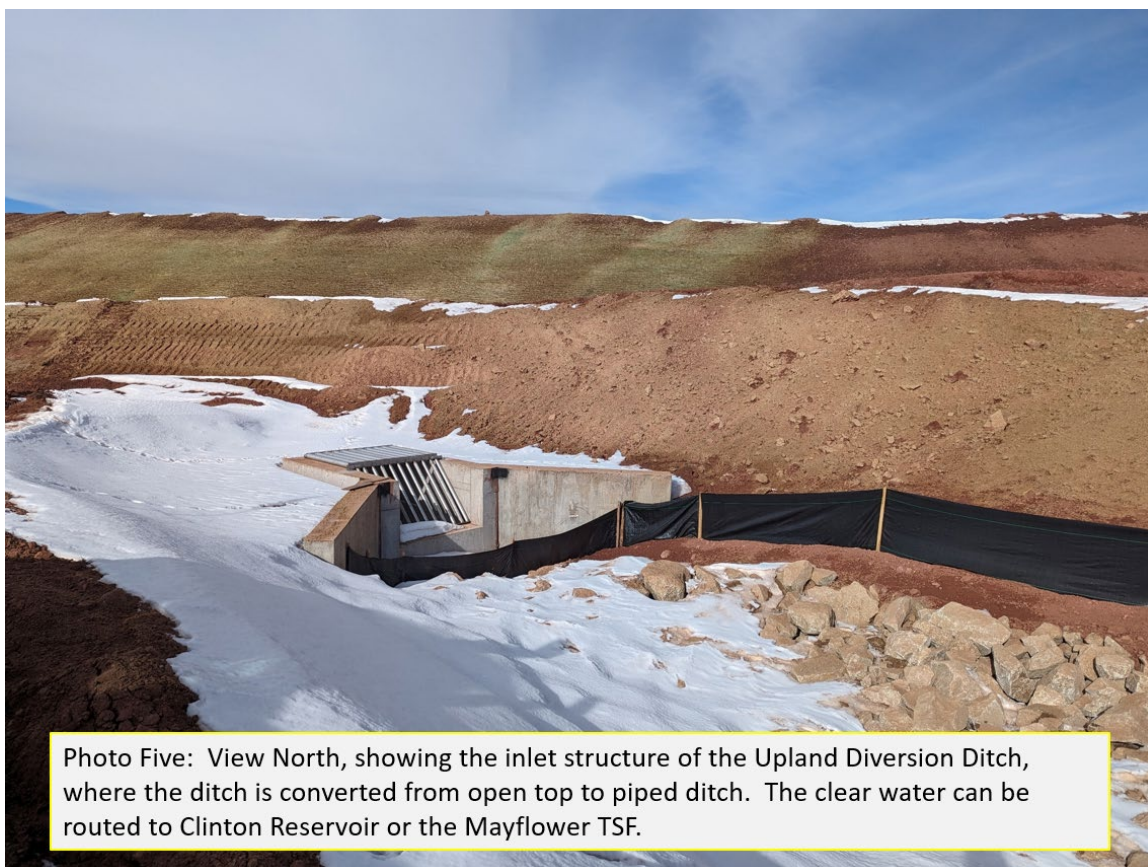
Along the up gradient side of the facility the Clear Water Ditch has been installed. The Clear Water Ditch consists of open top, rock lined ditch as well as covered pipe. The conversion point from open top ditch to pipe can be seen in Photo Five. The inlet structure to the pipe is free from debris and able to function as designed. The open top ditch portion, shown in Photo Six, is clear from obstruction and armored with rip rap to control erosion. The ditch is in excellent condition and no issues were noted along the entire observed length.

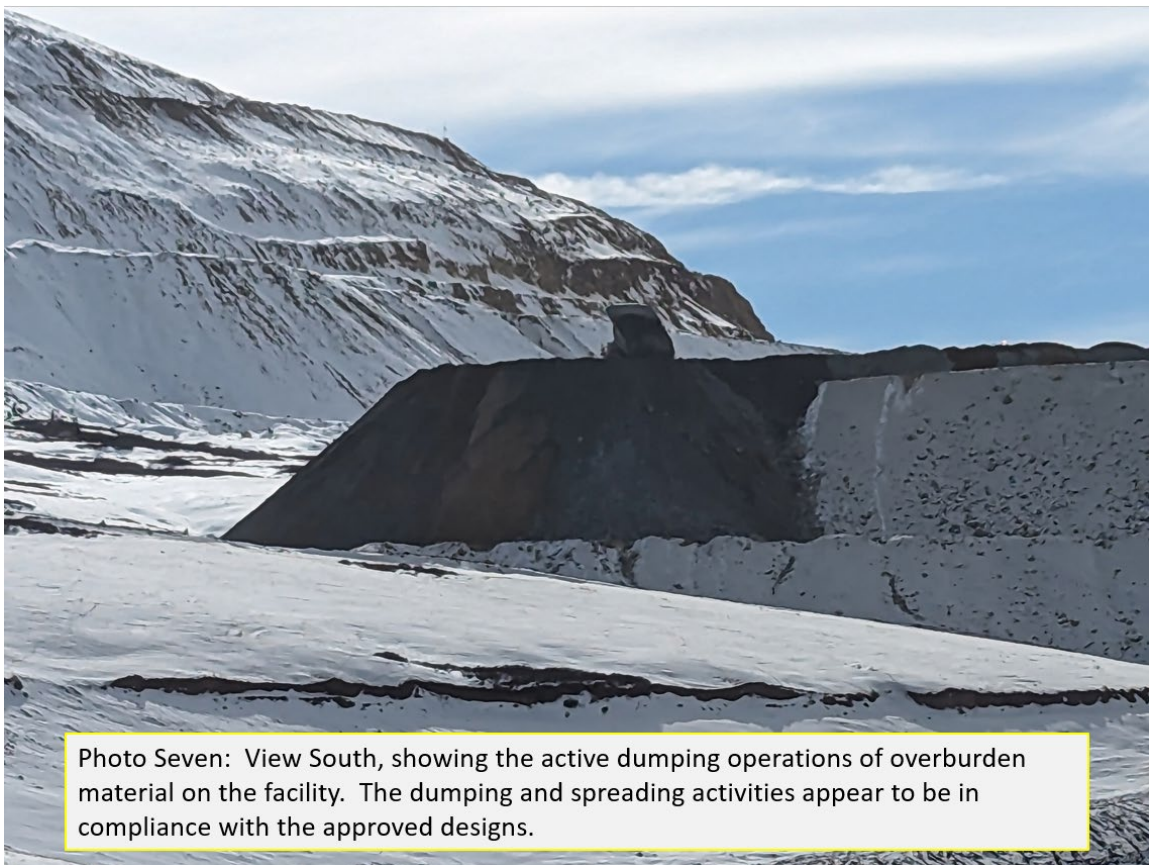
At the time of the inspection, overburden material was actively being dumped and spread in the active area of the facility. Active dumping operations can be seen in Photo Seven. The dumping and spreading appears consistent with the approved plan, and the current extent of the overburden material is in excellent condition. No evidence of settling, slumping or erosion along the out slopes was noted. The out slopes and current extent of the facility can be seen in Photo Eight.

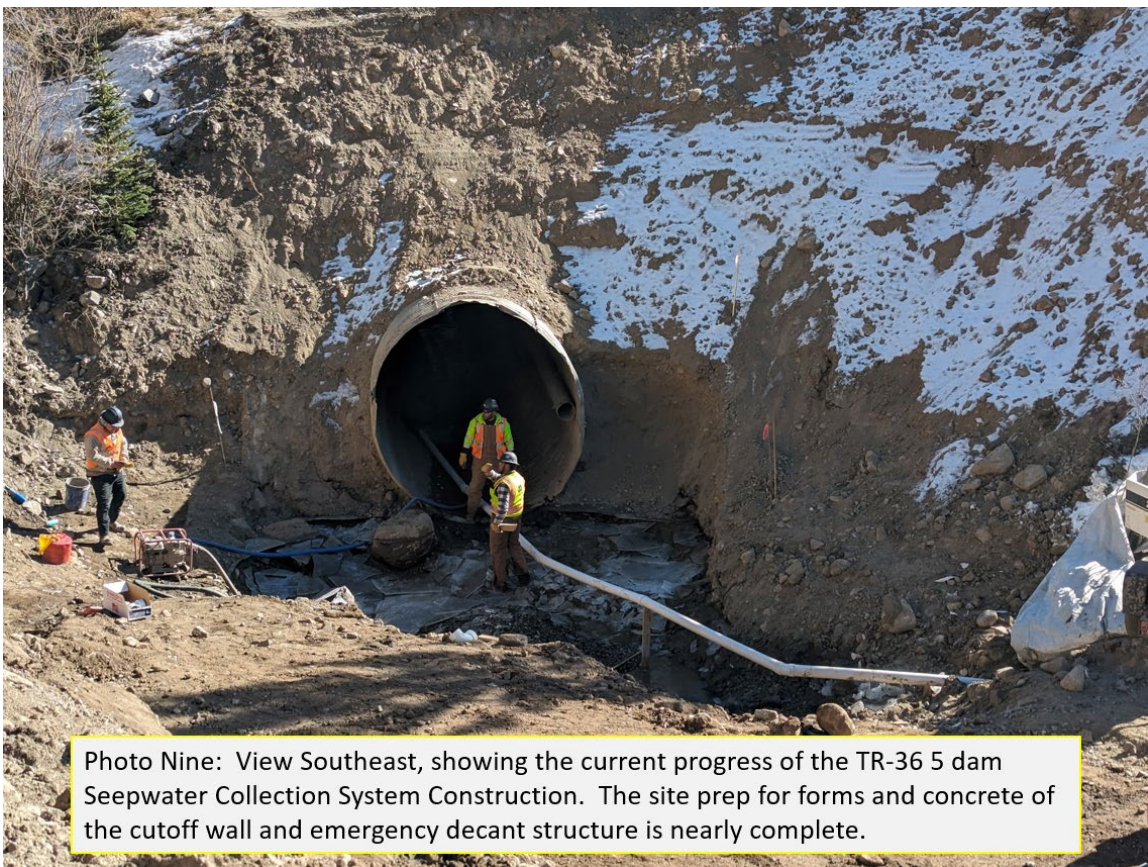
Construction of the recently approved TR-36, 5 dam Seepwater Collection System has begun. At the time of the inspection the main area of focus was site prep and excavation for the concrete cutoff wall and emergency decant structure. This area can be seen in Photo Nine. On site discussions with the Operator as well as their construction contractor indicate that progress has been slow due to freezing temperatures and encounters with groundwater. The excavation of the footprint of the cutoff wall and emergency decant structure has been slow, but moving forward. The area appears to be consistent with the approved designs and no issues were noted with construction area.
