MINERALS PROGRAM INSPECTION REPORT

MINE NAME: CBC Gravel Pit		MINE/PROSPECTING ID#: M-2009-030		MINERAL: Gravel and sand	COUNTY: Dolores
INSPECTION TYPE: Surety Release Inspection		WEATHER: Clear		INSP. DATE: November 29, 2023	INSP. TIME: 11:00
OPERATOR: Coal Bed Creek Construction, Inc.		OPERATOR REPRESENTATIVE: David Cressler		TYPE OF OPERATION: 110c - Construction Limited Impact	
REASON FOR INSPECTION: Surety Release Requested		BOND CALCULATION TYPE: None		BOND AMOUNT: \$0.00	
DATE OF COMPLAINT: NA		POST INSP. CONTACTS: None		JOINT INSP. AGENCY: None	
INSPECTOR(S): Todd Jesse		INSPECTOR'S SIGNATURE:

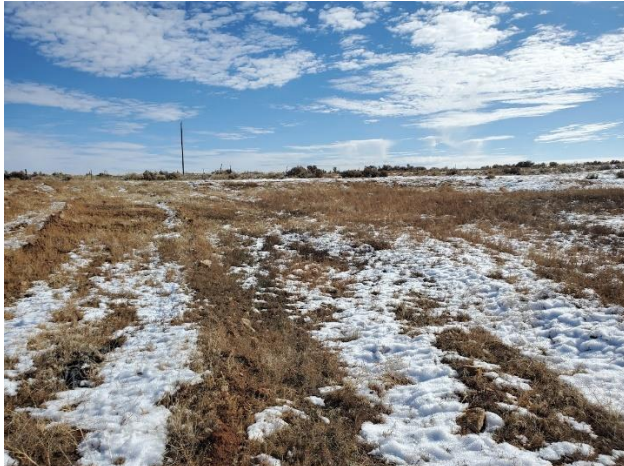
View to the northeast of northeast corner of the reclaimed areas.

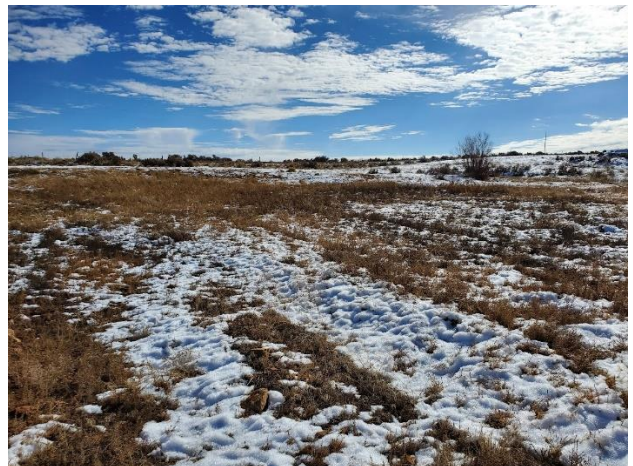
View to the southeast of southeast corner of the mining area.

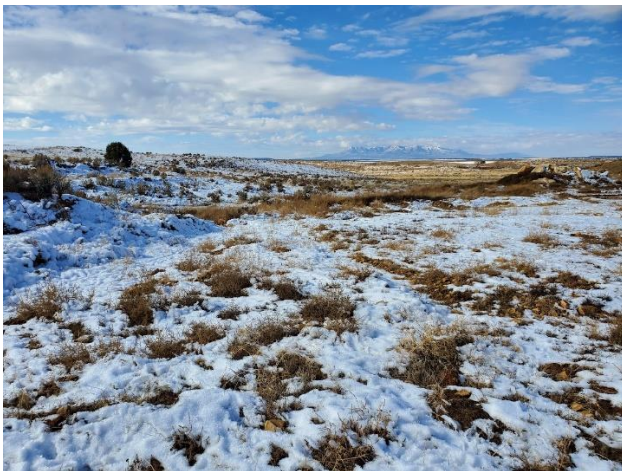
View to the southwest of southwest corner of the reclaimed pit.

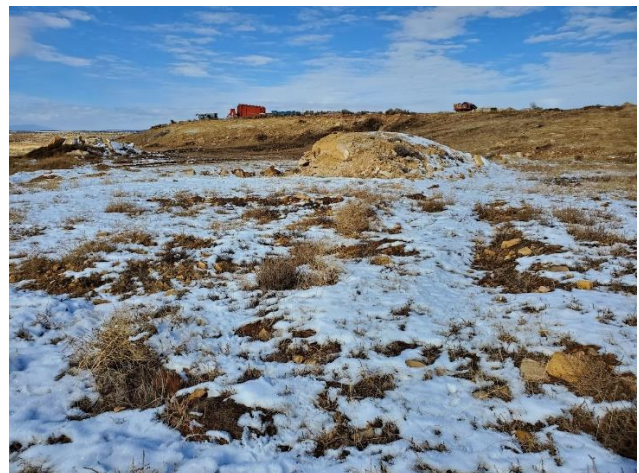
Pit walls have been graded to an approximate 3:1 grade. There are no highwalls on site and all slopes appear to be stable with no evidence of erosion or slumping. There is a remaining stockpile of processed material on site adjacent to the pit that the owner (same person as operator) would like to utilize on roads within their 5,000-acre farm. In the center of the reclaimed area there appears to be a stockpile of material but is actually an outcrop of sandstone. The outcrop is roughly 3 feet high and appears stable.

View to the northwest of northwest corner of the reclaimed area. Rock outcrop can be seen in the foreground. Undisturbed ground adjacent to the permit area can be seen in the background of the photo.
