MINERALS PROGRAM INSPECTION REPORT

MINE NAME: Cesar Pit	MINE/PROSPECTING ID#: M-1998-101	MINERAL: Sand and gravel and	COUNTY: Pueblo
INSPECTION TYPE: Monitoring	WEATHER: Clear	INSP. DATE: November 6, 2023	INSP. TIME: 11:30
OPERATOR: Tony J. Beltramo and Sons, Inc.	OPERATOR REPRESENTATIVE: Tim Beltramo	TYPE OF OPERATION: 112c - Construction Regular Operation

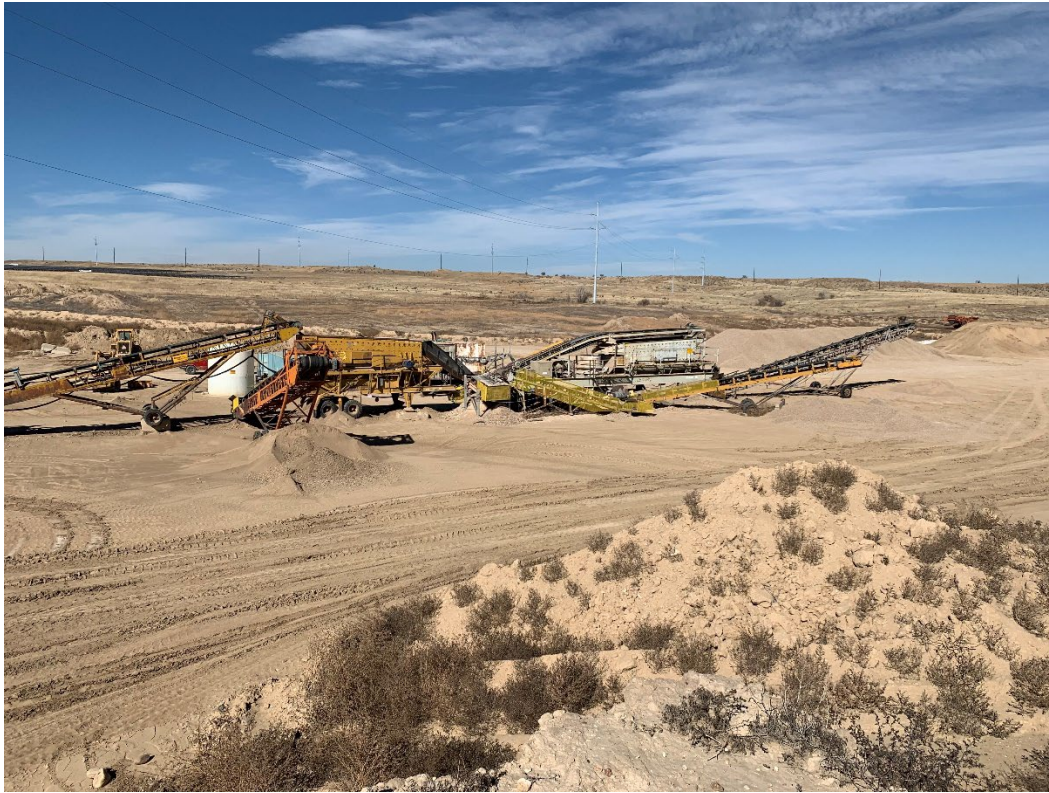
The current mining area and screening equipment are located northeast of the feedlot access road (photo 1). The high wall is located on the south side of the mining area. It is about 30 feet high and 1,000 feet long (photo 2).

Photo 1 – Processing area northeast of feedlot access road.

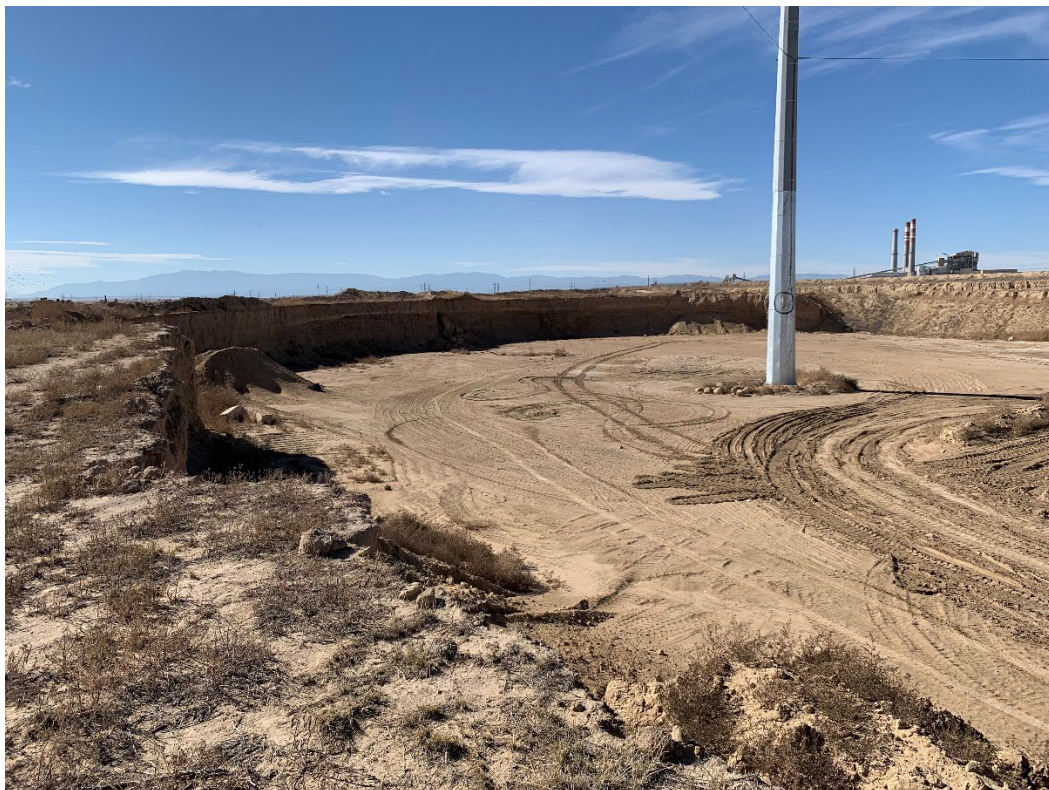
PROBLEM/POSSIBLE VIOLATION: Problem: New electric utility poles are not identified on the mining and reclamation maps. A structure agreement is needed between the operator and structure owner (Rule 6.4.19(c))

A high-power electric utility line has been installed through the mining area (photo 2). This line is traversing the mine permit and is not part of the mining operation. A steel power pole with a concrete footer has been installed in the middle of the current mining area. A possible problem has been cited because the power pole is not identified on the Mining Plan map and the Reclamation Plan map. Also, a structure agreement with the utility company needs to be submitted to the Division. See Possible Problem citation above for more information.

Photo 2 – Pit area with newly installed utility pole

CORRECTIVE ACTIONS: Submit updated mining and reclamation maps showing the location of the new electric utility power pole on each map. Submit a notarized letter, on utility letterhead, from the owner(s) of the utility that the mining and reclamation activities, as proposed, will have "no negative effect" on their utility (Rule 6.4.19(c)). These three items are due within 60 days of this inspection report issuance.

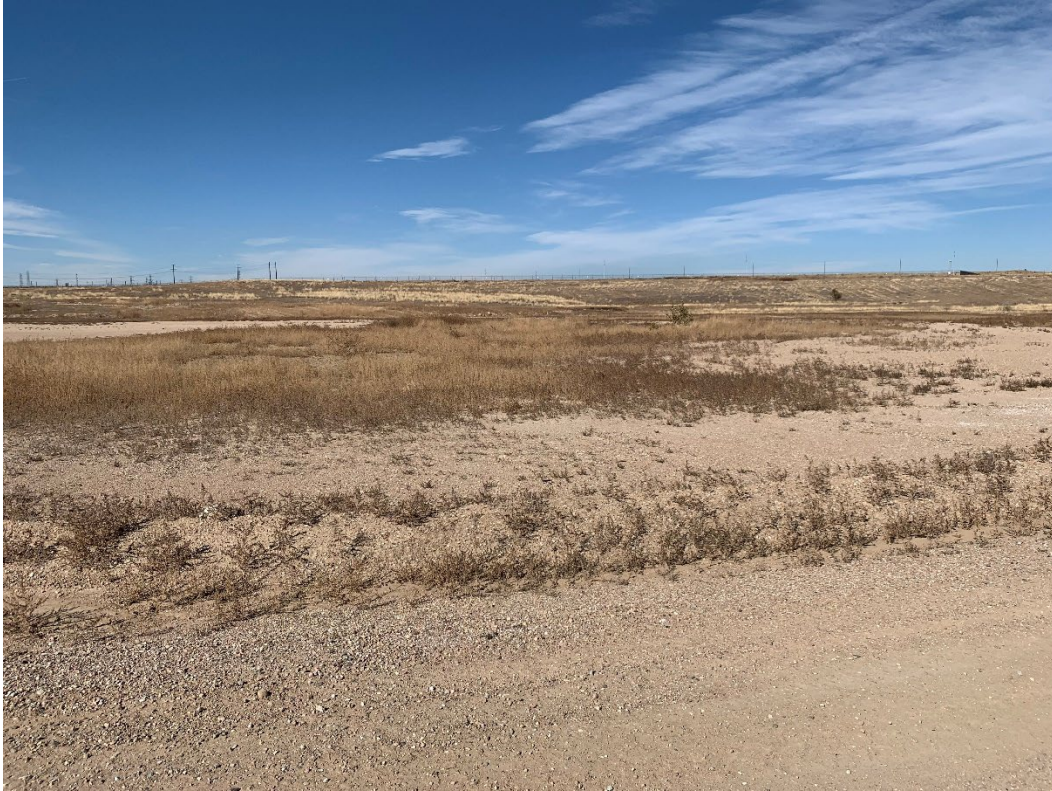
The area southwest of the feedlot access road is not currently being mined and is mostly in reclamation (photo 3). No mining equipment was in this area. The scale house and haul road are still in place and are not being reclaimed at this time.

Photo 3 – Southwestern mining area is mostly reclaimed.

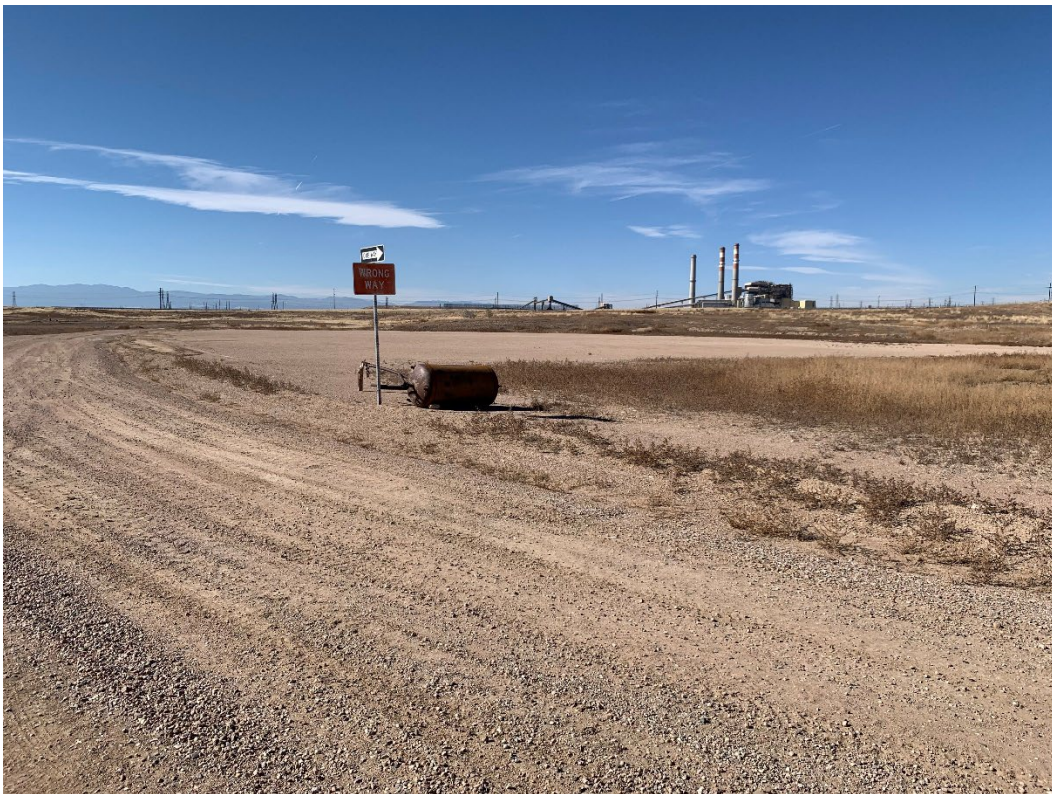
The pit walls have been graded to approximately 3h:1v and seeded. The pit floor west of the haul road has been seeded but the seed mix did not germinate in some areas (photo 4). This area will have to be evaluated as to why the seed mix did not sprout. Compaction may be a factor since this was where the processing equipment was located.

Photo 4 – The seed mix did not sprout in this area southwest of the feedlot.

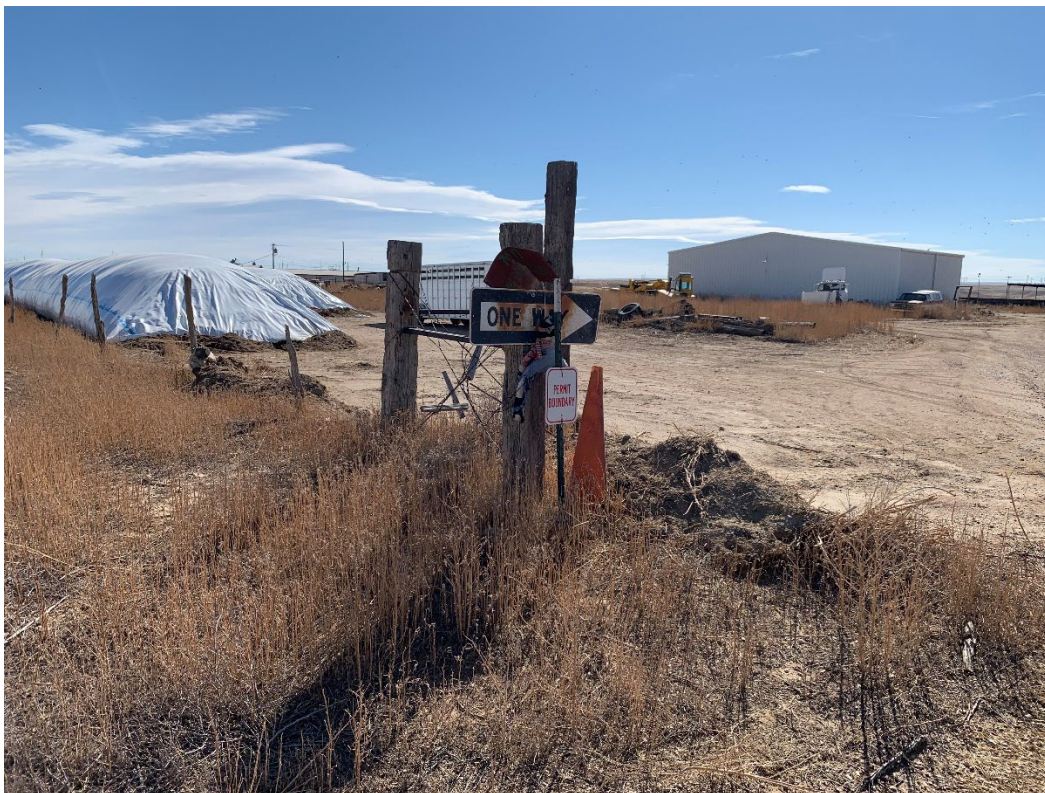
The mine permit boundary markers were in place (photo 5).

Photo 5 – Permit boundary marker near feedlot entrance.
