## MINERALS PROGRAM INSPECTION REPORT

<b>MINE NAME:</b> Del Norte Gravel Pit		<b>MINE/PROSPECTING ID#:</b> M-1978-071	<b>MINERAL:</b> Sand and gravel	<b>COUNTY:</b> Rio Grande
<b>INSPECTION TYPE:</b> Monitoring		<b>WEATHER:</b> Cloudy	<b>INSP. DATE:</b> November 20, 2023	<b>INSP. TIME:</b> 13:00
<b>OPERATOR:</b> Rio Grande County		<b>OPERATOR REPRESENTATIVE:</b> Patrick Sullivan	<b>TYPE OF OPERATION:</b> 112c - Construction Regular Operation	
<b>REASON FOR INSPECTION:</b> Normal I&E Program		<b>BOND CALCULATION TYPE:</b> None	<b>BOND AMOUNT:</b> \$0.00	
<b>DATE OF COMPLAINT:</b> NA		<b>POST INSP. CONTACTS:</b> None	<b>JOINT INSP. AGENCY:</b> None	
<b>INSPECTOR(S):</b> Todd Jesse	<b>INSPECTOR'S SIGNATURE:</b>

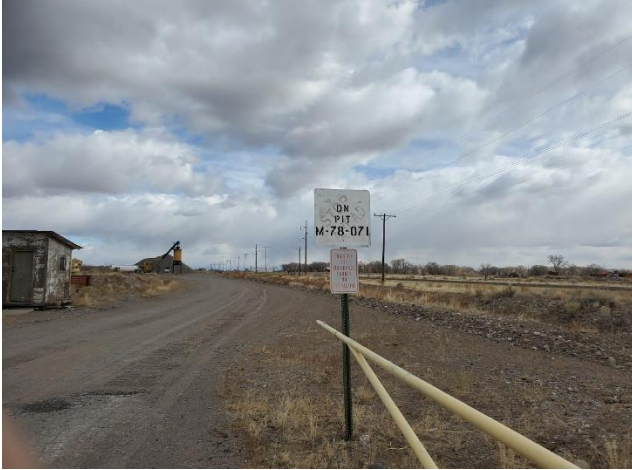
View to the east of proper Mine ID signage posted at the entrance.

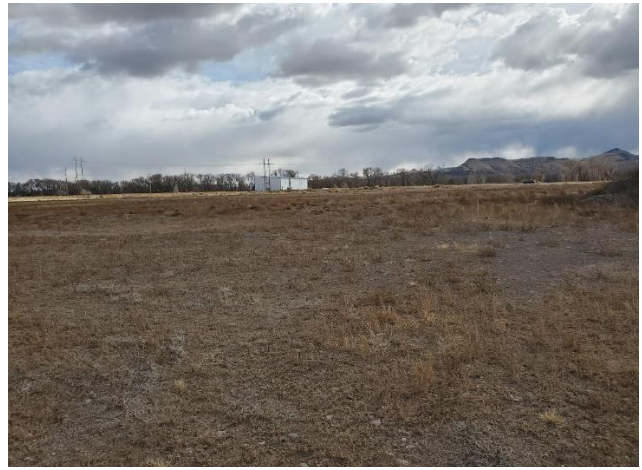
View to the east of undisturbed ground within the permit area.

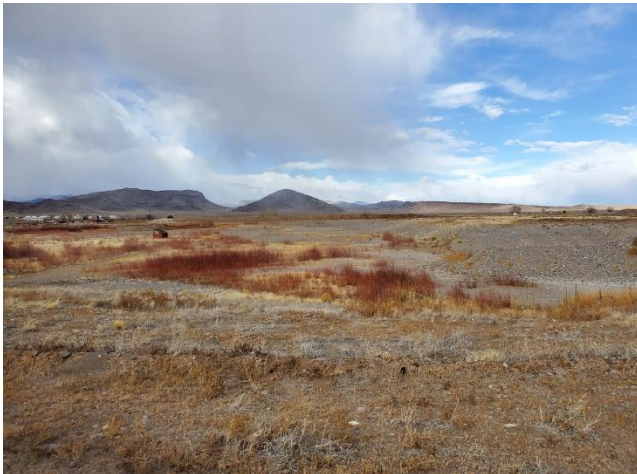
Current excavation occurs in the new pit to the east of the pond and is being conducted according to the submitted plan. The pit was active at the time of the inspection and the pit was well maintained. No evidence of water was noted in the new pit. Material is extracted at approximately reclamation grade resulting in no highwall on site. The side slopes of the pit are stable and well vegetated with volunteer species - showing no signs of erosion or slumping. Topsoil is stored along the northern permit boundary and is protected by vegetative cover. There appears to be an adequate amount of topsoil stockpiled for the permitted reclamation plan. There are multiple stockpiles of various sized materials both processed and unprocessed within the permit boundary. Imported materials include waste concrete and asphalt. These materials are benign and importation is included in the approved plan. The site acts as an intermittent source of material for Rio Grande Road and Bridge for projects in Rio Grande County. No state listed invasive species were identified on site during the inspection.

View to the north of eastern edge of the pit. Material is being excavated at reclamation grade.

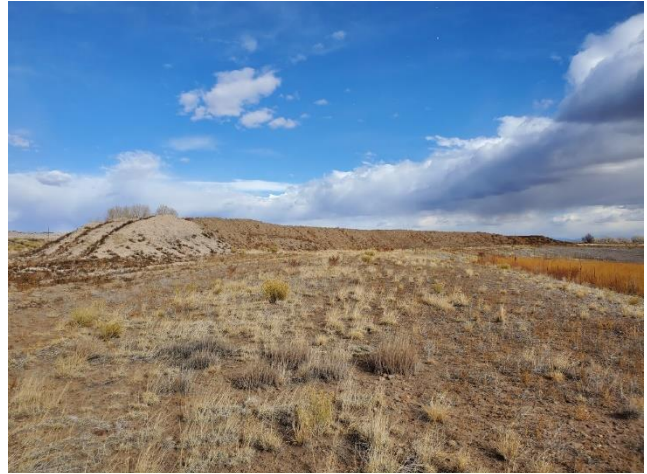
View to the northeast of principle topsoil stockpile along the northern permit boundary.

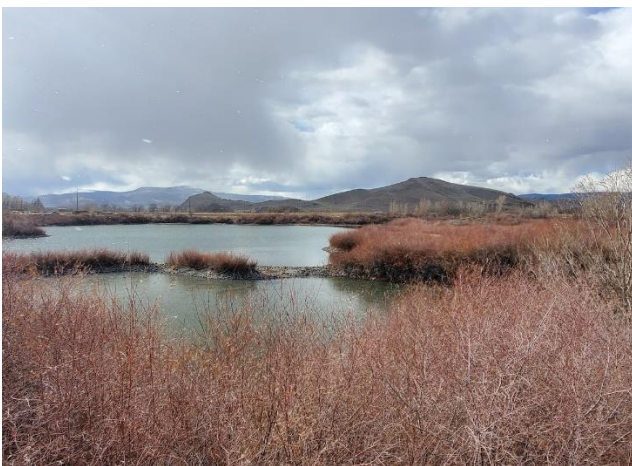
The proper mine identification signage was posted at the entrance to the site. Permit boundaries are clearly marked with fence lines. There are two pits within the permit area. The western pit ("old" pit) has been reclaimed and holds water that seeps into the pit from a ditch the runs along the pit boundary, which the Division of Water Resources does not consider to be groundwater. Waterfowl were seen using the pond during the inspection.

View to the west of water in the old pit.

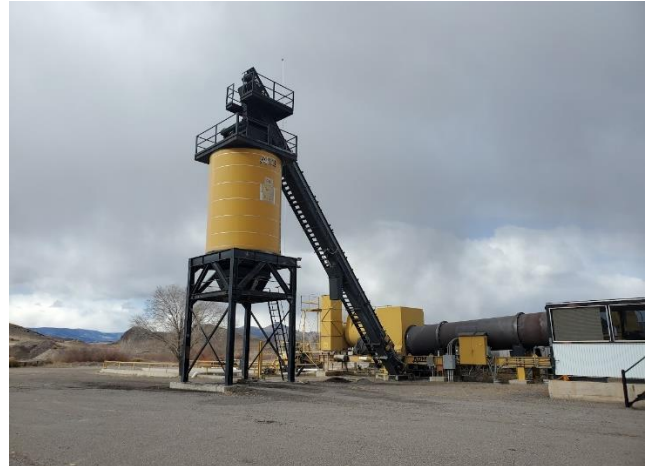
Site facilities include an office and asphalt plant. The office building was well kept on the outside. The asphalt plant was not operational at the time of the inspection but appeared to be well maintained. Hydrocarbons are stored in the facility area in secondary containment.

View to the north of asphalt plant on site. Plant was not active at the time of the inspection.
