MINERALS PROGRAM INSPECTION REPORT
PHONE: (303) 866-3567

MINE NAME: 10 Miles South Pit	MINE/PROSPECTING ID#: M-1978-066	MINERAL: Sand and gravel	COUNTY: Rio Grande
INSPECTION TYPE: Monitoring	WEATHER: Cloudy	INSP. DATE: November 20, 2023	INSP. TIME: 13:45
OPERATOR: Rio Grande County	OPERATOR REPRESENTATIVE: Patrick Sullivan	TYPE OF OPERATION: 112c - Construction Regular Operation	
REASON FOR INSPECTION: Normal I&E Program	BOND CALCULATION TYPE: None	BOND AMOUNT: \$0.00	
DATE OF COMPLAINT: NA	POST INSP. CONTACTS: None	JOINT INSP. AGENCY: None	
INSPECTOR(S): Todd Jesse	INSPECTOR'S SIGNATURE:

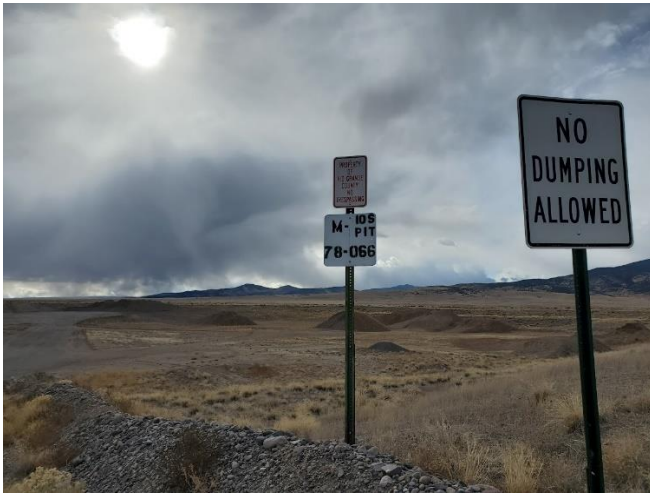
View to the south showing proper Mine ID signage posted at the entrance.

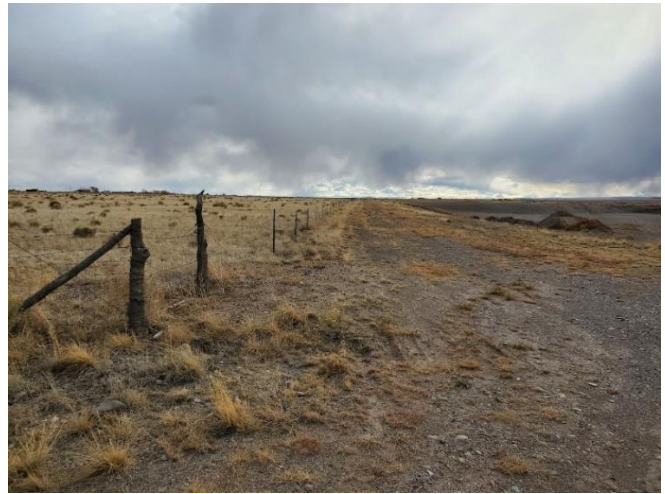
View to the south showing fence line that marks the eastern permit boundary.

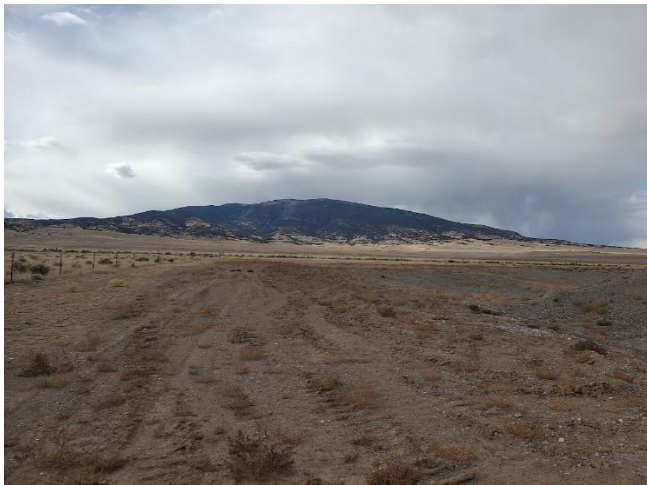
View to the west showing the southwest corner of the permit boundary. The fence line marks the permit boundary.

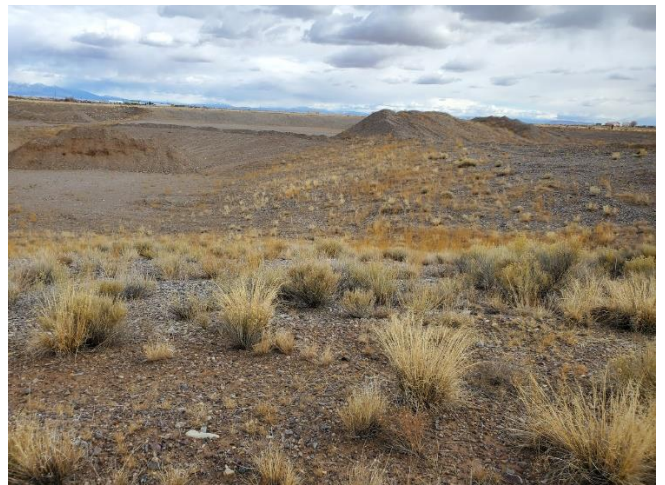
Mining has been conducted according to the submitted plan. Material was extracted at approximately reclamation grade resulting in no highwall on site. The side slopes of the pit are stable and well vegetated with volunteer species - showing no signs of erosion or slumping. The pit floor has multiple stockpiles of various sized materials both processed and unprocessed. In addition to product stockpiles there is also a topsoil pile on site. There appears to be an adequate amount of topsoil stockpiled for the permitted reclamation plan. All stockpiles are protected by volunteer plant species and appear stable. No state listed invasive species were identified on site during the inspection. No water is present in the pit floor.

View to the southeast showing the mining area of the pit. Material is extracted at reclamation grade.

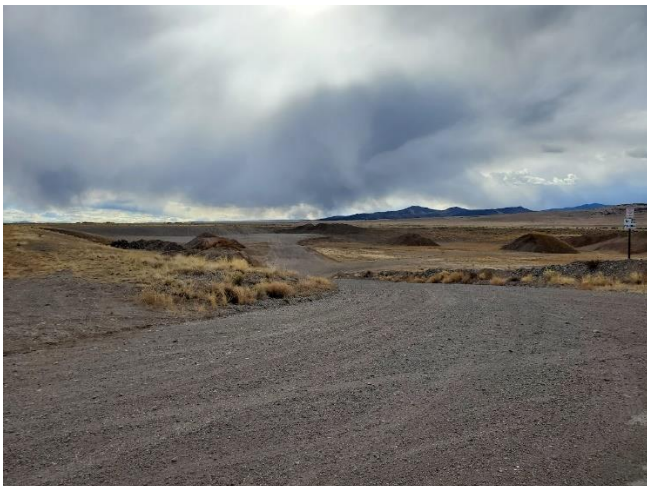
View to the southwest showing an overview of the pit. No evidence of exposed ground water

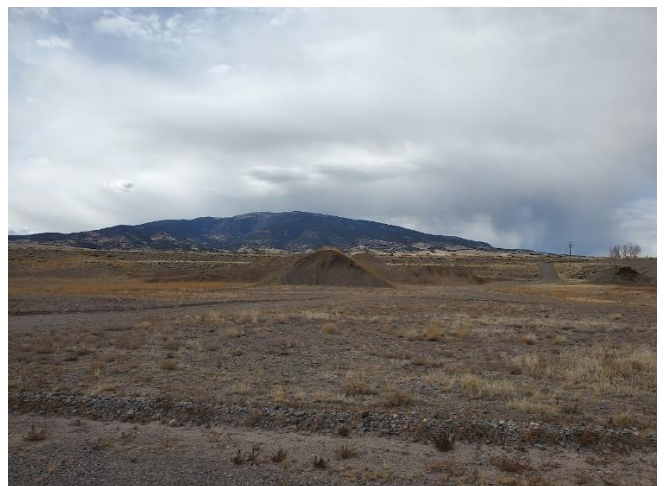
View to the west showing material stockpiles on the pit floor.
