To: Jerald Schnabel  
Riverbend Industries Inc.  
File: October 2023 Monitoring Summary

**Reference: October 2023 Geotechnical Monitoring Summary Pikeview Quarry**

PIKEVIEW QUARRY SLOPE  
MONITORING

OBSERVATIONS FROM  
OCTOBER INSPECTION

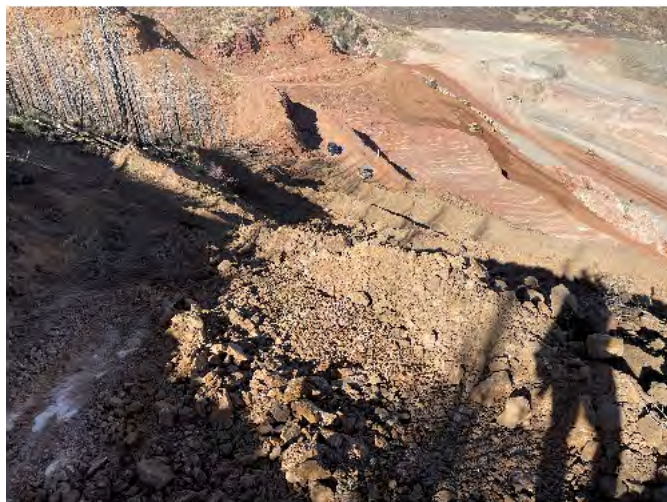
6. Access road pioneered to top of slope cut.

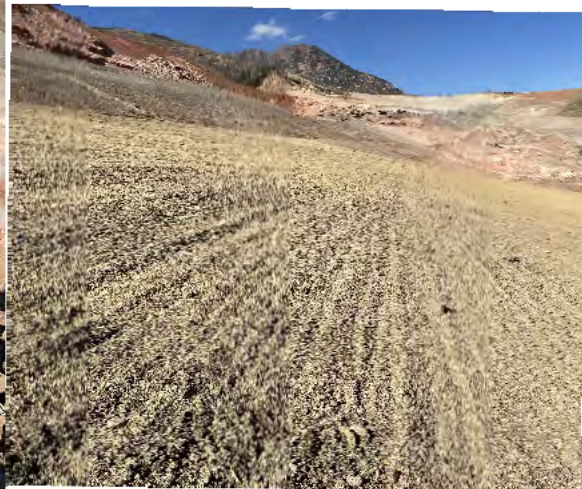
5. Slope below first bench. Hydroseeded and mulched

NOTE 1:  
NO CRACKS

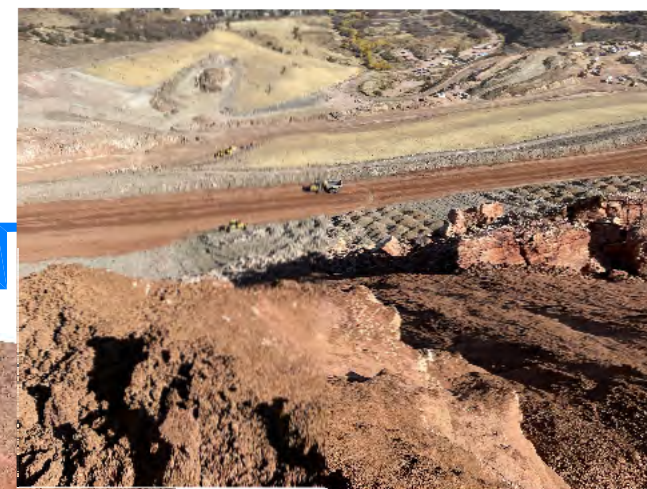
4. Material placed on bench for compaction.

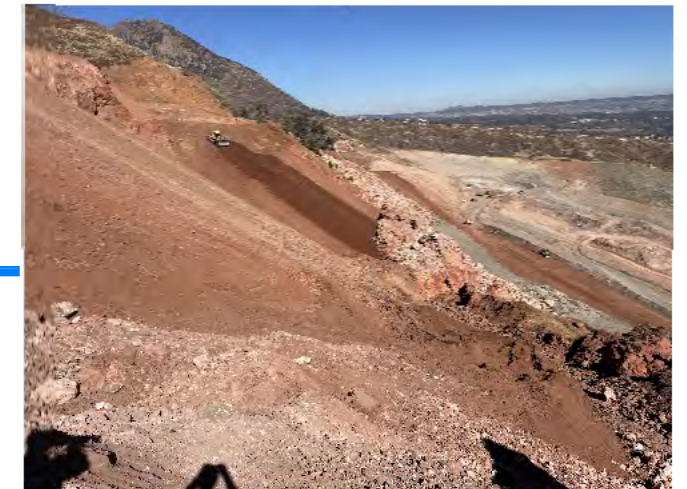
3. Dozer pushing material down from Upper Borrow Area to create access to Buttress.

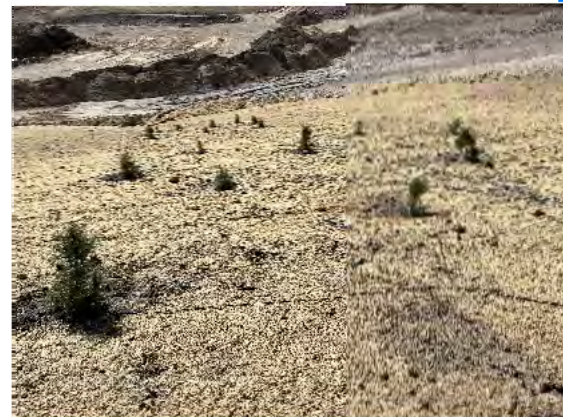
7. Trees and irrigation on the slope.

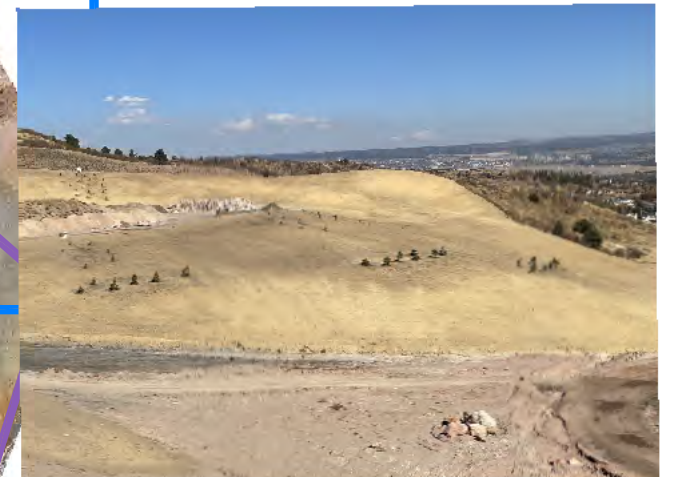
2. Graded borrow area with growth medium.

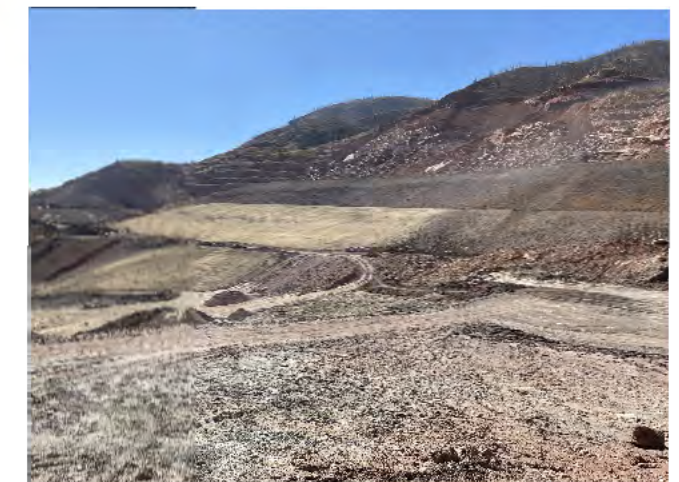
- The slope below the first bench has been placed to the final grade, and the second bench is partially completed. These slopes were traversed on foot and examined for cracks or signs of instability by Stantec engineers. No cracks or signs of instability were identified.

1. Bench slope at final grade.

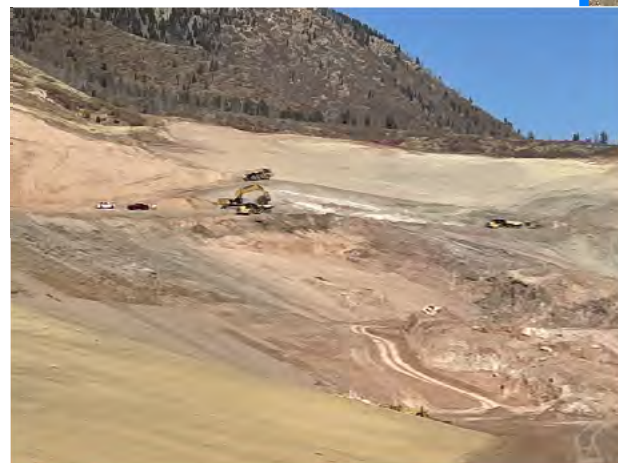
8. Excavator and haul trucks moving material.

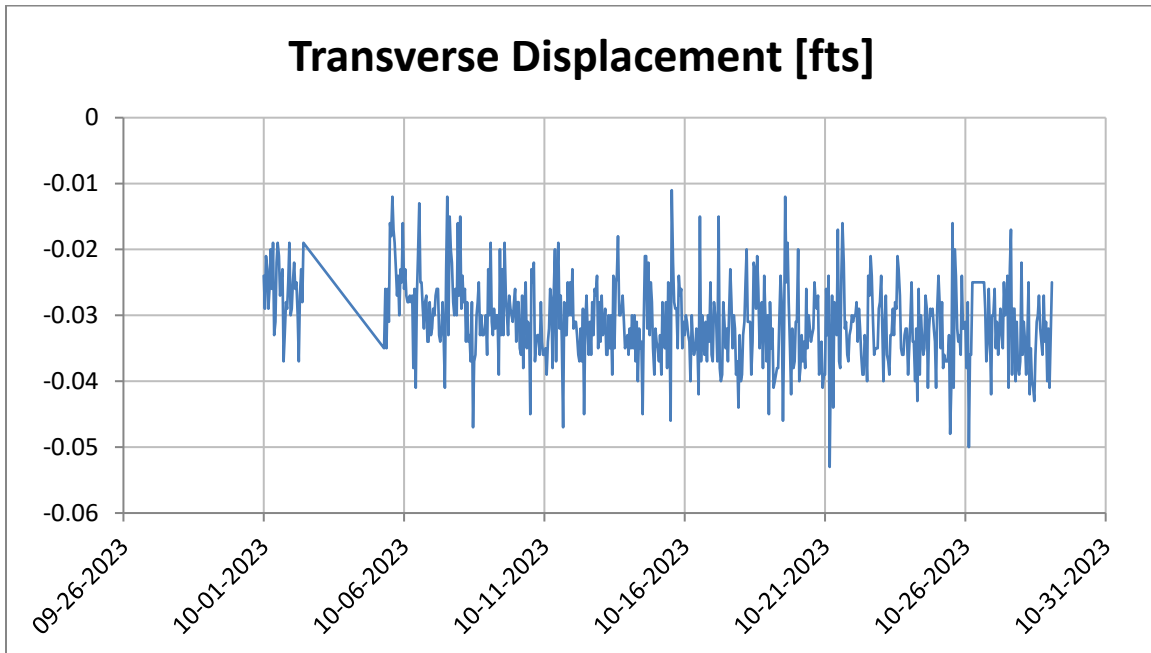
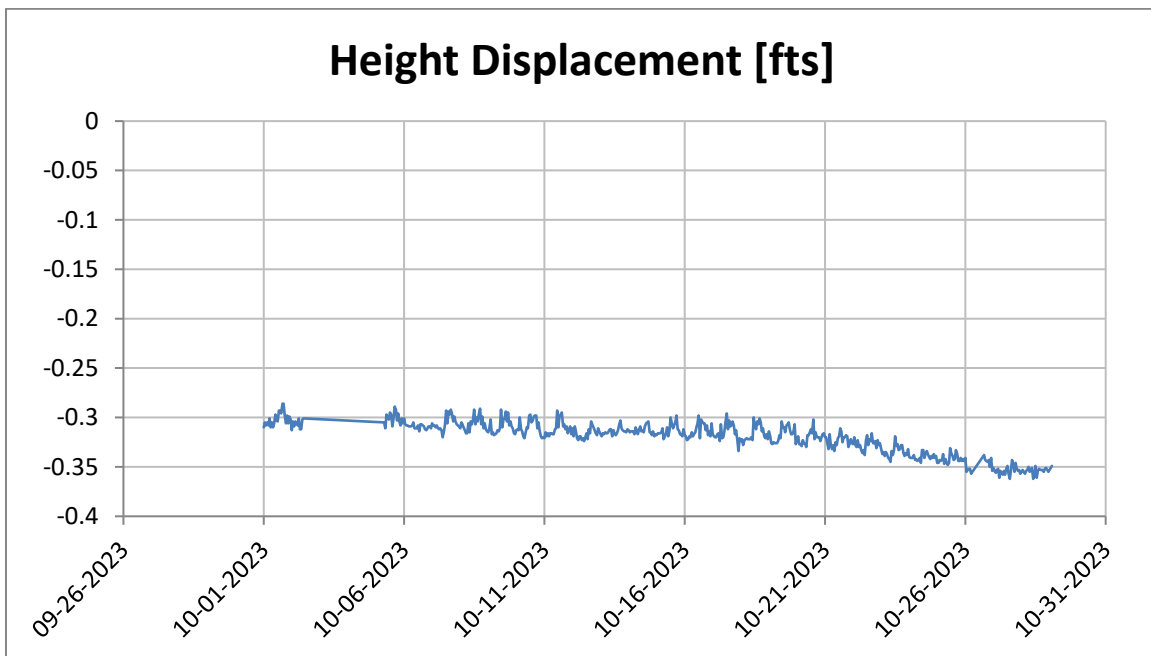
## Prism BR1

The data show stable conditions with no movements at 15 of 18 prisms with recorded displacements limited to data scatter and not actual movements. Prisms BR1, BR2 and NP66 are located above the landslide, and these prisms recorded slope creep movements at slow velocity. This settlement was likely related to loose fill or landslide material consolidating under its own weight. These prisms were placed in areas where slope creep movements are likely to occur; therefore, movements being recorded is expected. Plots of the transverse and height displacements for each prism are included in Appendix B.

1. Survey accuracy is  $\pm 0.016$  feet.
2. Alert threshold is  $\pm 0.35$  feet.
3. Transverse displacement is in the horizontal direction. Positive direction means closer to the robotic station.
4. Height displacement is in the vertical direction. Positive direction means higher in elevation.
5. Prism records slope creep movements.

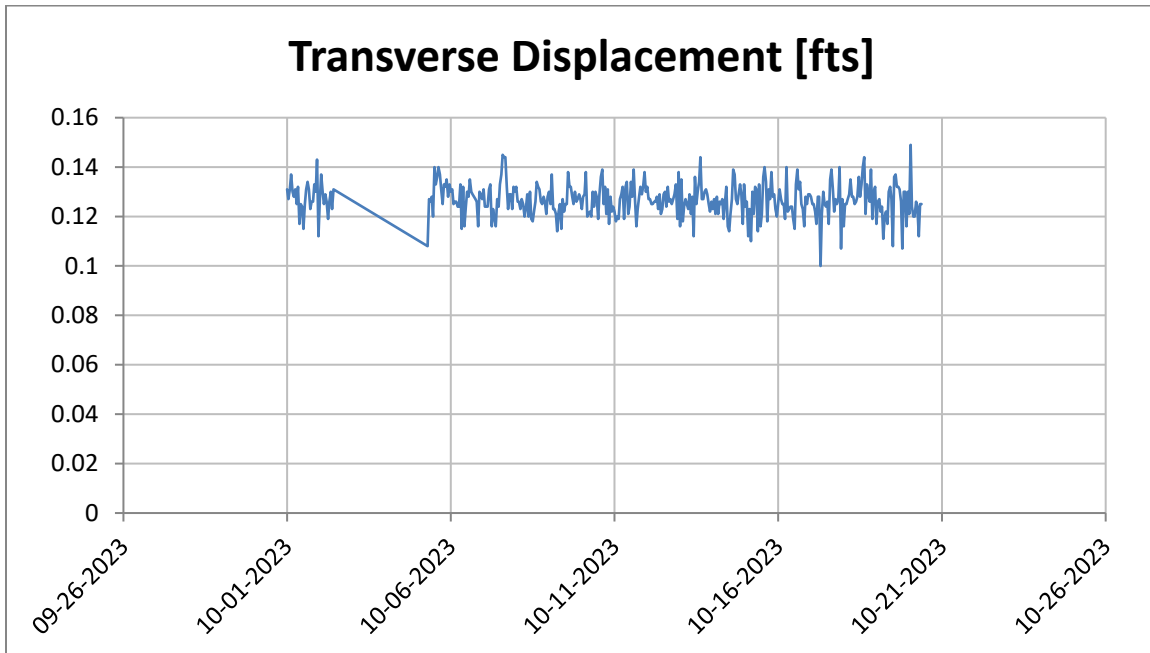
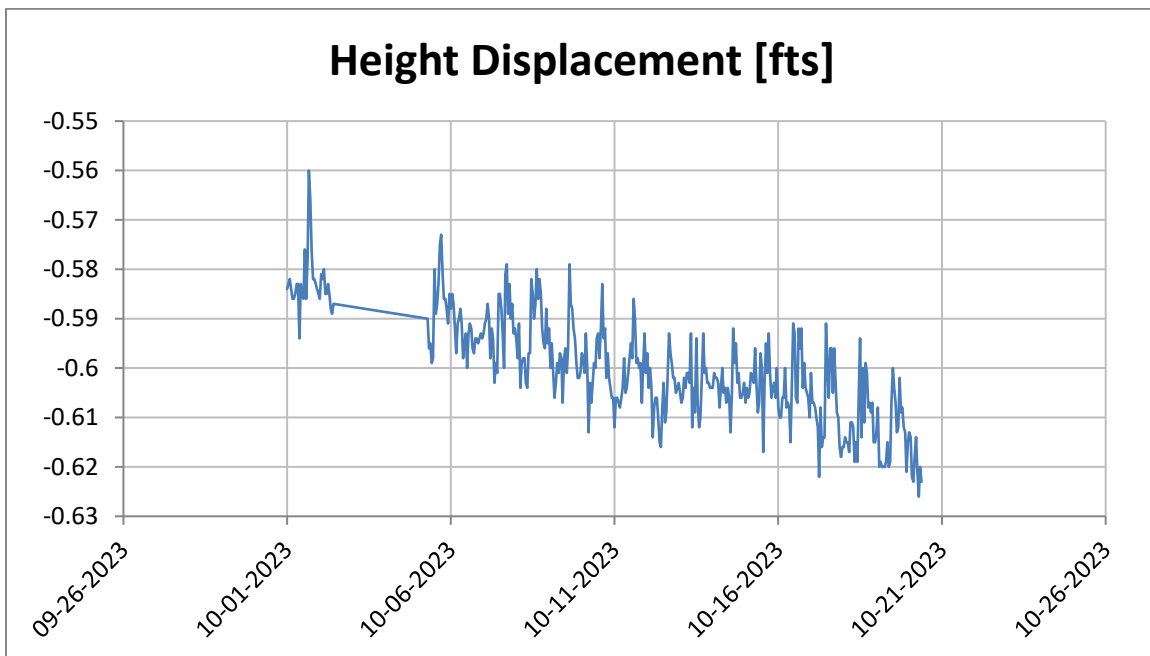
## Prism BR2

1. Survey accuracy is +/-0.016 feet.
2. Alert threshold is +/-0.35 feet.
3. Transverse displacement is in the horizontal direction. Positive direction means closer to the robotic station.
4. Height displacement is in the vertical direction. Positive direction means higher in elevation.
5. Prism records slope creep movements.

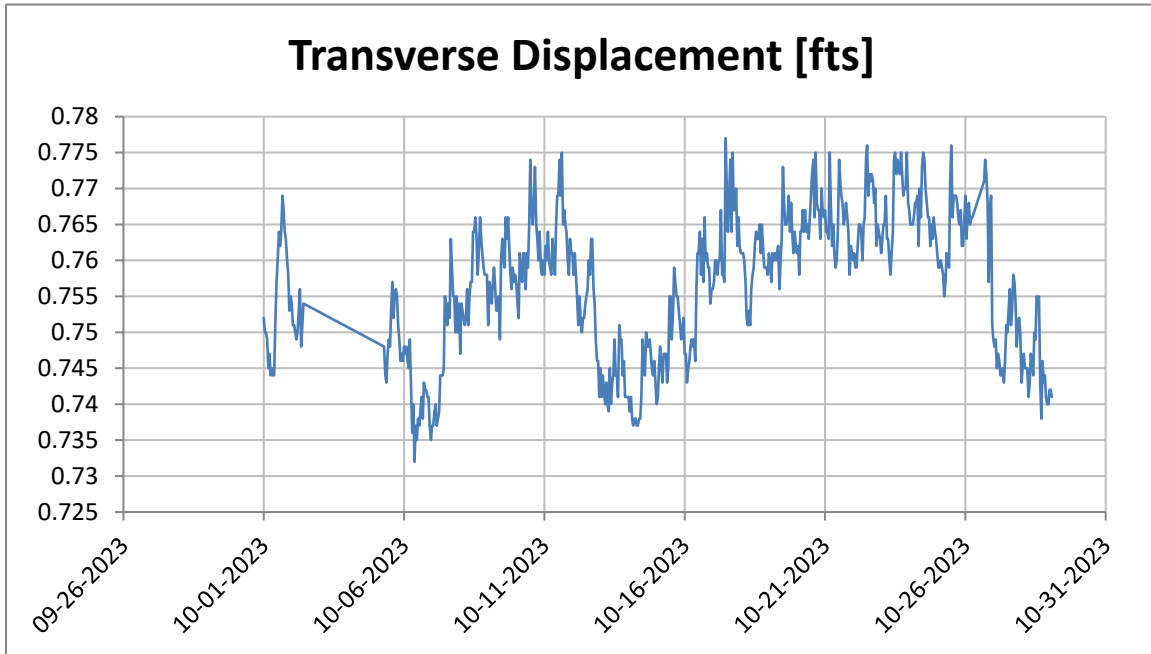
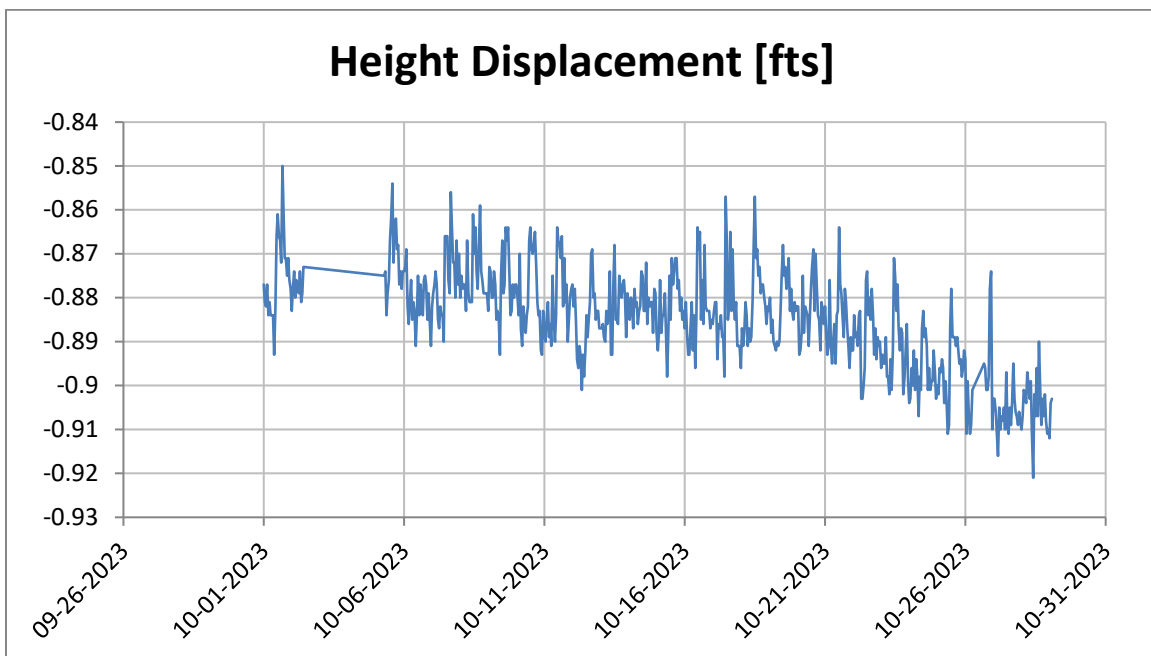
## NP66

1. Survey accuracy is +/-0.016 feet.
2. Alert threshold is +/-0.35 feet.
3. Transverse displacement is in the horizontal direction. Positive direction means closer to the robotic station.
4. Height displacement is in the vertical direction. Positive direction means higher in elevation.
5. Prism records slope creep movements.

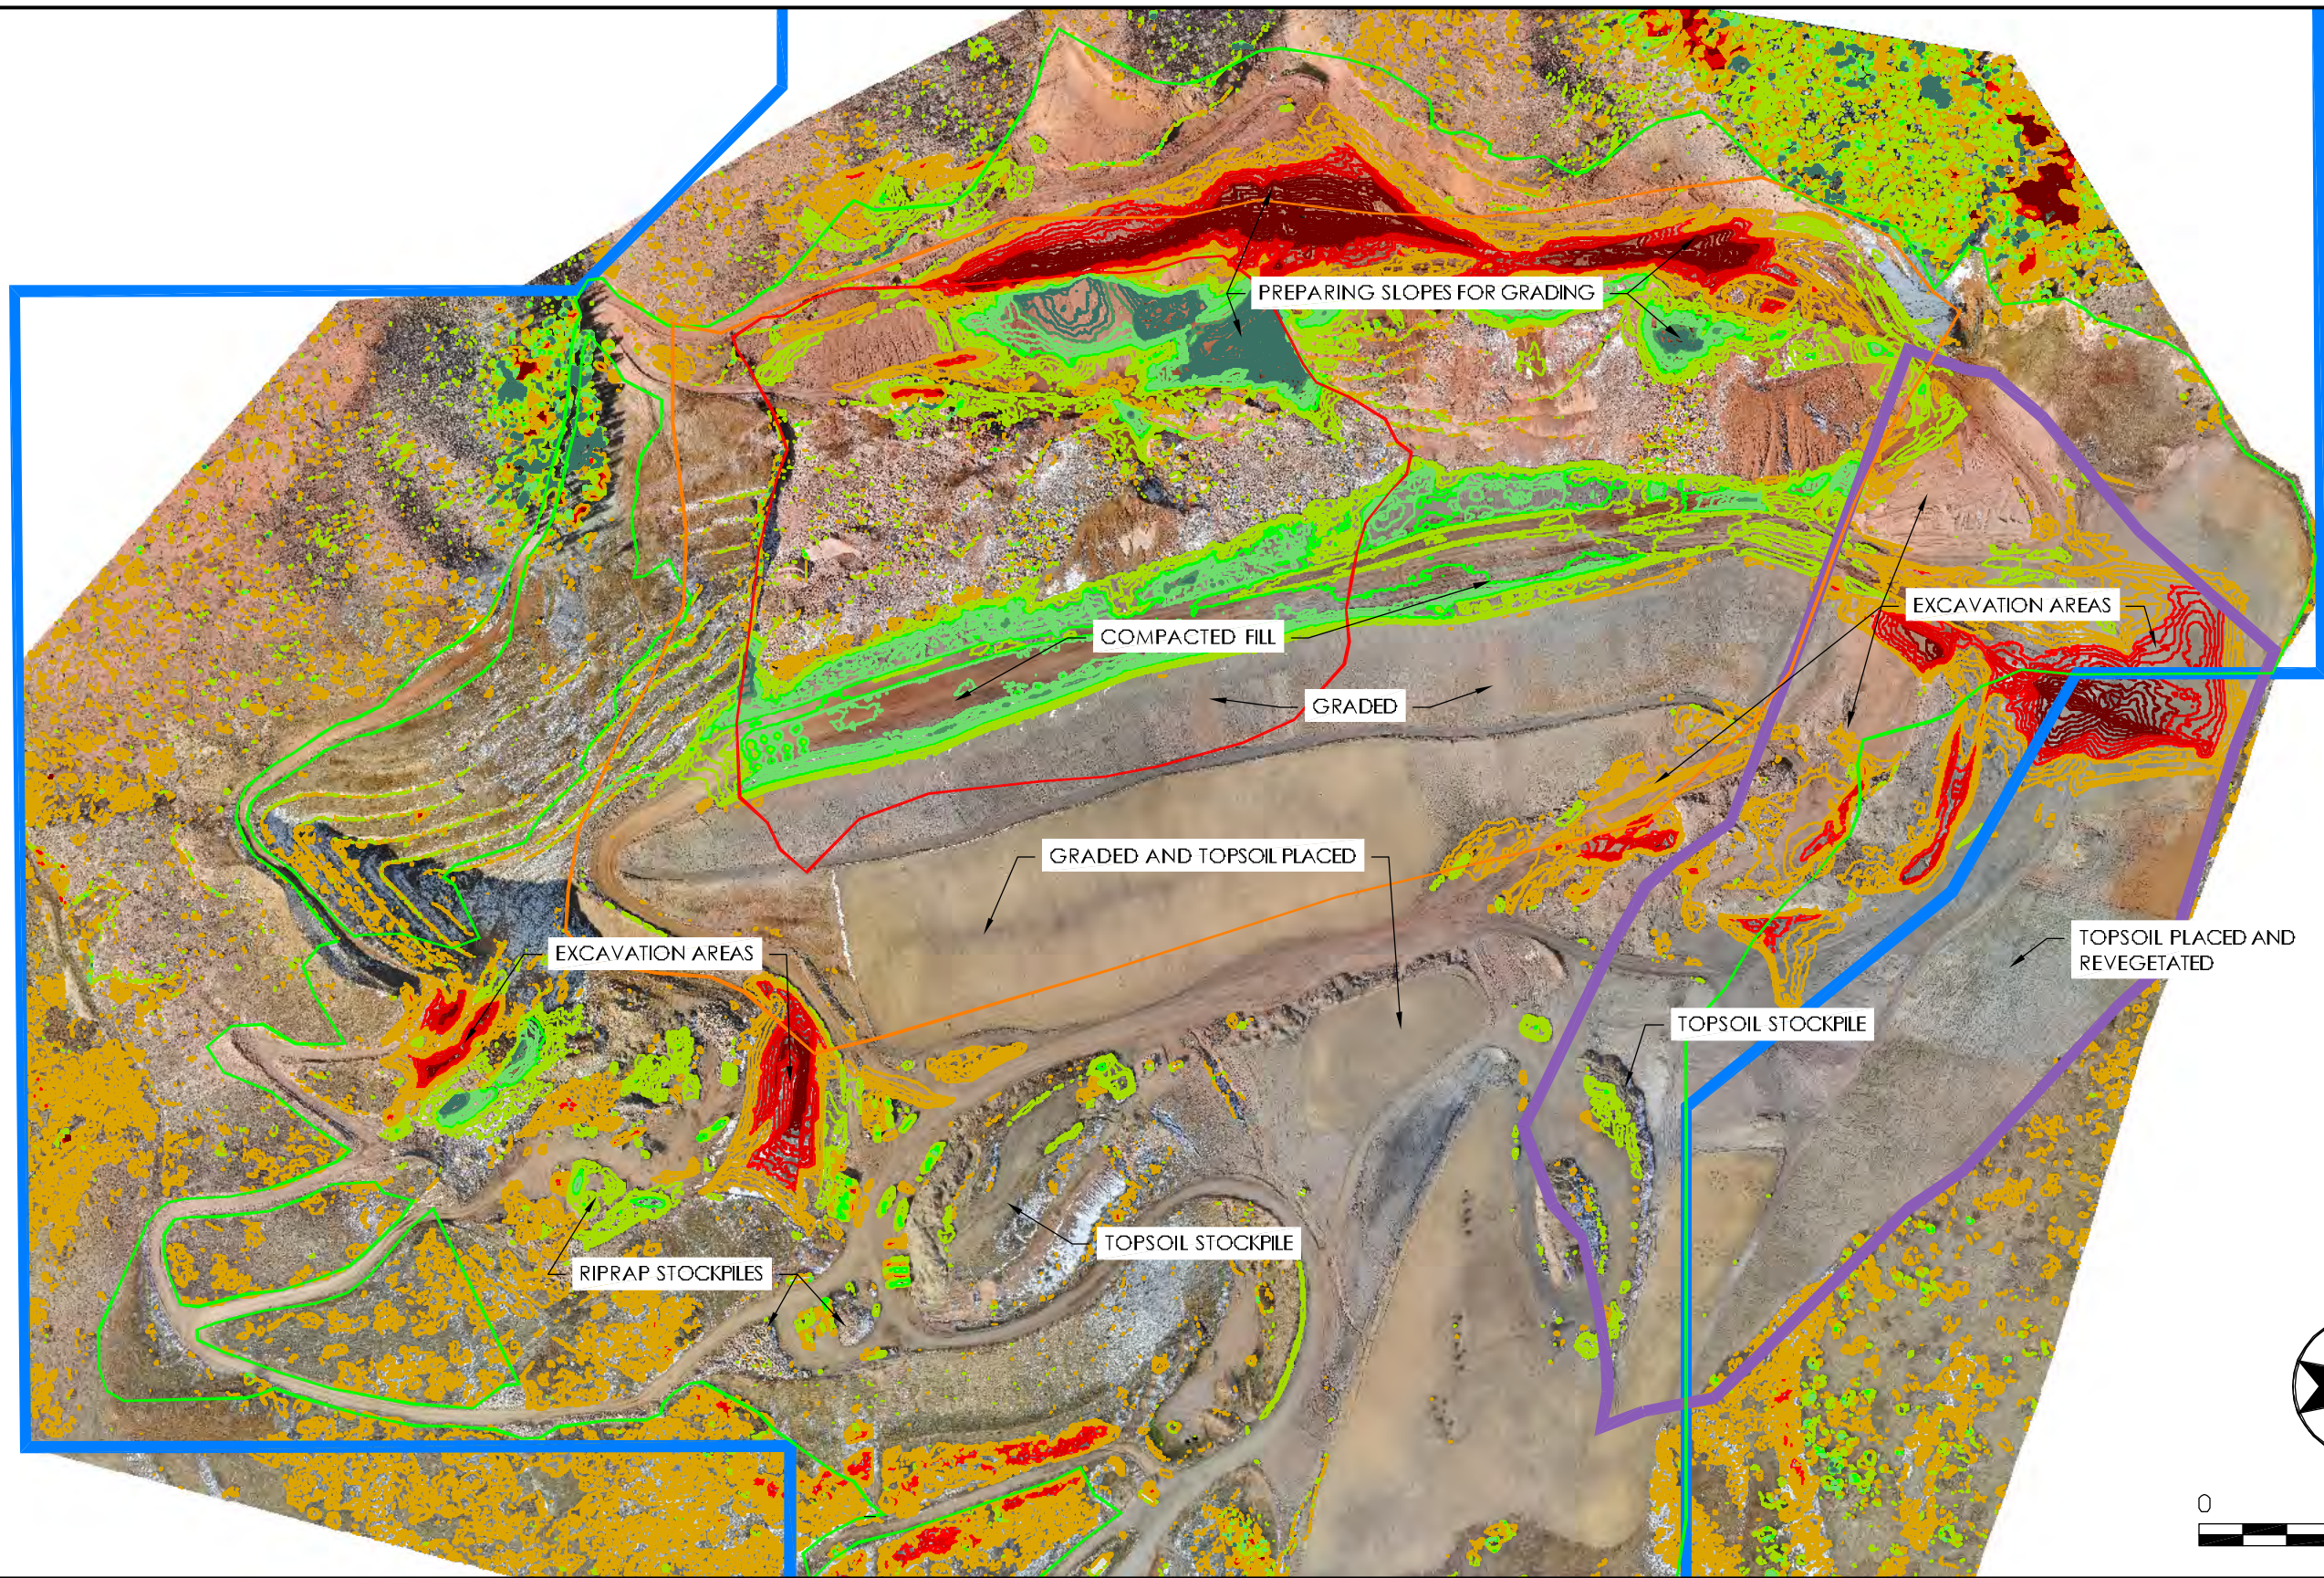
The October topography was also compared to the September topography to identify changes in the site topography. Comparison of the two surveys showed the placement of the fill material at the toe of the landslide. Fill material was excavated from the North and South Borrow Areas and placed in the Buttress Area. No slope movements or other changes in topography were identified. The current imagery and topography are included in Figures 1 and 3, and the comparison surface is included as Figure 5 in Appendix C.

As previously reported in the September 2020 monitoring report, there are limitations with the method of comparing drone surveys from different months. The drone data indicate changes in the slopes along each of the reclamation benches, buildings, and areas with trees or shrubs. These areas are stable, and the changes are the result of survey limitations on or near vertical slopes.
