MINERALS PROGRAM INSPECTION REPORT

MINE NAME: MMM Partnership Gravel Pit	MINE/PROSPECTING ID#: M-2006-042	MINERAL: Sand, gravel & borrow material	COUNTY: Logan
INSPECTION TYPE: Preoperation Inspection	WEATHER: Clear, cool	INSP. DATE: November 30, 2023	INSP. TIME: 10:00
OPERATOR: MMM Partnership, LLP.	OPERATOR REPRESENTATIVE: Mark Kokes	TYPE OF OPERATION: 112c - Construction Regular Operation	
REASON FOR INSPECTION: Pre-Operation Inspection for AM1	BOND CALCULATION TYPE: Complete Bond	BOND AMOUNT: \$67,200.00	
DATE OF COMPLAINT: NA	POST INSP. CONTACTS: None	JOINT INSP. AGENCY: None	
INSPECTOR(S): Nikie Gagnon	INSPECTOR'S SIGNATURE:

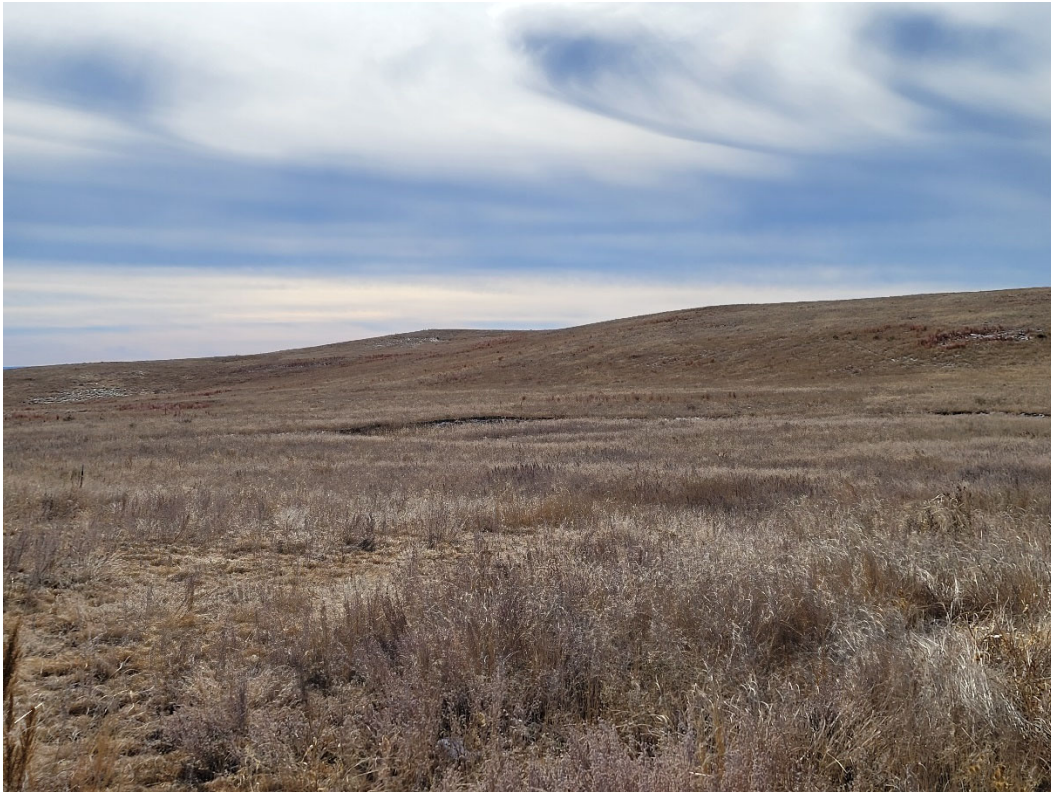
AM1 proposes a 32.4 acre mine expansion, south of the existing mining disturbance. During this inspection, the Division observed the expansion area, a flat grassy basin below a 1500' long gently sloped ridge that runs from the northwest corner to the southeast. According to the Operator, mining will be conducted to level out the top of ridge leaving a flatter area with gentle slopes flowing north and east across the parcel. The Operator proposes to mine the expansion area in three 8-acre phases. Topsoil and overburden will be stripped and stored adjacent to each phase. Once mining is complete in an area of 8 acres, the land will be recontoured, graded, and stockpiled topsoil will be reapplied. Mining will begin in the southeast corner of the expansion area and move northwest.

Photo 1: View looking southeast across the expansion area.

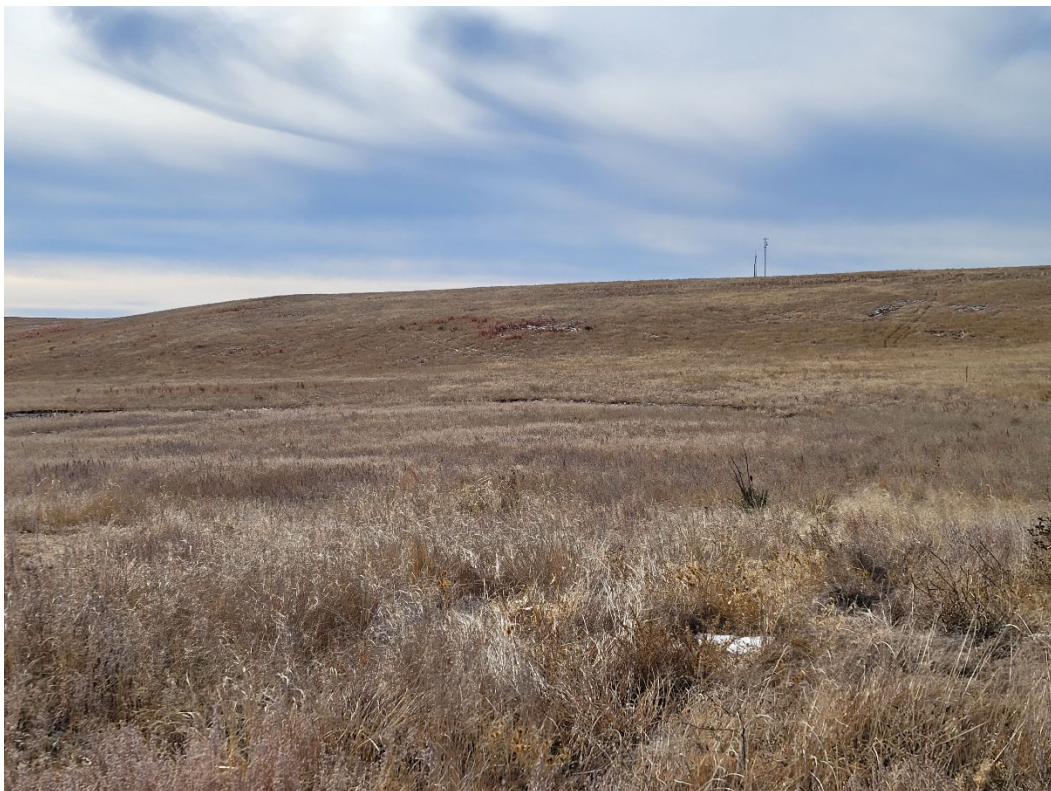
Photo 2: View looking south across the expansion area.

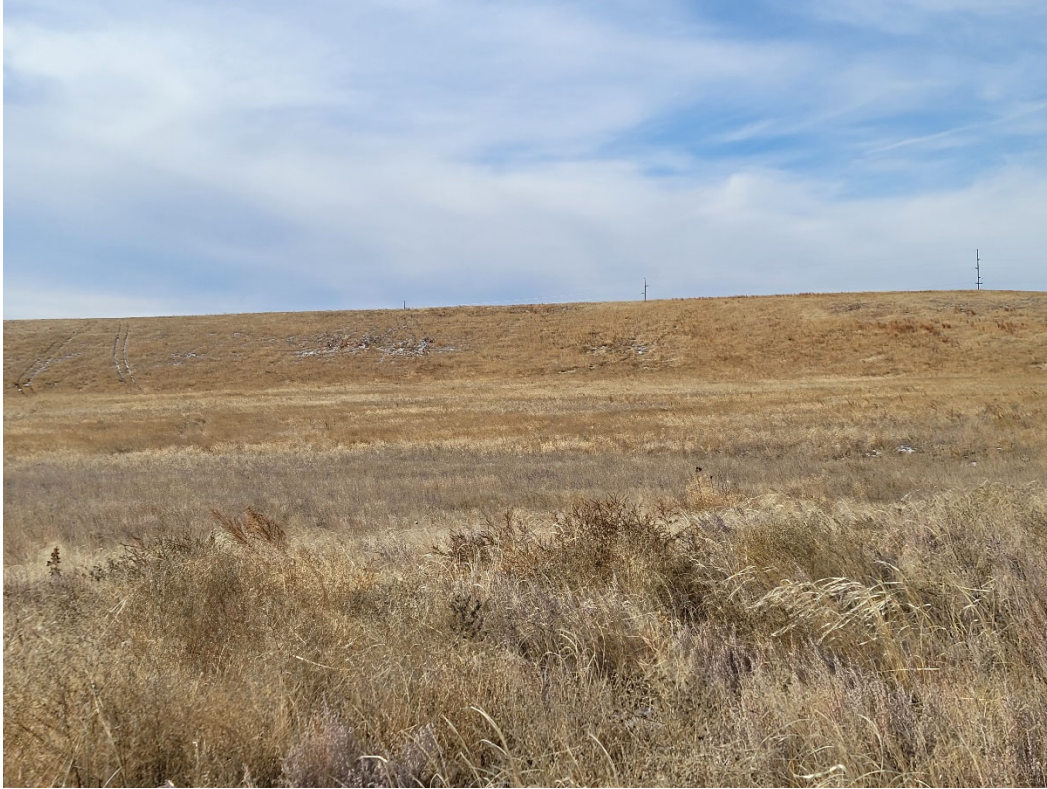
Photo 3: View looking southwest across the expansion area.

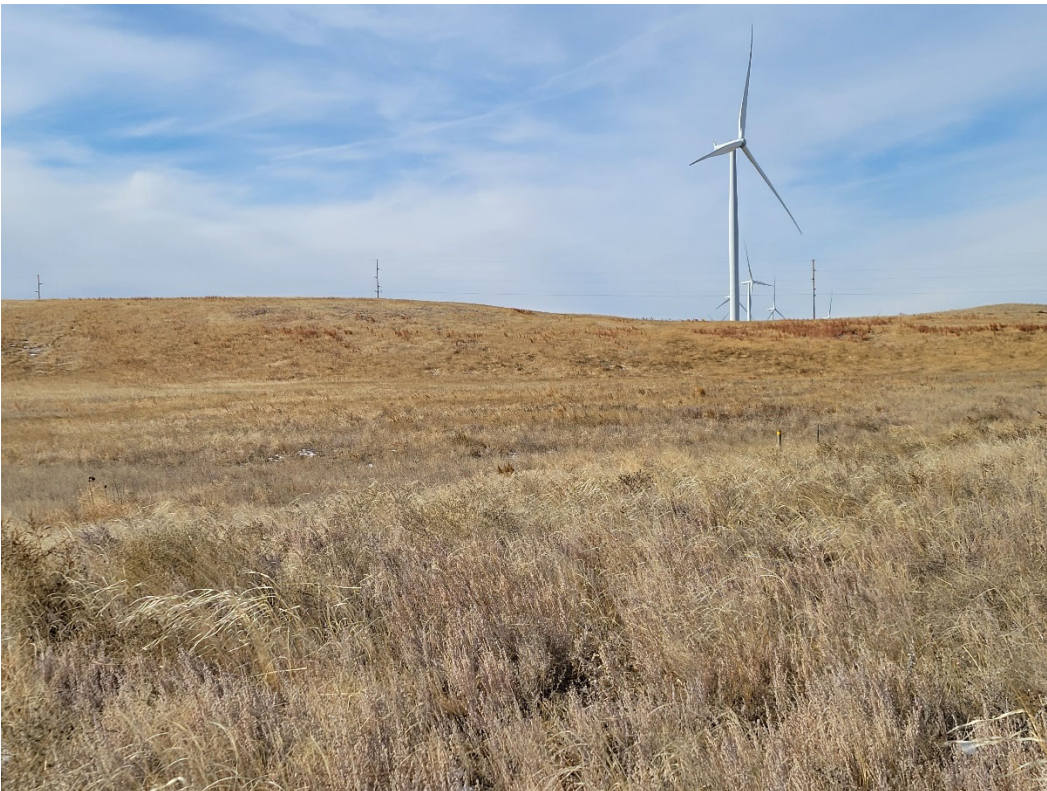
Photo 4: View looking northwest at expansion area.

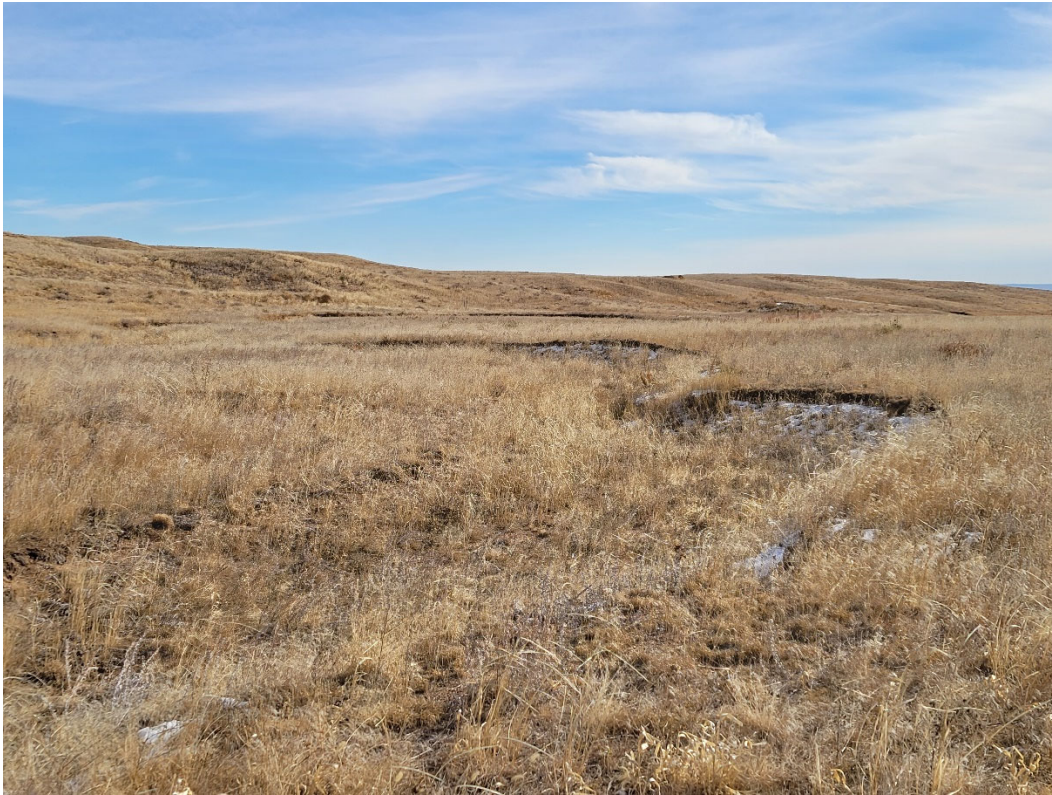
McCracken Draw, an ephemeral drainage, runs from the northwest to southeast across the parcel, between the existing pit and the AM1 expansion area. This ephemeral drainage is outside the existing and proposed expansion boundary. The creek was dry during this inspection and the Operator indicated the creek is typically dry. The mine plan states straw bales or earthen berms will be placed along the boundary of the expansion area to allow stormwater to infiltrate into the ground and prevent erosion off site into the drainage.

Photo 5: Looking southeast at McCracken Draw that runs between the existing and proposed permit areas.

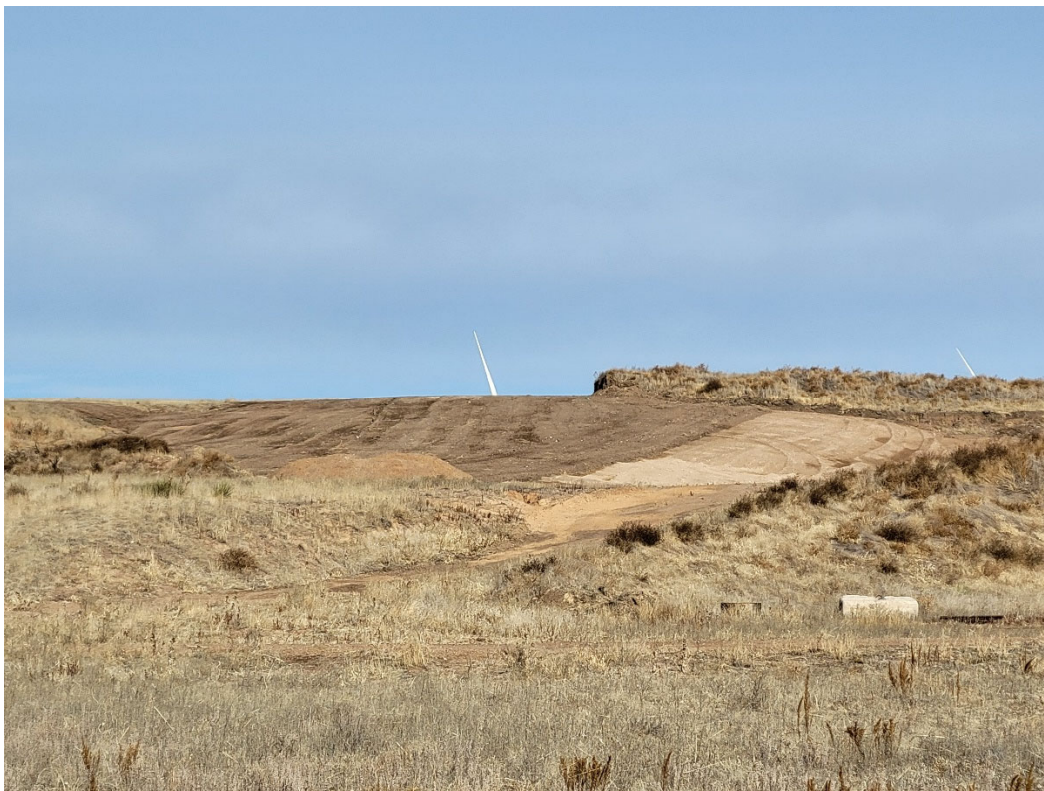
Photo 6: Recently topsoiled area in the northwest corner of the existing permit area.

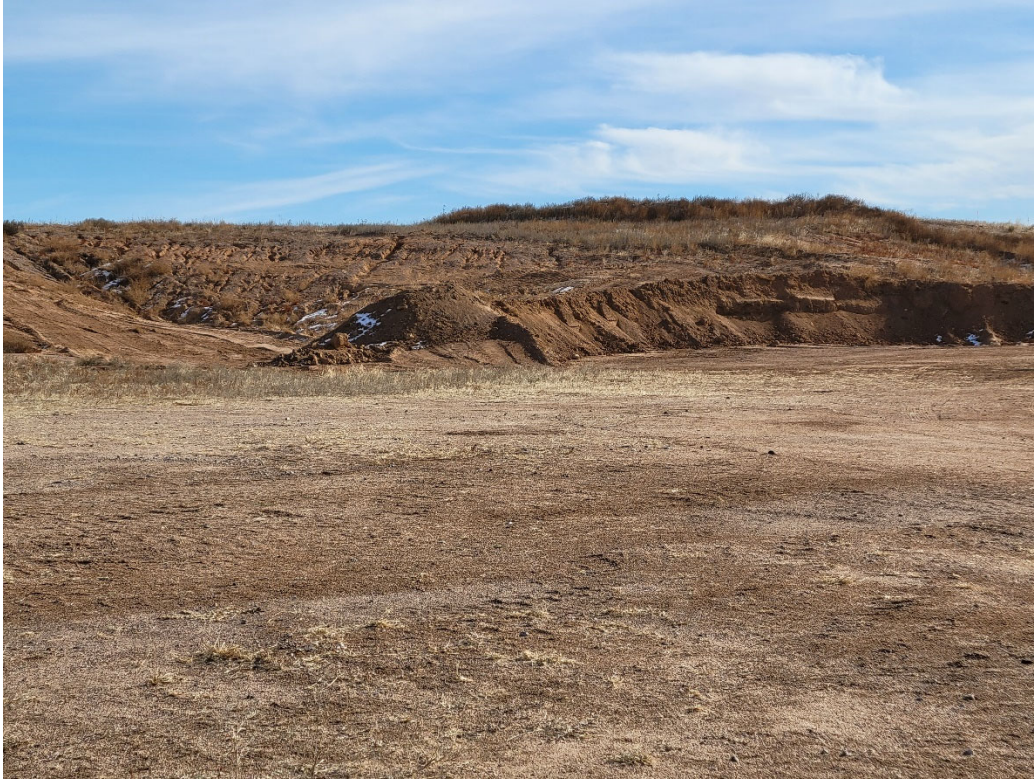
Photo 7: Looking east across the pit floor in the existing permit area.

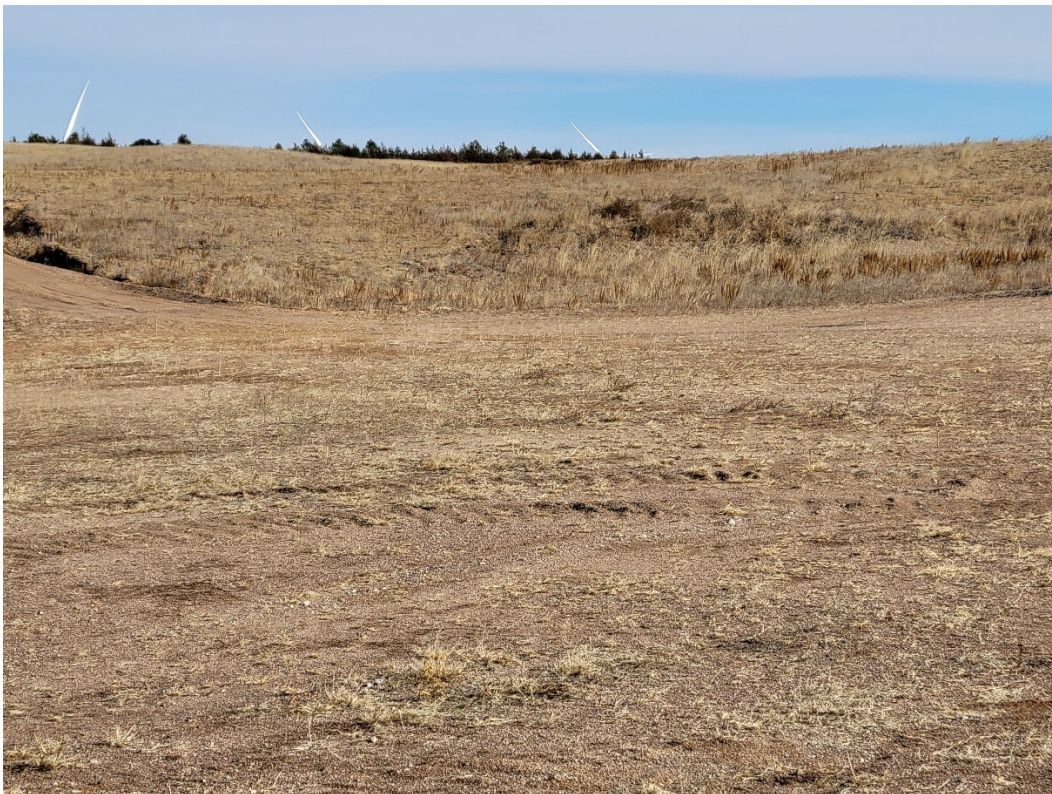
Photo 8: Looking northeast from the pit floor at revegetated slopes in the existing permit area.

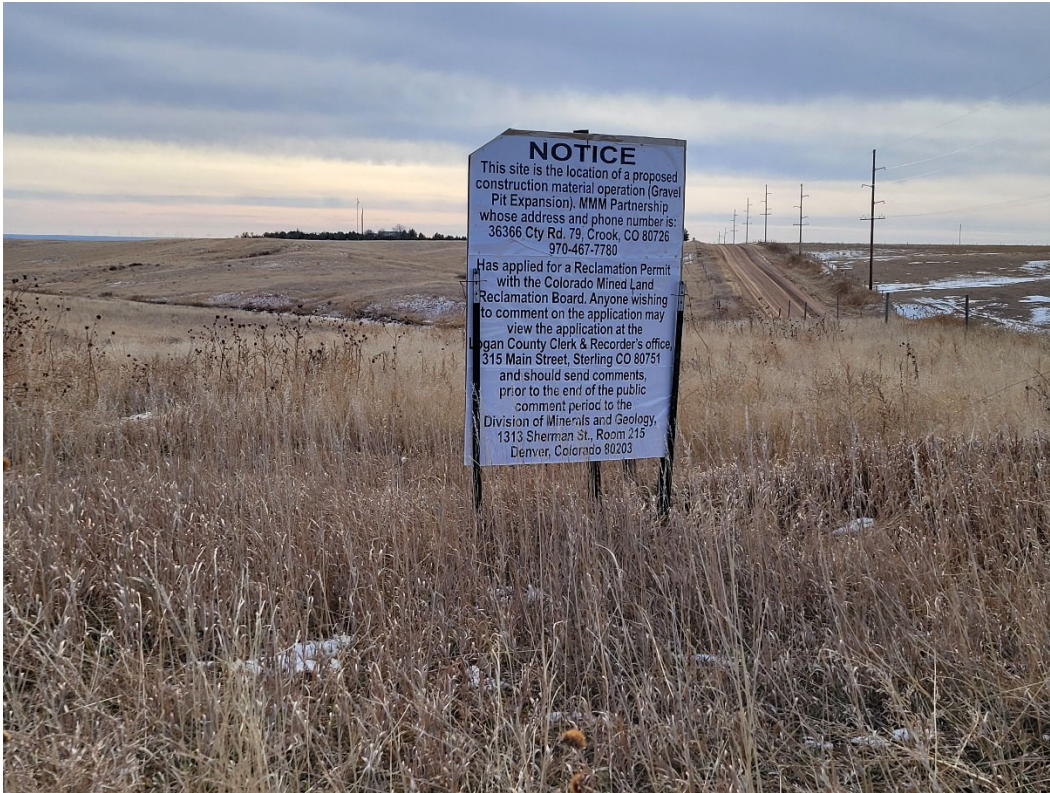
A notice sign required by 1.6.2(1)(b) was posted at the entrance to the site. The amendment area was surveyed, and GPS points were submitted with the application. Boundary markers are installed at the survey points around the perimeter of the expansion area.

Photo 9: Notice sign posted at the entrance to the site is visible from the county road.
