## MINERALS PROGRAM INSPECTION REPORT

<b>MINE NAME:</b> O'Bannon Pit	<b>MINE/PROSPECTING ID#:</b> M-1980-201	<b>MINERAL:</b> Sand and gravel	<b>COUNTY:</b> Rio Grande
<b>INSPECTION TYPE:</b> Monitoring	<b>WEATHER:</b> Clear	<b>INSP. DATE:</b> November 20, 2023	<b>INSP. TIME:</b> 12:00
<b>OPERATOR:</b> Mathias Concrete, Inc.	<b>OPERATOR REPRESENTATIVE:</b> Darren Black	<b>TYPE OF OPERATION:</b> 112c - Construction Regular Operation	
<b>REASON FOR INSPECTION:</b> Normal I&E Program	<b>BOND CALCULATION TYPE:</b>	<b>BOND AMOUNT:</b> \$19,400.00	
<b>DATE OF COMPLAINT:</b> NA	<b>POST INSP. CONTACTS:</b> None	<b>JOINT INSP. AGENCY:</b> None	
<b>INSPECTOR(S):</b> Todd Jesse	<b>INSPECTOR'S SIGNATURE:</b>

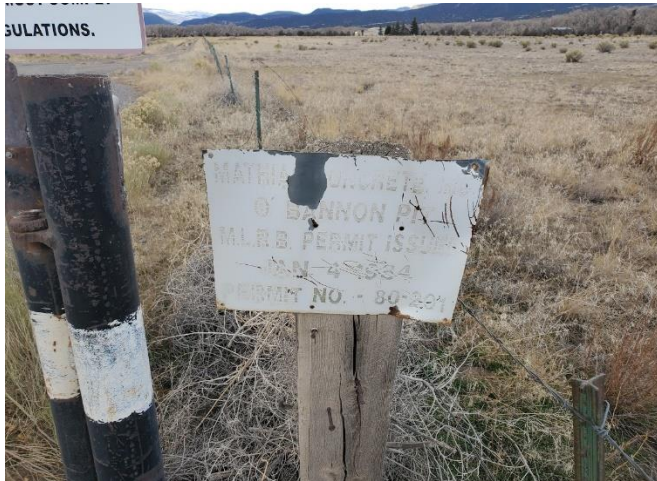
The proper mine identification signage was posted at the entrance to the site. Permit boundaries are clearly marked with fence line. Mining has been conducted according to the submitted plan. Material was extracted at approximately reclamation grade resulting in no highwall in the majority of the pit. In the mining area there is a highwall that measures roughly 20 foot high by 300 foot long. The side slopes of the pit are stable and well vegetated with volunteer species - showing no signs of erosion or slumping. The pit floor has multiple stockpiles of various sized materials both processed and unprocessed. In addition to product stockpiles there is also a topsoil pile on site. There appears to be an adequate amount of topsoil stockpiled for the permitted reclamation plan. All stockpiles are protected by volunteer plant species and appear stable. No state listed invasive species were identified on site during the inspection. No evidence of exposed groundwater was found on site.

View to the west of proper Mine ID signage. Fenceline in the background marks permit boundary.

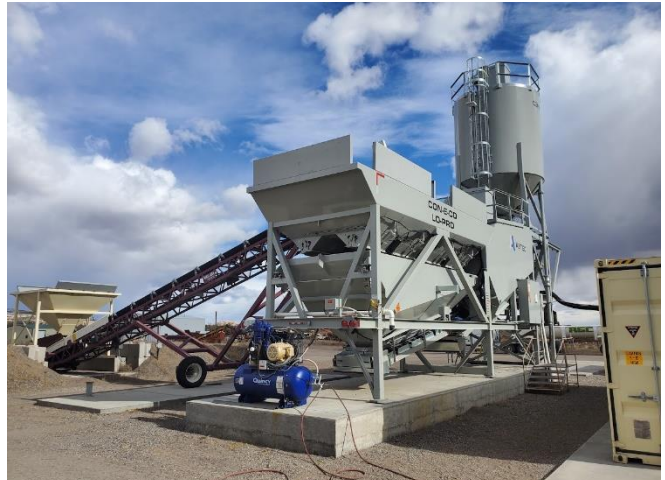
On-site facilities include an office, shop building, hot plant, and hydrocarbon storage. Hydrocarbons are stored in secondary containment. No evidence of spills or leaks were noted. All facilities are well maintained and clean. Housekeeping on site is impeccable – the yard was even freshly graded.

View to the east of batch plant on site. Equipment is clean and well kept.

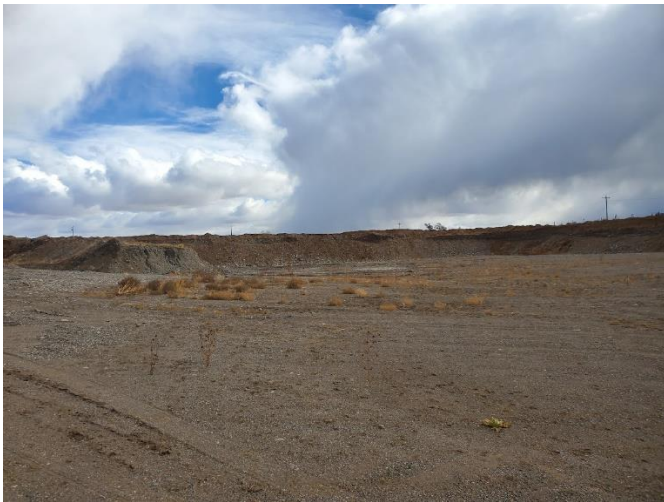
View to the southeast of the mining area and highwall.

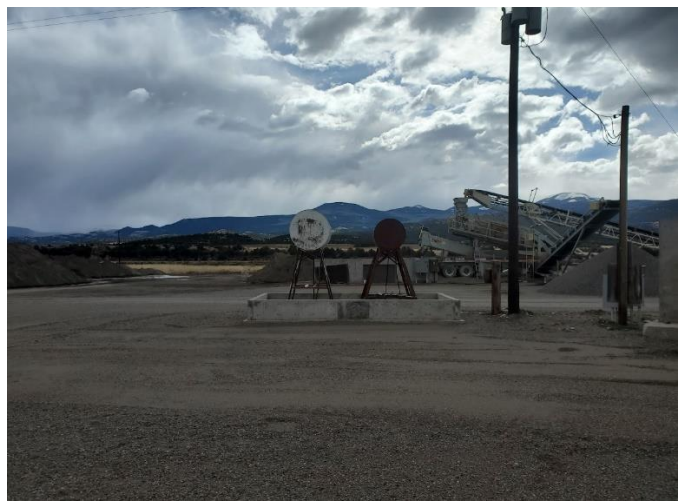
View to the south of hydrocarbons in secondary containment.

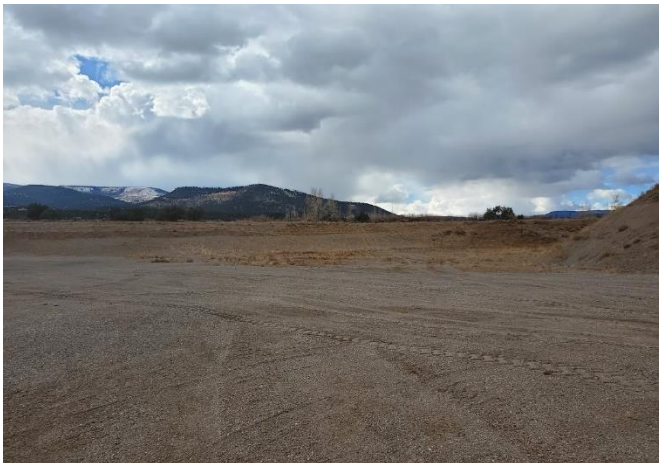
View to the southwest of southwest corner of the pit. Pit walls are at reclamation grade. No signs of exposed groundwater.

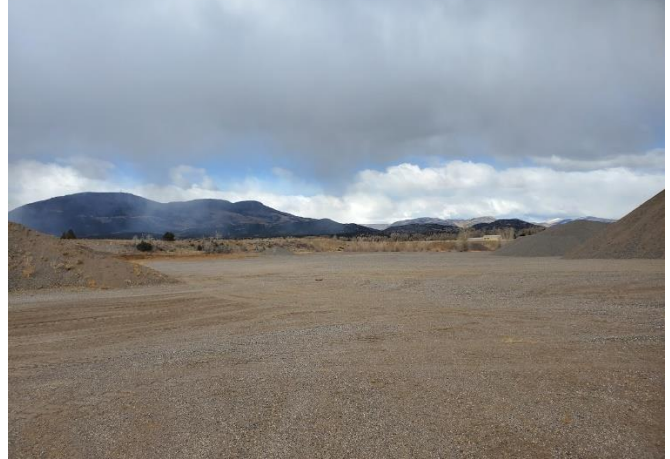
View to the northwest of northwest corner of the pit. Pit walls are at reclamation grade.
