Bowie #1 inspection report

Permit Number: C-1981-038 Mine Name: Bowie No. 1 Mine Operator: Bowie Resources, LLC Operator Address: Mr. Basil R Bear P.O. Box 1488 Paonia, CO 81428	County: Delta Operation Type: Underground Permit Status: Active Ownership: Private
	Operator Representative Present: None
Operator Representative Signature: (Field Issuance Only)

Inspection Start Date: December 6, 2023 Inspection Start Time: 10:45 Inspection End Date: December 6, 2023 Inspection End Time: 13:45		Inspection Type: Coal Complete Inspection Inspection Reason: Normal I&E Program Weather: Clear	
Joint Inspection Agency: None		Joint Inspection Contacts: 	
Post Inspection Agency: None		Post Inspection Contacts: 	
Inspector(s): Robert Zuber, P.E.	Inspector's Signature:

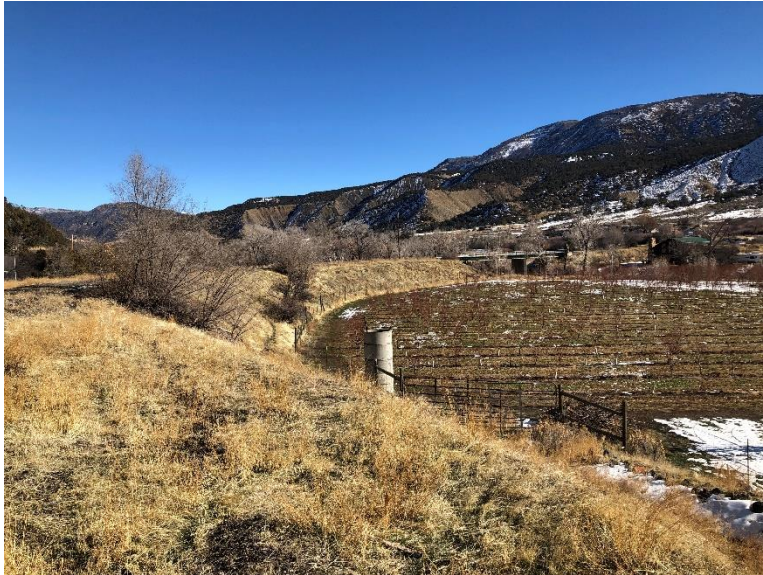
No erosion was seen at the loadout, including the steep slope between the loadout and the orchard below. The trestle across the river appears stable.

East side of slope below the loadout with bridge in background

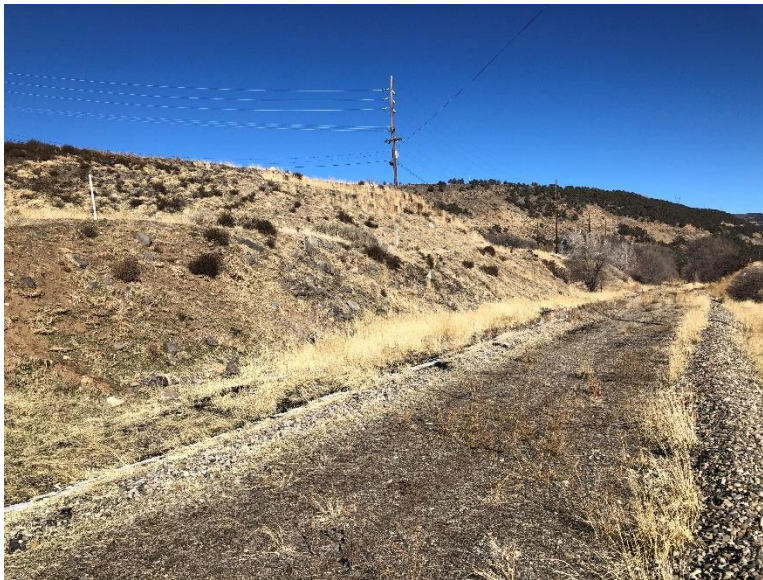
West side of slope below the loadout

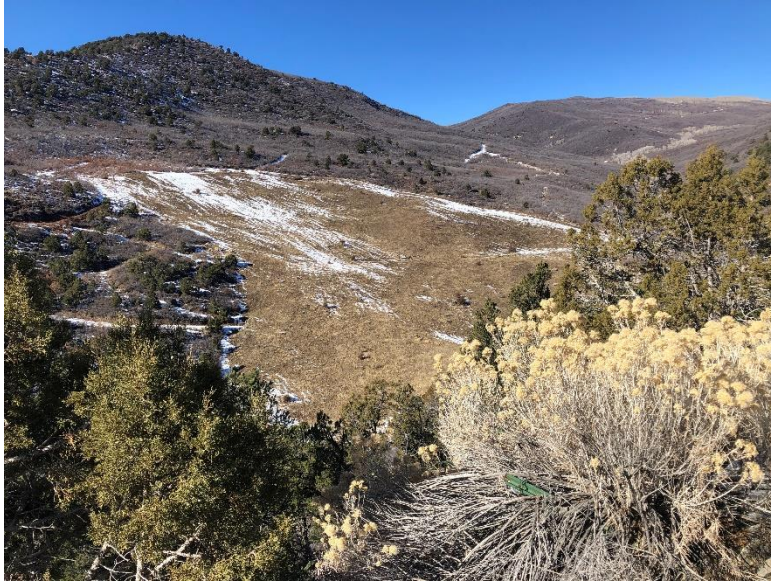
The ponds at the loadout, the Coal Storage Area (near Black Bridge Road), and the West Mine were empty of water or close to empty, and no problems were identified with these ponds.

West Mine from Johnson Road

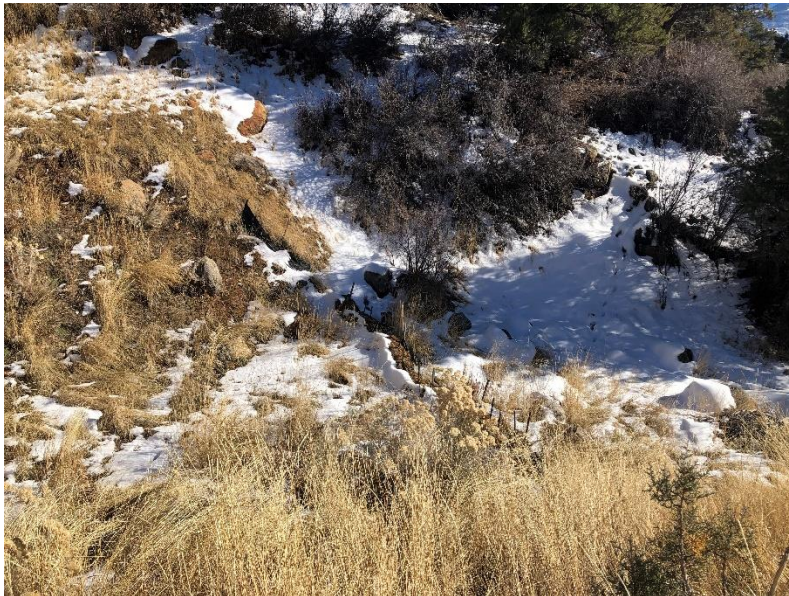
No erosion was seen at the reclaimed areas of the East Mine, including the drainage where the reclaimed ponds (Ponds 1 – 4) are located.

Straw bales at reclaimed Pond 4, below the East Mine
