MINERALS PROGRAM INSPECTION REPORT
PHONE: (303) 866-3567

MINE NAME: Shot Rock Pit	MINE/PROSPECTING ID#: M-2012-023	MINERAL: Crushed stone material	COUNTY: Las Animas
INSPECTION TYPE: Monitoring	WEATHER: Clear	INSP. DATE: November 28, 2023	INSP. TIME: 01:00
OPERATOR: Tamrock Gravel LLC	OPERATOR REPRESENTATIVE: Brent and Tami Tamburelli	TYPE OF OPERATION: 112c - Construction Regular Operation	
REASON FOR INSPECTION: Normal I&E Program	BOND CALCULATION TYPE: Complete Bond	BOND AMOUNT: \$22,800.00	
DATE OF COMPLAINT: NA	POST INSP. CONTACTS: None	JOINT INSP. AGENCY: None	
INSPECTOR(S): Amber Gibson	INSPECTOR'S SIGNATURE:

INSPECTION TOPIC: Slides & Other Damage

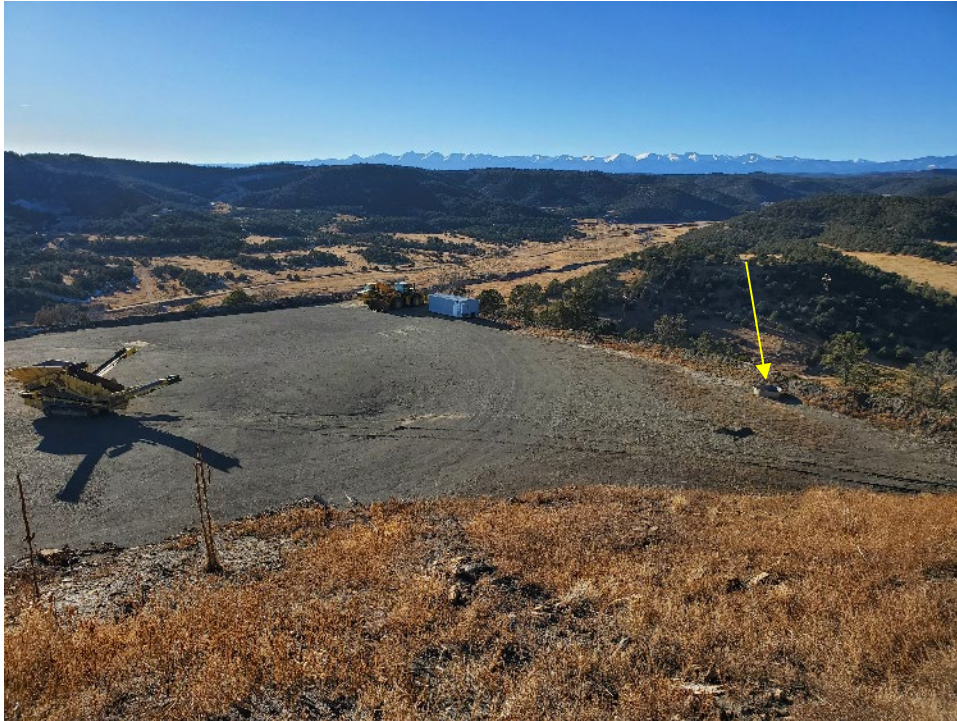
The Division did not observe the presence of toxic chemicals onsite. A round basin was observed near the portable office trailer on the west side of the site (see Photo 1 & Map 1). The Operator stated that this acted as a secondary containment structure when fuel was being stored on-site. No fuel storage remained on-site at the time of the inspection.

A portable office trailer and a few pieces of equipment (a screener, front end loader, and a haul truck) are currently on-site (Photo 1: Map 1). The excavator that will be used for backfilling is at another one of the Operator's projects, but will be transported back for use in reclamation tasks.

Photo 1: Looking at the western corner of the site. Pictured is equipment, a portable office, and an empty fuel tank barrier tub (arrow).

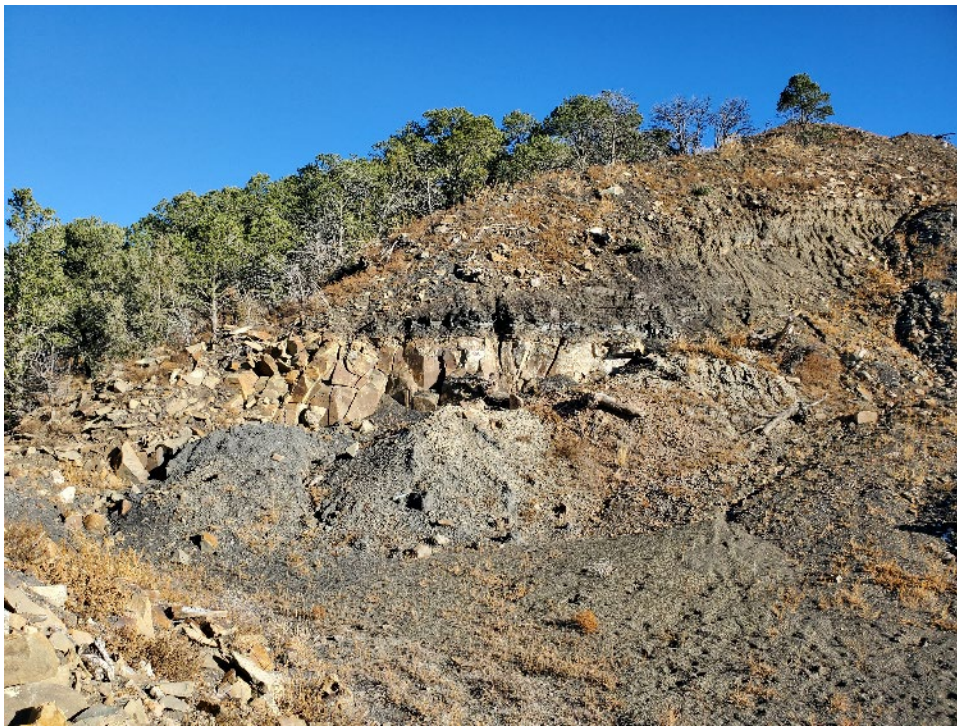
Photo 2: Looking at the western-most extent of the highwall. Overburden is stockpiled above and below the cut.

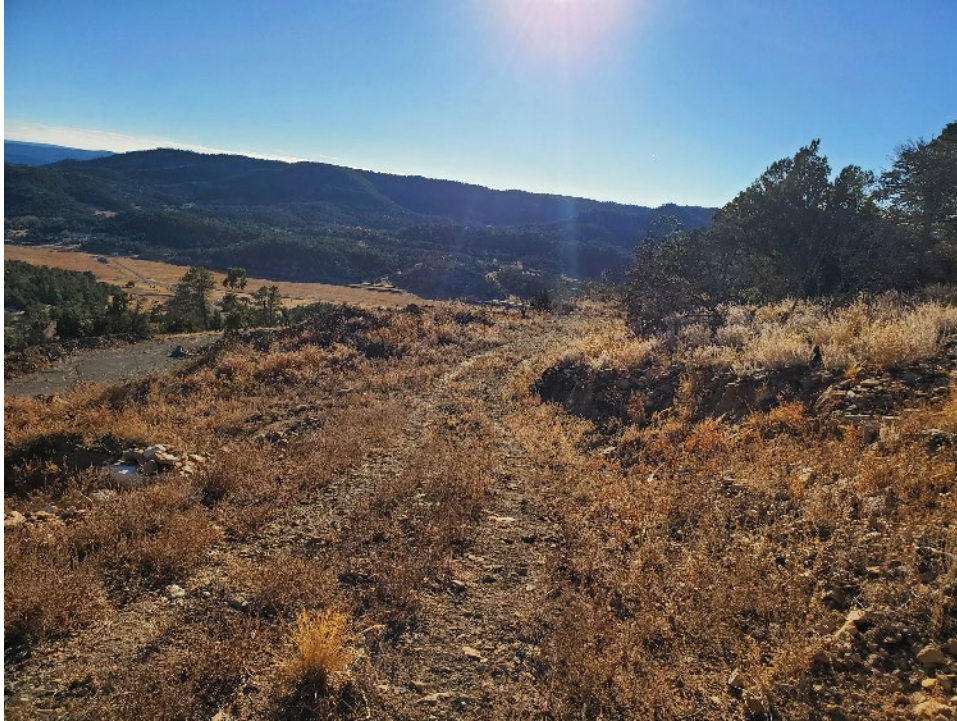
Photo 3: Two track road that runs along the top of the highwall. Overburden is stockpiled to the south of the road, and a few topsoil piles are stockpiled to the north along the road.

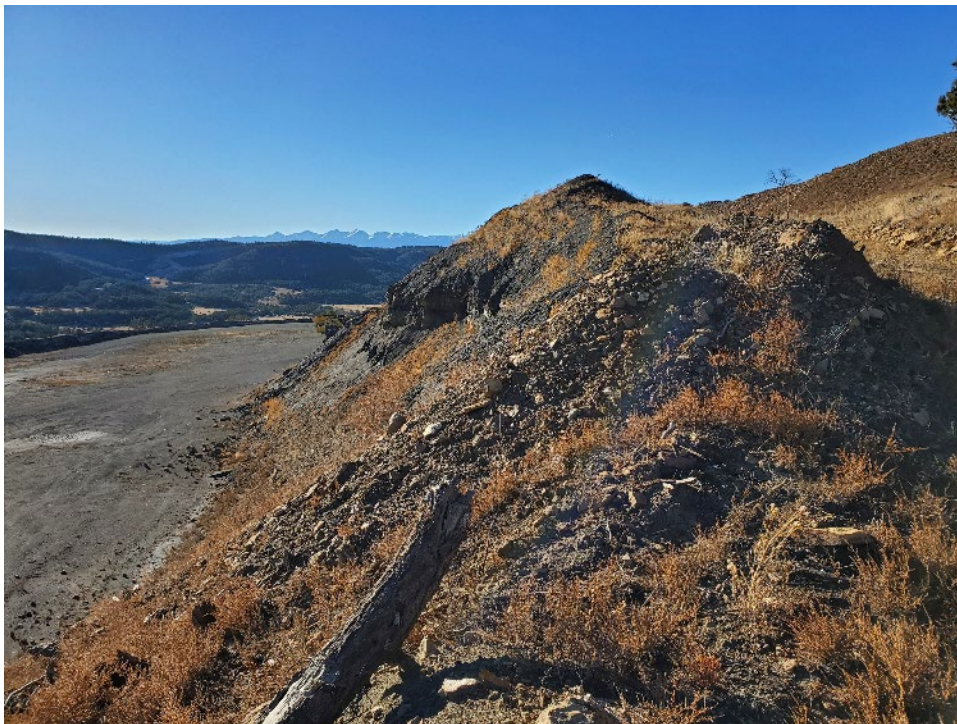
Photo 4: Looking west along the highwall from the top.

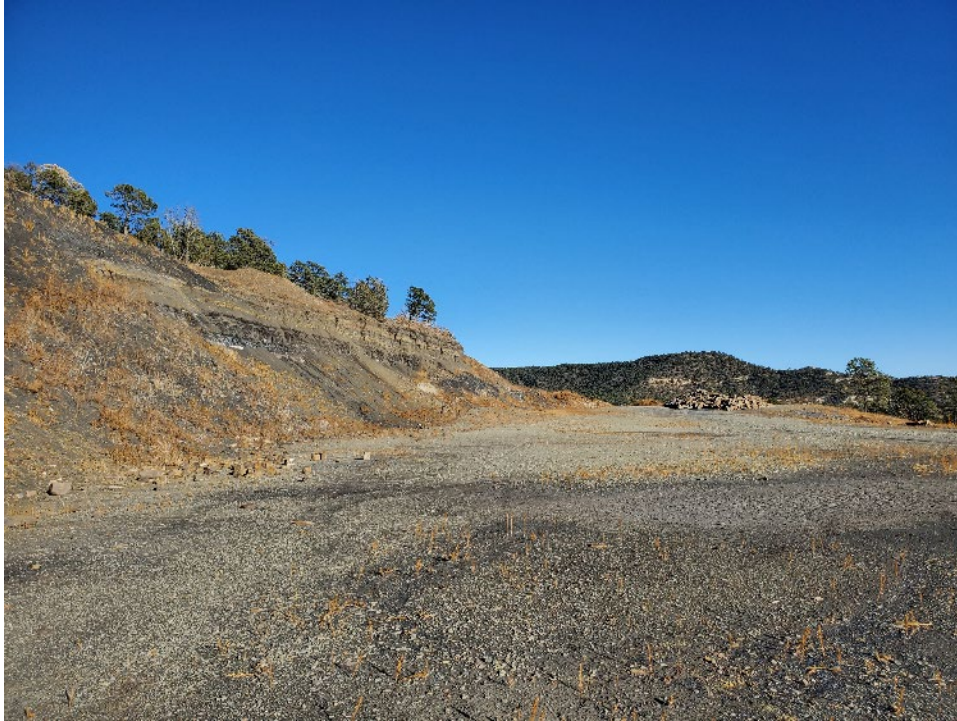
Photo 5: Looking east along the highwall in the pit area.

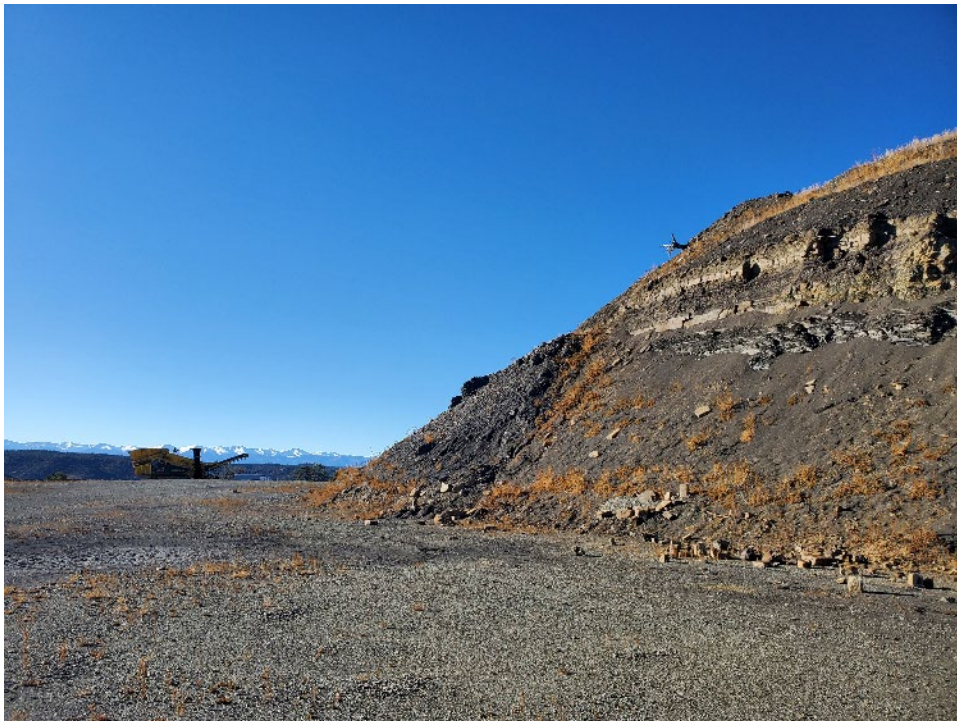
Photo 6: Looking west along the highwall in the pit area. The maximum height of the highwall is estimated at 17' from field measurements.

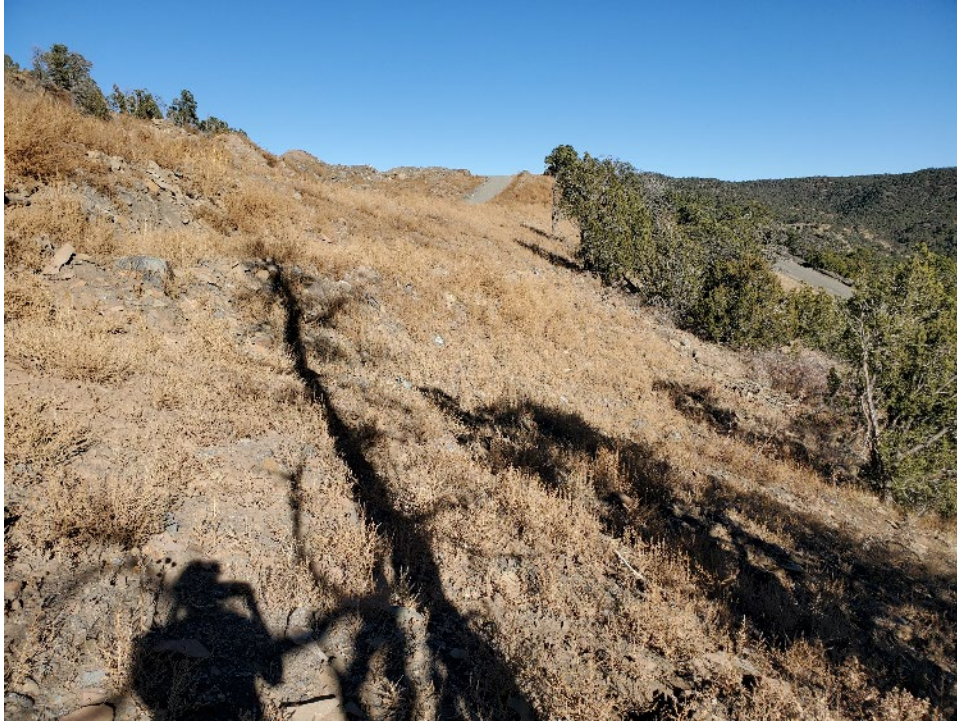
However, during the inspection, the Operator stated that they instead intend to backfill the entire highwall to at least a 3H:1V slope. Onsite, there is backfill and overburden material along the top of the highwall, as well as at the bases (Photos 2-6 & Map 1). The Operator also wants to reduce the slope along the south-side of the permit, by pulling material in from the MSHA berm and overburden material that had been placed on the south slope, back up into the pit area. The Division is in agreement with the Operator, that reducing the slopes at the site further than what was planned will better help to reduce erosion onsite and facilitate re-vegetation. Some material has already been replaced on-site. Where the road from the equipment storage area (Plant Area on mine plan map) leads down into the pit, the ground beneath had been blasted and regraded (see

Photo 7 & Map 1). The Operator stated that they are not ready to seed that area because they plan to re-disturb it and create armored ditches throughout to aid in sediment control.

Photo 7: Looking east downslope of the internal road.

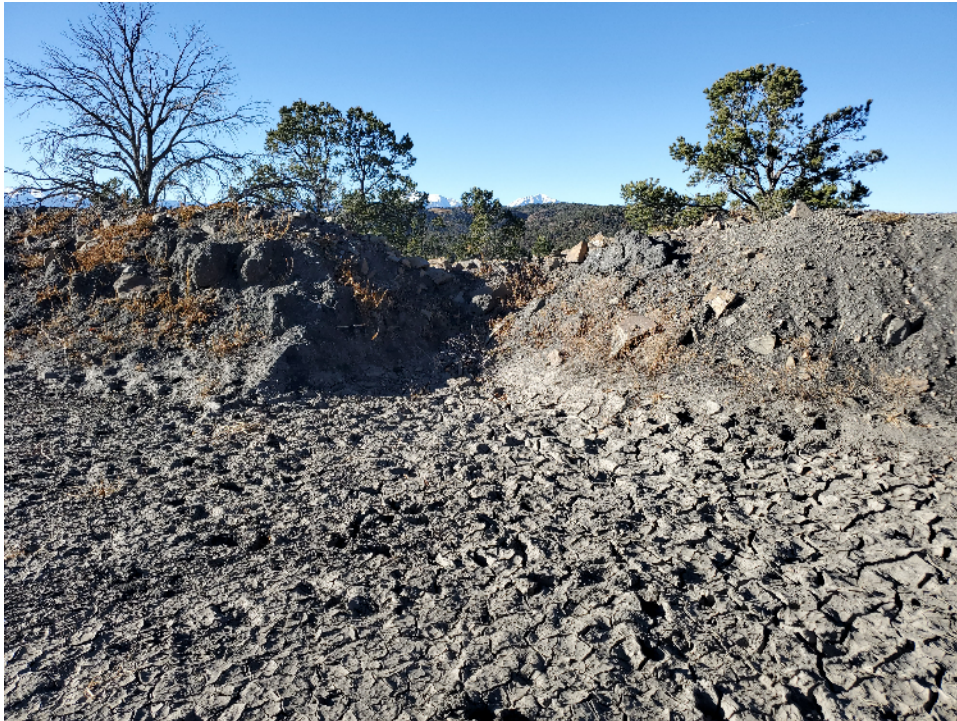
No standing water was observed onsite during the inspection. The Operator has ensured that areas where water tends to flow to have been walled off through the use of berms (Photo 8; Map 1), or slowed down by installing armored ditches (Photo 9; Map 1).

Photo 8: Looking west at an area along the pit boundary that had accumulated water. The berms in place have helped to control sedimentation and erosion from leaving the site in this area.

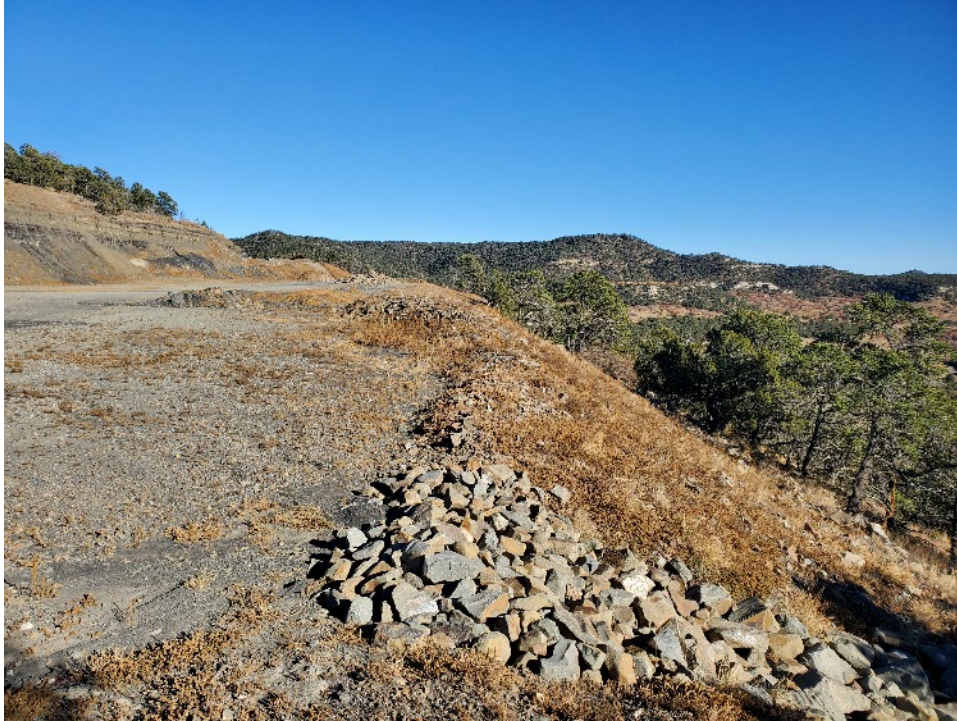
Photo 9: Looking east at an armored channel installed to help with sediment control onsite.

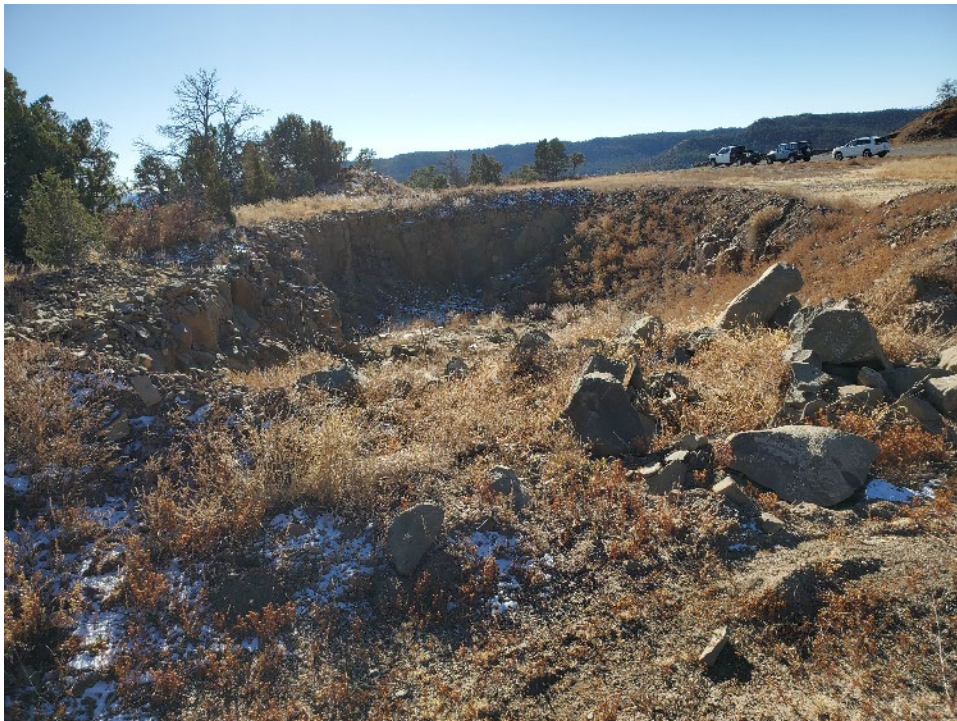
A disturbed area near the entrance to the site (Photo 10; Map 1) is shown on the Pre-Mining map as present prior to the issuance of the permit, as a result of a historic operation conducted in the area. This has not been re-disturbed since the permit has been issued. The western portion of the permit had also been disturbed by a previous mine, and consisted of partially reclaimed areas from the previous operation. This area has been re-disturbed as a result of permitted actions.

Photo 10: Looking west at the 'Old mine' disturbance located in the east corner of the site.

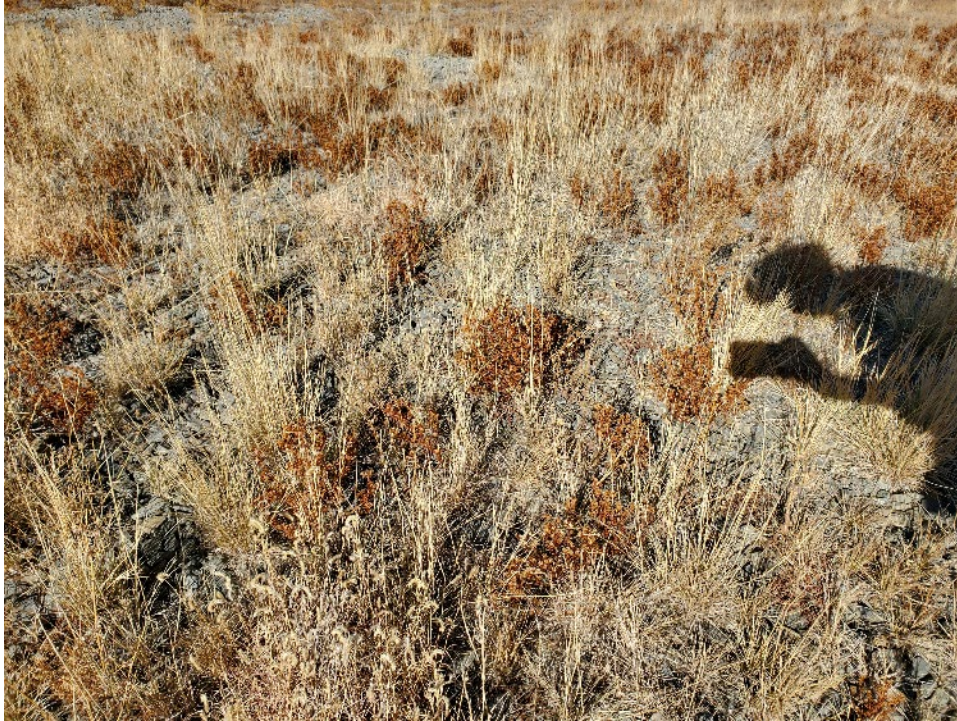
Near the entrance to the site, where equipment had been stored during mining, the Division observed a variety of grasses growing through the rubble (Photo 11; Map 1). When asked if the Operators had done some broadcast seeding in this area, they stated that they had, and that they were testing how well the seed would

germinate. At this time, the Operator has not replaced any topsoil or seeded outside of the testing area.

Photo 11: Variety of grasses growing in the test area in the east portion of the site where broadcast seeding had been done.

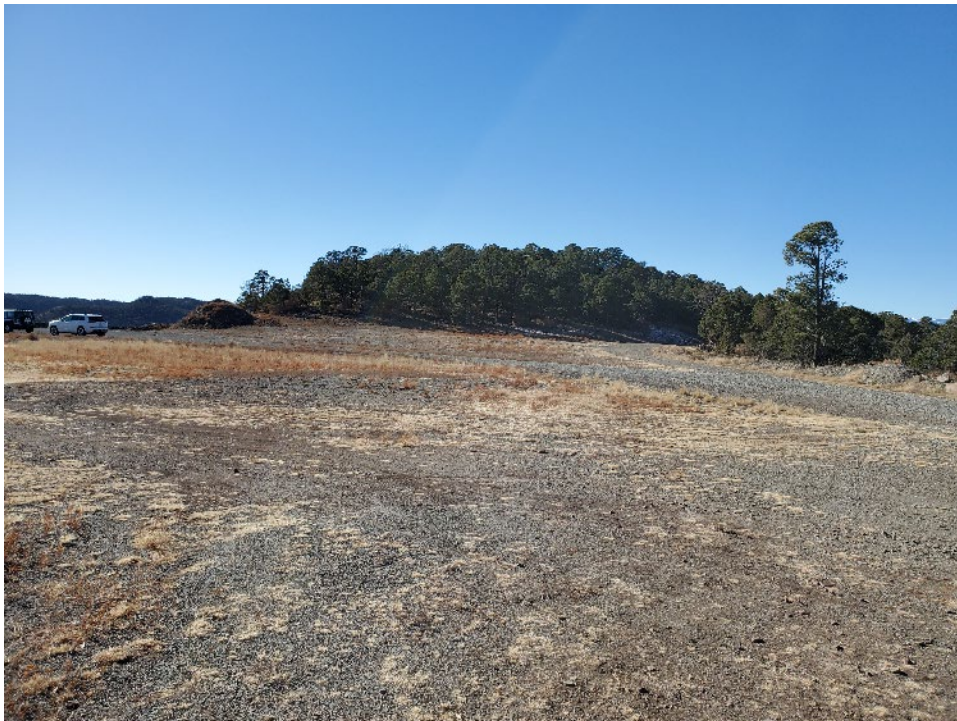
Photo 12: Looking north across the equipment storage area (Plant Area on Mine Map). Approximately 11 acres of area along the northern boundary of the permit is undisturbed and contains various woody vegetation.

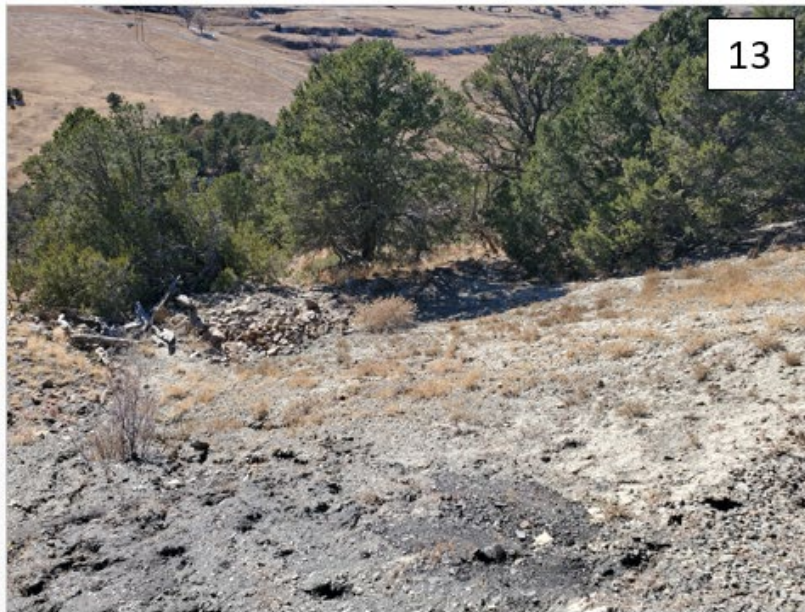
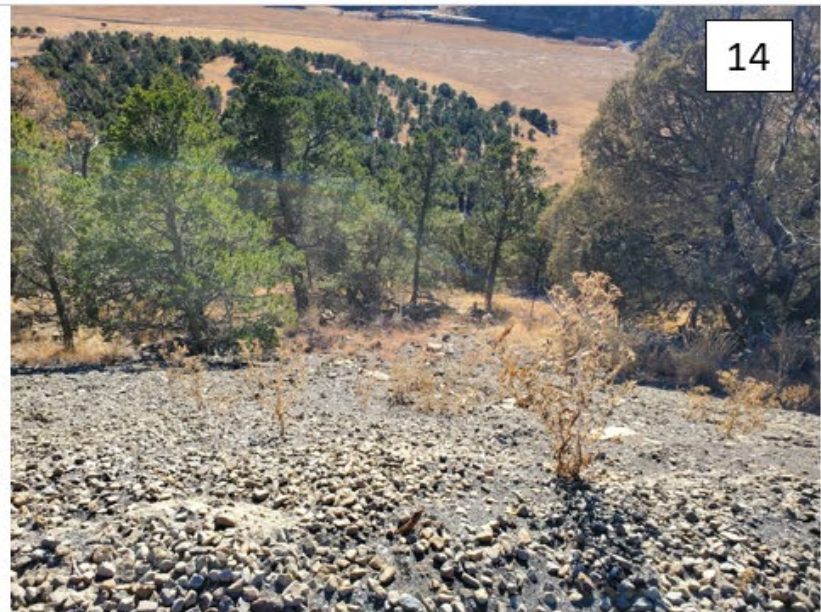
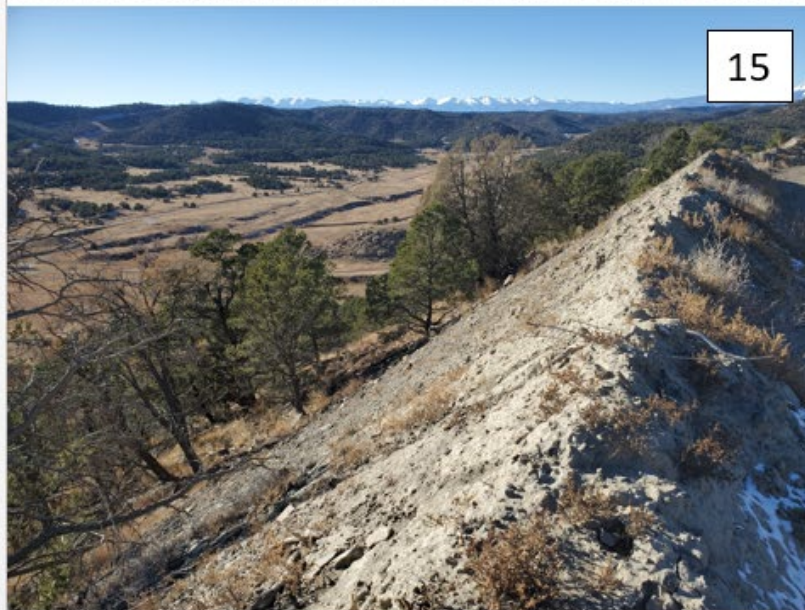
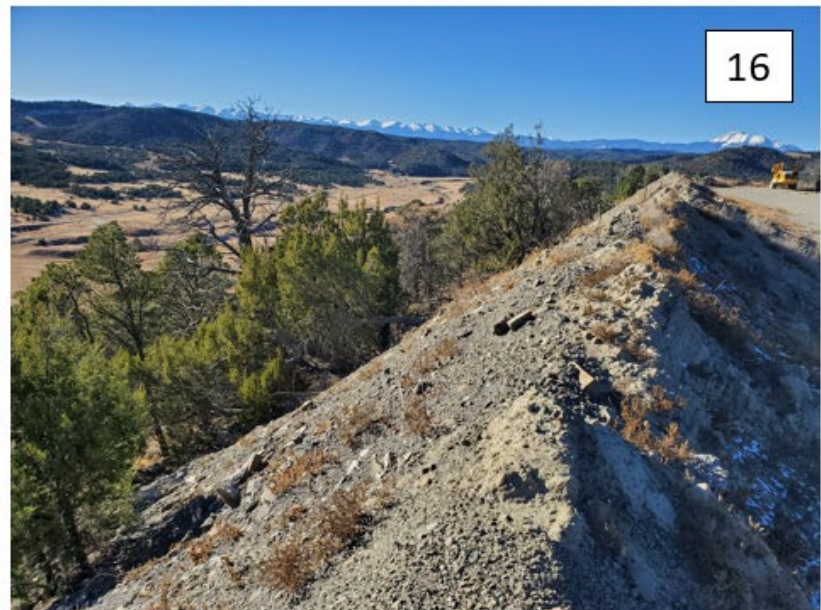
POSSIBLE VIOLATION: Approximately 0.34 acres of land has been affected outside of the approved permit boundary near the approved permit site, in addition to the 0.62 acres near the entrance road to the operation cited in the previous inspection report for the Division's October 24, 2023 inspection. This brings the total off-site disturbance to 0.96 acres. This is a possible violation at this time pursuant to: 1.) C.R.S. 34-32.5-109(1) for failure to first obtain from the board or office a reclamation permit prior to engaging in a new operation. AND/OR 2.) C.R.S. 34-32.5-116(4)(i) for failure to protect areas outside of the affected land from slides or damages occurring during the mining operation.

Additionally, along the south-west portion of the permit, where the Operator stated that they were required by MSHA to build higher safety berms, approximately 0.23 acres contain material that appears to have slid down-slope and off-site (see Map 1 and Figure 1).

Photo 13-16: Photos 13 and 14 are looking downslope, and Photos 15 and 16 are looking across, the MSHA berms in the south-west portion of the permit. Sliding has occurred downslope of these berms.

CORRECTIVE ACTIONS: This possible violation will require a hearing before the Mined Land Reclamation Board. The schedule and other details for the MLRB hearing will be provided under a separate document to be sent via certified mail to the Operator.

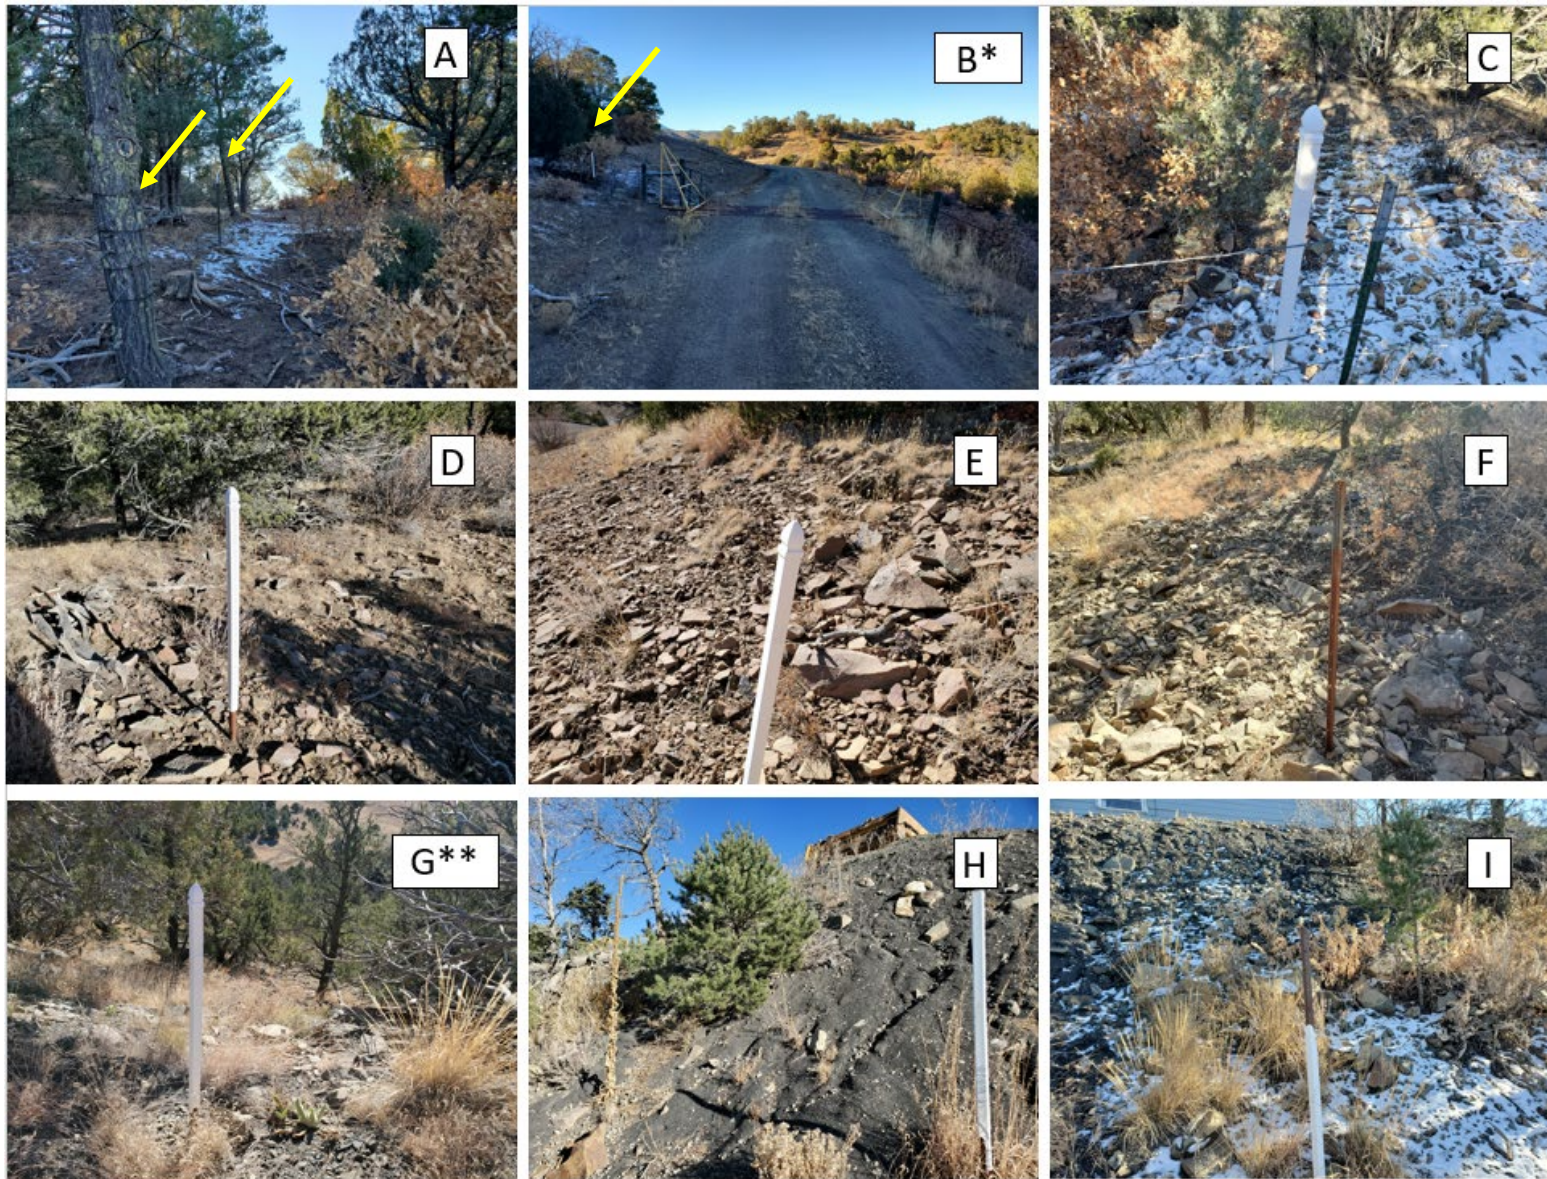
PROBLEM: The affected area boundary markers are missing or incorrectly placed. This is a problem for failure to maintain boundary markers around the affected area as required by Section 3.1.12(2) of the rule.

Where the red polygons indicate off-site damage, no permit boundary markers were located in the immediate vicinity. Additionally, the markers on the west side of the permit appear to be located more inland than what is depicted on the Mine Plan map.

The affected area boundary is marked on the north, east, and south-east side of the permit boundary. The markers in the west corner do not appear to follow the affected boundary. The entire 21 acre area of the permit is approved to be affected, with 3.54 acres of it designated as set-backs along the boundary, ranging from 15 to 110 feet in from the boundary. It appears the set backs are marked along the western edge of the boundary, but not the affected/permit boundary itself. This has been **cited above as a problem**. The Operator shall install permit/affected boundary markers along the south and west border of the operation, and provide photographs and coordinates of the markers to the Division by the corrective action date.

Photo 17 A-I (red icon markers on Map 1): Photos 17 A – I indicate the permit boundary locations observed in the field during the November 2023 inspection.
**Red icon on Map 1 for B indicates the marker's location – not the photo capture location. **Photo for G was taken while streaming a path in Esri Field maps (see purple path on Map 1), an exact point along the line was not saved.*

CORRECTIVE ACTIONS: The Operator shall replace the boundary markers in the correct location(s). The

Operator shall provide photos and coordinates as proof to the Division that this has been done by the corrective action date.

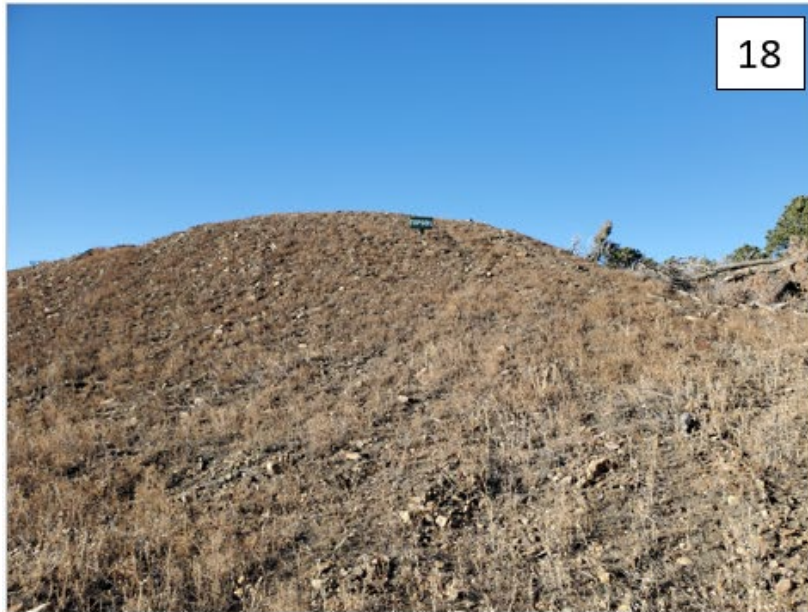
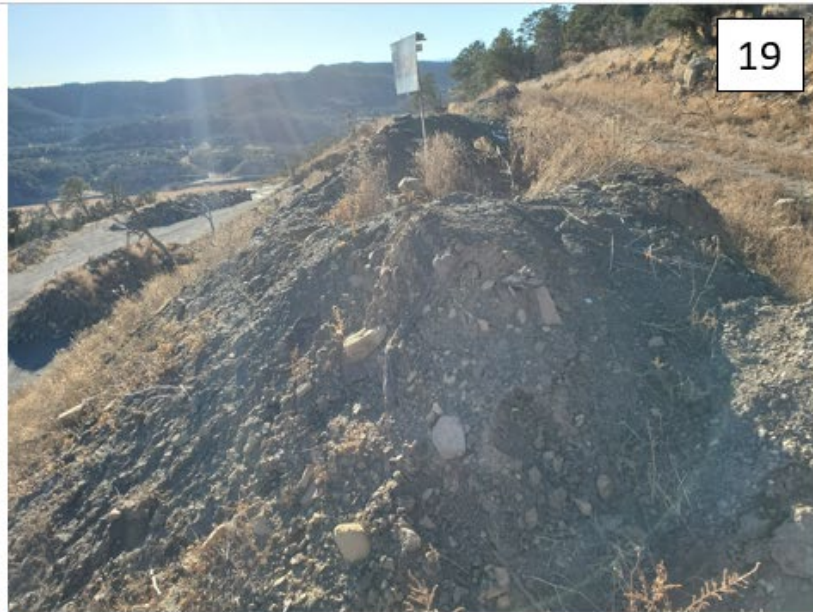
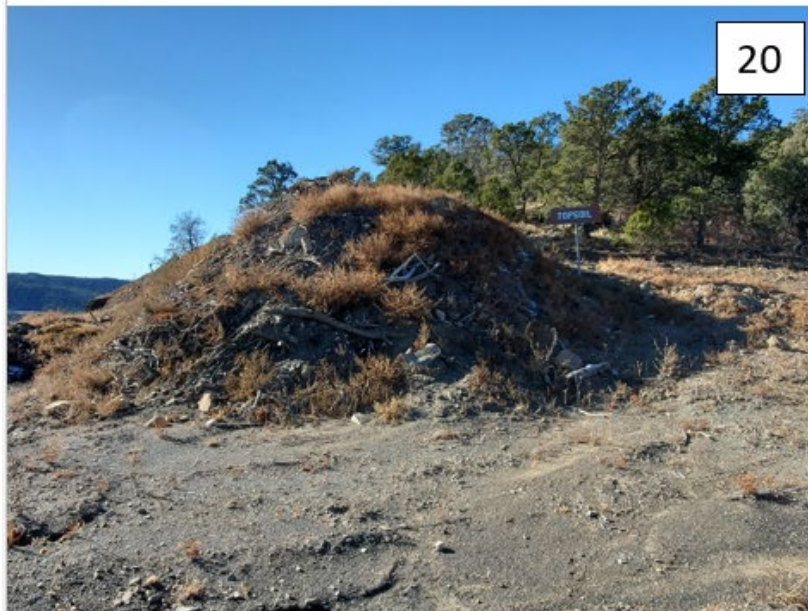
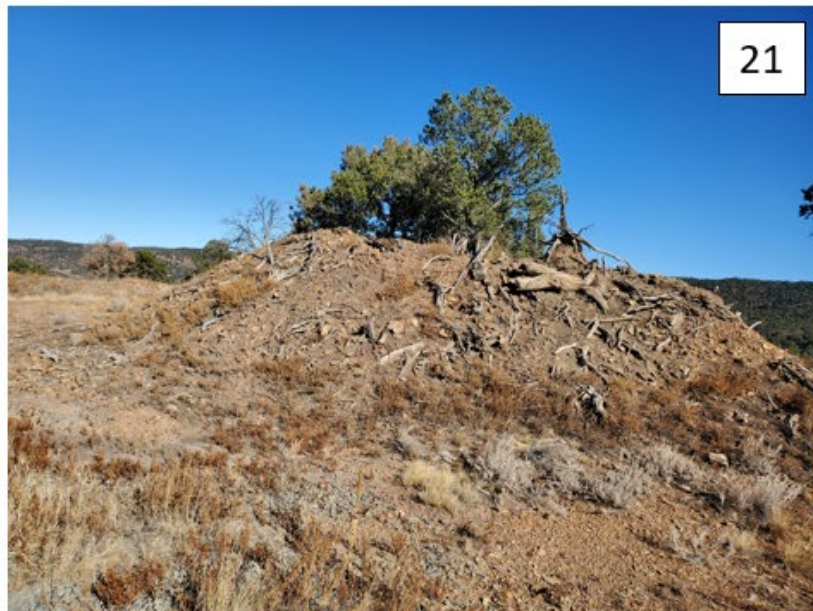
Various topsoil piles were observed throughout the site (Photos 18-21; Map 1). The Operator has posted signs displaying "Topsoil" at the majority of the locations. The Operator stated that they may also screen some of the overburden piles to collect additional growth medium soil if needed. Many of the topsoil and overburden piles contained large woody debris (Photo 18-22; Map 1). Pursuant to Rule 3.1.9(2), woody vegetation shall be removed from or appropriately incorporated into the existing topsoil prior to excavation within the affected areas. The Operator stated that they left the woody debris in the topsoil to act as compost material. The topsoil piles did not display signs of erosion, and appear to be stable at this time.

Photos 18-21: Photos 18-20 are topsoil piles that were marked with signs. Photo 21 shows a stockpile that the Operator stated is also topsoil. The piles in Photos 20 and 21 contain large woody material.

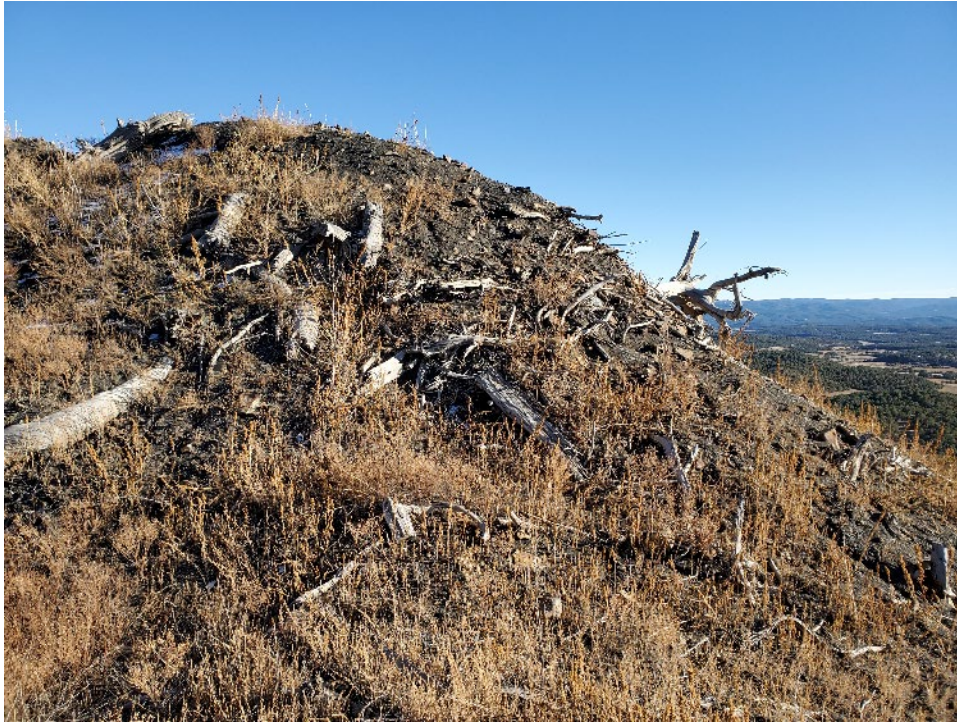
Photo 22: Overburden above the highwall containing woody vegetation.

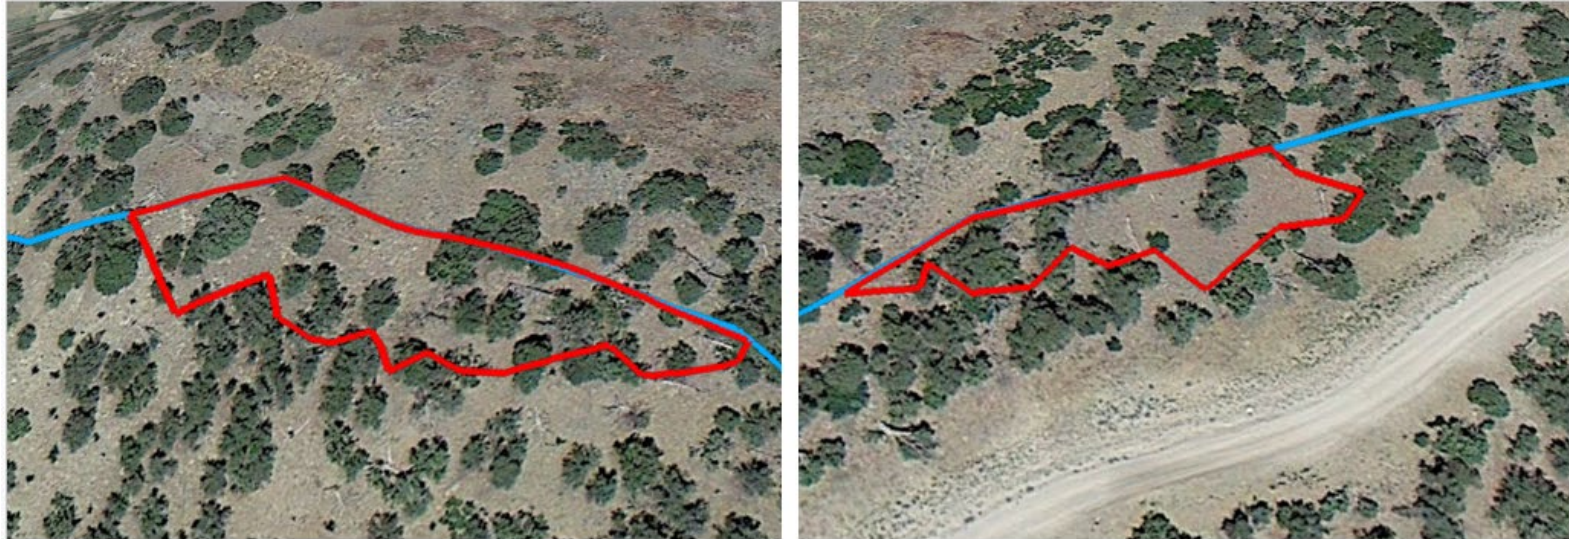
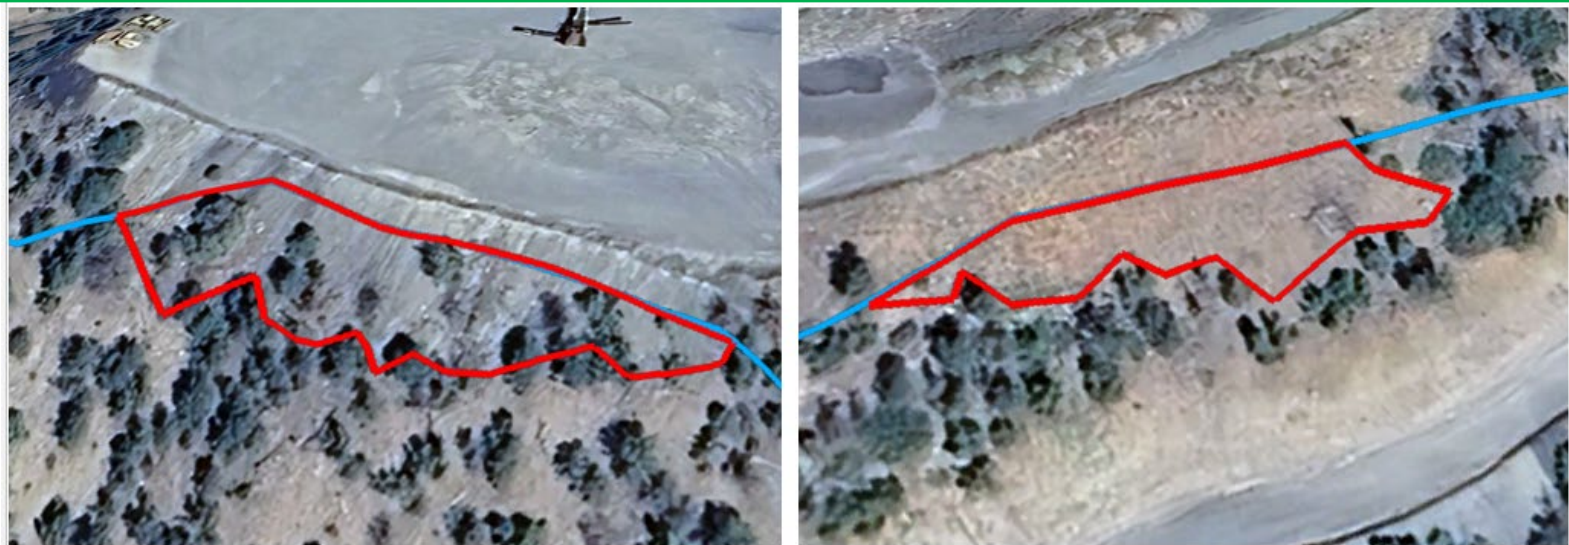
The Operator stated that the area leading down from the equipment storage area on the east side of the permit, had been blasted and backfilled. Further cut and fill work will be conducted in this area, and the Operator also plans to install armored ditches to facilitate controlled drainage. However, upon further review of recent Google Earth Pro aerial images, it appears that an approximately 0.11 acre area outside of the permit boundary has been affected. The Operator had excavated this area and it has since backfilled with material. This backfilled area is downslope of the permit boundary (see Map 1 and Figure 1).

Figure 1: The images on the top row provide a close-up look at the offsite areas in question on Map1 as of May 2012. The images on the bottom represent current on-site conditions within these areas as of October 2023. The area highlighted in the image on the left encompasses an area of approximately 0.23 acres, and the right encompasses approximately 0.11 acres.
