Inspection report for Bowie #2

PERMIT INFORMATION

Permit Number: C-1996-083 Mine Name: Bowie No. 2 Mine Operator: Bowie Resources, LLC Operator Address: Mr. Basil Bear P.O. Box 1488 Paonia, CO 81428	County: Delta Operation Type: Underground Permit Status: Active Ownership: Private
	Operator Representative Present: Basil Bear in office
Operator Representative Signature: (Field Issuance Only)

INSPECTION INFORMATION

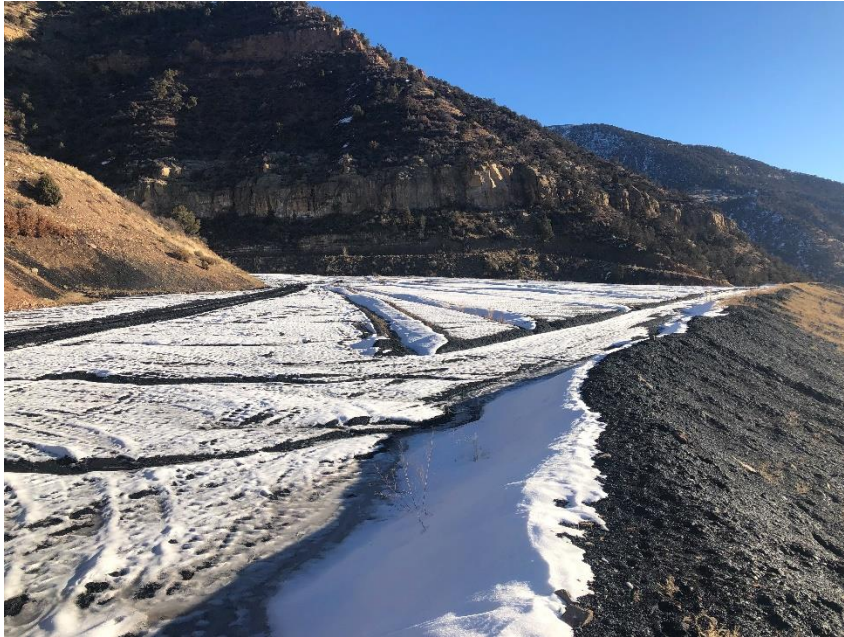
Gob Piles 1, 2, 3, and 4 appeared stable. The small ditches and BMPs on the upper part of Gob Pile #2 appeared to be functioning. The rills on Gob Pile #2 have not gotten worse.

Upper portion of Gob Pile #2

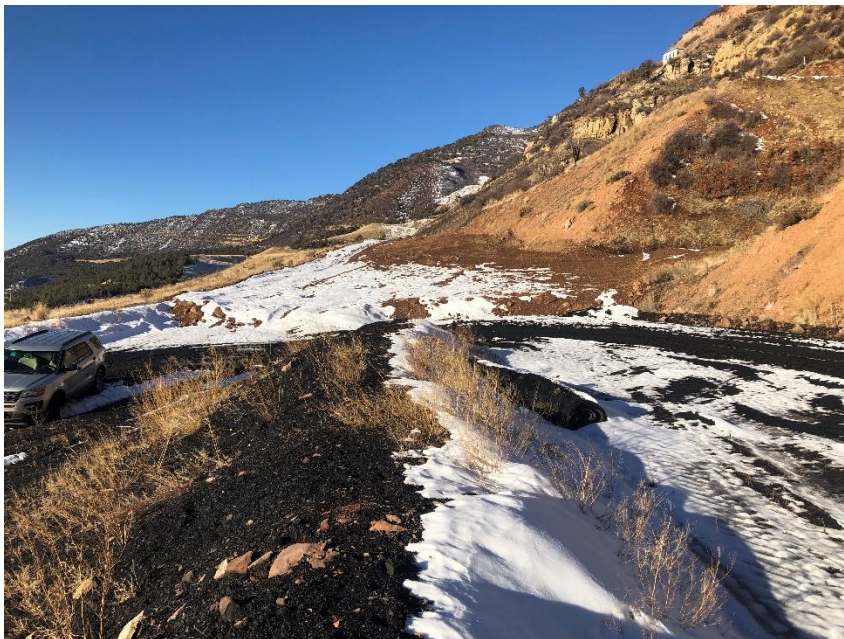
Graded area on west side of Gob Pile #2

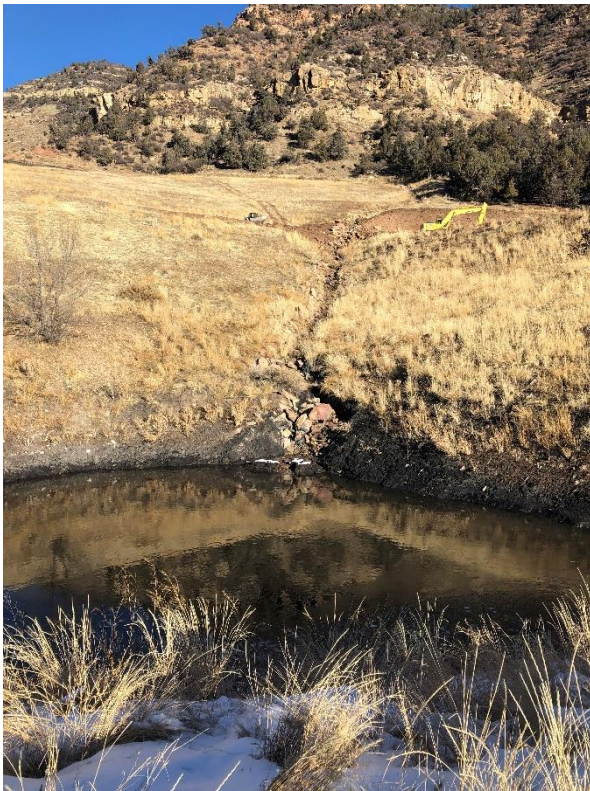
Erosion was seen at the inlet channel on the east side of Pond F. Unless repairs are precluded by safety concerns, this erosion should be addressed with additional riprap. No problems with other ditches were identified.

Erosion of inlet at Pond F

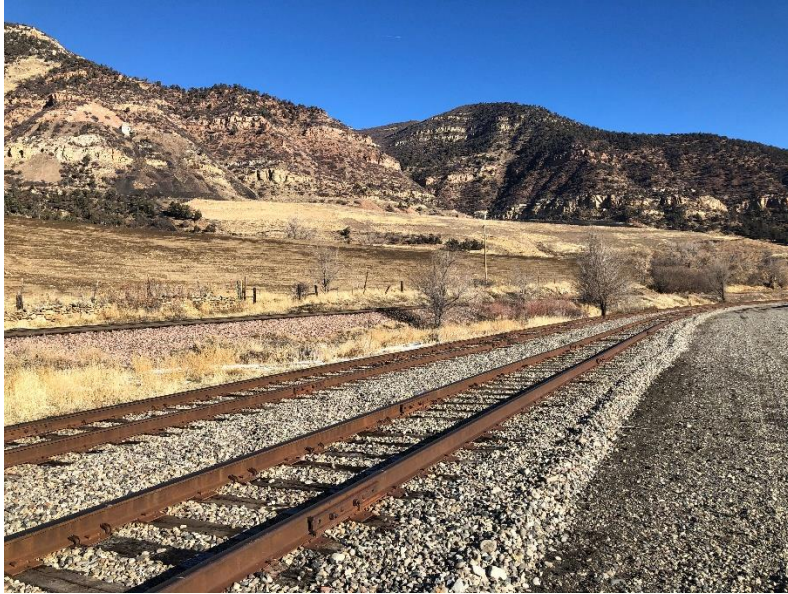
Rail tracks below Gob Pile #3

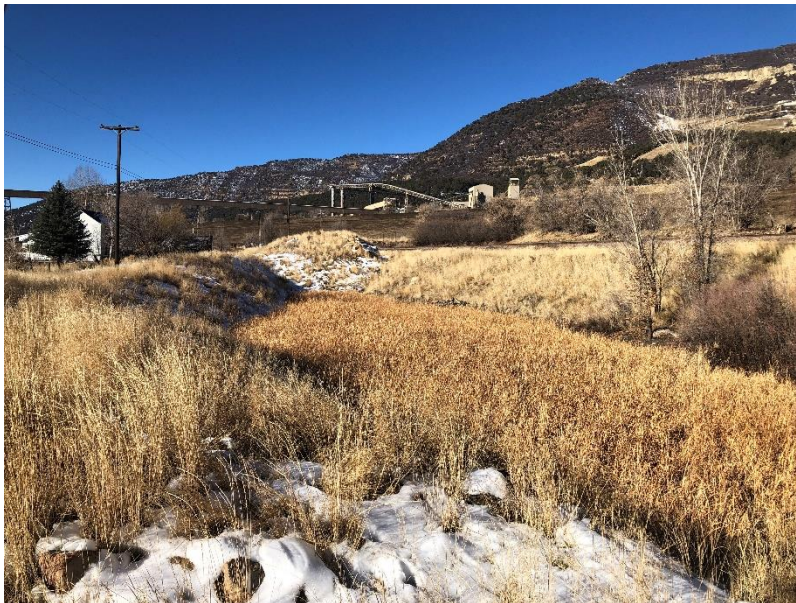
Six sediment ponds were inspected: B, C, D, F, J, and K. None of the ponds were close to discharging. Some were almost dry, but Ponds B and F contained significant water. The bottom of Pond J is obscured by cattails. No significant problems were identified with embankments, spillways, inlet channels, or other features of the ponds.

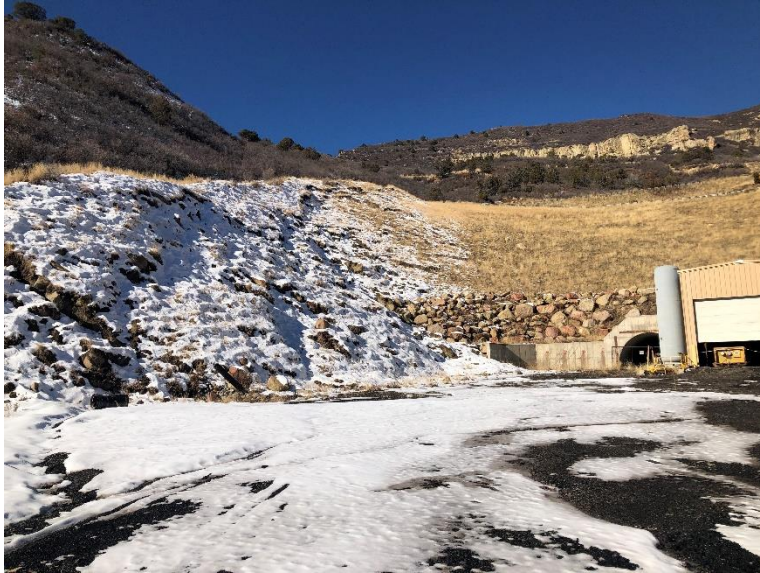
It appears that slumps above Curve Number 6 along the Haul Road, above the B Portal bench, above Curve Number 11, and above the D Portal bench have not moved significantly in recent months. Also, it does not appear that the large slide above Curve Number 10 has moved more in recent months.

Slump at B Portal Bench

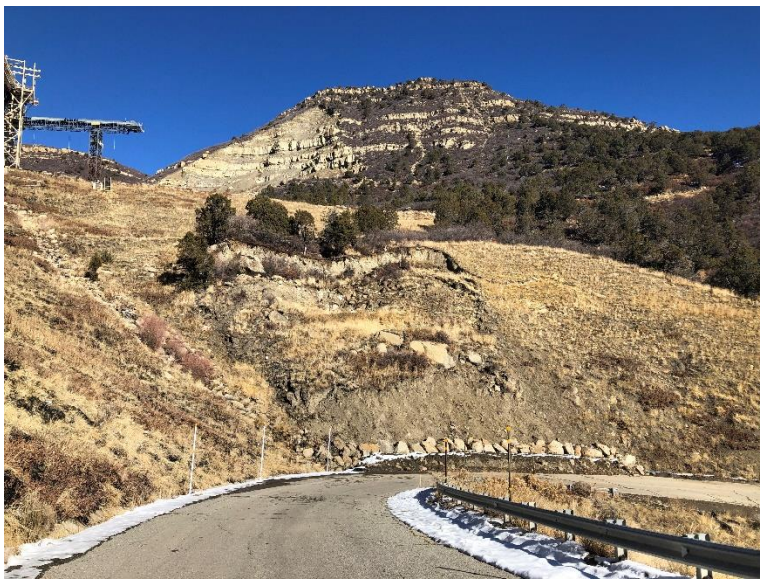
The road to the portals was in adequate condition. The majority of slopes adjacent to this road were stable, with the exception of the slide above Curve 10.

Slide at Curve 10
