### MINERALS PROGRAM INSPECTION REPORT

<b>MINE NAME:</b> Mary's Mountain Gravel Pit	<b>MINE/PROSPECTING ID#:</b> M-2003-068	<b>MINERAL:</b> Sand and gravel	<b>COUNTY:</b> Huerfano
<b>INSPECTION TYPE:</b> Monitoring	<b>WEATHER:</b> Clear	<b>INSP. DATE:</b> November 29, 2023	<b>INSP. TIME:</b> 10:50
<b>OPERATOR:</b> Ronald B. Montano	<b>OPERATOR REPRESENTATIVE:</b> Luis Nunez	<b>TYPE OF OPERATION:</b> 110c - Construction Limited Impact

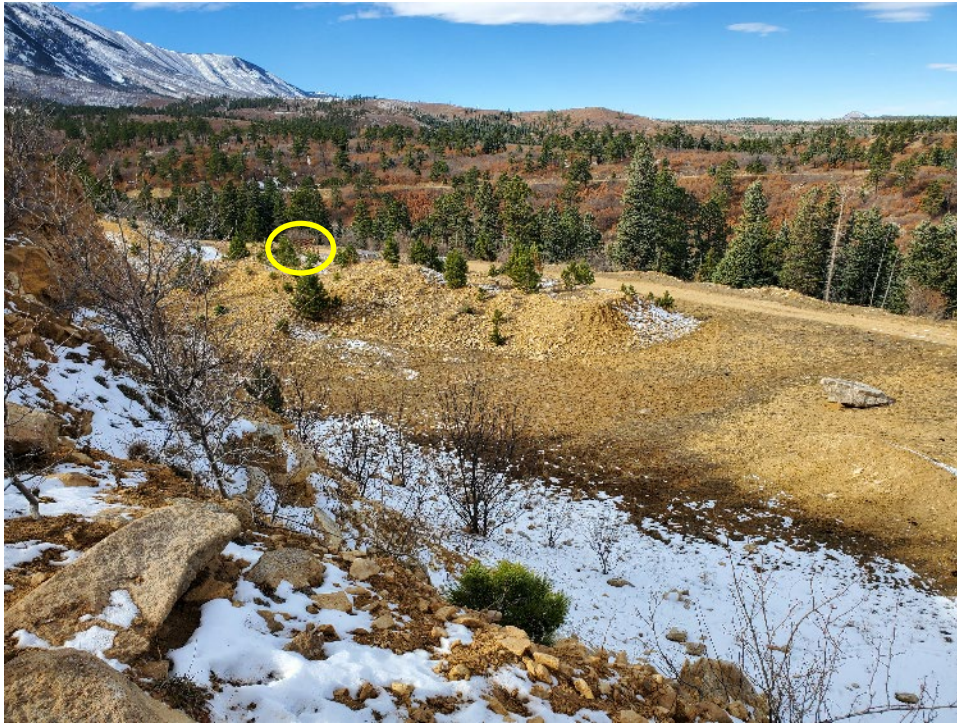
No excavation has occurred on-site since SO1 was approved. The only equipment on-site is a portable grizzly screener (see Photo 1; Map 1). The Division used a combination of Esri Field Maps and Google Earth Pro to estimate the length of the current highwalls at the site to be 817.5 feet long (see red lines on Map 1). The Division and the Operator estimate the maximum height of the highwalls to be about 25-28 feet, with a site-wide average being between 15 and 20 feet.

**Photo 1:** Looking at the west side of the pit from the highwall. Circled in yellow is the portable grizzly screener.

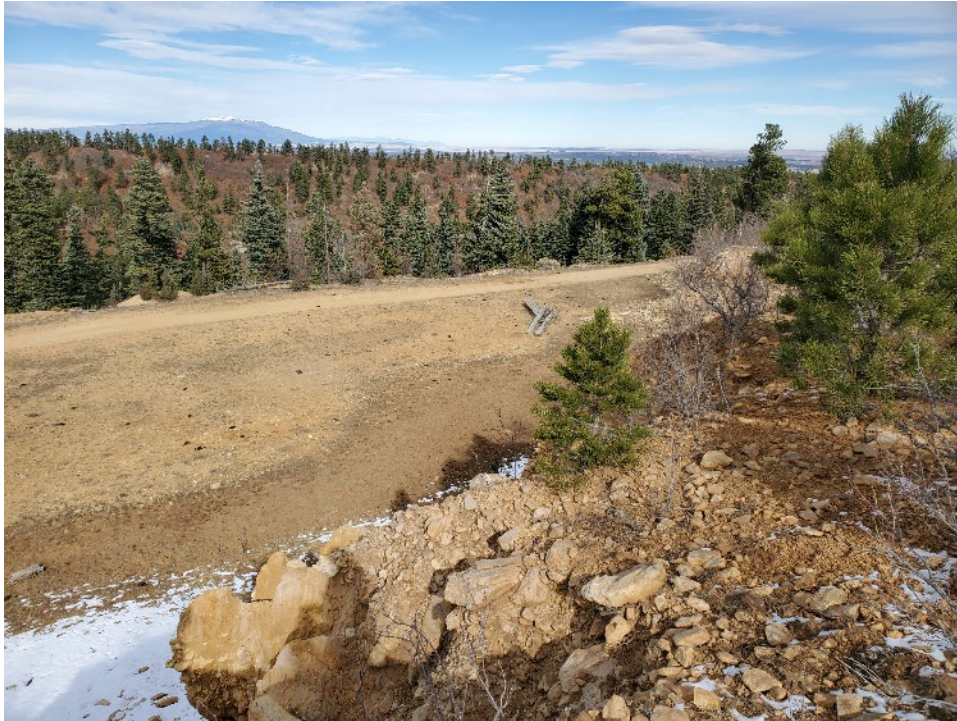
**Photo 2:** Looking at the east side of the pit from the highwall.

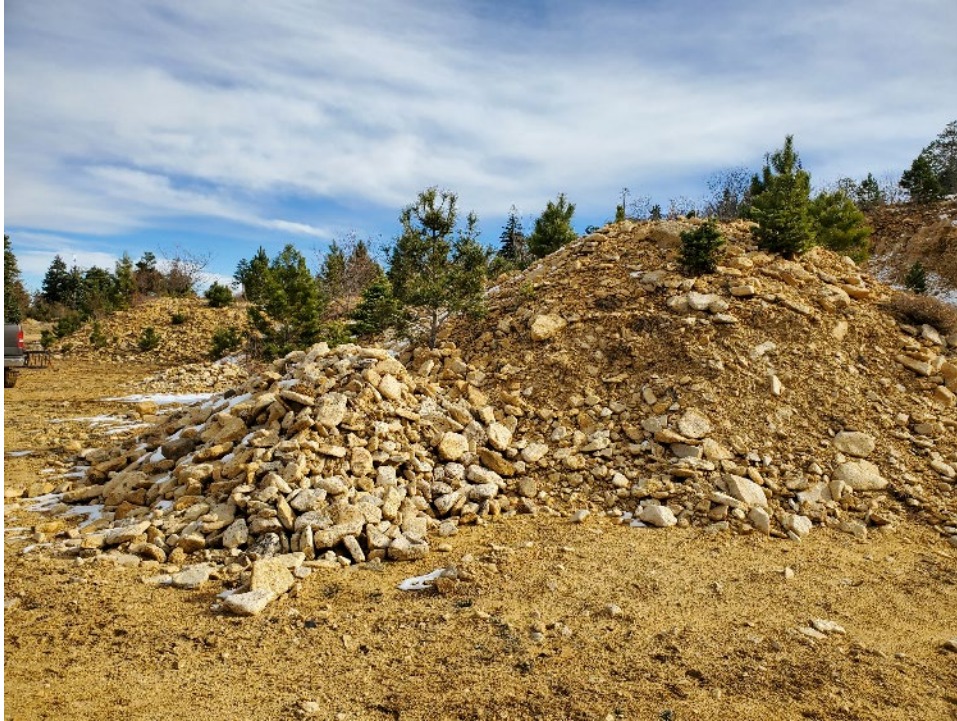
**Photo 3:** Looking east at the product stockpile from the south side of the entrance road.

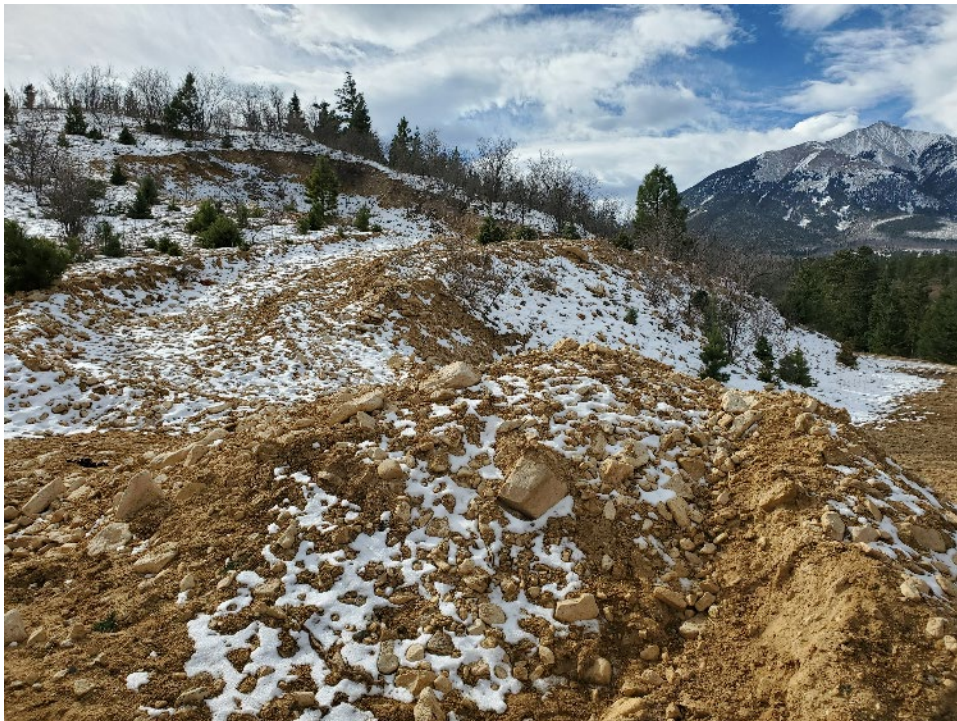
**Photo 4:** Looking at the highwall cut along the west side of the pit.

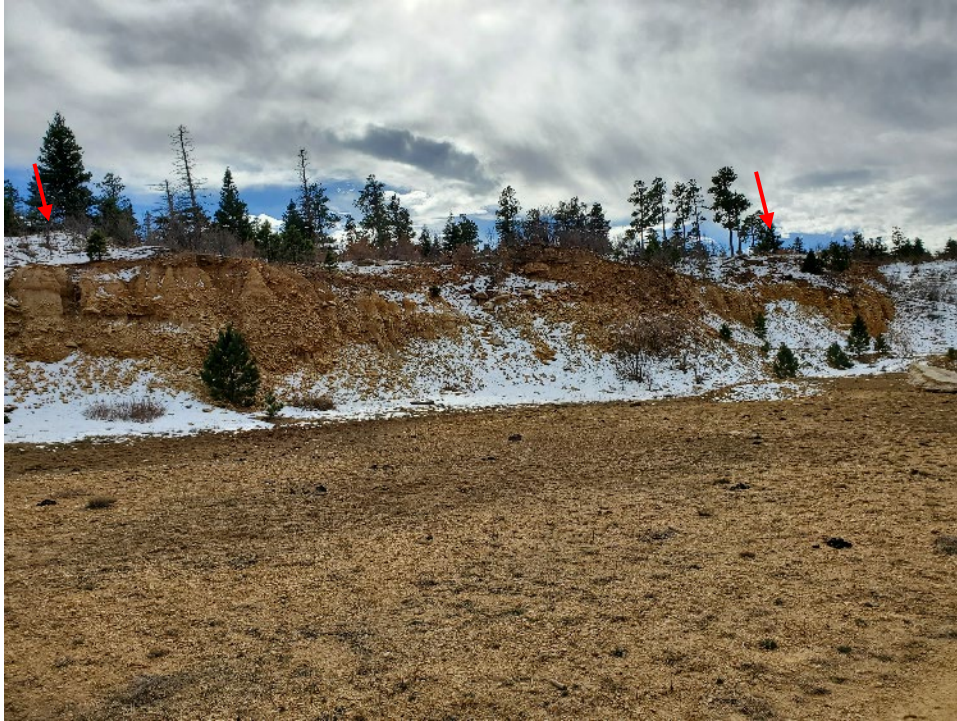
The topsoil piles located along the south side of the southern highwall appear stable at this time (Photo 5; Map 1).

**Photo 5:** Looking south at the tallest point in the highwall. Arrows point to some of the topsoil pile locations.

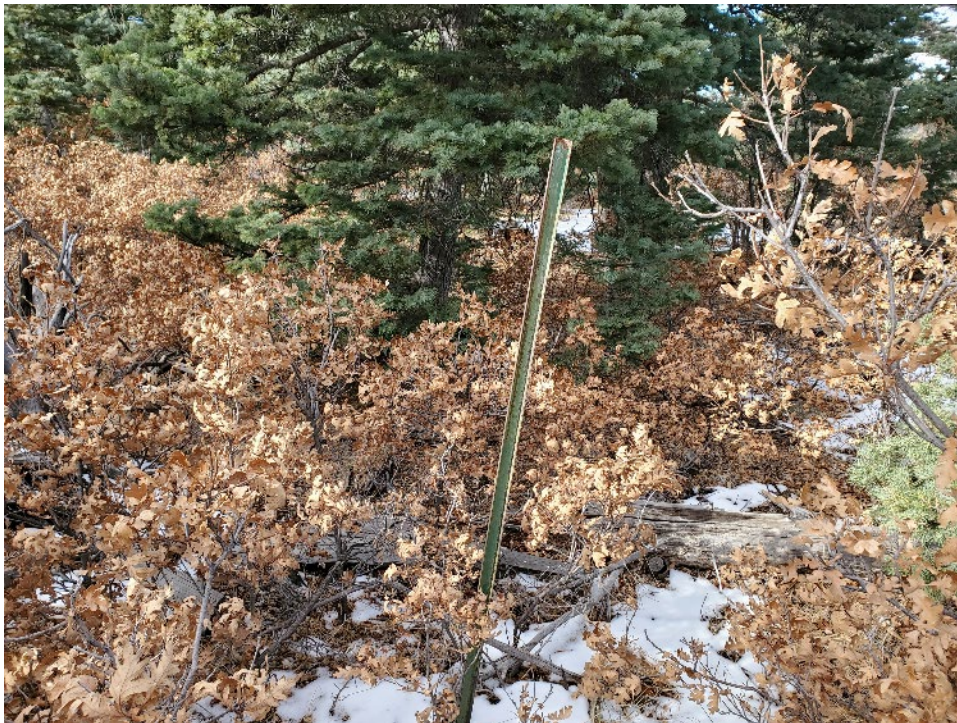
During the inspection, the Operator and the Division walked the approximate boundary of the permit and located two markers (Photos 6-7; Map 1). The marker in the north-east corner of the site appeared to be in the correct spot. The marker on the west side of the permit appeared to lie along the western border, but no western corner markers were found. The Operator and Division came across a two track road south of the permit boundary where the Division approximates the south-west corner may intercept. The Division and the Operator also estimated that the north-west corner is near a sapling located off of the entrance road where the Division and Operator piled rocks near the base (Photo 8; Map 1).

**Photo 6:** Looking west at the marker found along the western permit boundary.

- The boundaries of the affected area must be marked by monuments or other markers that are clearly visible and adequate to delineate such boundaries. The Operator shall use the approved survey map included with the original permit application to replace the boundary markers. The Operator shall also submit photos and coordinates of the installed corner markers via email to the Division by the corrective action date.

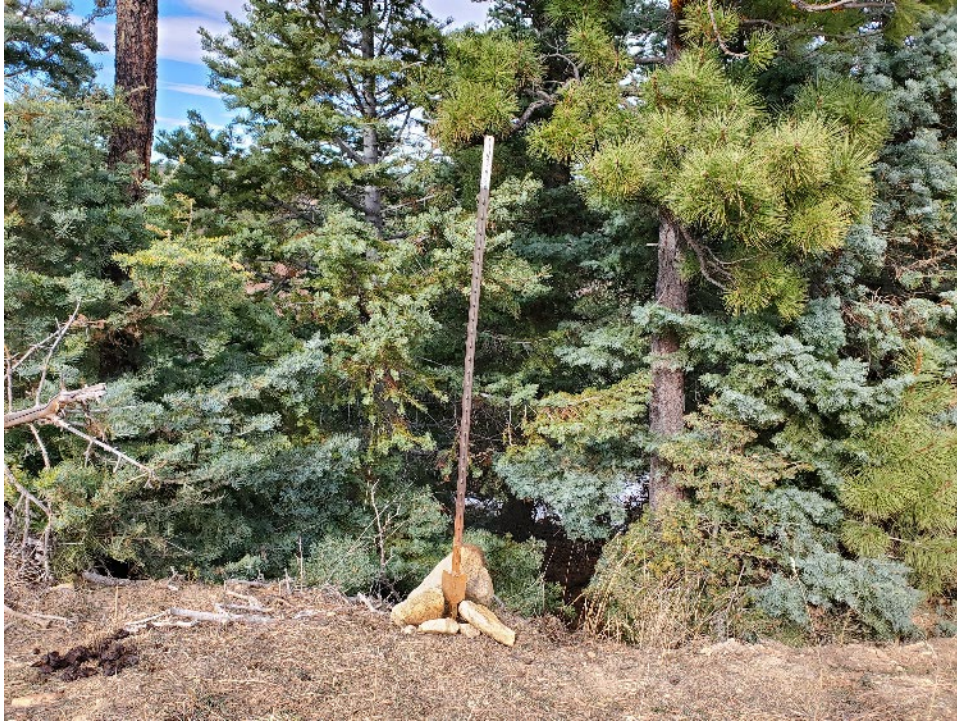
**Photo 7:** Looking north at the north-east corner permit boundary marker.

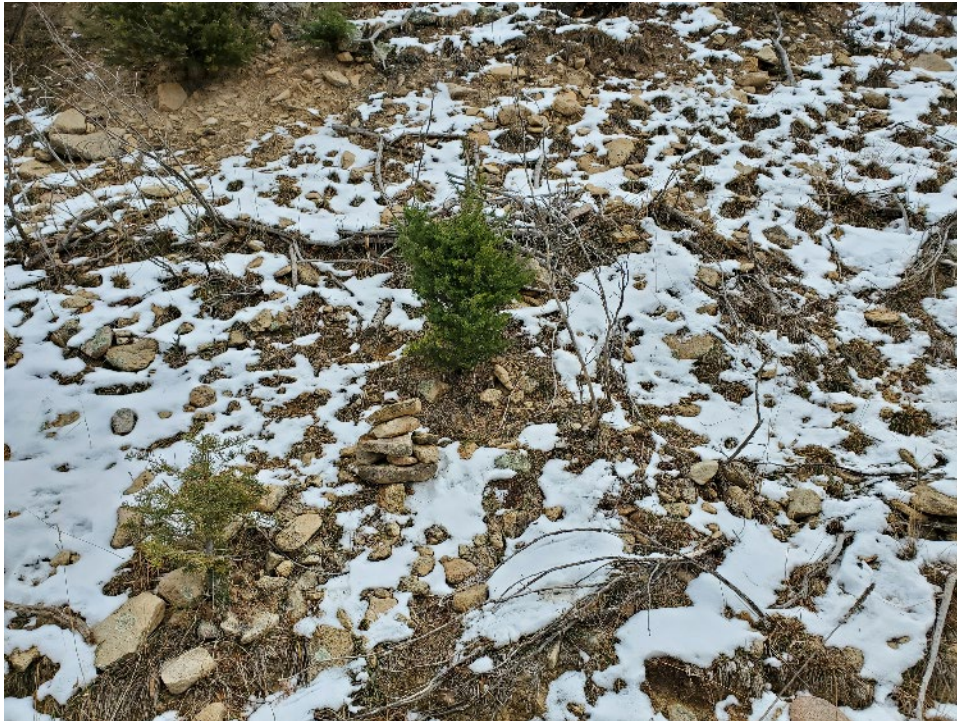
**Photo 8:** Looking south at the sapling that marks the approximate north-west permit boundary corner.

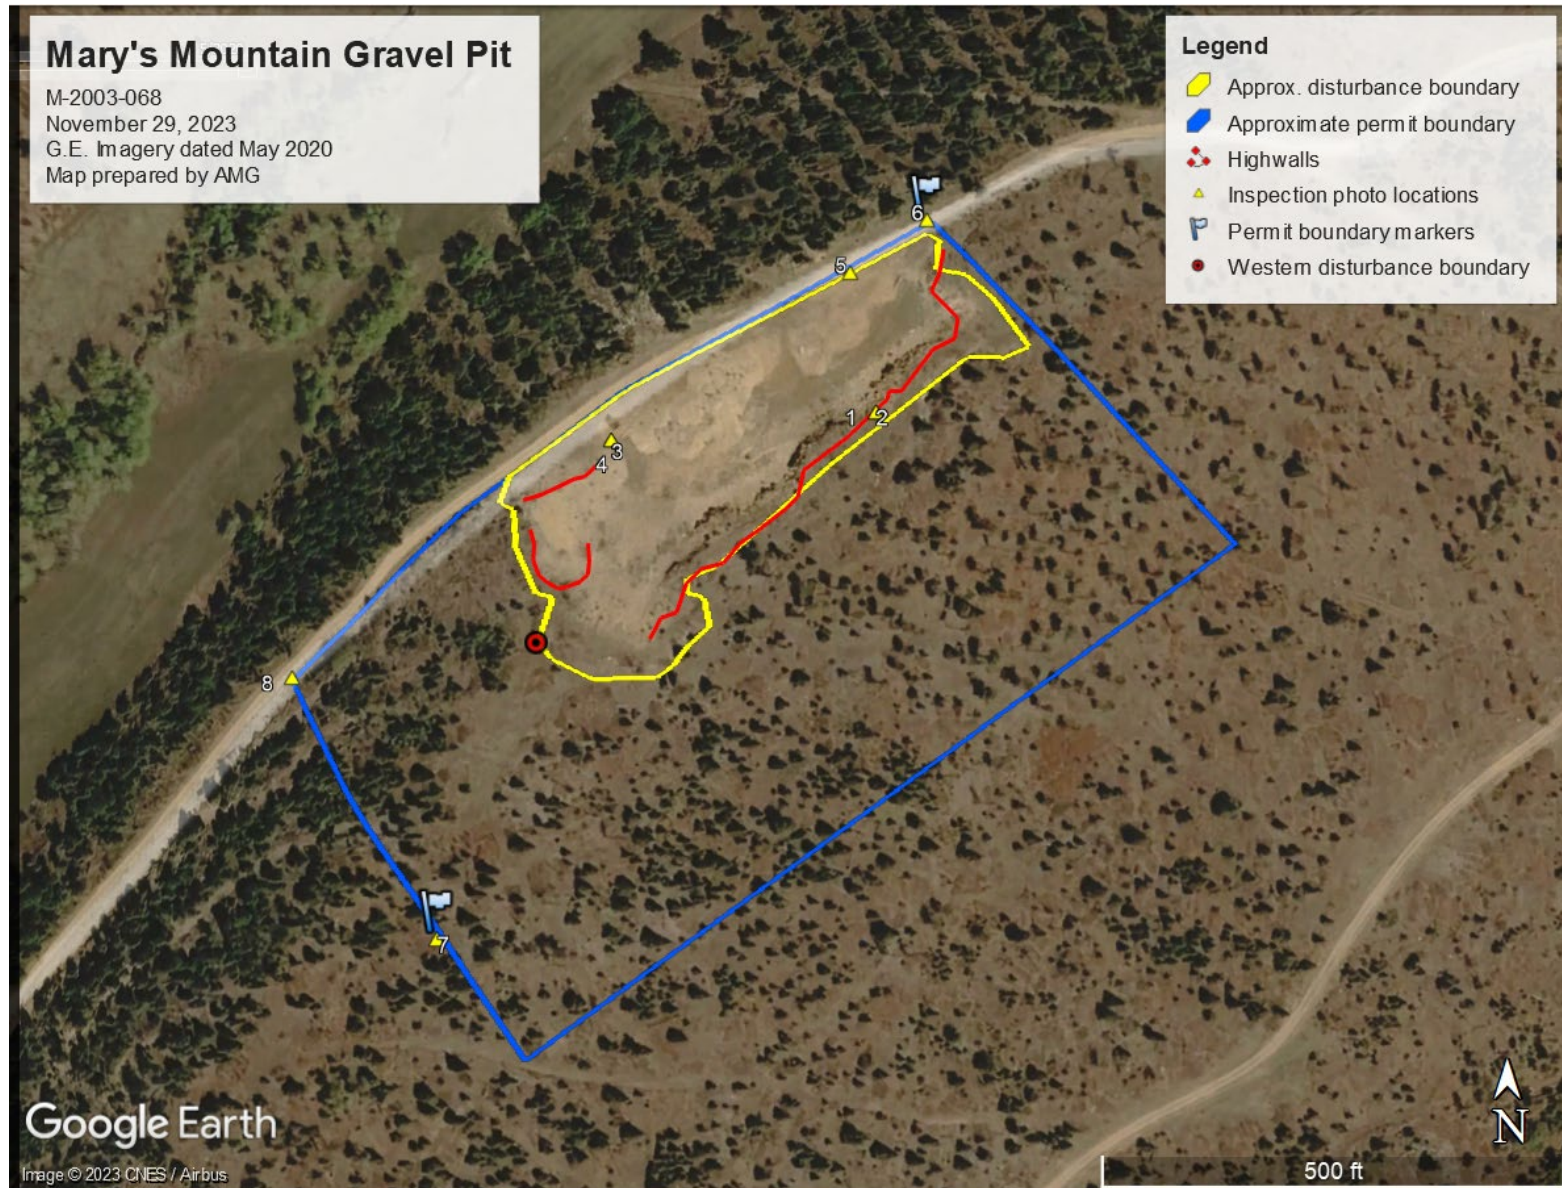
The extent of the disturbance on-site is estimated at approximately 2.53 acres (yellow polygon on Map 1). A coordinate point was taken at the western-most extent of the site (red dot on Map 1). The disturbance consists of a single pit, highwalls along the east, south, and west boundaries of the pit, product stockpiles along the south side of the entrance road, and topsoil stockpiles along the south border of the highwall (Photos 1-5; Map 1). When the Operator uses material from the site, it is sourced from the piles near the entrance road. The disturbance at the site appears stable, and no signs of excessive erosion were observed during the inspection.

However, the Division's estimate of the permit boundary (blue polygon on Map 1) is extrapolated from an image overlay of the approved mining plan map into Google Earth Pro software and the approved 9.9 acres, and does not represent the exact location of the boundary. The approved mining plan map submitted with the original 110c application for the site represents the currently approved permit boundary. This map is a survey map of the site (see Map 2).

**Map 1:** Map generated by the Division, using Google Earth Pro, of the Mary's Mountain Gravel Pit.

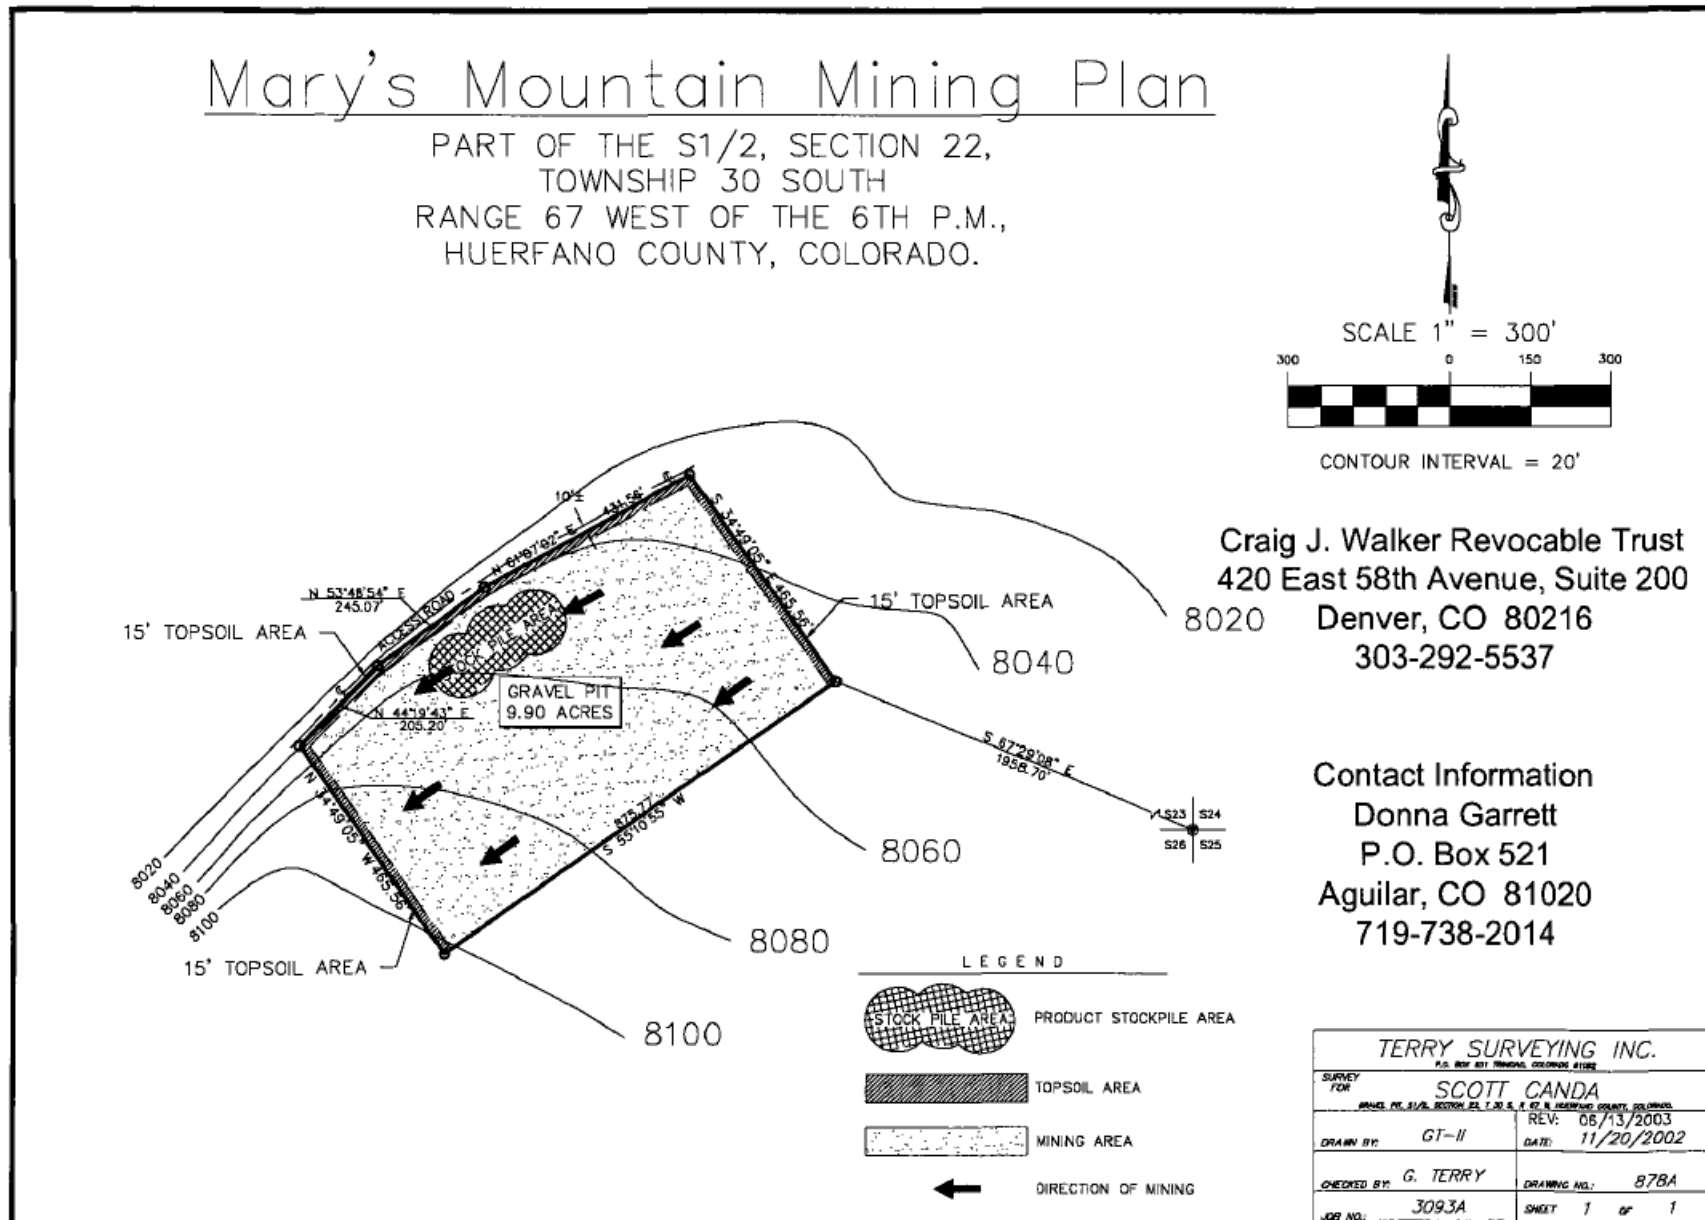
**Map 2:** Photo of the approved Mining Plan Map for the Mary's Mountain Gravel Pit included with the 110c application.
