**MINERALS PROGRAM INSPECTION REPORT**  
**PHONE: (303) 866-3567**

<b>MINE NAME:</b> White River Pit	<b>MINE/PROSPECTING ID#:</b> M-2008-070	<b>MINERAL:</b> Gravel	<b>COUNTY:</b> Rio Blanco
<b>INSPECTION TYPE:</b> Monitoring	<b>WEATHER:</b> Foggy, Snow	<b>INSP. DATE:</b> November 30, 2023	<b>INSP. TIME:</b> 09:00
<b>OPERATOR:</b> OWL SWD Operating, LLC	<b>OPERATOR REPRESENTATIVE:</b> None	<b>TYPE OF OPERATION:</b> 112c - Construction Regular Operation	
<b>REASON FOR INSPECTION:</b> Normal I&E Program	<b>BOND CALCULATION TYPE:</b> Complete Bond	<b>BOND AMOUNT:</b> \$106,548.00	
<b>DATE OF COMPLAINT:</b> NA	<b>POST INSP. CONTACTS:</b> DRMS	<b>JOINT INSP. AGENCY:</b> None	
<b>INSPECTOR(S):</b> Amy Yeldell	<b>INSPECTOR'S SIGNATURE:</b>

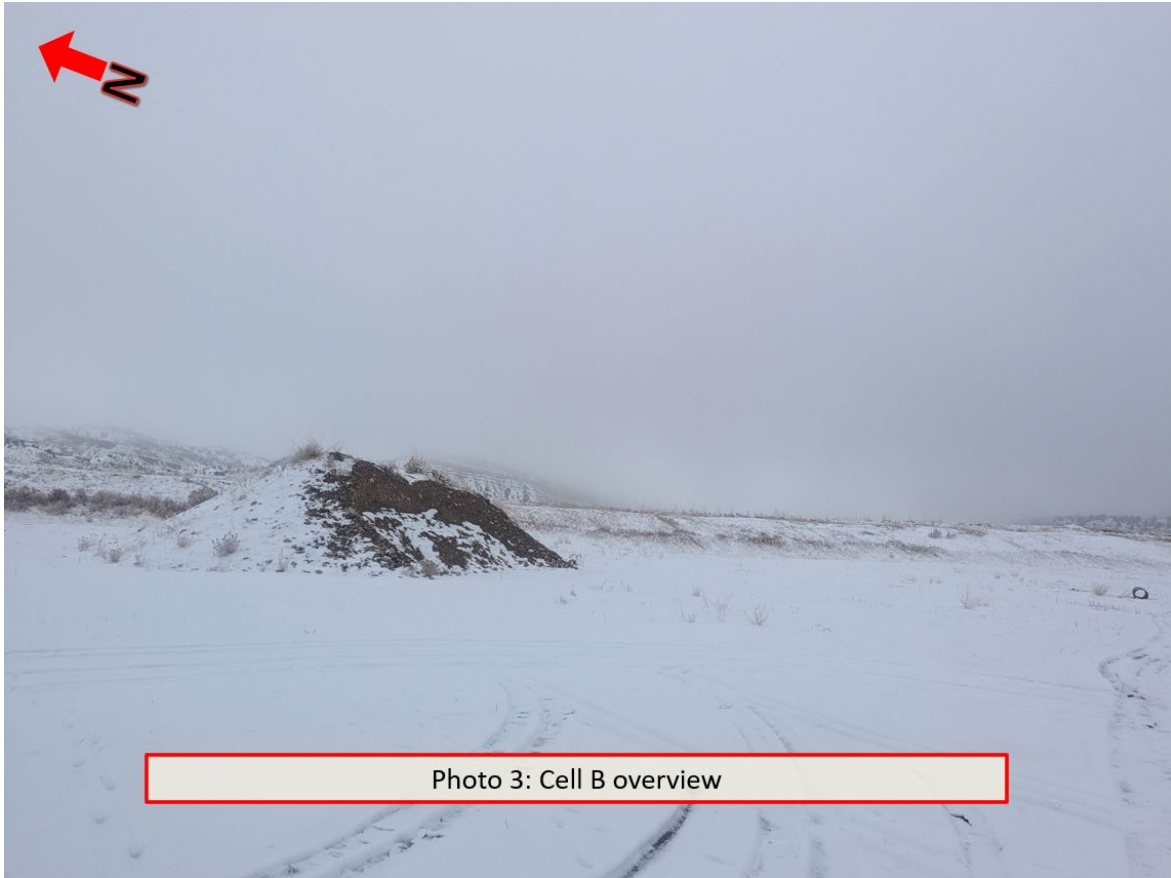
Photo 3: Cell B overview

Cells B and C are the active pit area. The slope between Cell B and Cell A is near vertical and approximately 300 LF at 15'H. Generally, most slopes within Cells B and C appear to be graded to a 3H: 1V with the exception of the southern tip of Cell B. The top 5' of material has been removed but the bench remains approximately 10' higher than the rest of the pit floor. Slopes with Misc. grading is primarily 1H: 1V and a combination of backfill and cut/fill.
