Division of Reclamation,  
Mining and Safety

### MINERALS PROGRAM INSPECTION REPORT

<b>MINE NAME:</b> Lopez Quarry No. 2	<b>MINE/PROSPECTING ID#:</b> M-2007-034	<b>MINERAL:</b> Sand and gravel	<b>COUNTY:</b> Las Animas
<b>INSPECTION TYPE:</b> Monitoring	<b>WEATHER:</b> Clear	<b>INSP. DATE:</b> November 29, 2023	<b>INSP. TIME:</b> 08:15
<b>OPERATOR:</b> S & S Services	<b>OPERATOR REPRESENTATIVE:</b> Lonnie Lopez	<b>TYPE OF OPERATION:</b> 110c - Construction Limited Impact

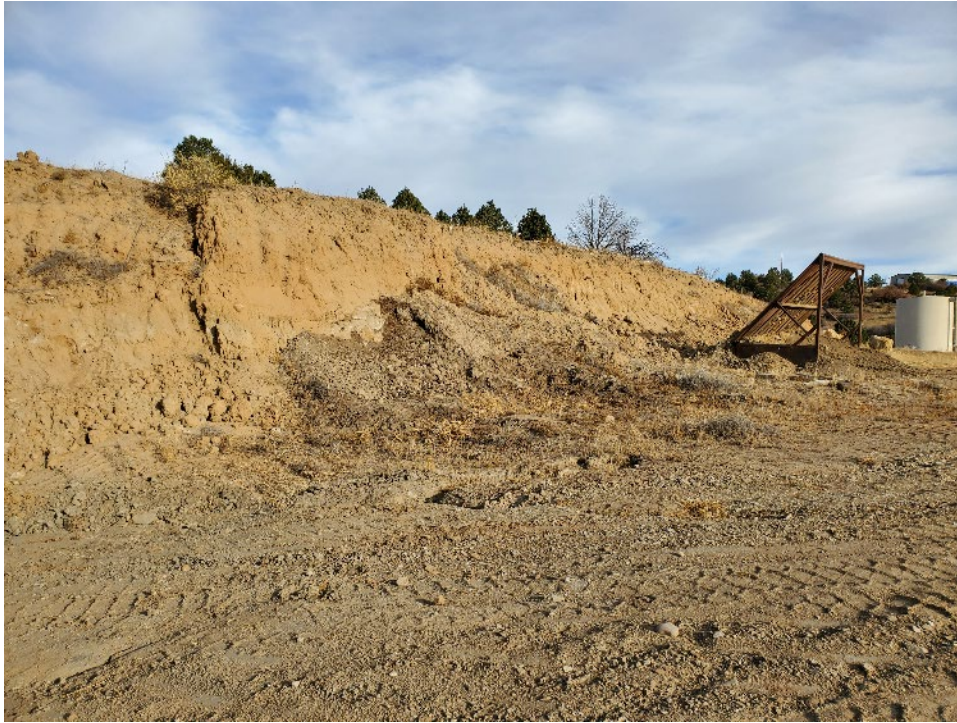
A few highwalls currently exist at the site (Photos 1-3, and purple path lines on Map 1). The northernmost highwall on Map 1 used to extend westward to the western boundary. There also used to be a pit extending eastward from the location of Photo 4, indicating the observed disturbance boundary (Photo 4; Map 1). These areas have since been backfilled by the Operator. The area at the disturbance boundary has been graded (Photo 4; Map 1), but the south-western area where the highwall had extended has not. Erosion in the form of ruts and gullies was observed in this area (Photos 5-9; Map 1). However, the Operator has placed and maintained a berm along the south boundary of the permit to ensure that excess sediment has not left the site (Photos 10 & 11; Map 1). The excess erosion in this area has been **cited as a problem** above. The Operator shall grade and stabilize this area to prevent further erosion. Once this area has been stabilized, the Operator shall submit photo evidence as proof by the corrective action date.

**Photo 1:** Looking north-west at the taller (west) highwall.

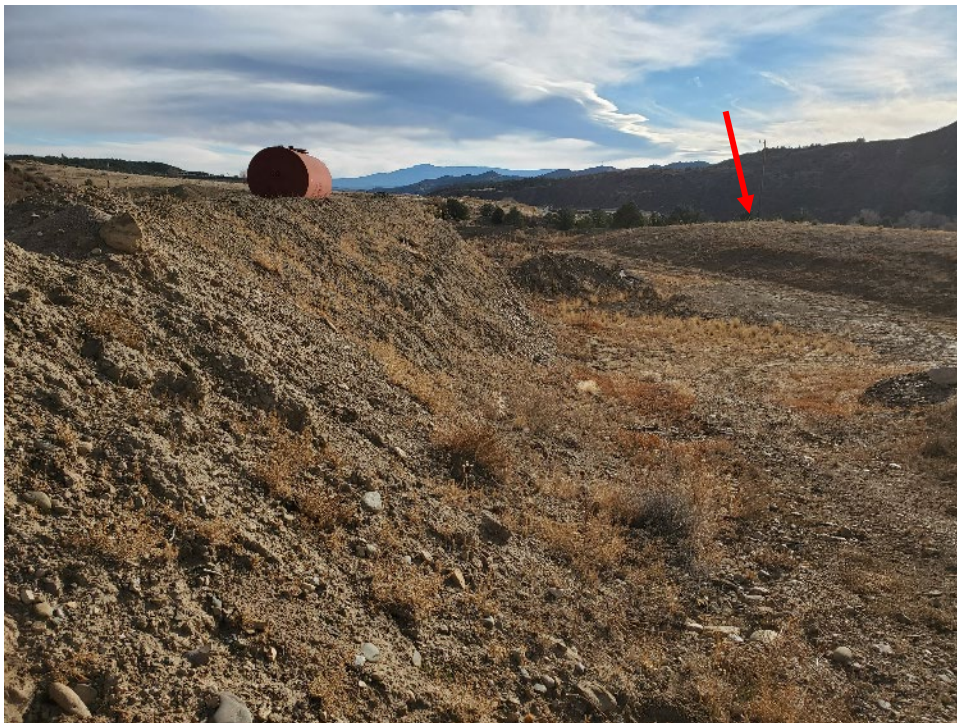
**Photo 2:** Looking east along the shorter (east) highwall, north of the topsoil pile (red arrow).

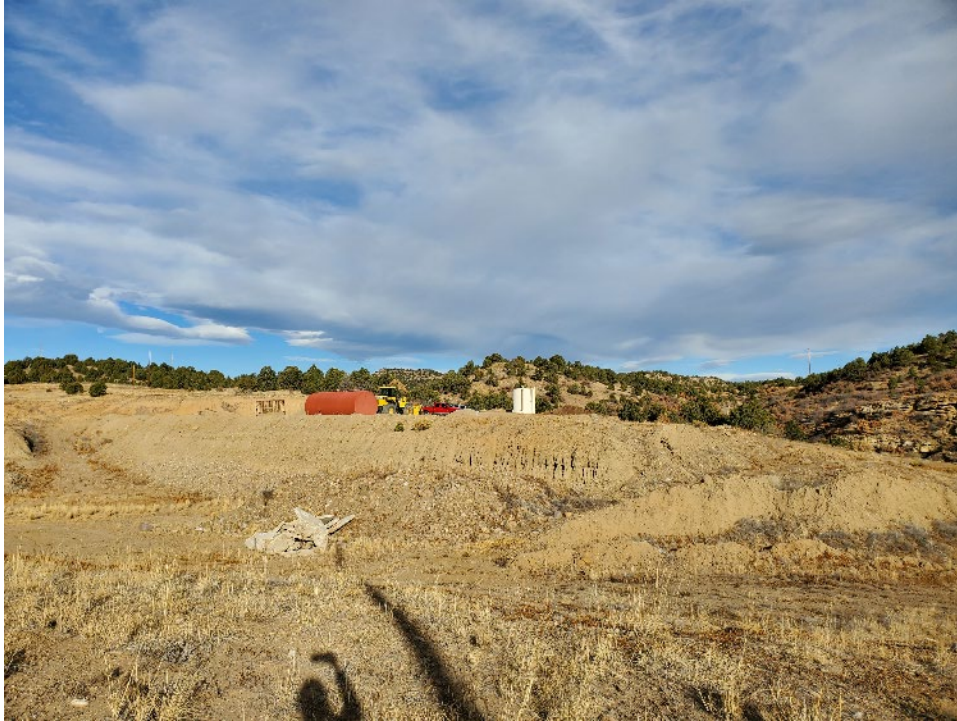
Equipment onsite included a loader, a grizzly screener, and a water tank (Photo 3; Map 1). There is also a white tank acquired from the gas company that is currently being stored onsite, but will likely be converted to scrap (Photo 3; Map 1). Overall, the site is operating according to the approved mine plan, the affected acres are within the permit boundary, and no off-site damage was observed.

**Photo 3:** Looking north from the topsoil pile at the west and east highwalls. In the photo is the grizzly screener, red water tank, loader, and extra tank.

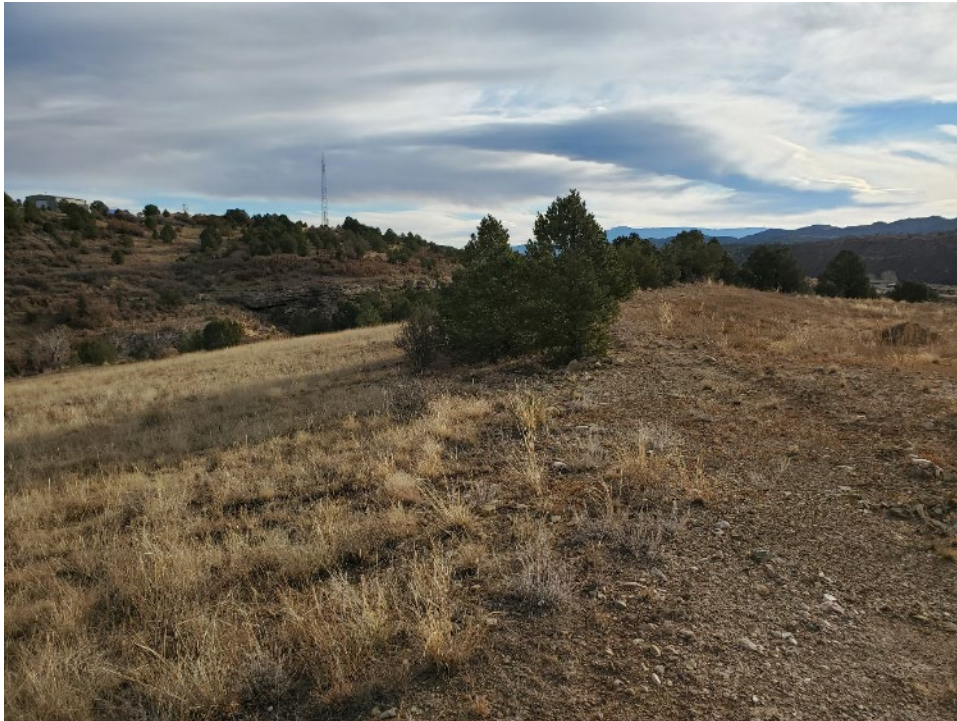
**Photo 4:** Looking east along the northern disturbance boundary. The area to the left of the trees is un-affected.

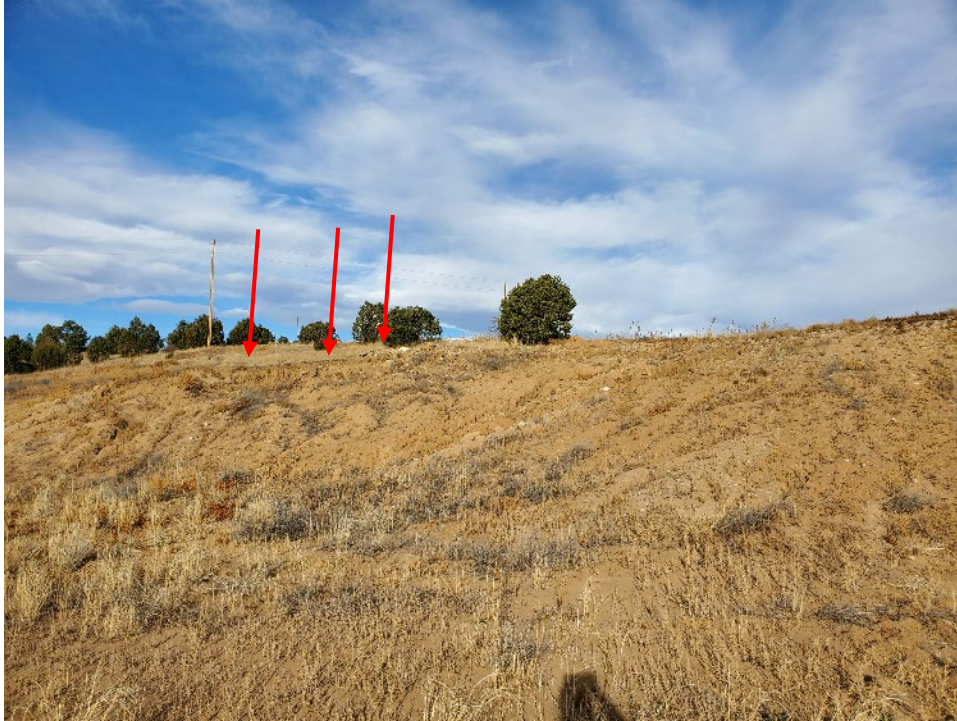
**Photo 5:** Area where the highwall that extended to the western boundary of the permit has been backfilled. The arrows indicate an area where the old highwall is partially exposed.

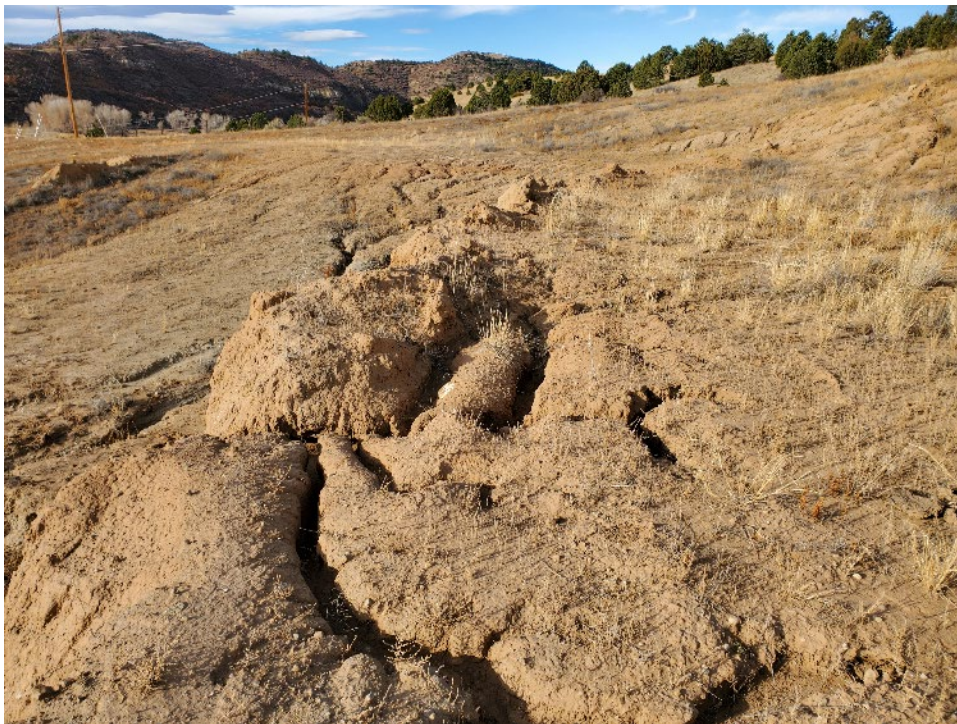
**PROBLEM:** Erosion gullies and ruts were observed on-site. This is a problem at this time for failure to protect the affected land from erosion pursuant to C.R.S. 34-32.5-116 (4) (j).

**Photo 6:** Area south of the old highwall area where erosion gullies have formed.

**CORRECTIVE ACTIONS:** The Operator shall provide photo documentation to the Division verifying erosion gullies and ruts have been repaired, and that the site has have been reconstructed and stabilized to prevent erosion damage by the corrective action date.

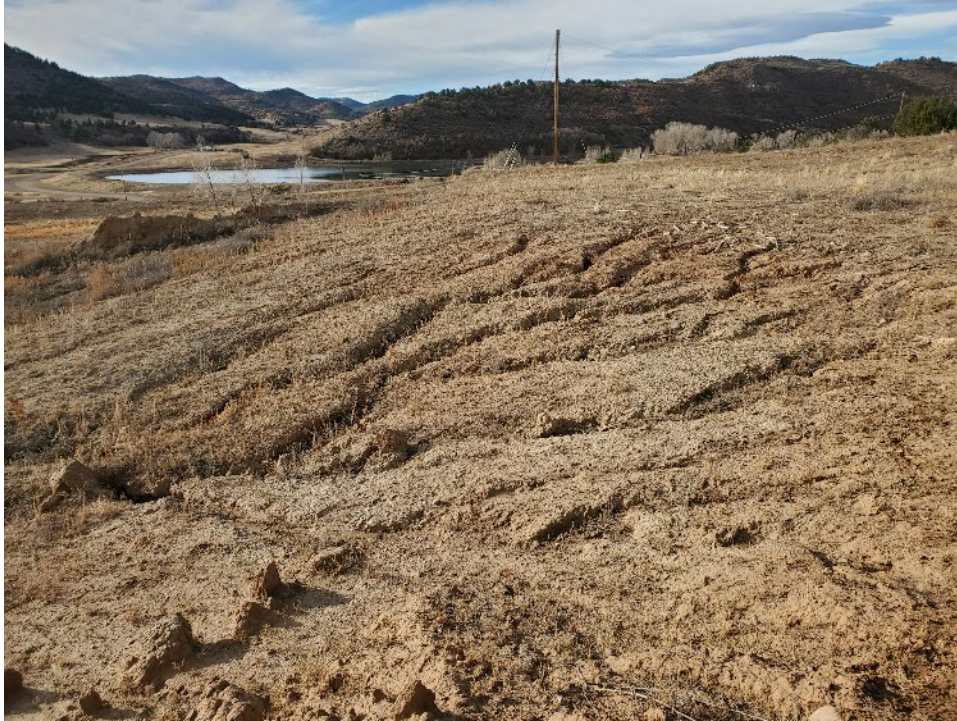
**Photo 7:** Area south of the old highwall that has been backfilled but has begun to erode.

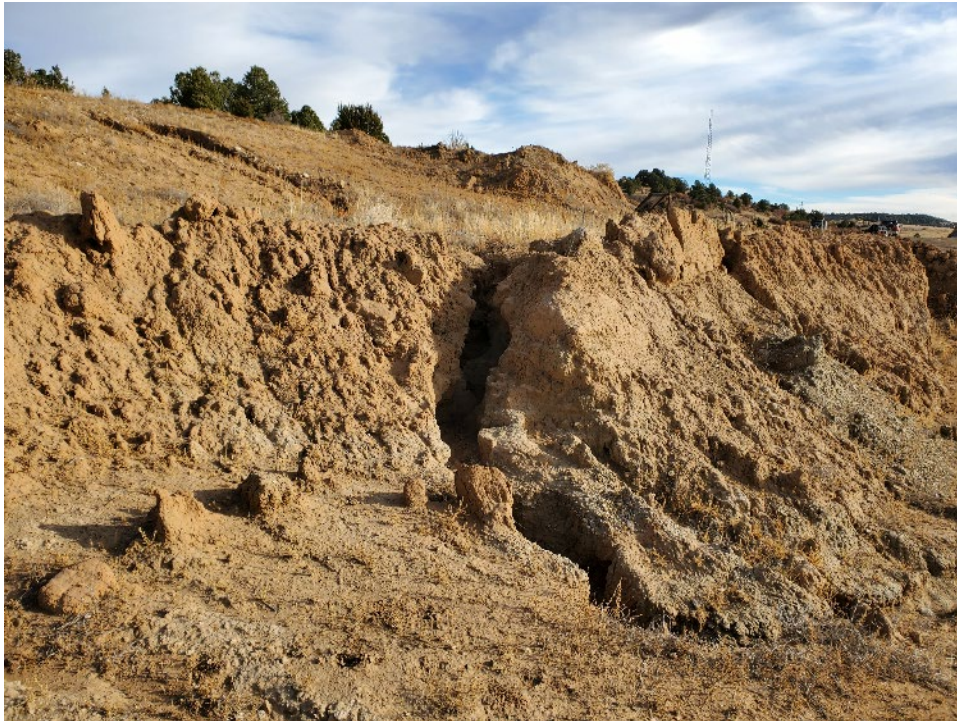
**Photo 8:** Southern edge of the west highwall where it dwindles out in a westward direction (south of Photo 8's icon on Map 1).

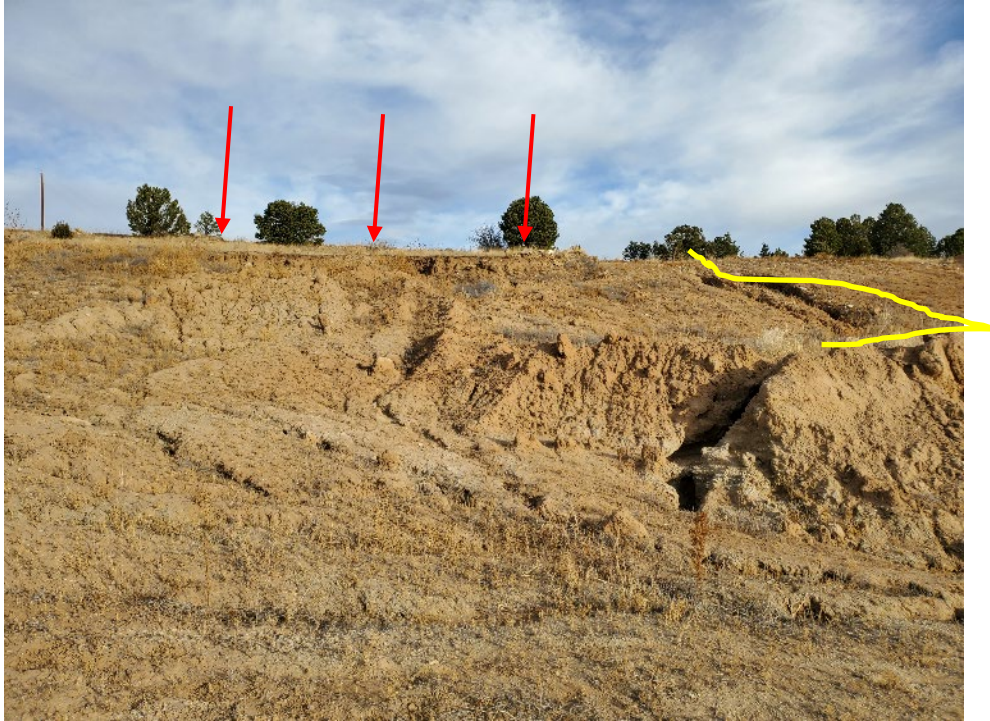
**Photo 9:** Looking north from near the south-west corner of the pit at the old highwall (red arrows) and the current highwall's corner (yellow line).

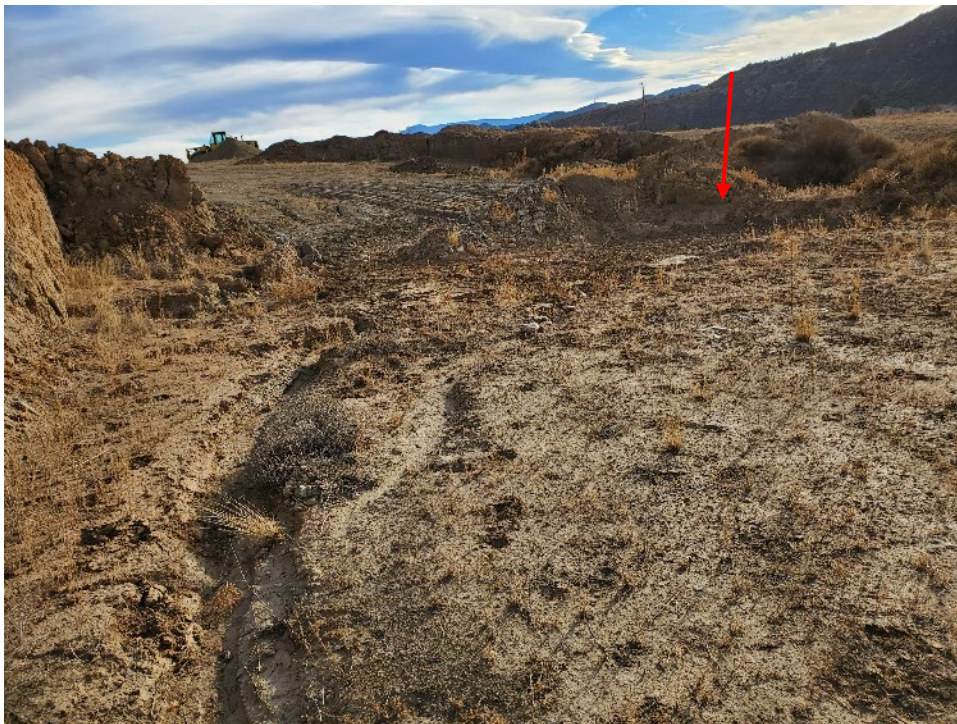
**Photo 10:** Looking south at an area where the water and sediment from the erosion in the west side of the pit is accumulating and is contained by a southern berm.

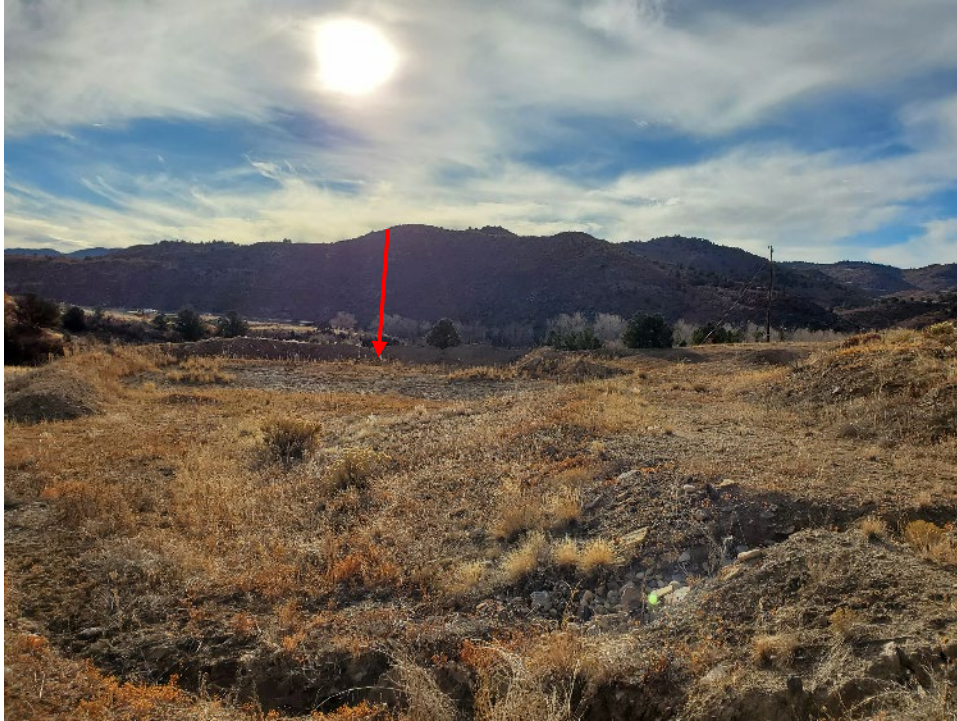
**Photo 11:** Looking south-east at an area where the water and sediment from storm water on the east side of the pit is accumulating and is contained by a southern berm.

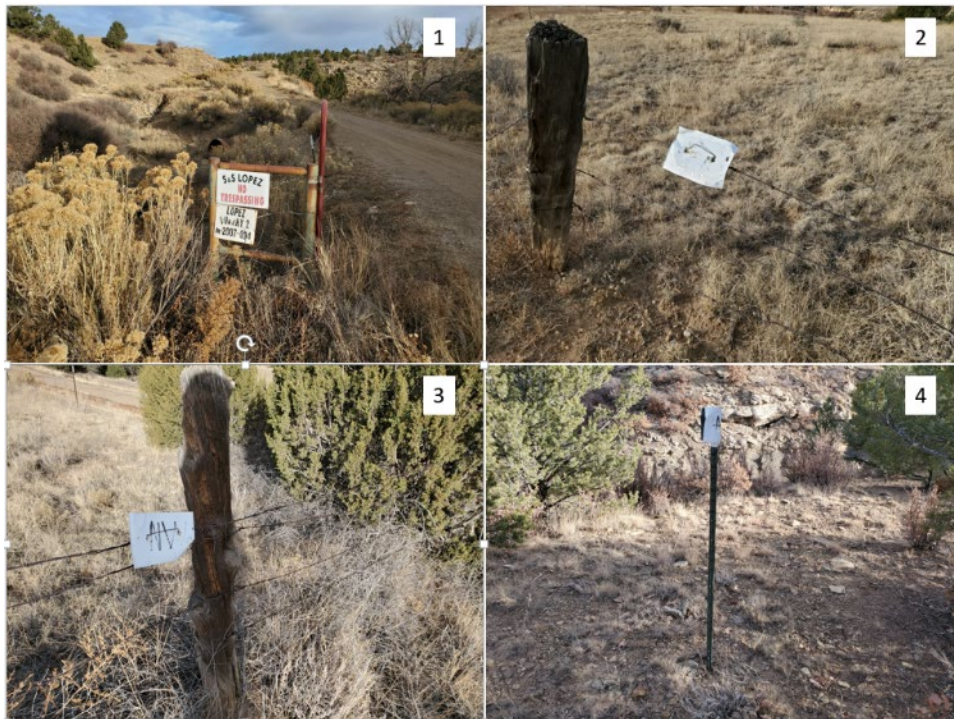
A permit sign, posted in compliance with Rule 3.1.12(1) was observed at the entrance to the site (Photo 12.1; Map 1). The corners of the active pit area were marked with signs on the fence line (Photos 12.2-12.4; Map 1). At the inspection, the Division brought the Operator's September 2023 annual report map. On the map, there is a boundary drawn as the 'pit boundary'. The pit is within the approved permit boundary. However, the way that the boundary is illustrated on the map, gives the impression that there is mining disturbance outside of the approved affected area. This has been **cited as a problem** above, pursuant to Rule 3.1.12(2) which states that the affected area must be marked by boundaries. As a 110c operation, the entire permitted area is approved to be affected. The Operator stated during the inspection that they do not intend to mine north of what has already been affected. Because of this, the Operator was instructed during the inspection to move their north-east corner boundary more to the east, but within the permit boundary, to encompass the entire on-site disturbance.

**Photos 12.1-12.4:** 1) Permit sign at entrance from public road. 2-4) Pit boundary corner posts. *\*The south-east corner was also marked and observed by the Division, but the point taken in the field did not save.*

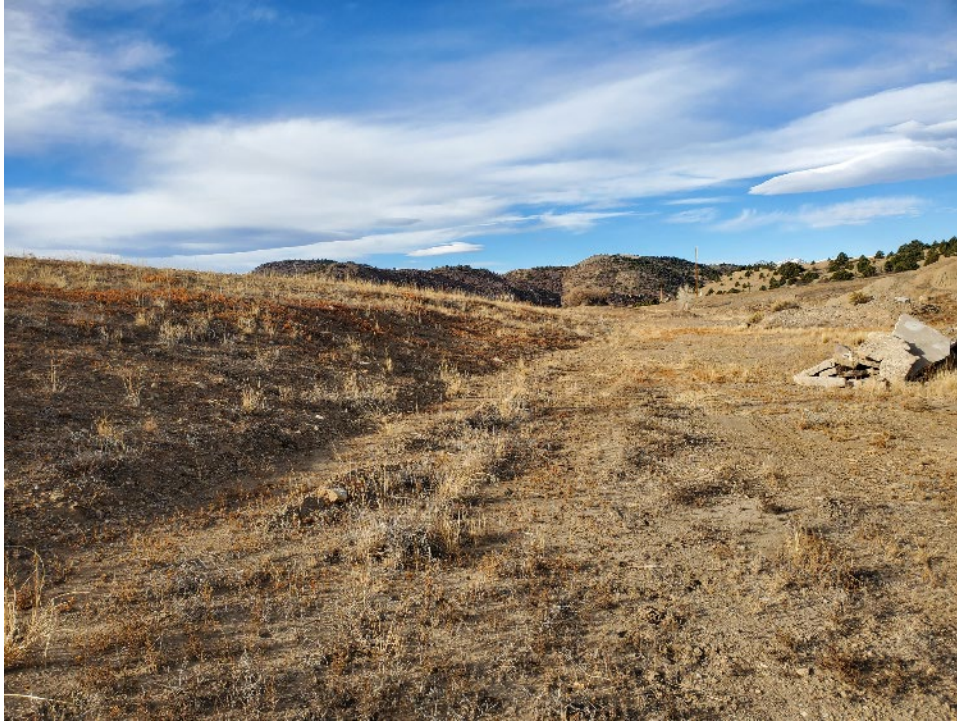
A topsoil pile was observed running east to west near the south-east corner of the pit boundary. The majority of the pile appears to be stable (Photo 13; Map 1). The Operator stated that they seeded the topsoil pile in 2020 along the south side. On the south-west portion of the pile, on the north facing side, some erosion rills are forming (Photo 14; Map 1). This has been **cited as a problem** above. The Operator shall stabilize the pile and provide photo evidence to the Division by the corrective action date.

**Photo 13:** Looking west along the topsoil pile.

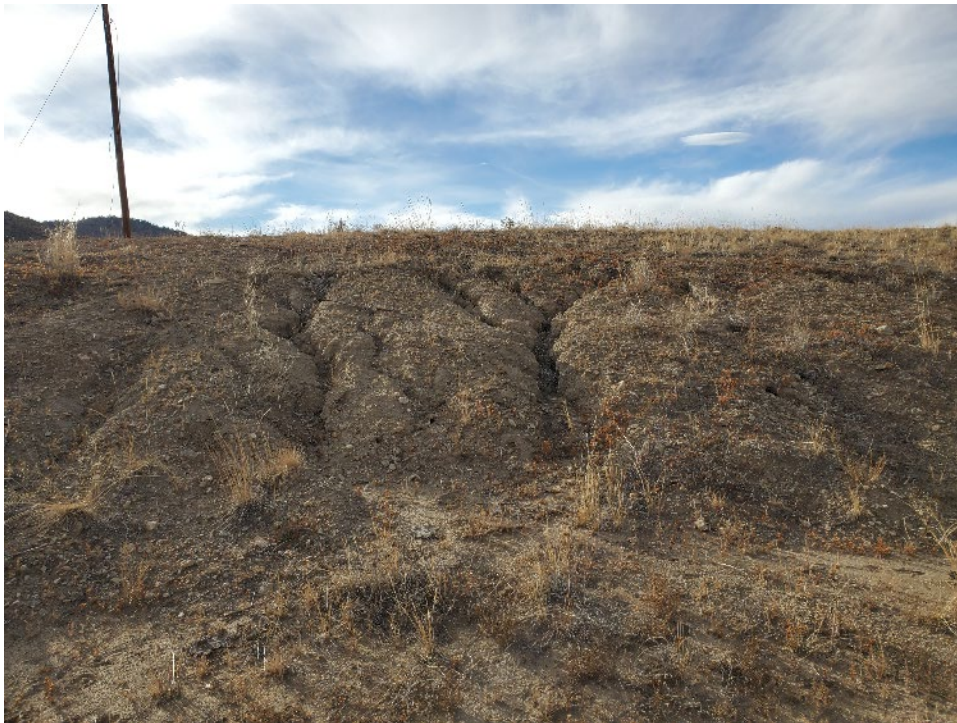
**PROBLEM:** An area of the east side of the topsoil stockpile does not have established vegetation on it and therefore is susceptible to erosion. Some rills were observed on the pile during the inspection. Rule 3.1.9(1) states if topsoil is not replaced into the backfill area within a time short enough to avoid deterioration of the topsoil, vegetative cover or other means shall be employed so that the topsoil is protected from erosion.

**Photo 14:** Looking south at an area on the north facing side of the east portion of the topsoil pile where erosion is occurring.

**CORRECTIVE ACTIONS:** The Operator shall seed the stockpile with the seed mix that was submitted as part of the approved Reclamation Plan. The Operator shall demonstrate compliance by submitting seed tags, a bill of sale or photographs of seeding activities.

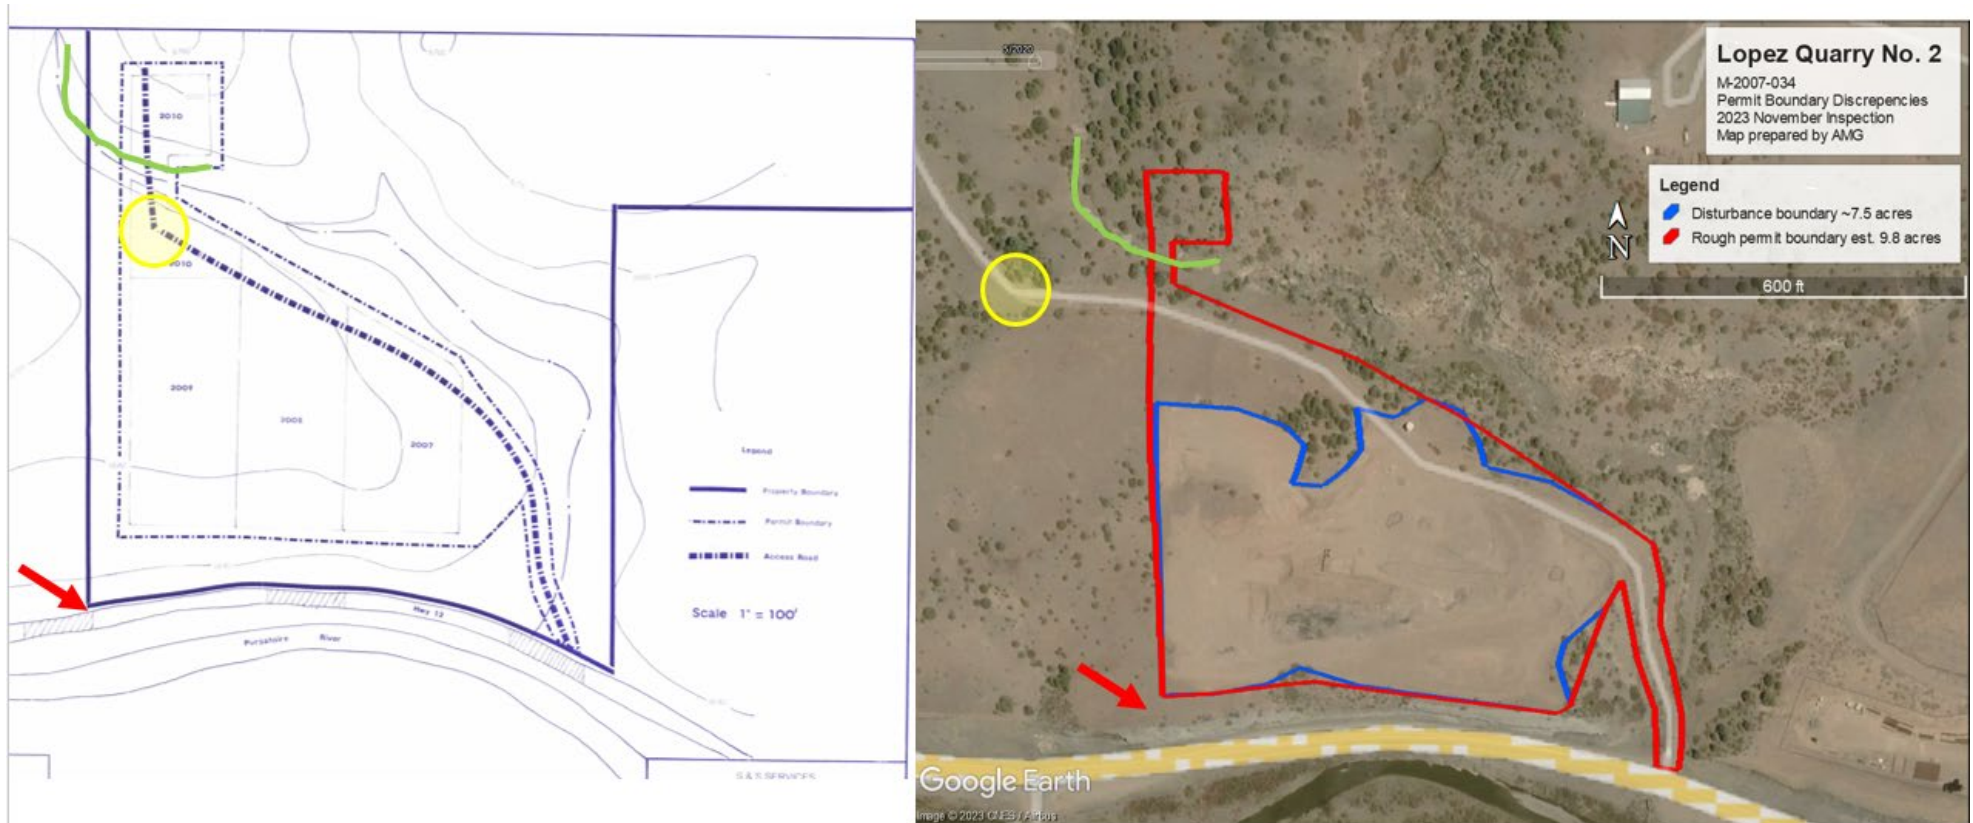
**PROBLEM:** The affected area boundary markers are incorrectly placed. This is a problem for failure to maintain boundary markers around the affected area as required by Section 3.1.12(2) of the rule.

However, upon further review of the site, the marked corners, and the approved map, there appears to be multiple discrepancies as to where the permit boundary lies (see Figure 1). The Operator shall conduct a survey and supply and updated map to correct these discrepancies, and to clarify the permit boundary so that it matches the on-ground features by the corrective action date.

**Figure 1:** This figure highlights the main discrepancies in the permit boundary. The map on the left is the approved mining plan map with the approved boundary. The map on the right contains a red polygon that represents an approximation of how the permit boundary actually falls in the area, and a blue polygon that highlights the disturbance boundary onsite. When looking at aerial imagery in Google Earth (right image), we see that a few features on the ground are not as depicted on the Mining Plan Map (yellow circle, green line, and red arrow). The yellow circle highlights where the access road bends to the north-west. The red arrow highlights the proximity of the permit extent to the highway. The green line highlights where the river bends in relation to the bend in the access road.

**CORRECTIVE ACTIONS:** The Operator shall replace the boundary markers in the correct location(s). The Operator shall provide photographic and/or GPS coordinates of the replaced marker as proof to the Division that this has been done by the corrective action date.
