December 10, 2023

Project No.: 19125

Regarding: Daniels Sand Pit 2, Permit No. M-1973-007-SG  
Slope Stability Monthly Monitoring Report

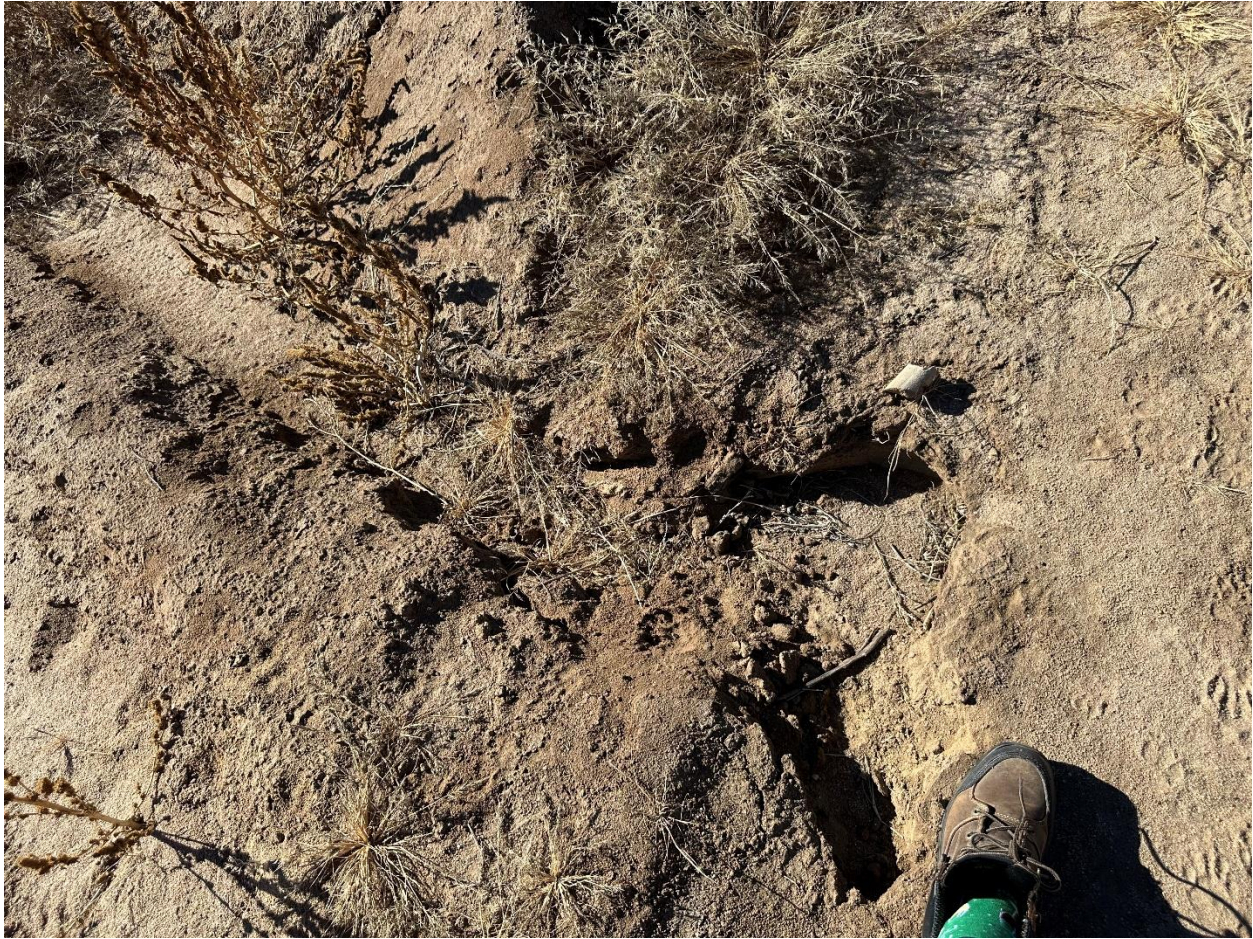
- 1) One erosion gully has reached the ditch road (eastern portion of the buttress).
- 2) Some erosion gullies have been repaired. However, several erosion gullies still exist within the embankment slope. We recommend those areas be reconstructed ASAP and that the areas be seeded per the reclamation plan.
- 3) Weather: 40-68°, sunny, winds 10 mph
- 4) Visual observation of the Fountain Mutual Ditch and ditch road:
  - a) No tension cracks.
  - b) Vegetation growing on banks of ditch and on invert.
  - c) Water flowing in ditch.
  - d) The ditch berm stability is in question.
- 5) Visual observations of the Buttress Slope
  - a) The buttress slope varies from 3H:1V to 4H:1V.
  - b) Vegetation (mainly weeds) are growing in some locations on the buttress.
  - c) Several locations show visible evidence of surface water runoff and expanding erosion gullies throughout the buttress.

Photo 1. Erosion gully on ditch access road (zoomed in)

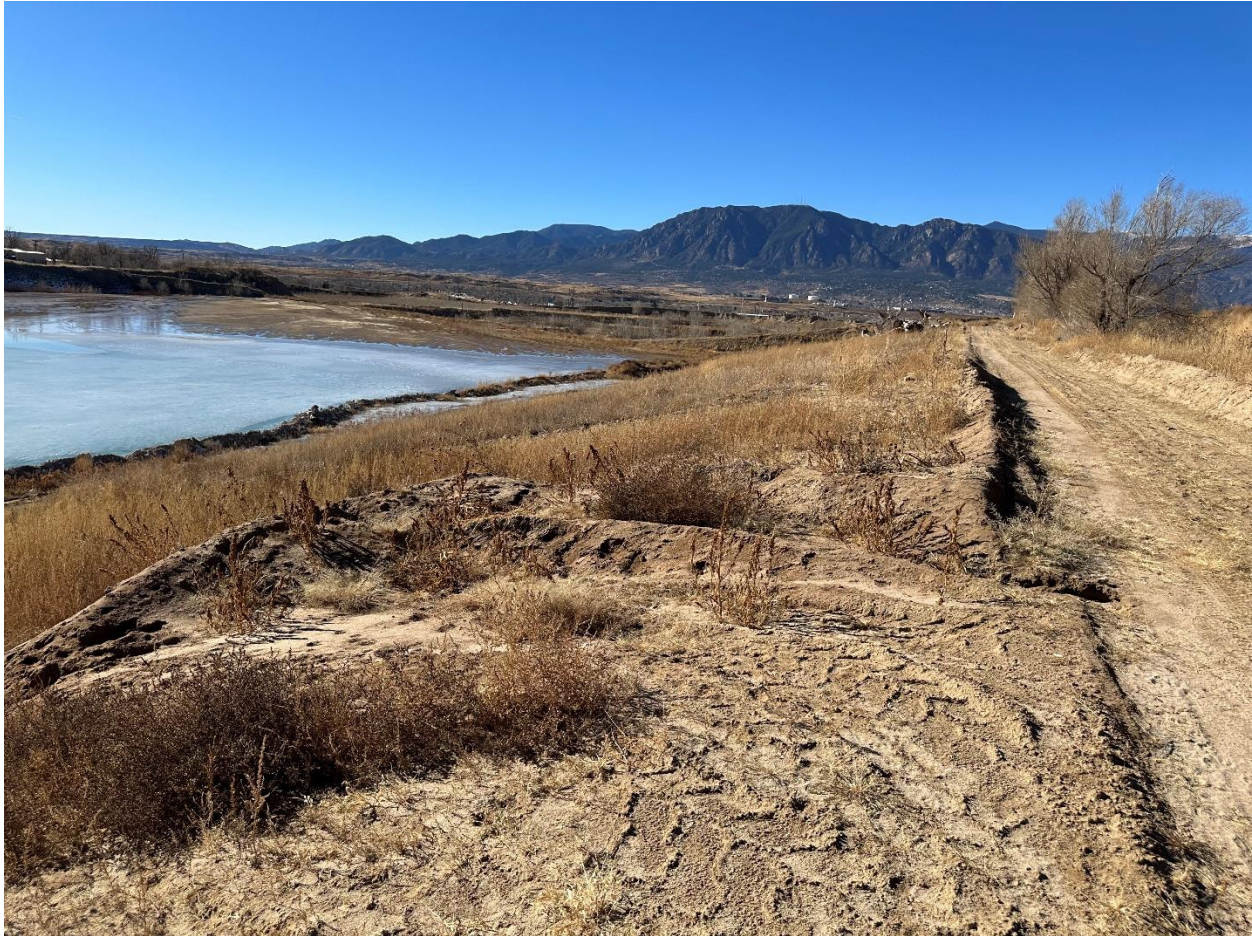
Photo 2. Erosion gully on ditch access road

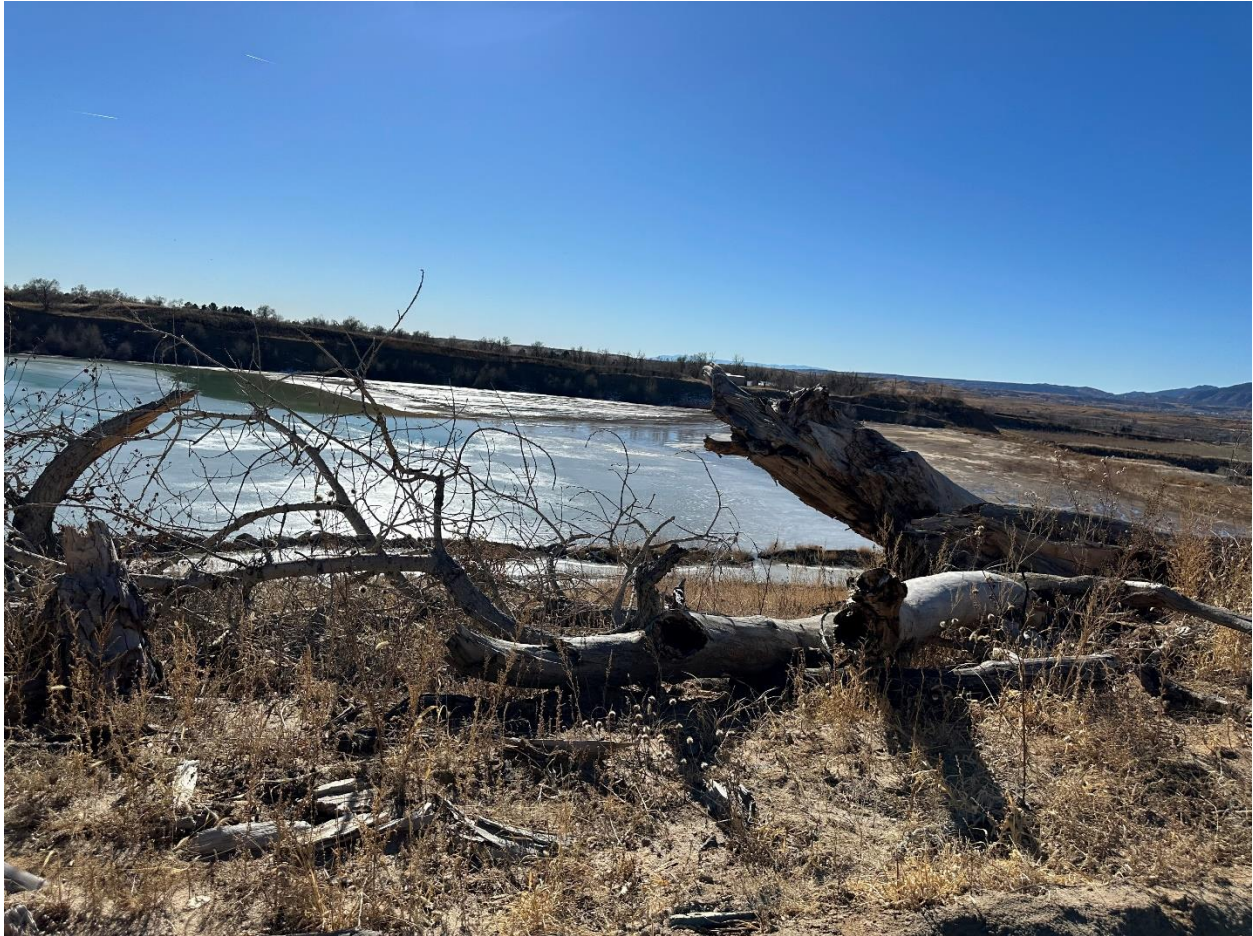
- d) Several broken trees exist on the slope/buttruss crest near the ditch access road.

Photo 3. Tree south of access road and on crest of buttress slope

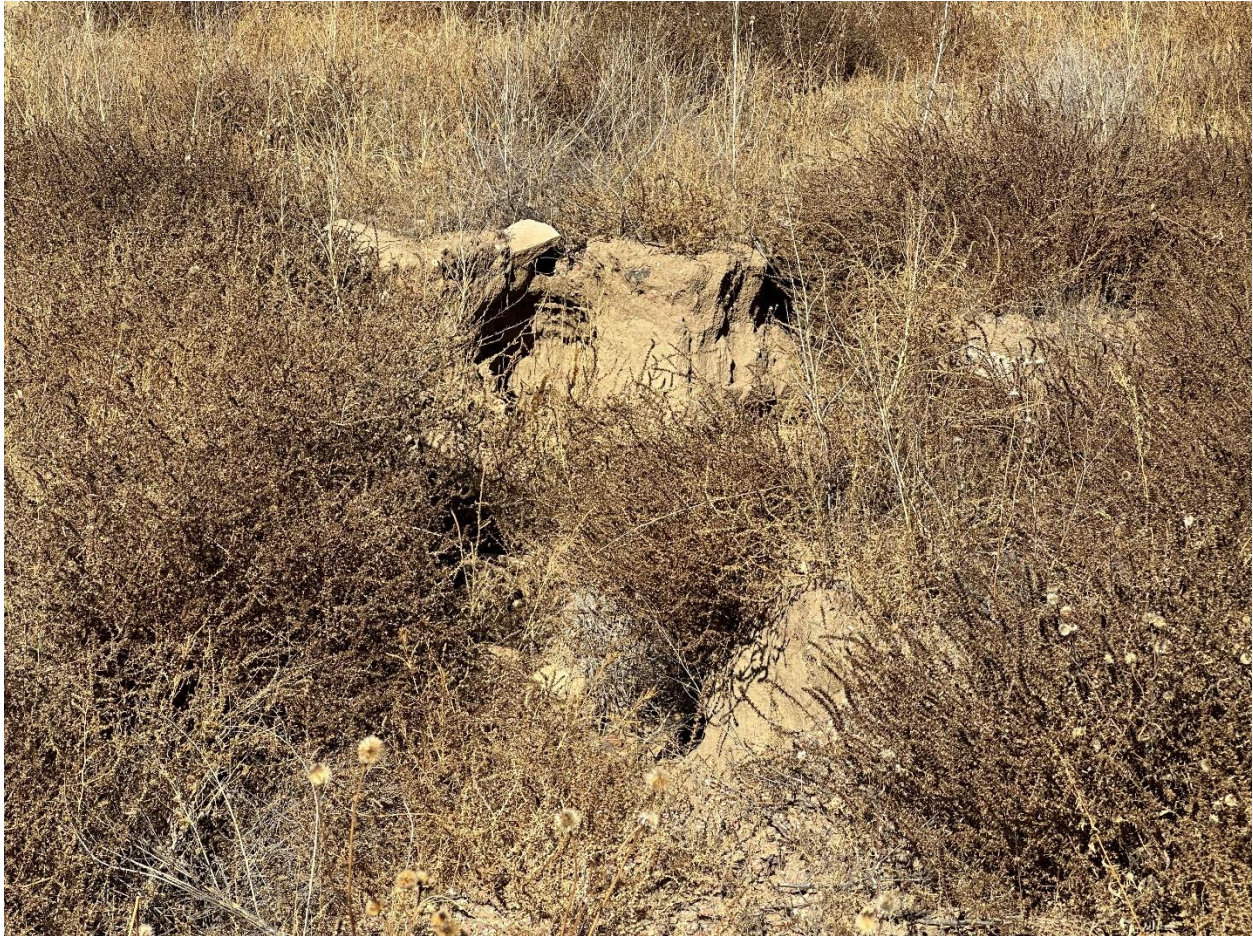
Photo 4. Erosion gullies in eastern portion of buttress

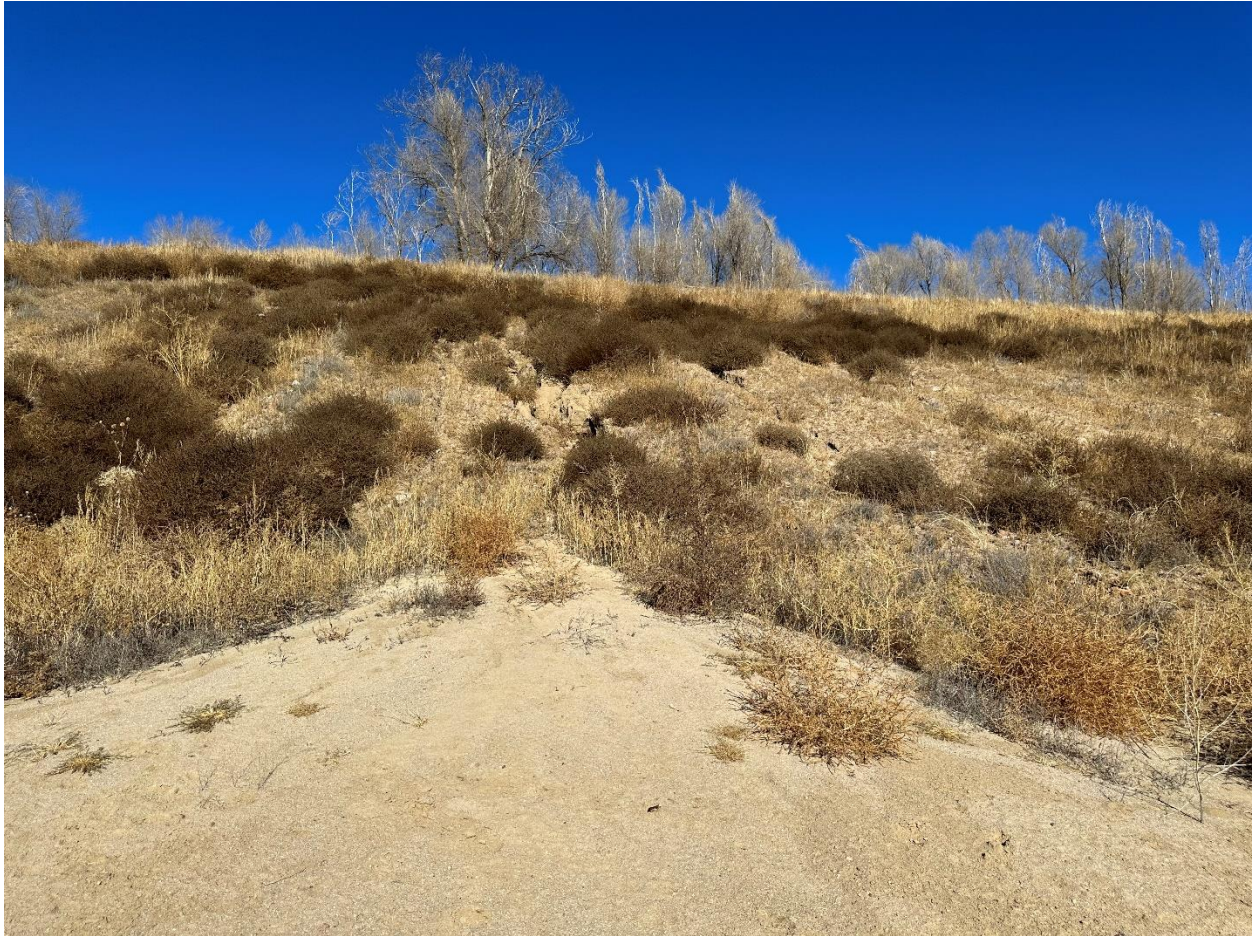
Photo 5. Erosion gullies in central area of buttress, note sand at toe of slope

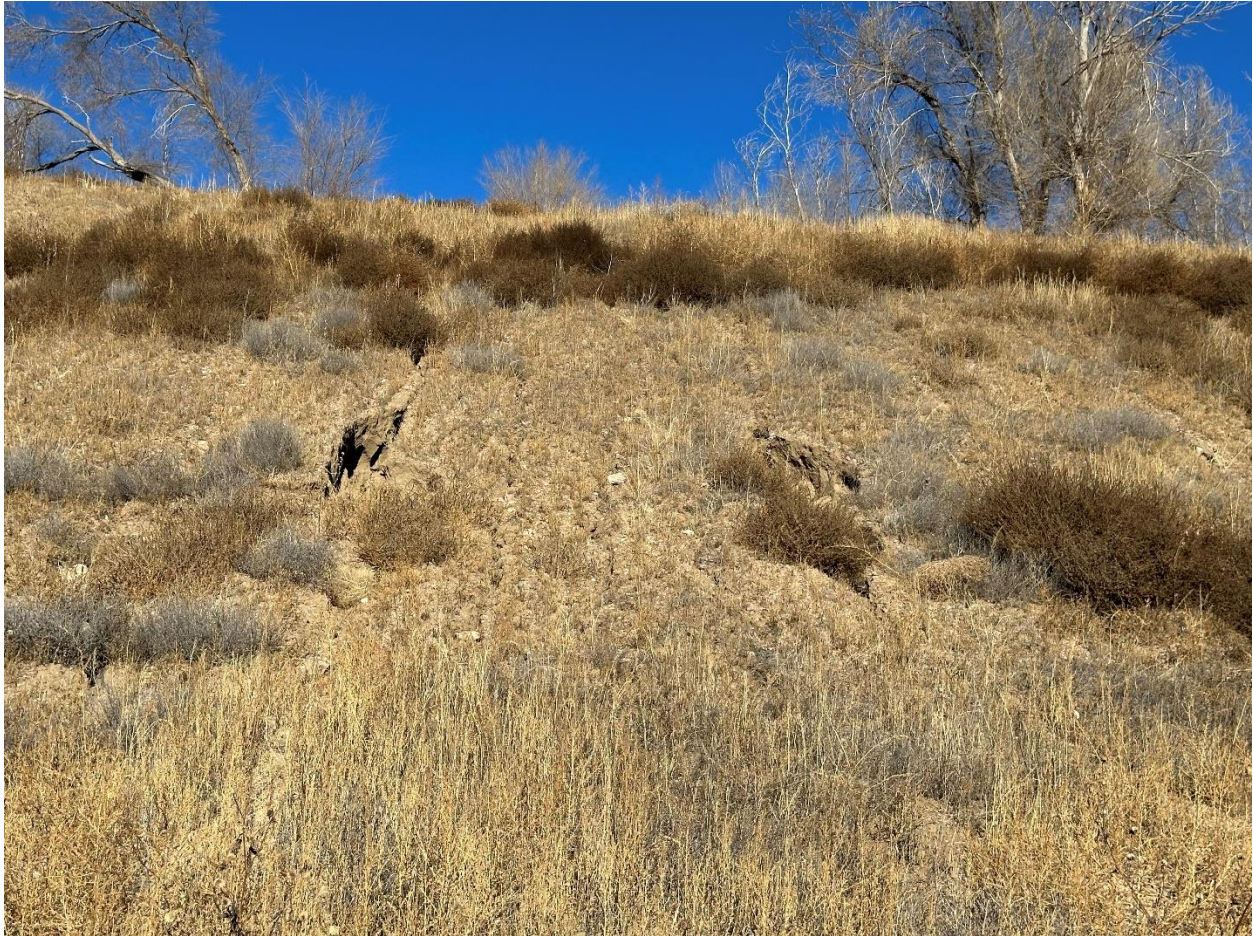
Photo 6. Erosion gullies in central area of buttress

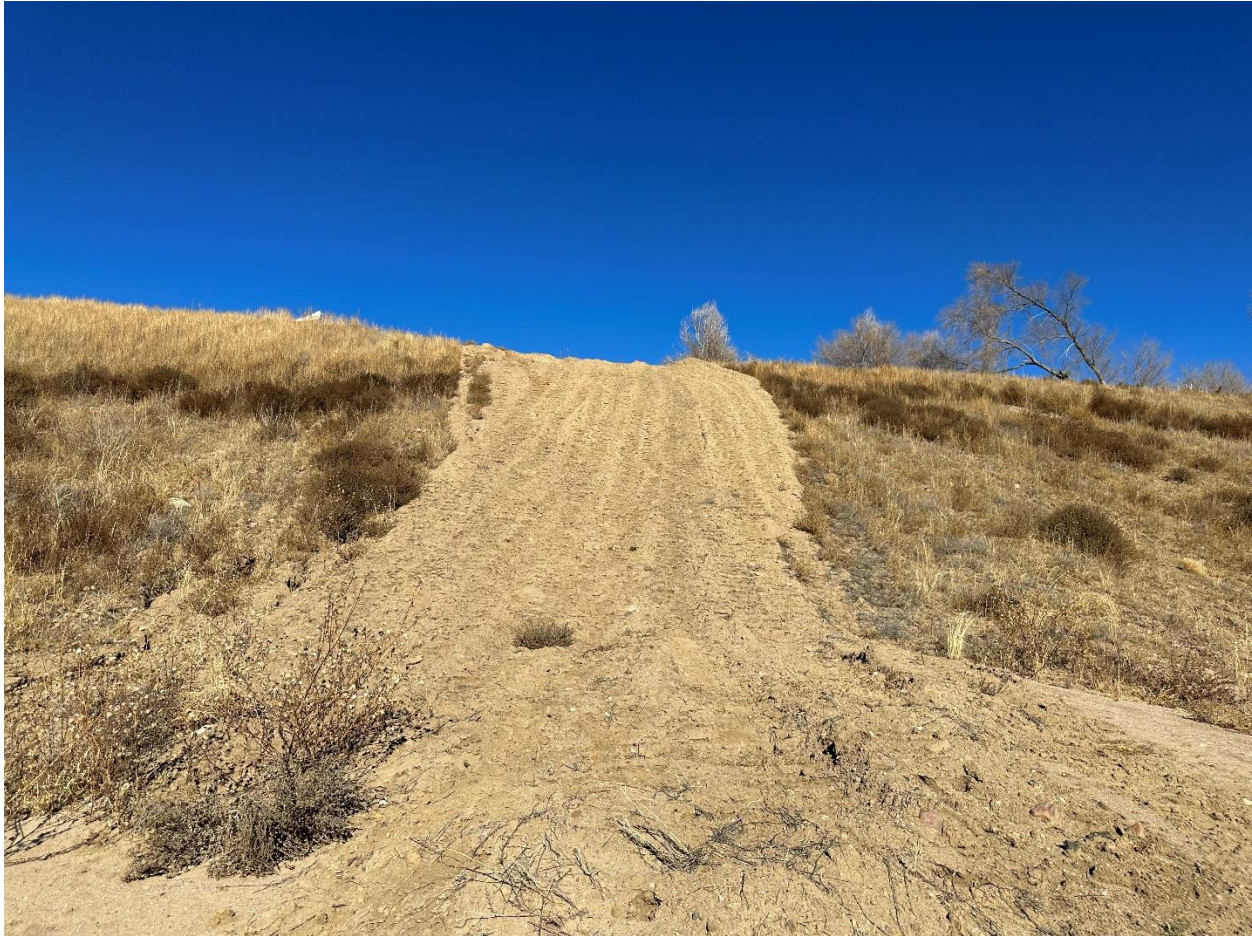
Photo 7. Recent repair on western portion of buttress

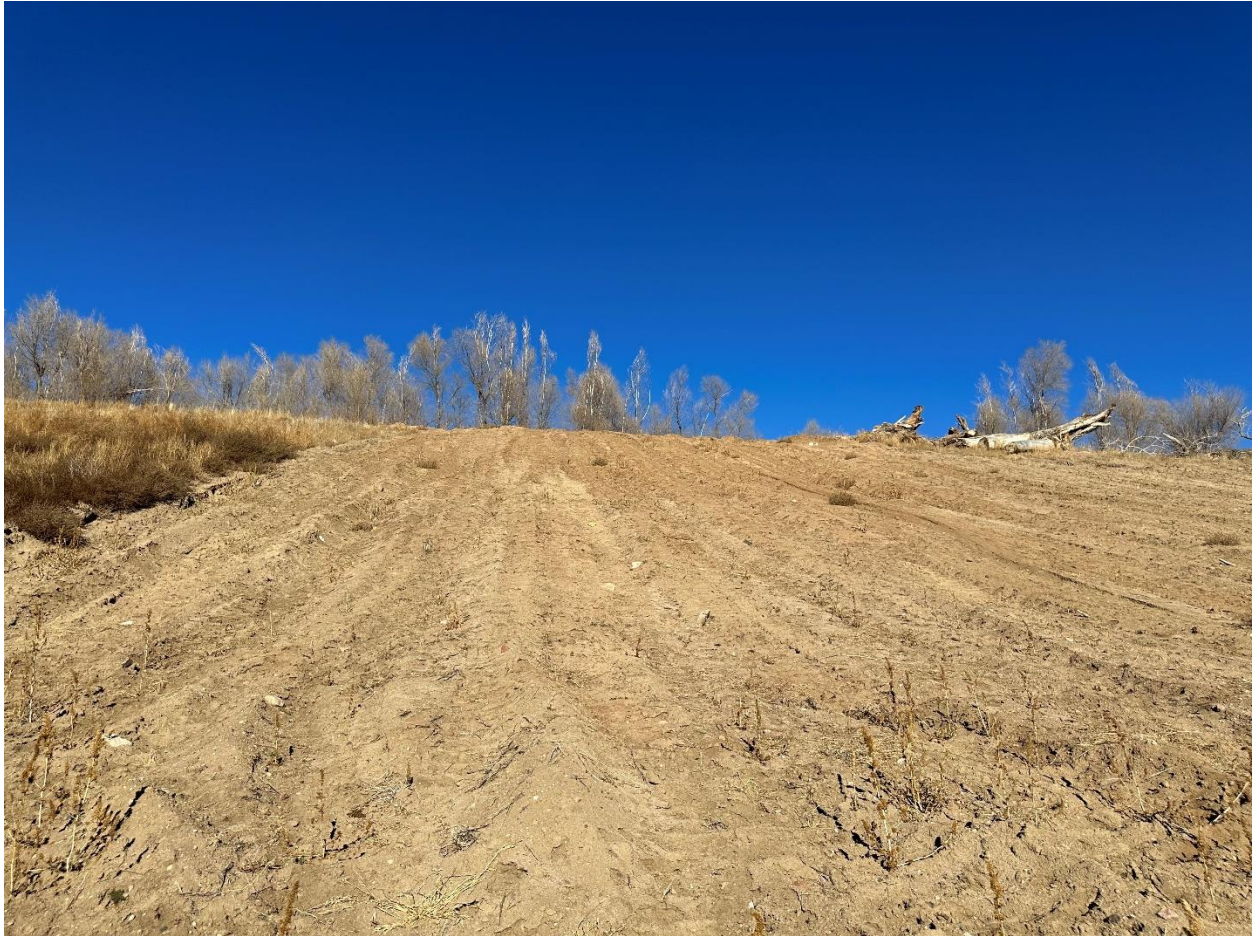
Photo 8. Repair on buttress

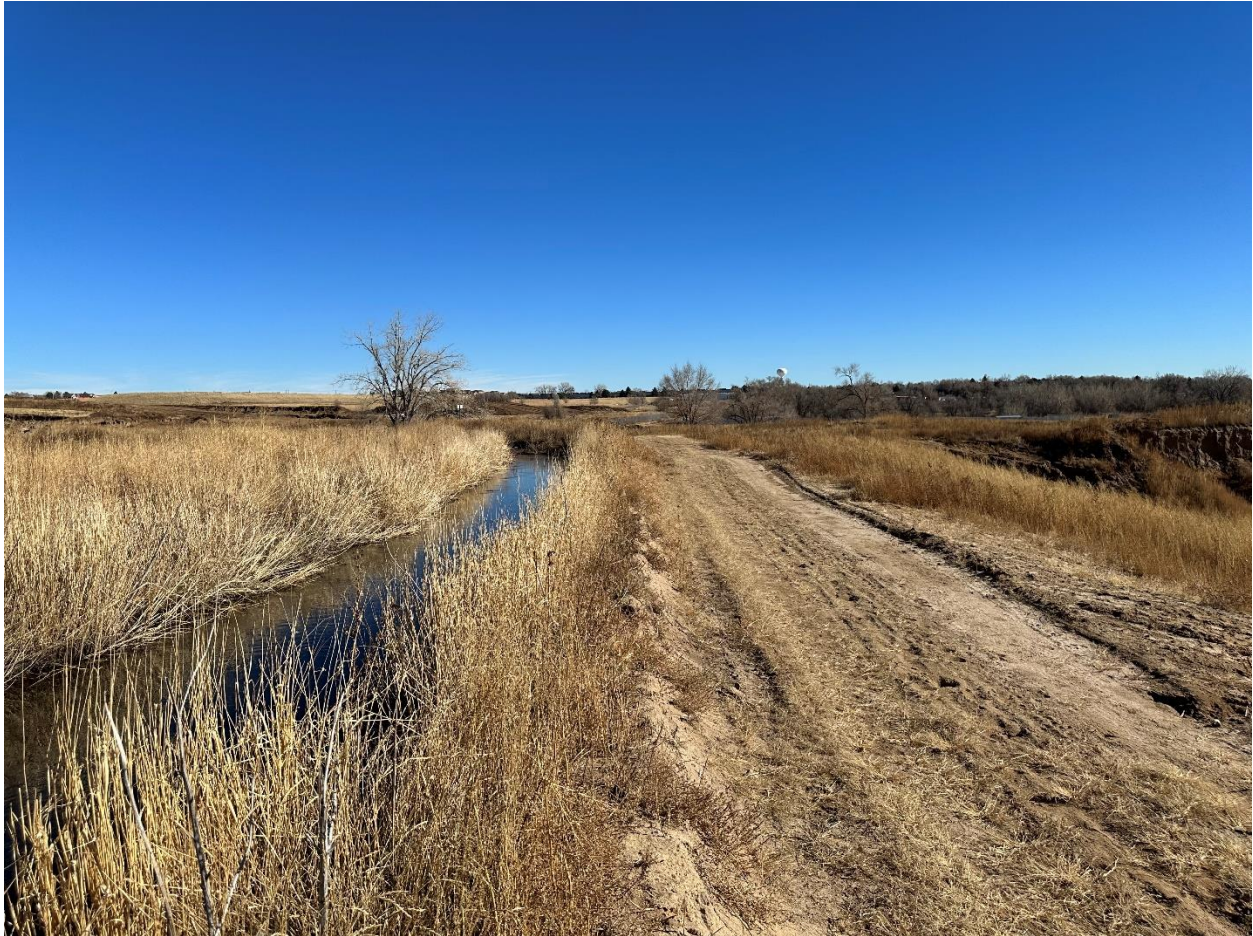
Photo 9. Ditch and access road looking east

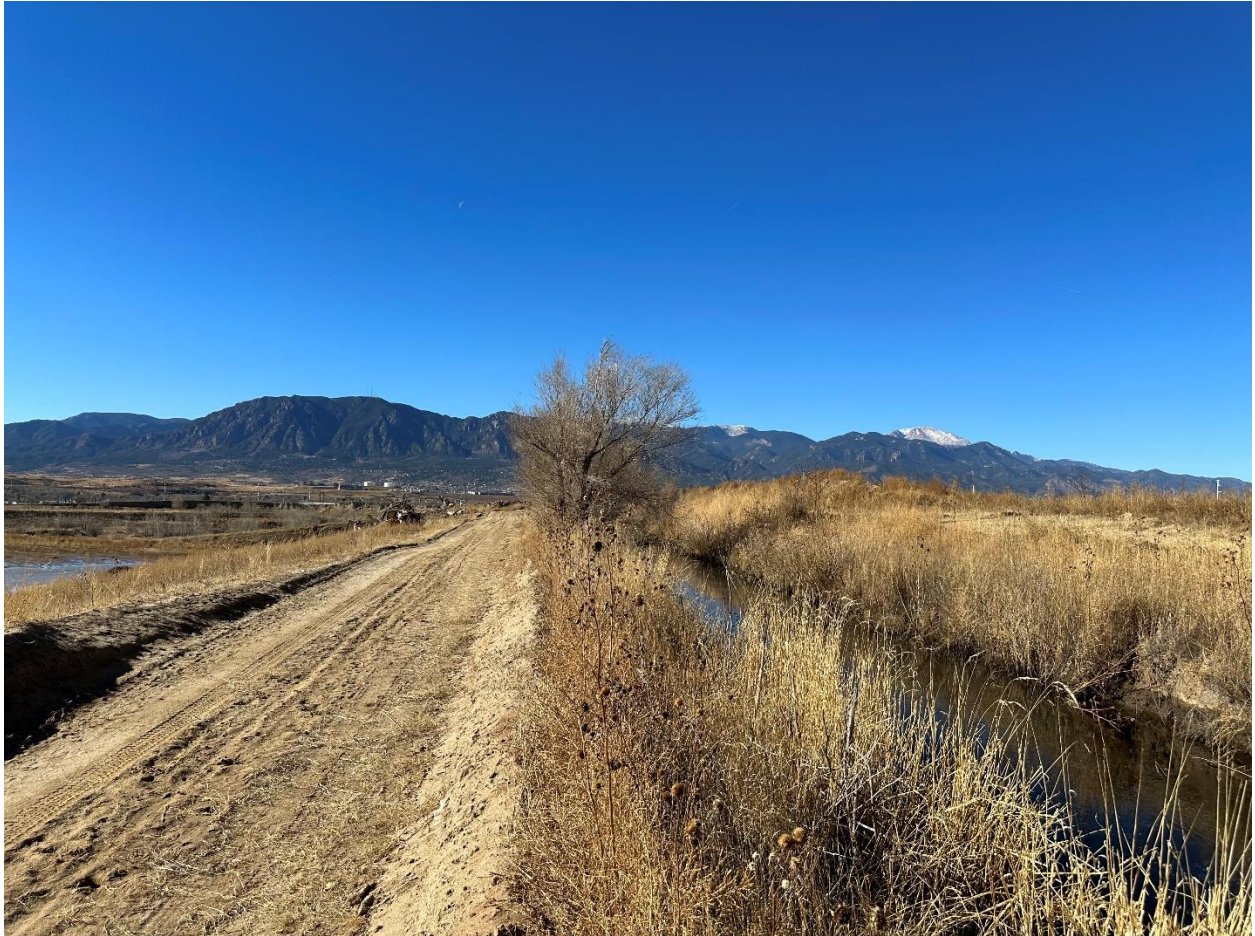
Photo 10. Ditch and access road looking west

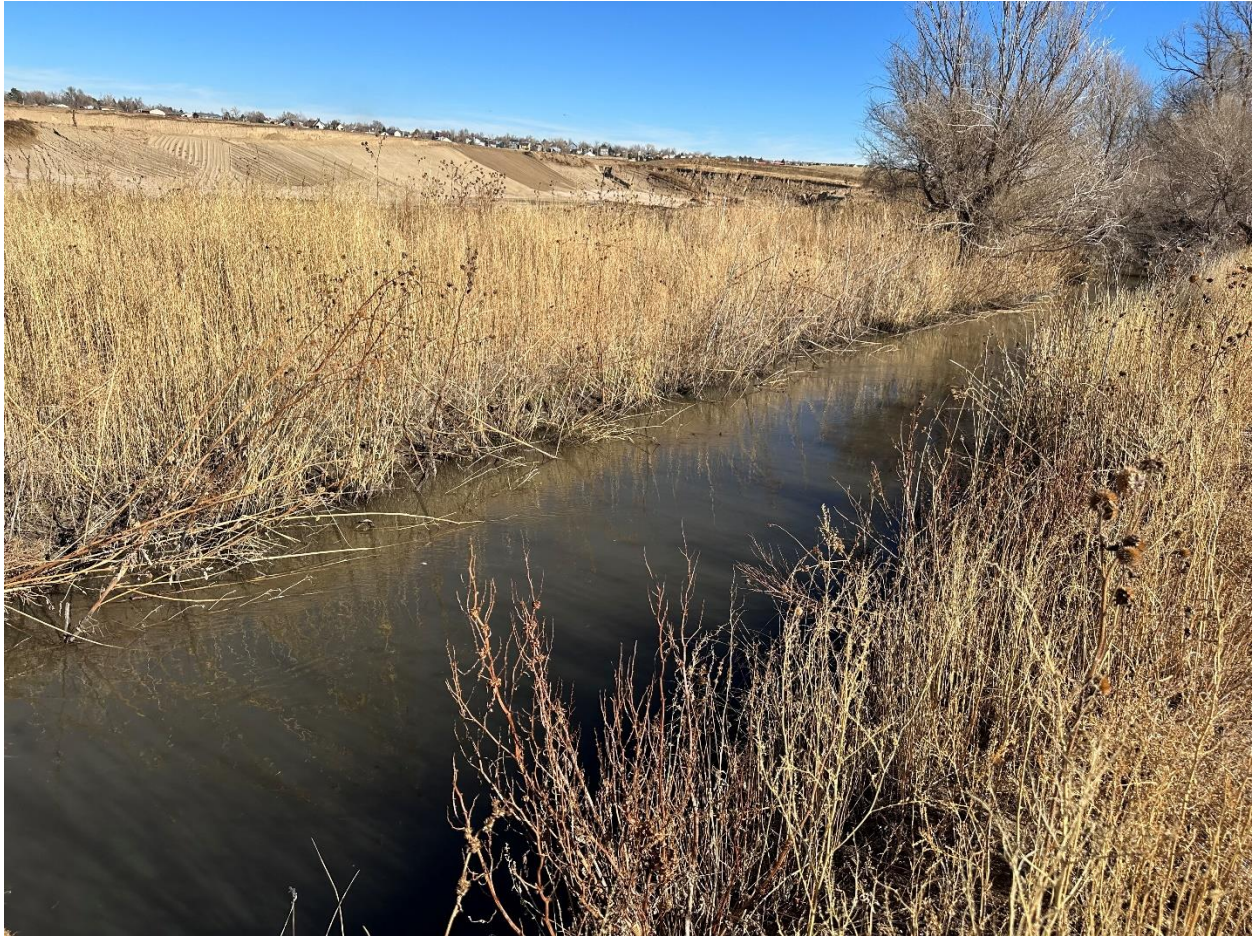
Photo 11. Water present in ditch

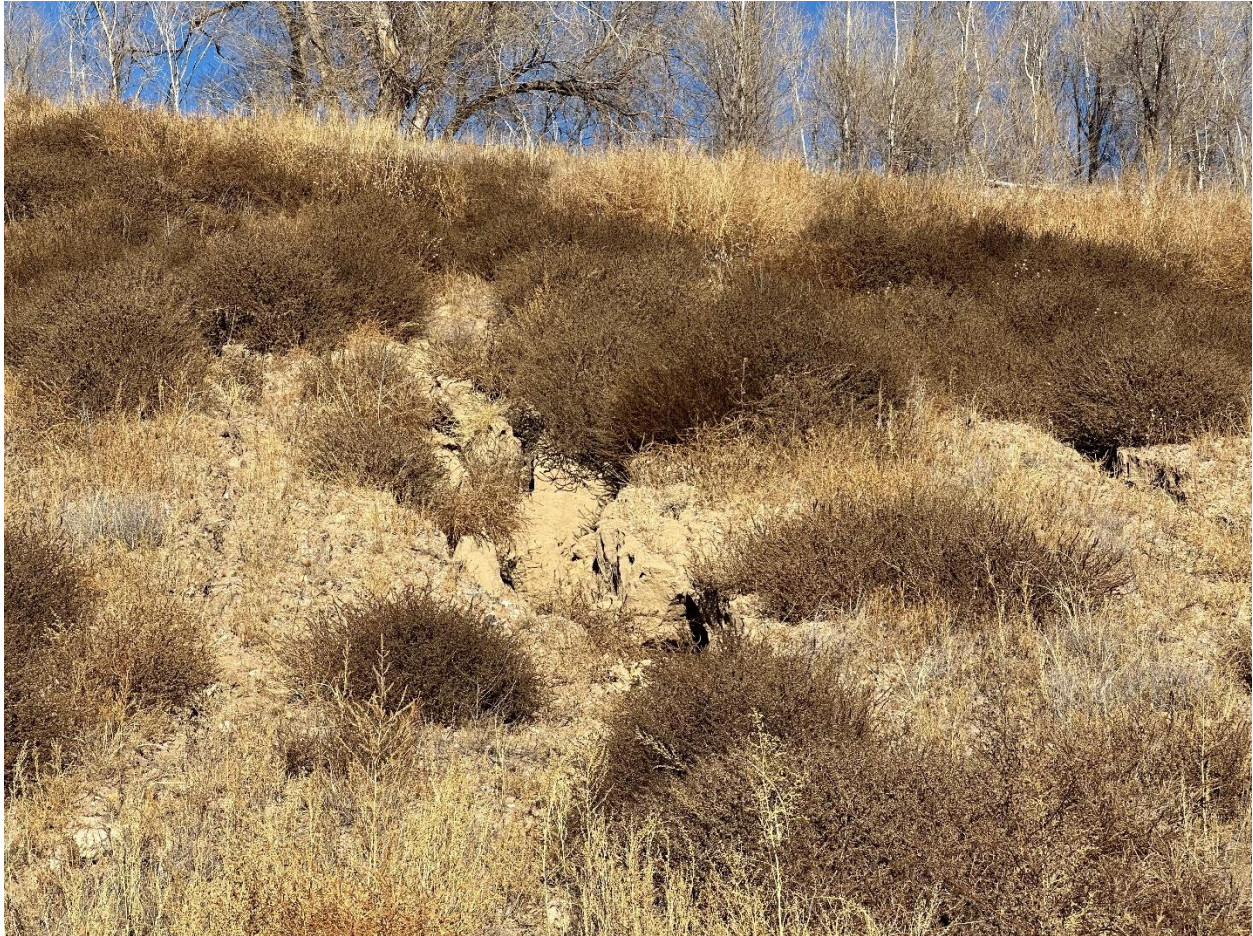
Photo 12. Erosion gullies
