**Denver Field Branch  
Mine Site Evaluation Narrative**

Permittee:	Blue Mountain Energy, Inc
Operator:	Blue Mountain Energy, Inc
Site:	Deserado Mine
Permit No:	C-1981-018
Date of Inspection:	November 28, 2023
Inspection Type:	Oversight complete
Weather:	Cloudy and cold with frozen, snowy ground conditions
Operator Representative:	Kurt Blunt
State Officials:	Todd Jesse, Travis Marshall, and Clayton Wein; Division of Reclamation, Mining and Safety
OSMRE Official:	Tom Medlin #562

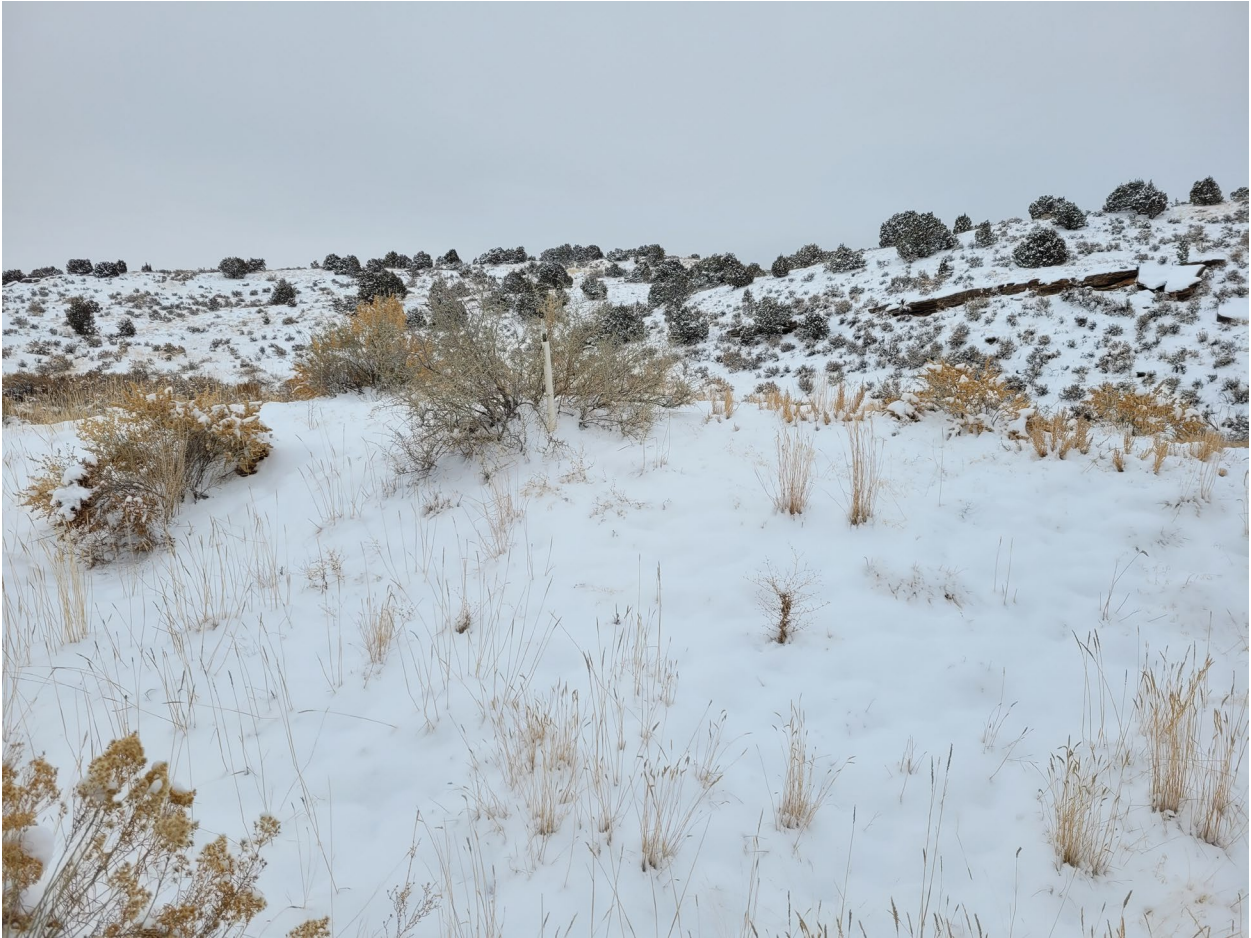
Topsoil stockpiles throughout the permit area were identified by markers as required. See Figure 1.

The B seam vent shaft no. 1 pad topsoil stockpile was inspected. The stockpile was stable and vegetated; no evidence of resource loss was noted. See Figure 1.

Figure 1. B seam vent shaft no. 1 pad topsoil stockpile. Typical stockpile marker, center.

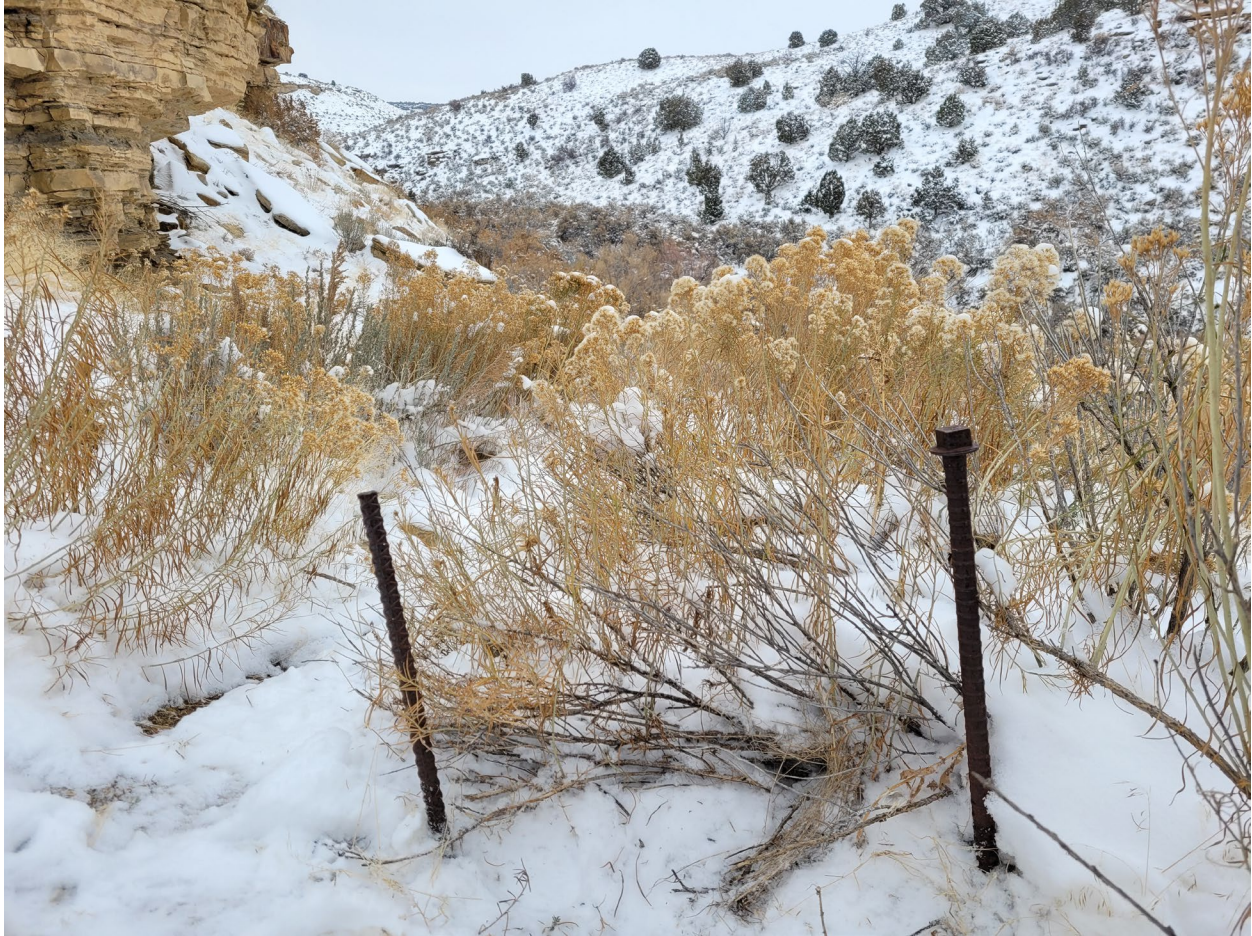
Runoff from the explosives storage pad is treated by a series of straw bales. The first of these straw bales was missing and should be replaced. See Figure 2. Additionally, a small pile of flexible fiberglass piping had accumulated around the corner from the explosives storage. Mr. Blunt agreed to have the piping relocated.

Figure 2. Explosives storage disturbed area runoff treatment; straw bale missing.

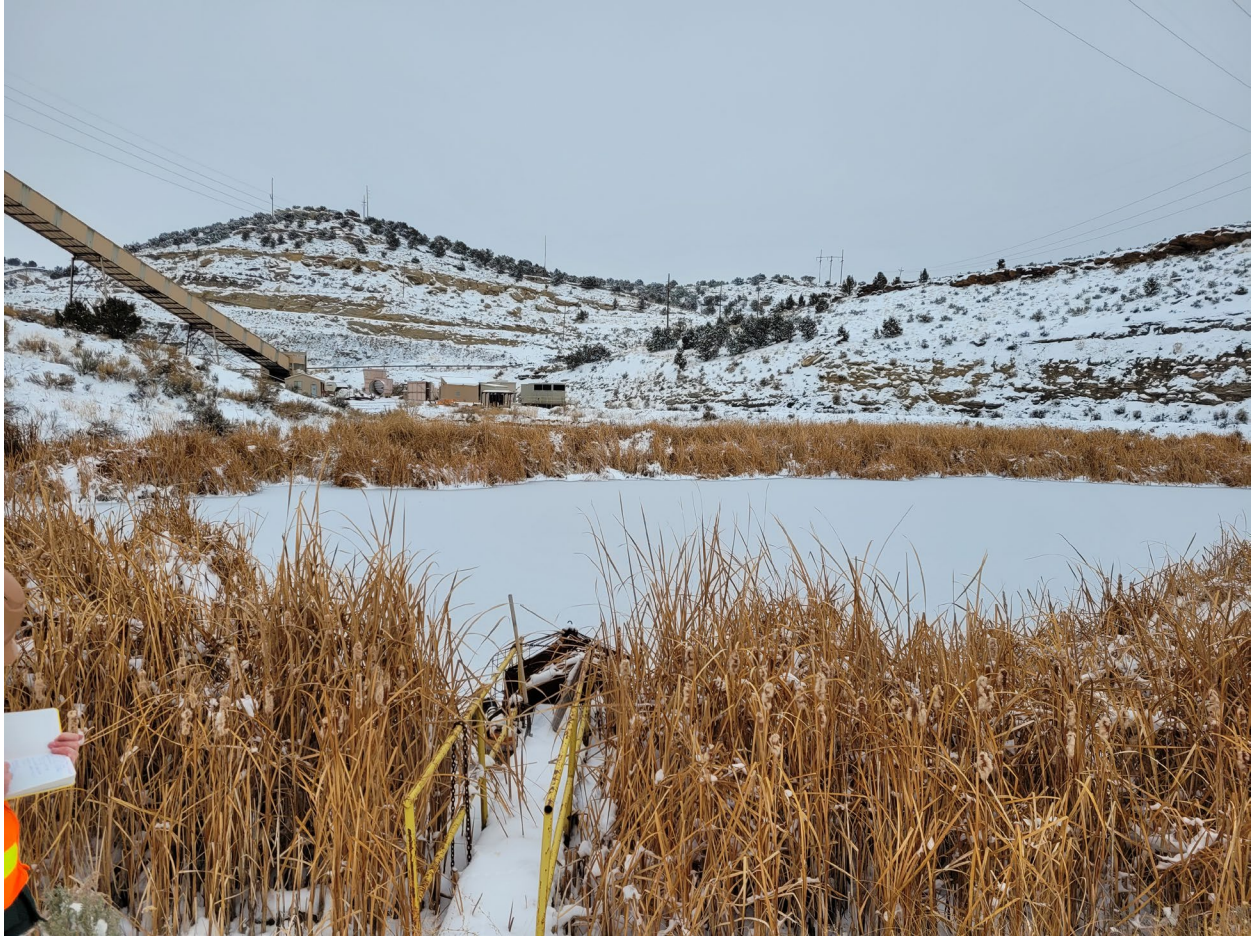
Figure 3. DP1 pond.

DP1 pond was discharging at the time of inspection. No issues were noted. See Figure 3.

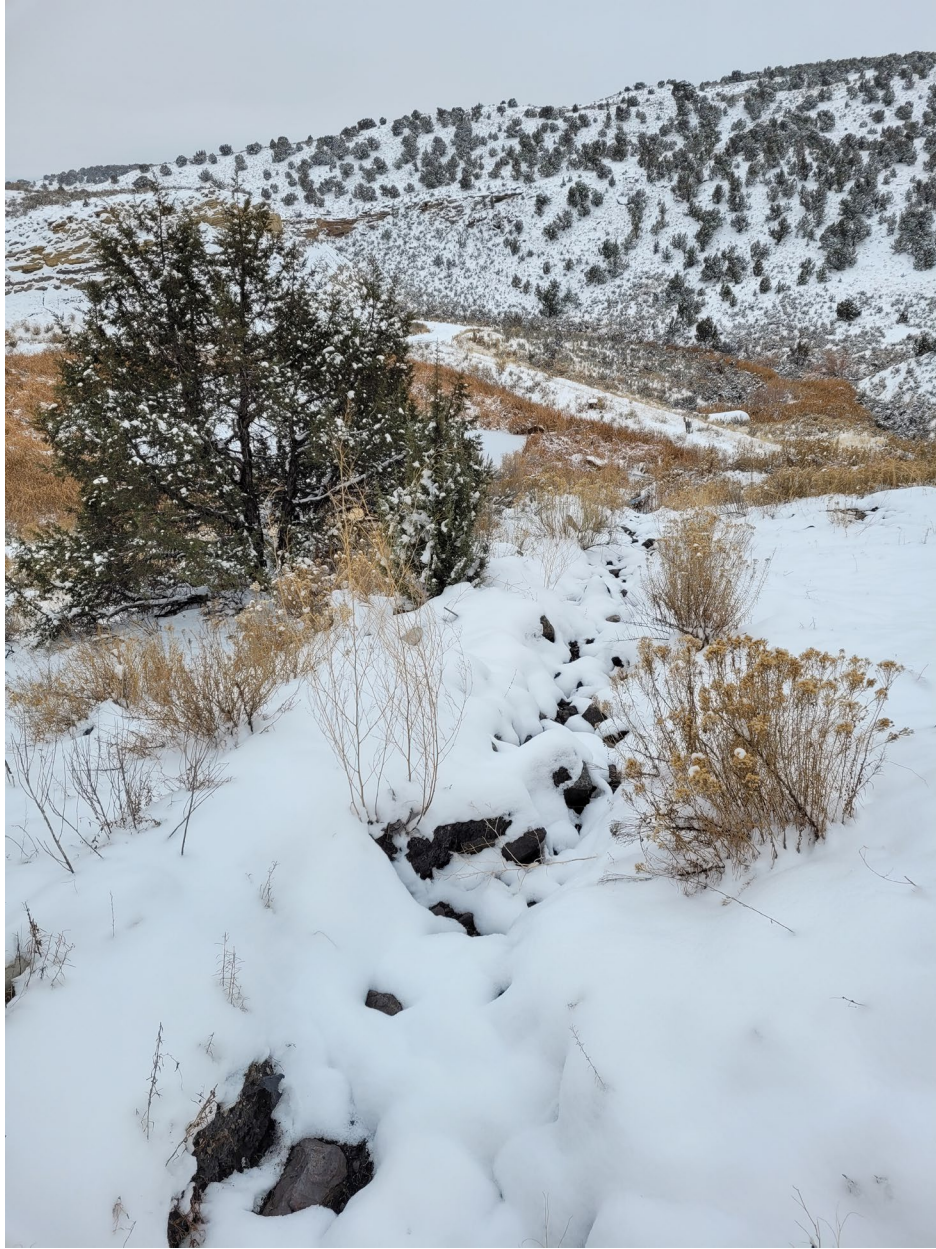
Figure 4. Middle facilities bench ditch.

Armored ditching which conveys disturbed area drainage from the middle facilities bench to DP1 was inspected and found to be open and stable. See Figure 4.

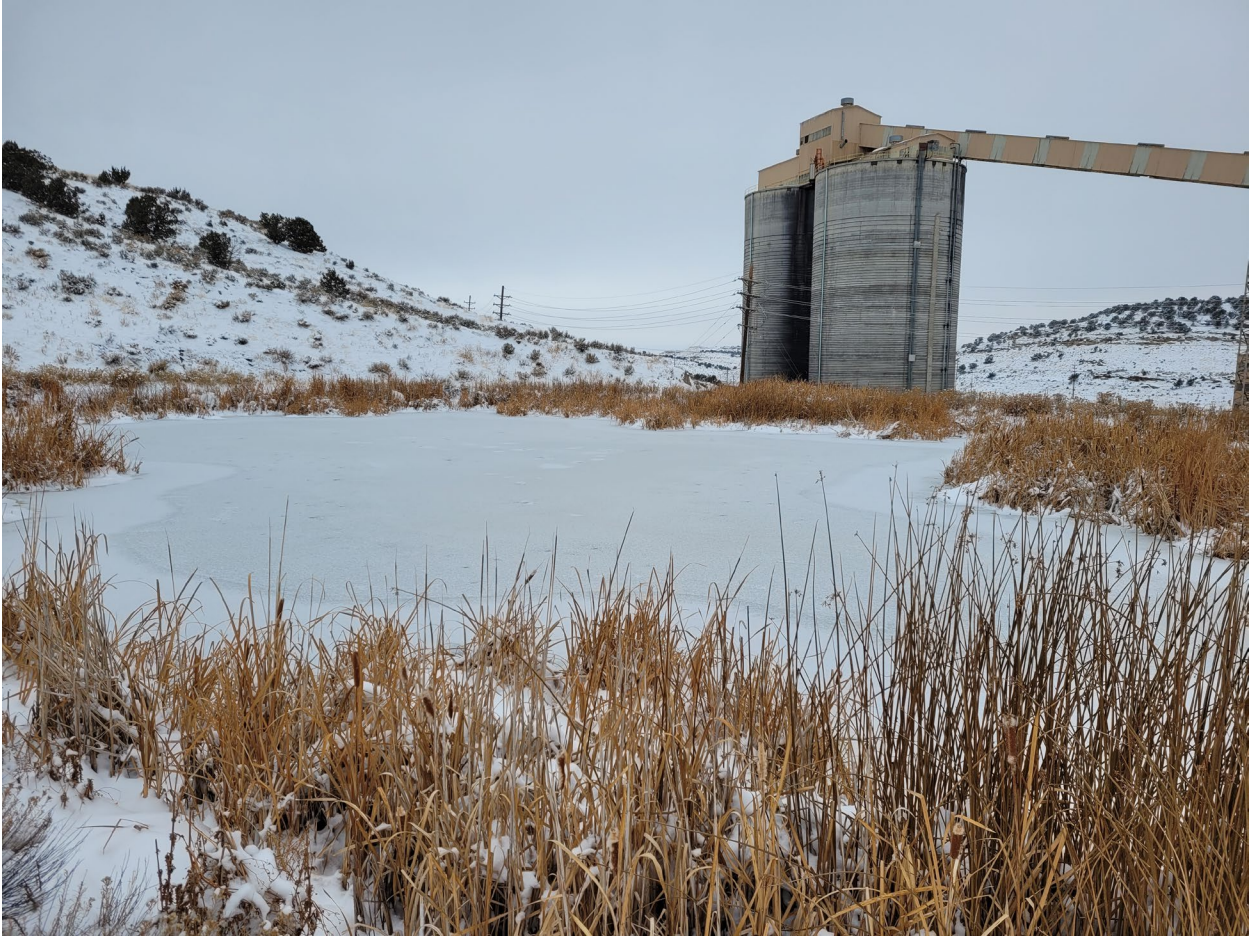
PP2 pond was frozen and stable at the time of inspection. Mr. Blunt indicated cattail removal is planned for spring. See Figure 5.

Figure 5. PP2 pond; cattail removal is planned for spring.

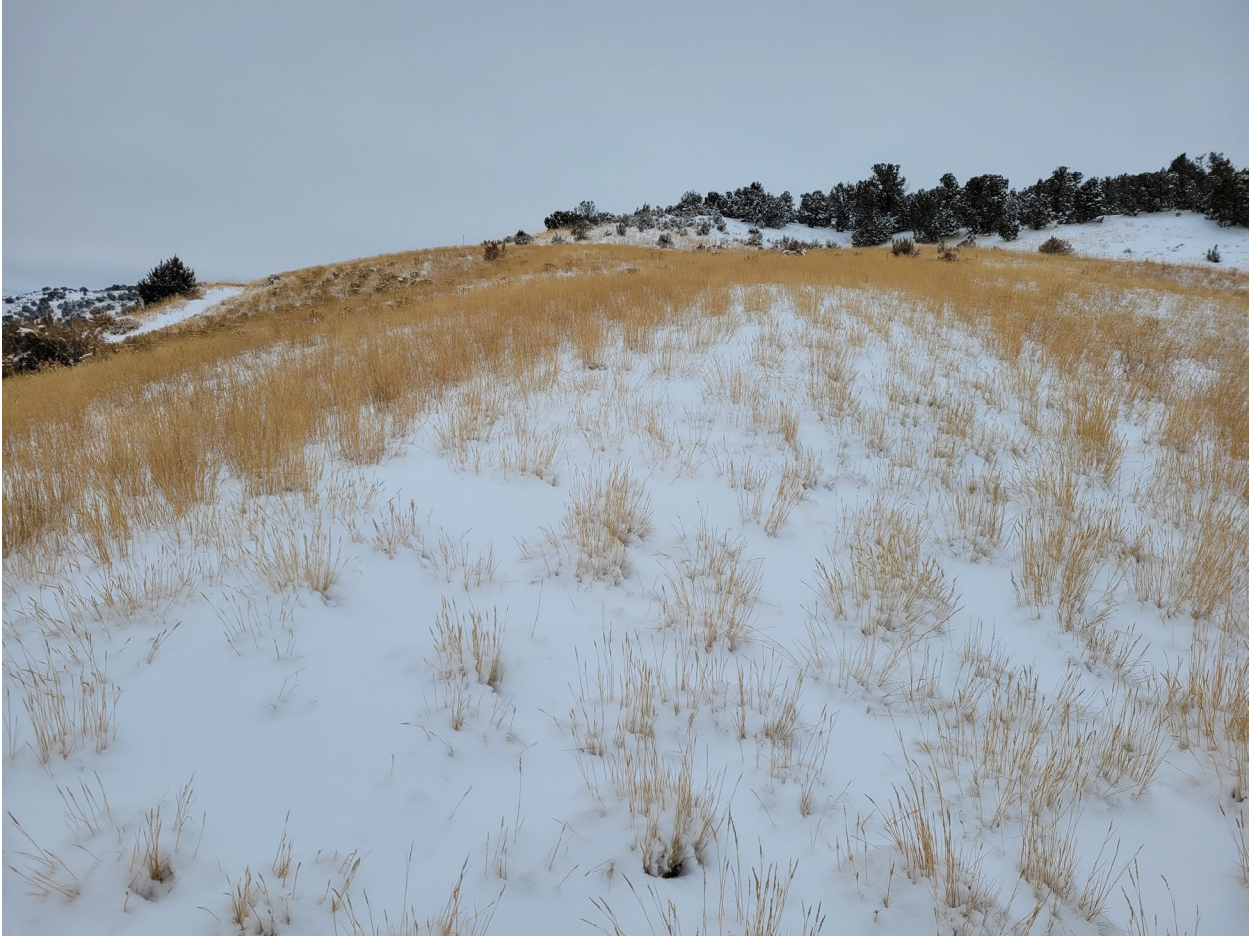
Figure 6. Main facilities topsoil stockpile.

The main facilities topsoil stockpile was inspected. The stockpile was stable and vegetated; no issues were noted. See Figure 6.

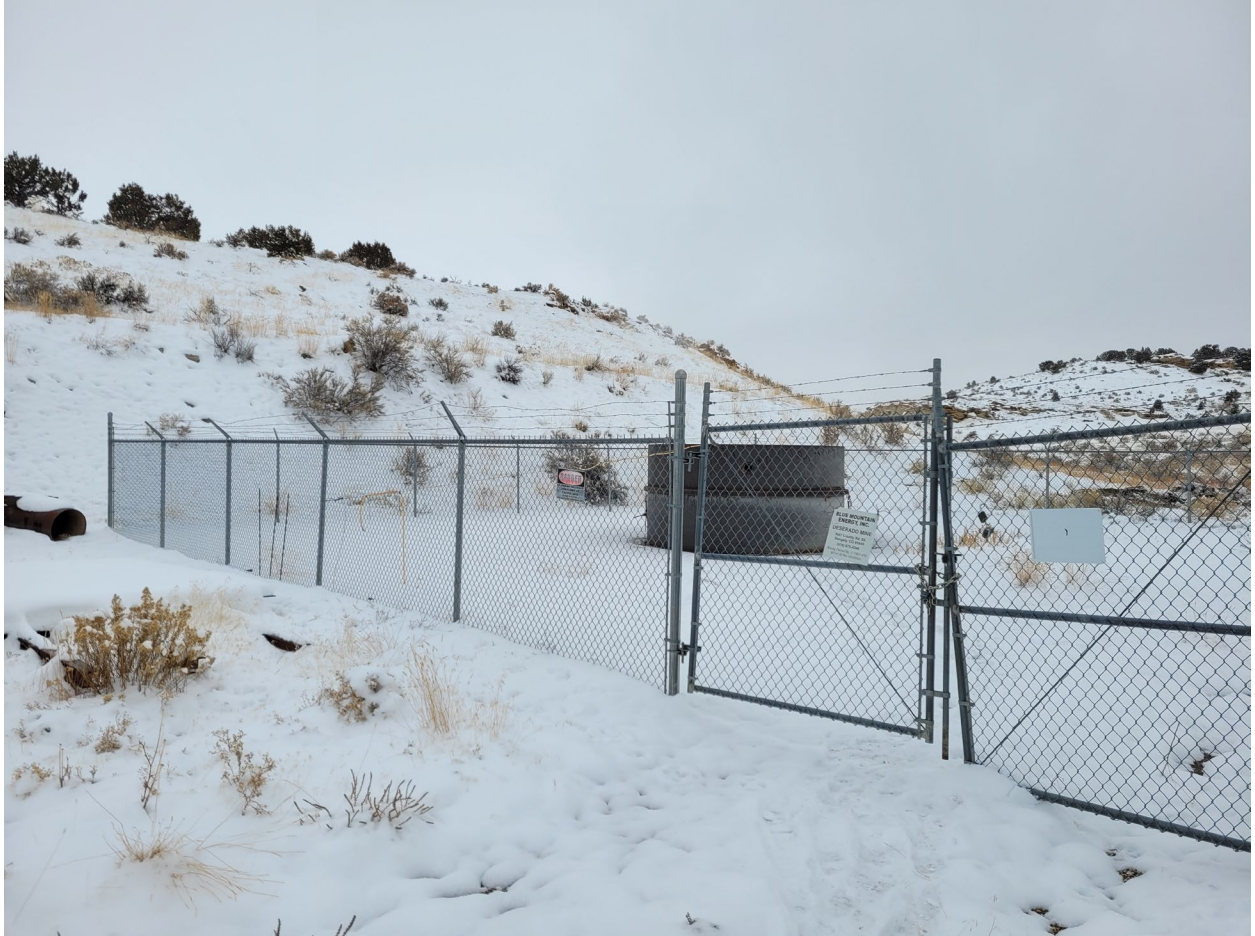
Figure 7. B seam vent shaft no. 1 pad.

The B seam vent shaft no. 1 pad was inspected. The pad and hillside behind were stable and the shaft was fenced and signed. See Figure 7.

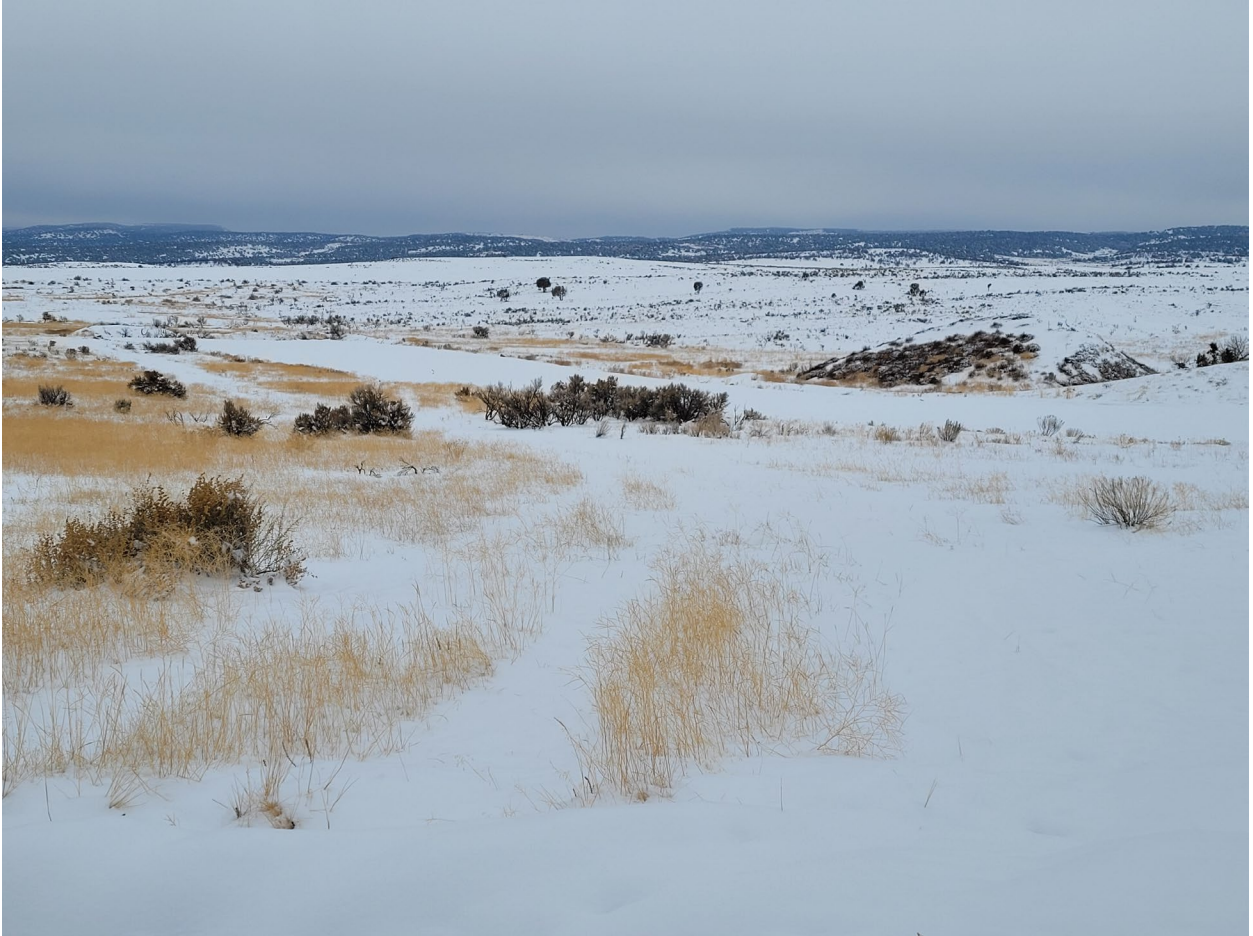
Figure 8. Reclaimed landfill, center.

Due to access constraints the minesite landfill was observed from the nearest road. The landfill had recently been reclaimed. See Figure 8.

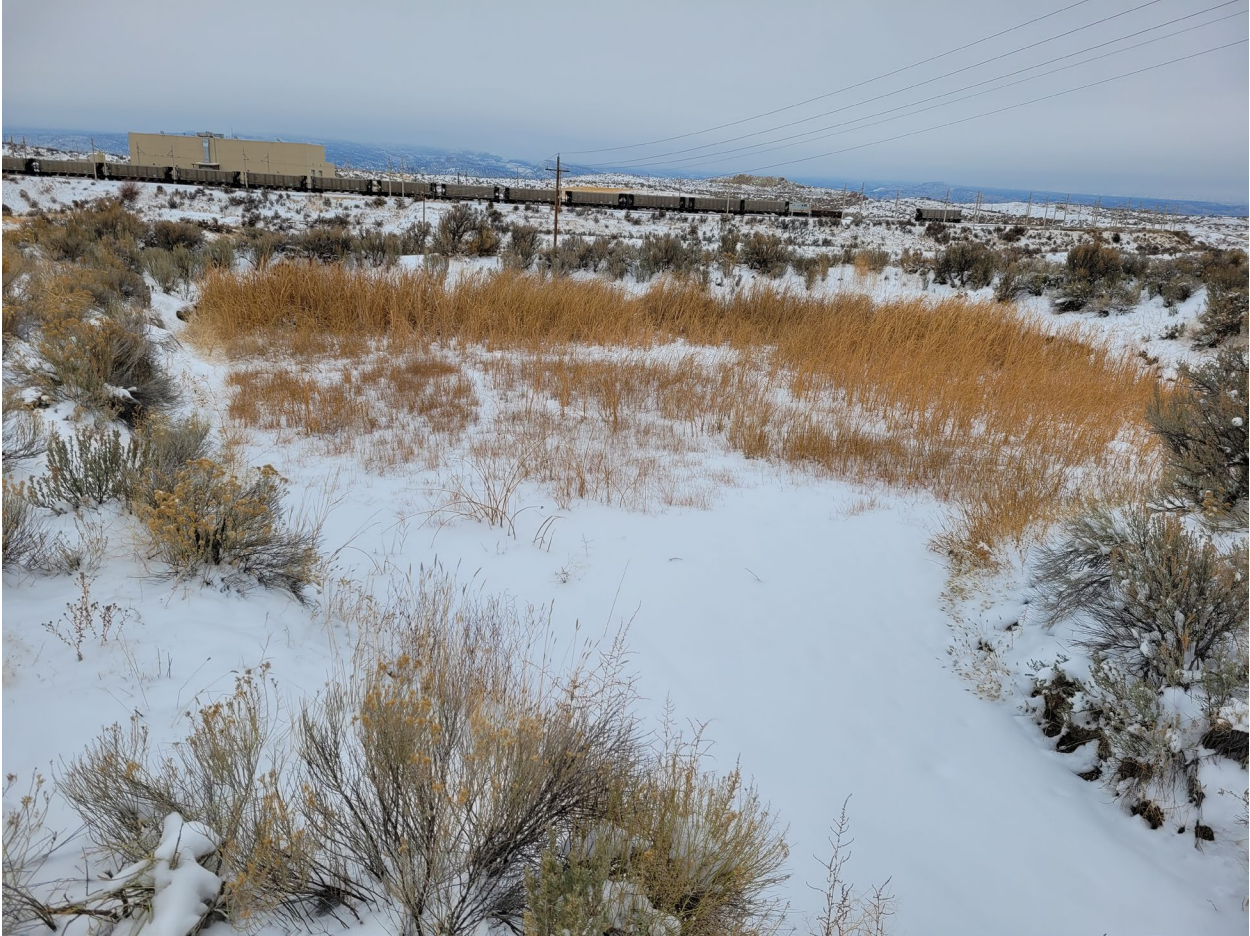
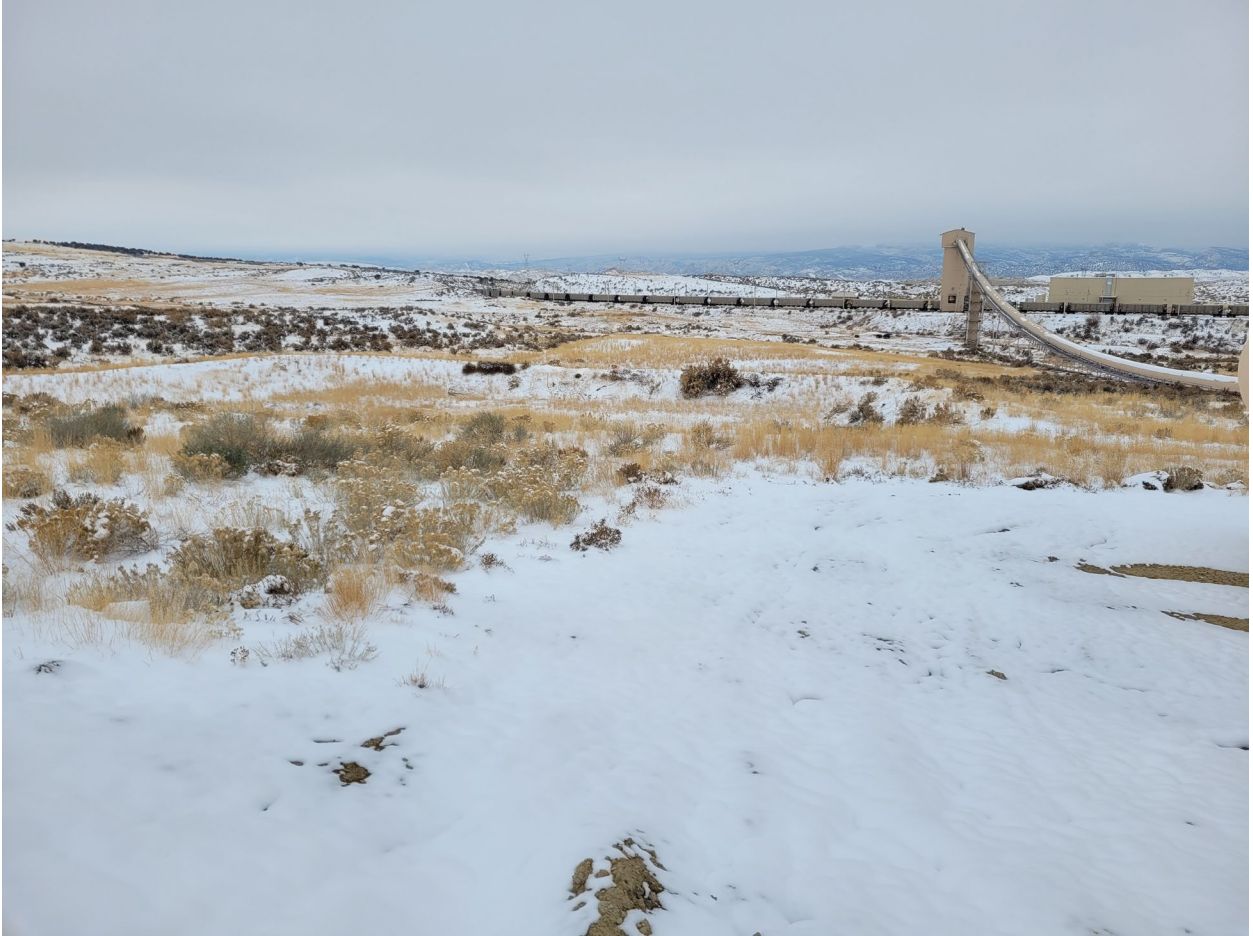
Slot storage ponds no. 1 and no. 2 were inspected. The ponds were dry and stable. See Figures 9 - 10.

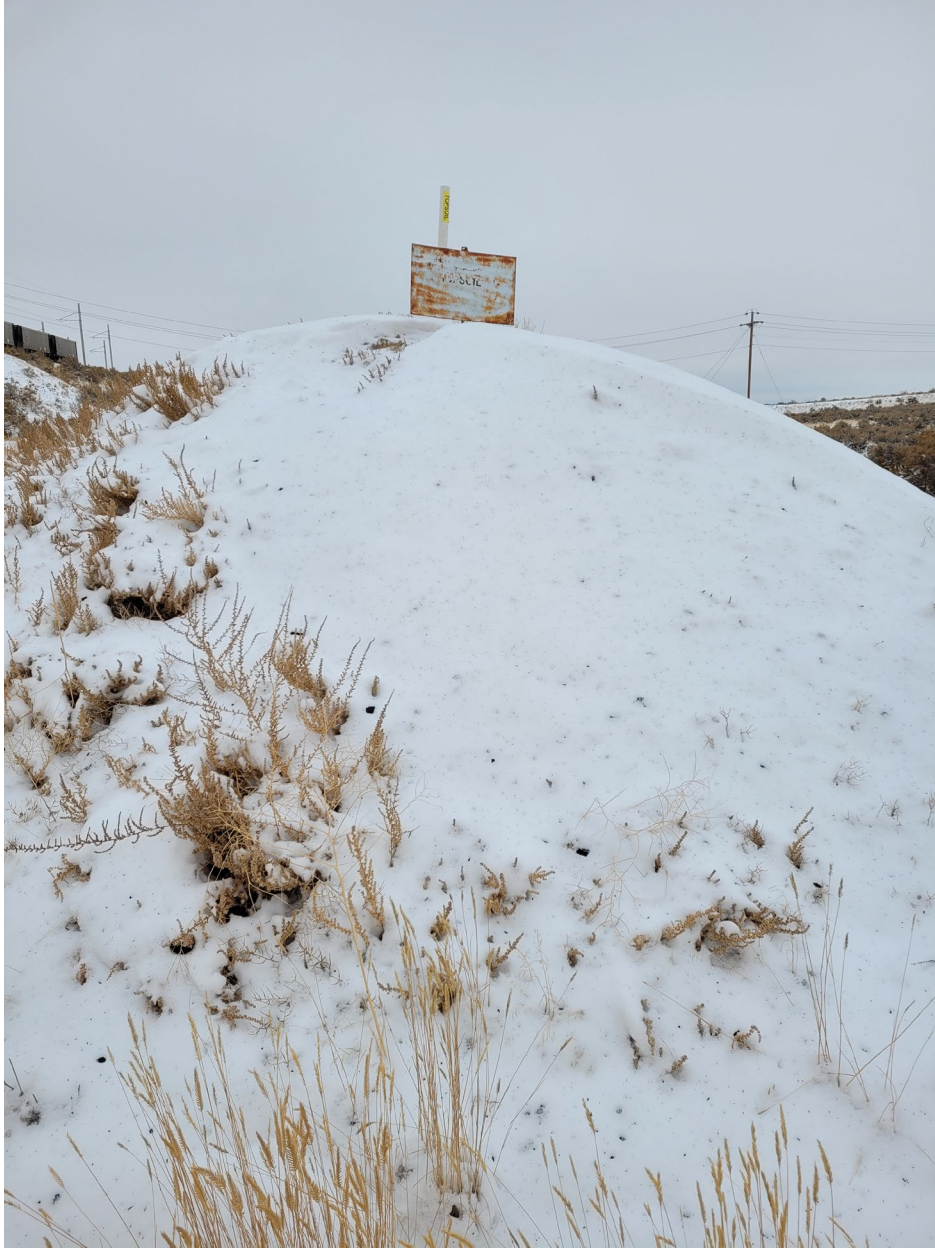
Figure 11. RR1 pond topsoil stockpile.

The RR1 pond topsoil stockpile was inspected. The stockpile was stable and vegetated; no evidence of resource loss was noted. See Figure 11.

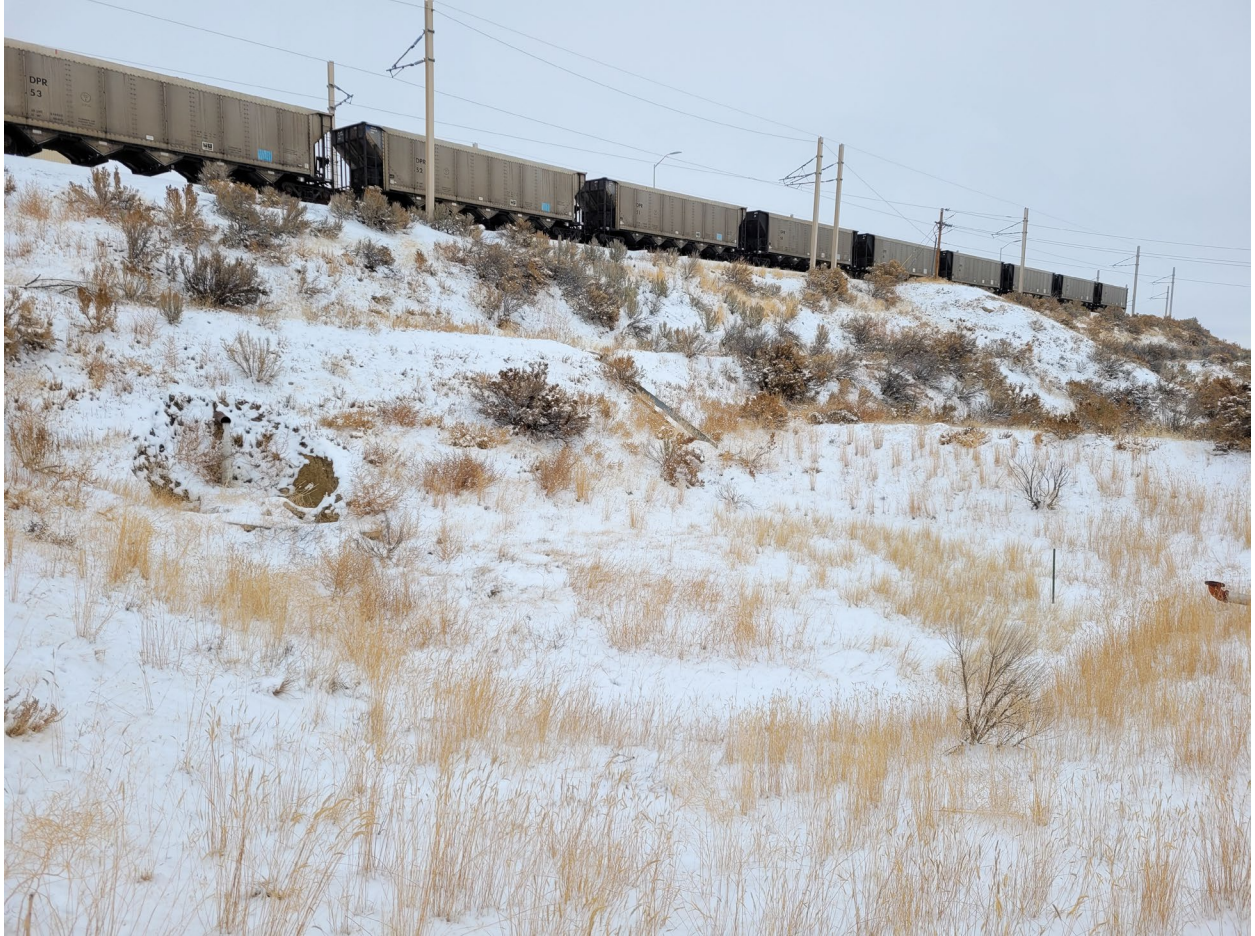
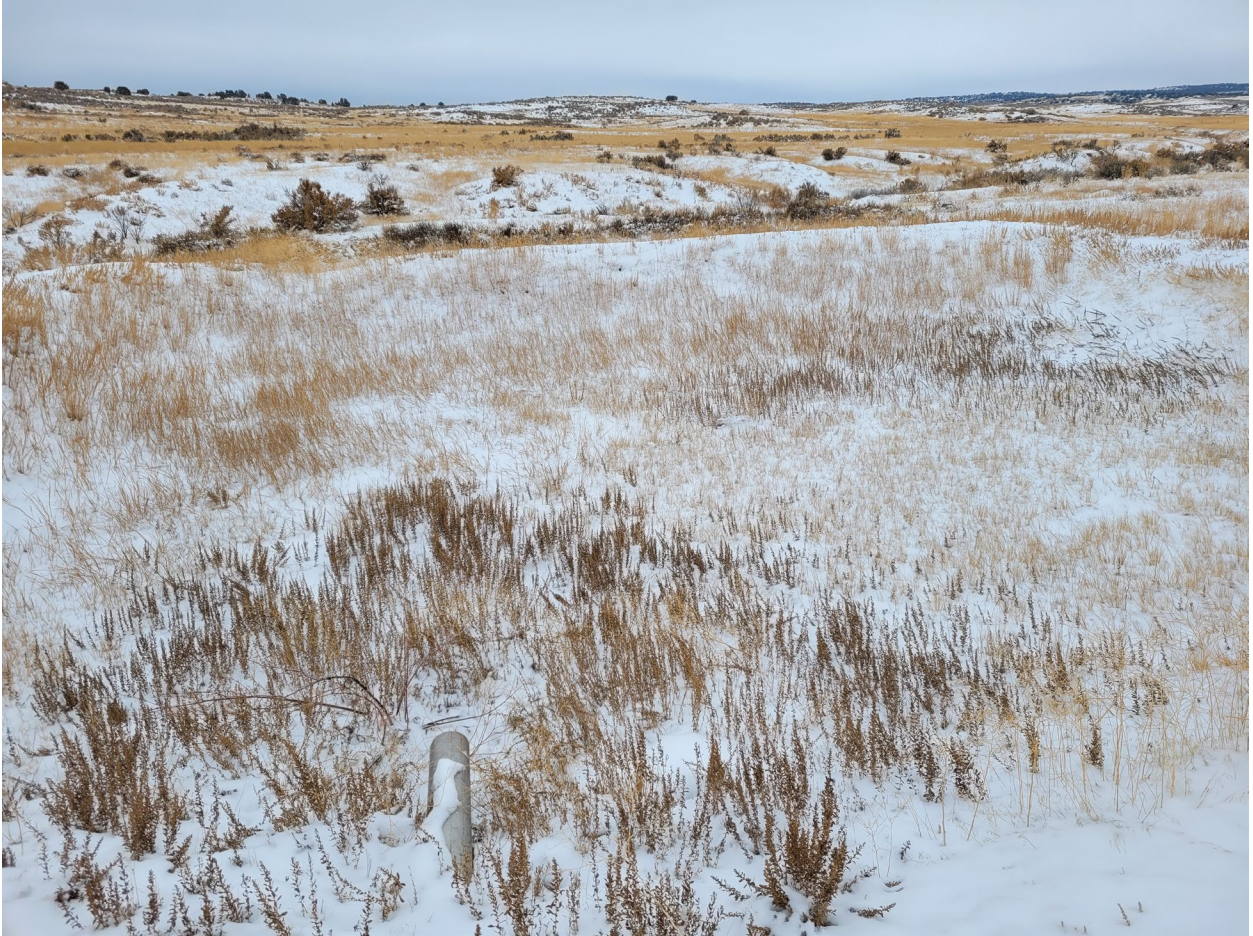
RR1 pond and RR1 sump were inspected. The pond and sump were both dry and stable. See Figures 12 - 13.

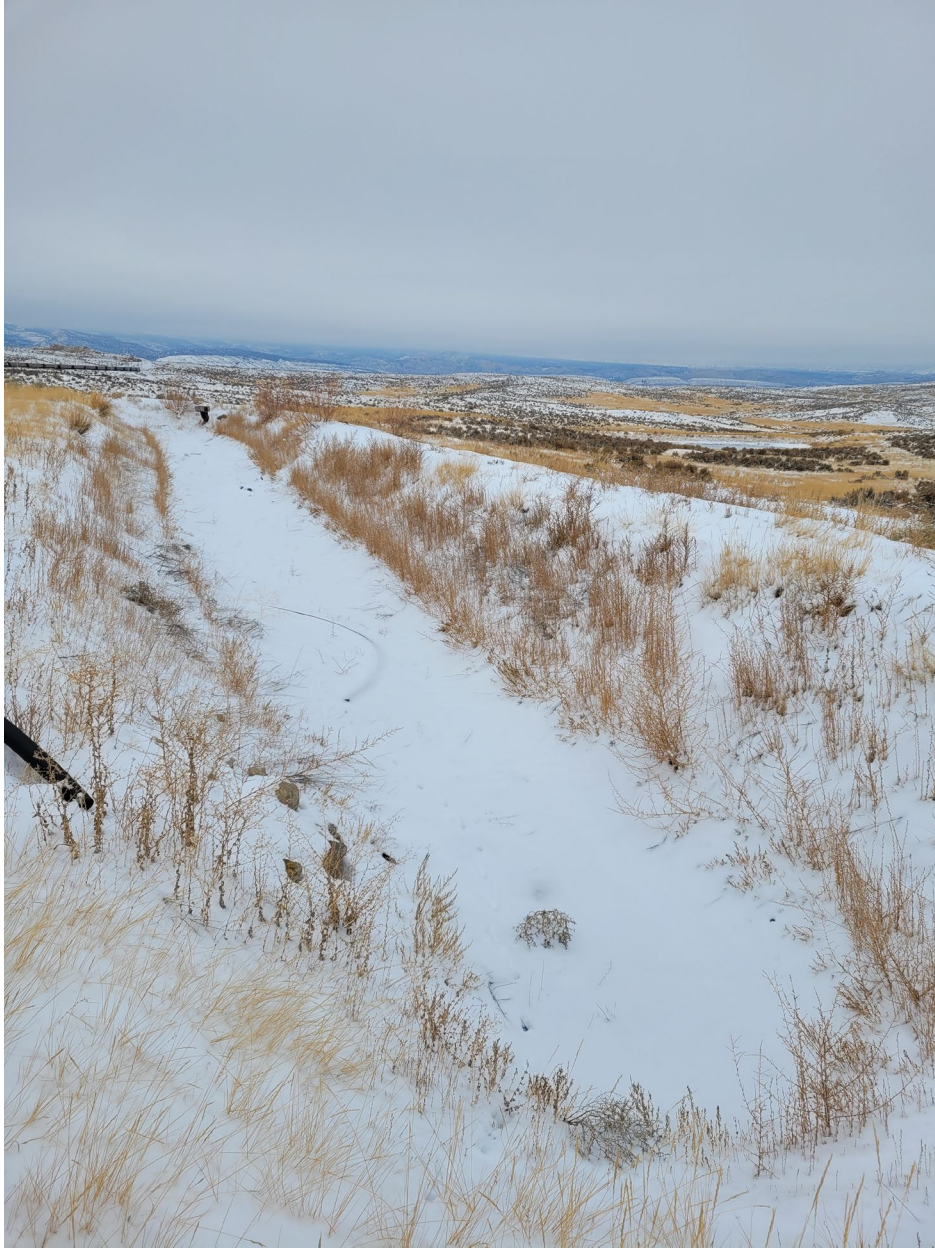
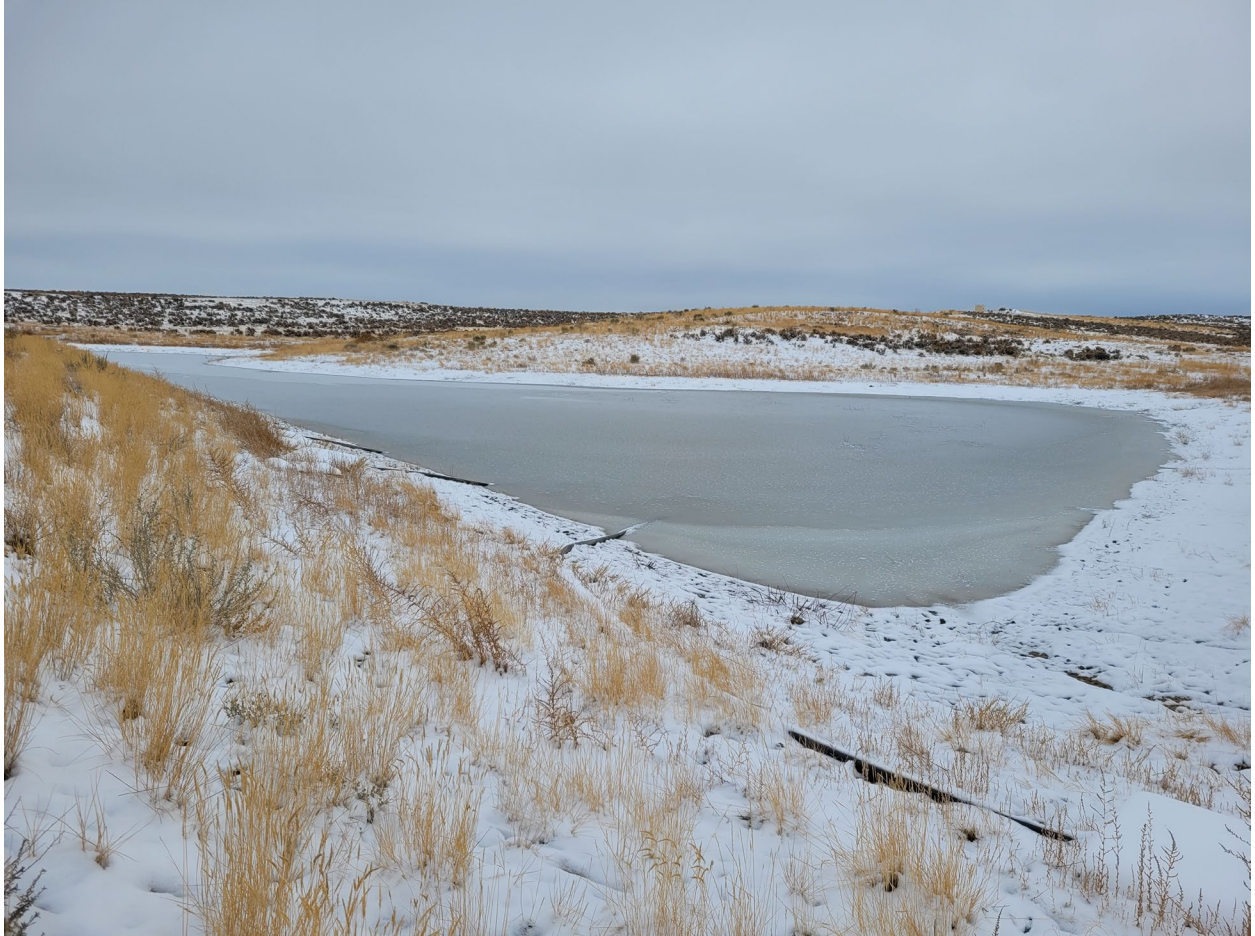
The B seam dewatering system no. 2 was inspected. The upper and lower cells were dry and stable while the middle cell was stable and contained frozen water. See Figures 14 - 15.

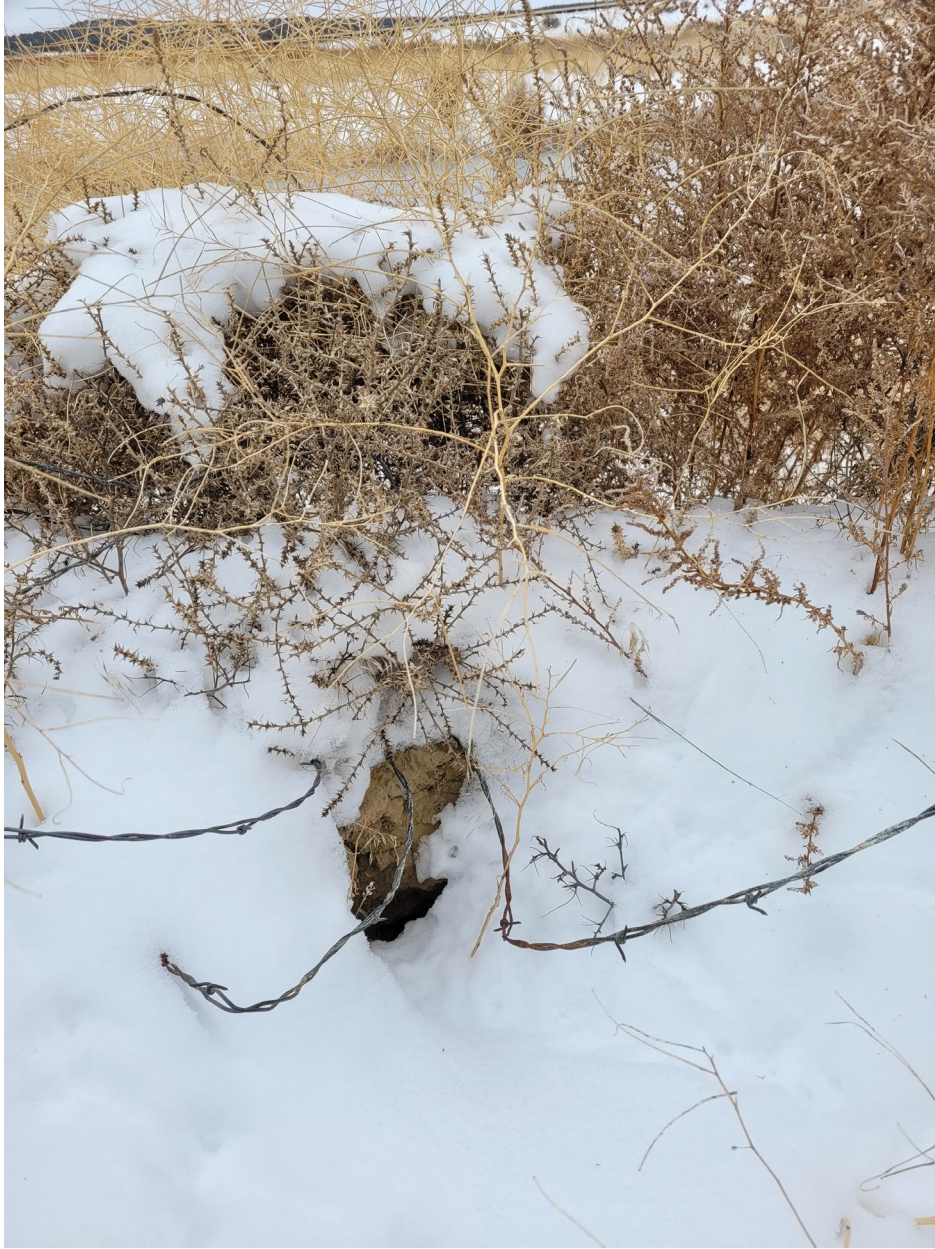
The B seam dewatering system no. 1 was inspected. All cells contained water and were stable. The last chance pond was discharging. An animal burrow was noted in the embankment of the last chance pond, southwestern portion. Mr. Blunt agreed to have the burrow filled. See Figure 16.

Figure 16. Animal burrow, last chance pond.

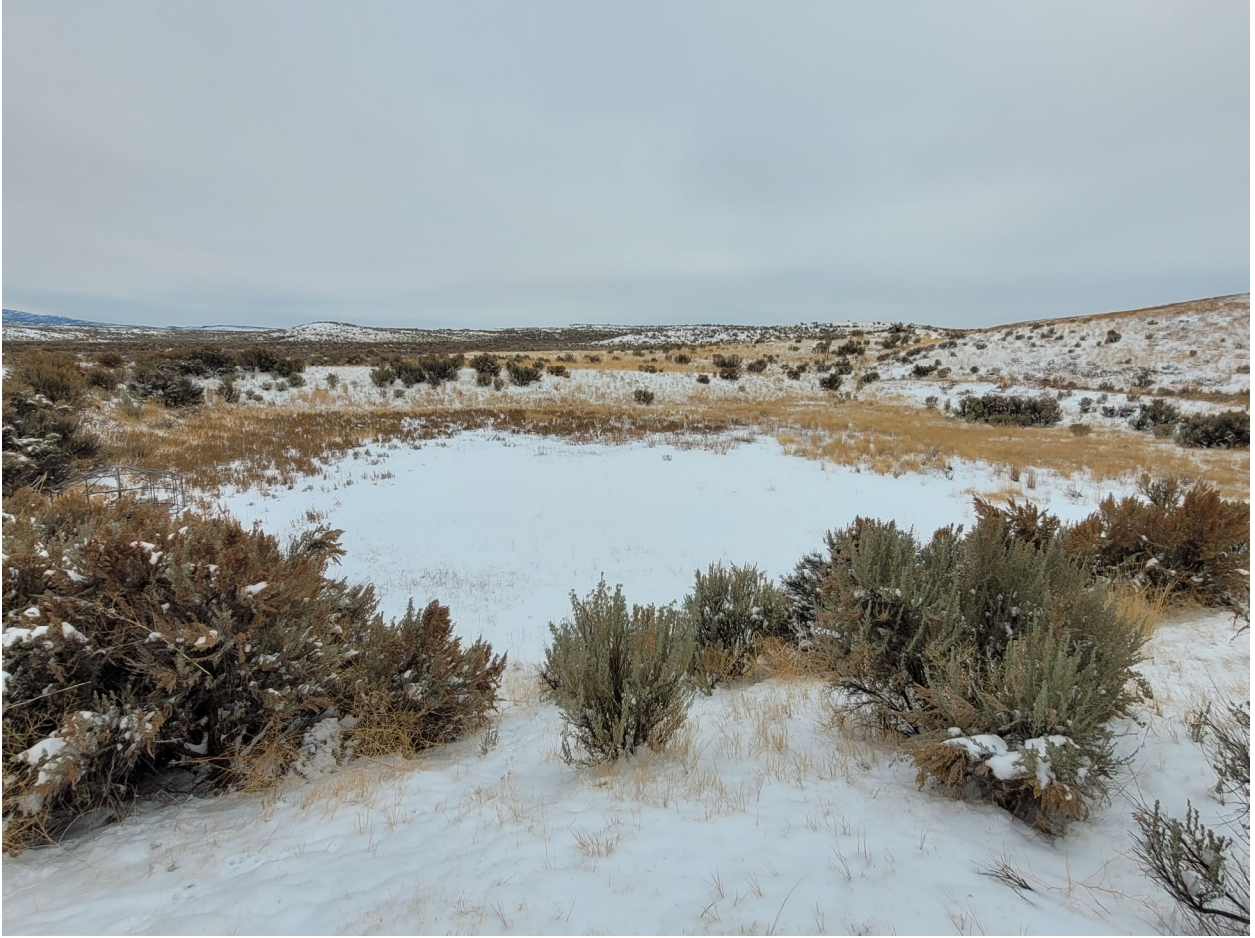
Figure 17. RP1 pond.

RP1 pond was inspected. The pond was covered with snow and no issues were noted. See Figure 17.

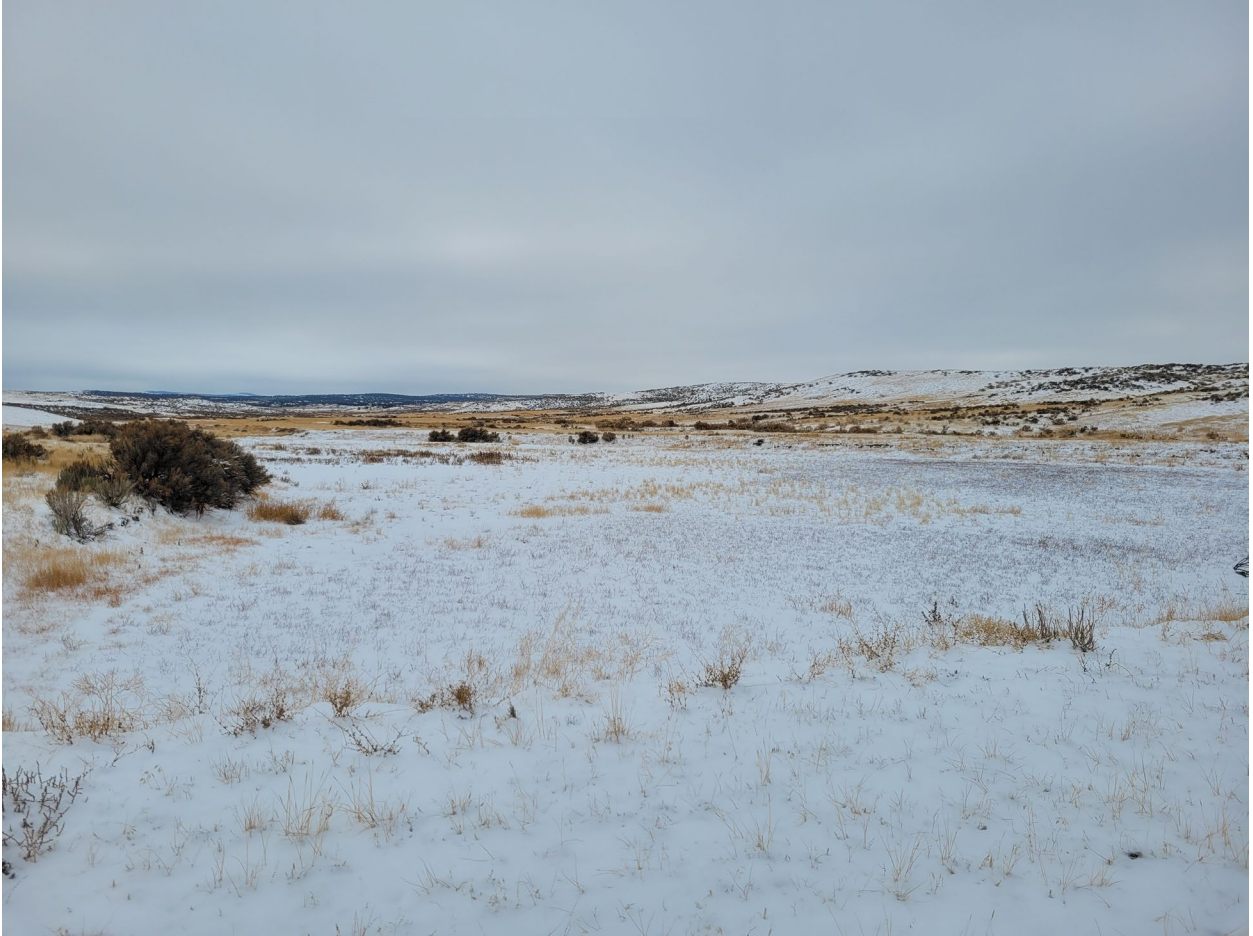
Figure 18. RP5 pond.

At the time of inspection RP5 pond was snow covered and appeared stable. No issues were noted. See Figure 18.

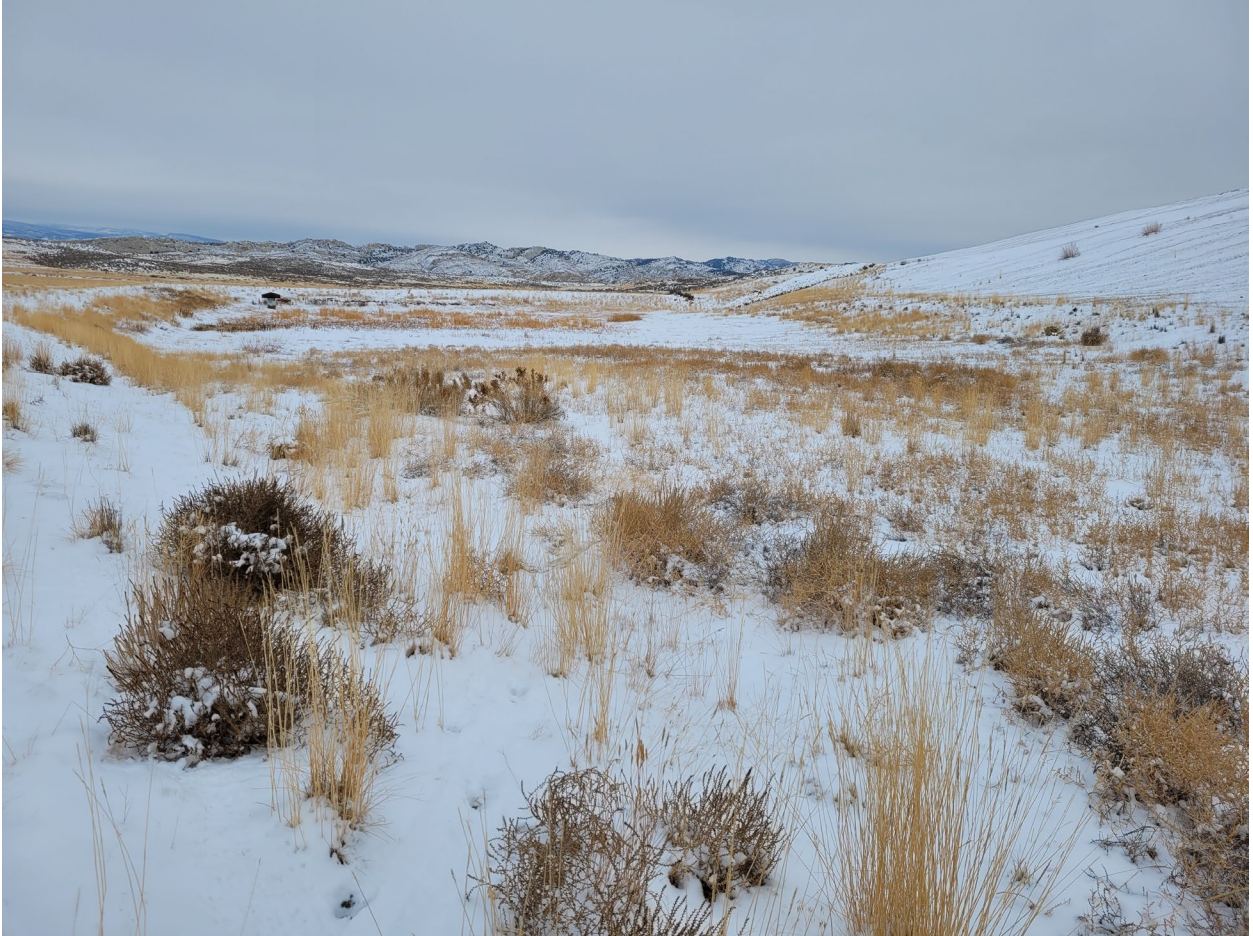
Figure 19. RP4 pond.

RP4 pond was snow covered and appeared stable. An animal burrow was noted on the embankment of the pond, northwestern portion. Mr. Blunt agreed to have the burrow filled. See Figure 19.
