**Denver Field Branch  
Mine Site Evaluation Narrative**

Permittee:	Blue Mountain Energy, Inc
Operator:	Blue Mountain Energy, Inc
Site:	Deserado Mine
Permit No:	C-1981-018
Date of Inspection:	November 28, 2023
Inspection Type:	Oversight complete
Weather:	Cloudy and cold with frozen, snowy ground conditions
Operator Representative:	Kurt Blunt
State Officials:	Todd Jesse, Travis Marshall, and Clayton Wein; Division of Reclamation, Mining and Safety
OSMRE Official:	Tom Medlin #562

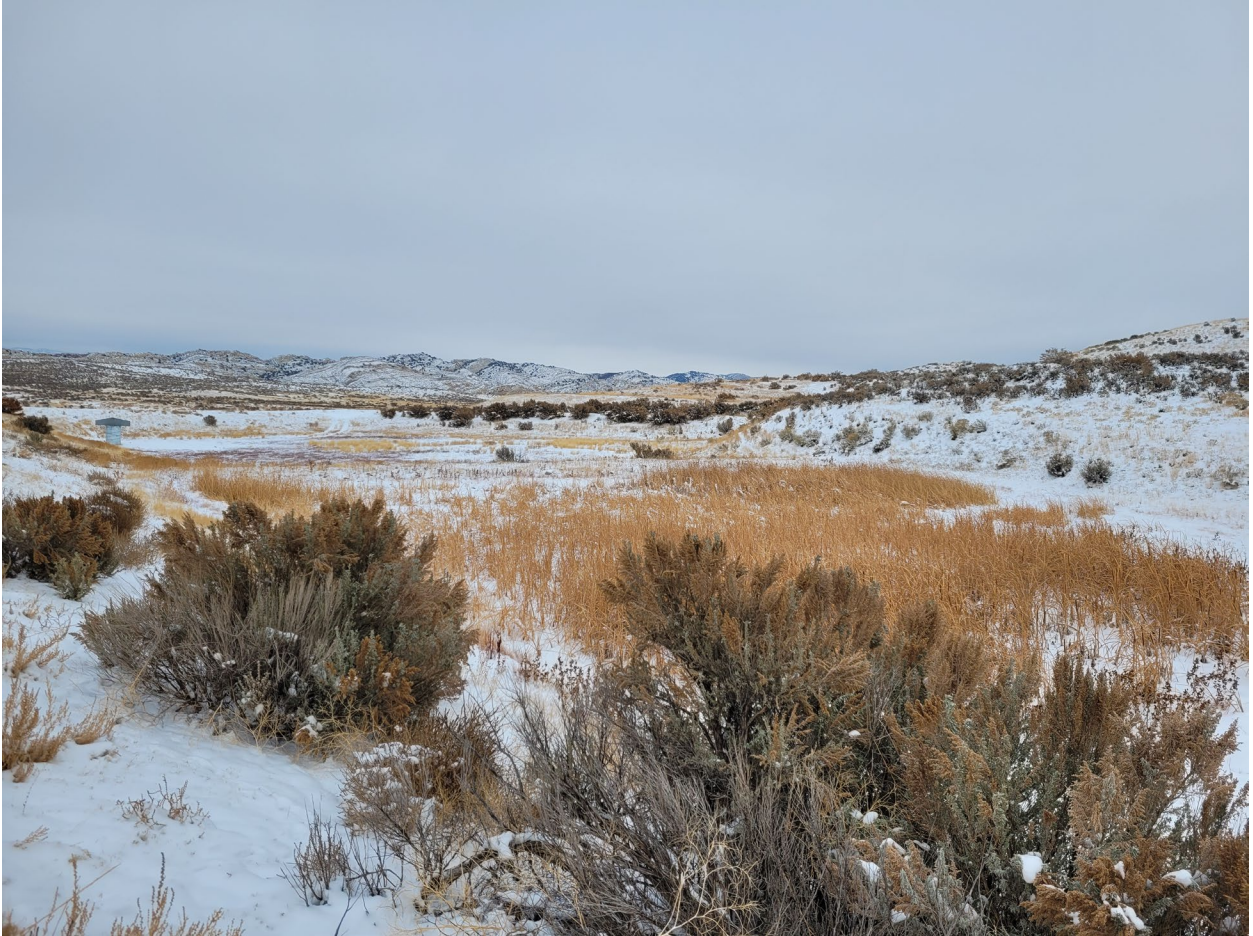
Figure 20. RP2/3 pond.

The RP2/3 pond system was inspected and found to be stable. Two of the three cells were snow covered; the third cell contained water. No discharge was occurring and no issues were identified. See Figure 20.

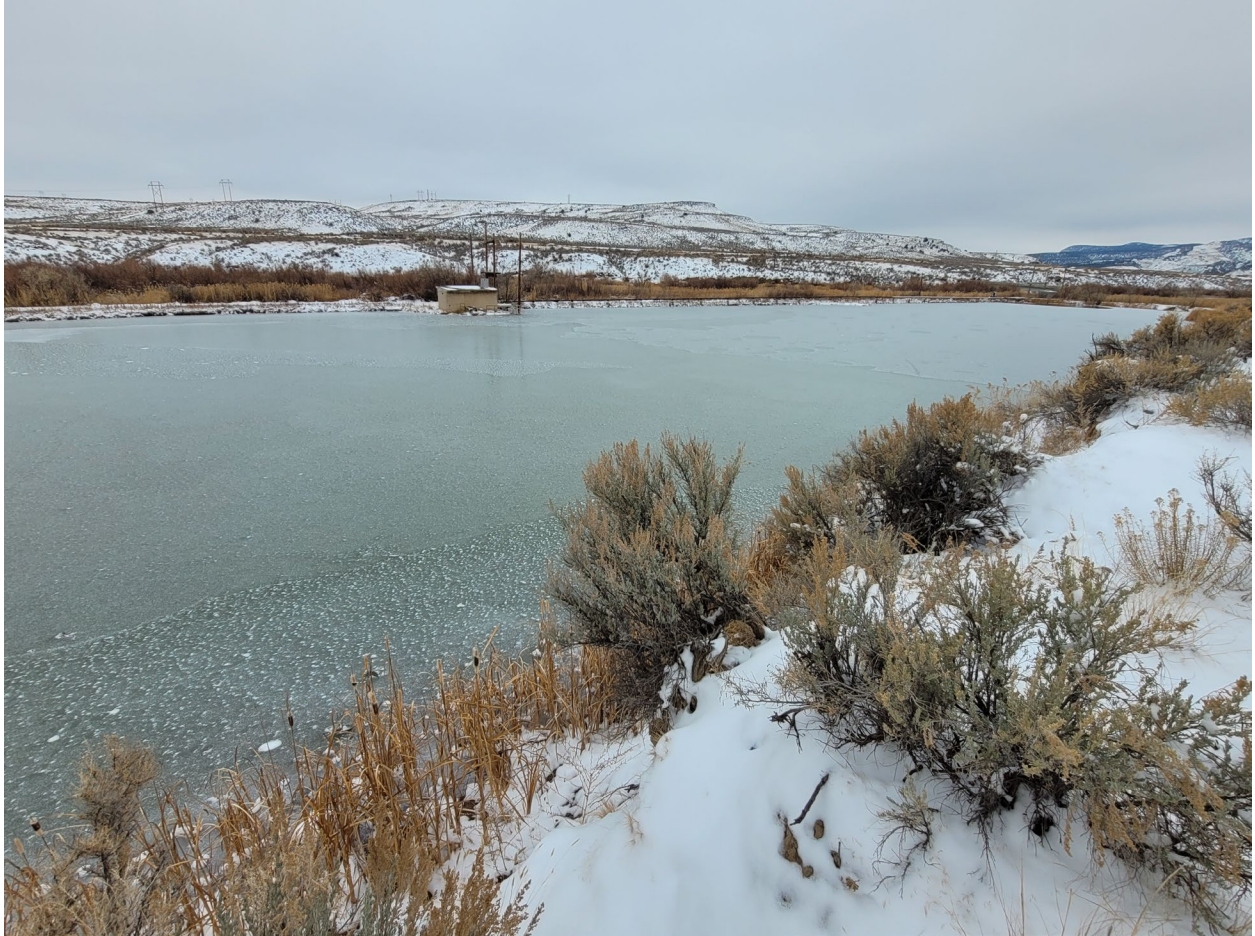
Figure 21. Raw water lagoon.

The raw water lagoon was inspected. The lagoon contained a large quantity of water covered by ice. No issues were noted. See Figure 21.

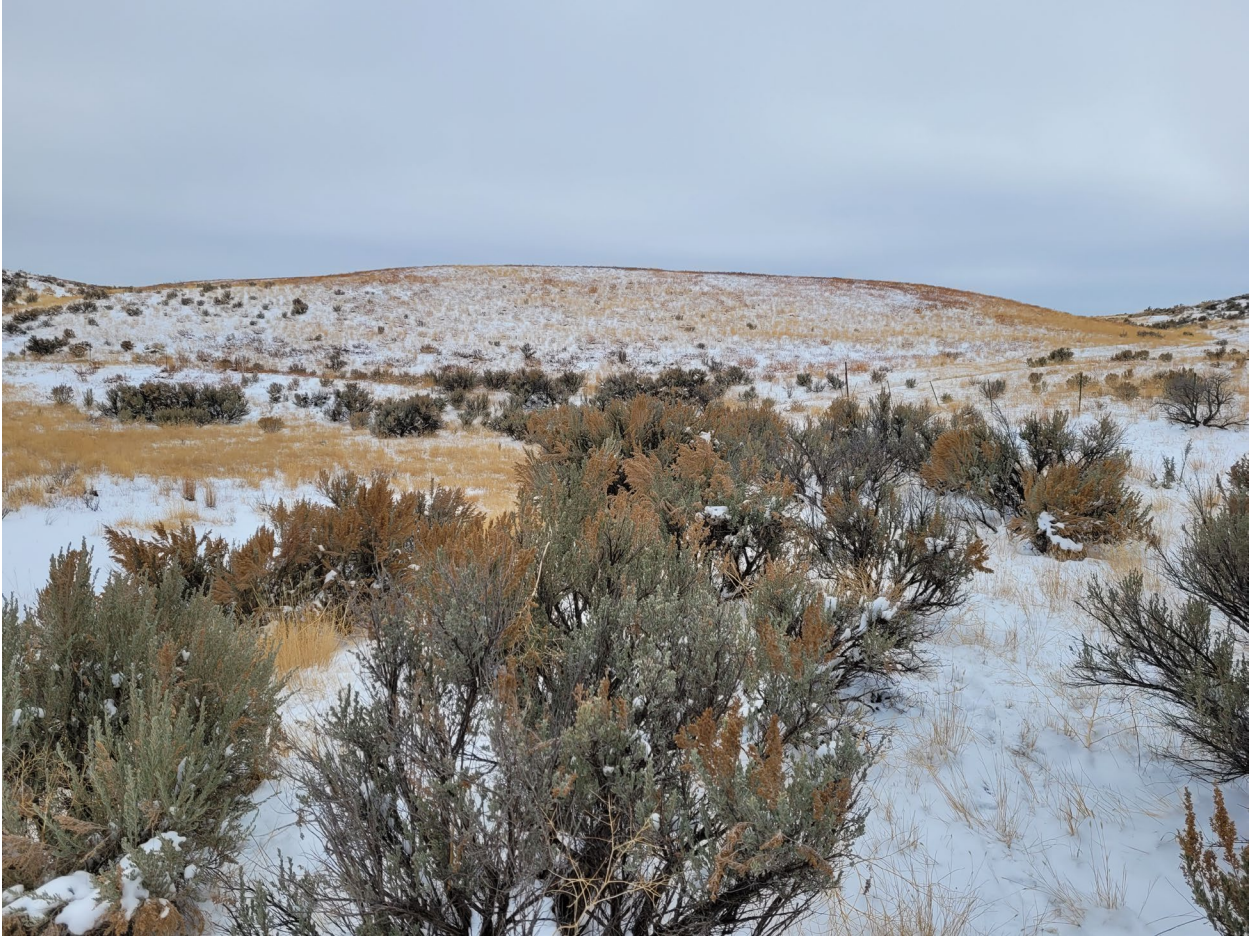
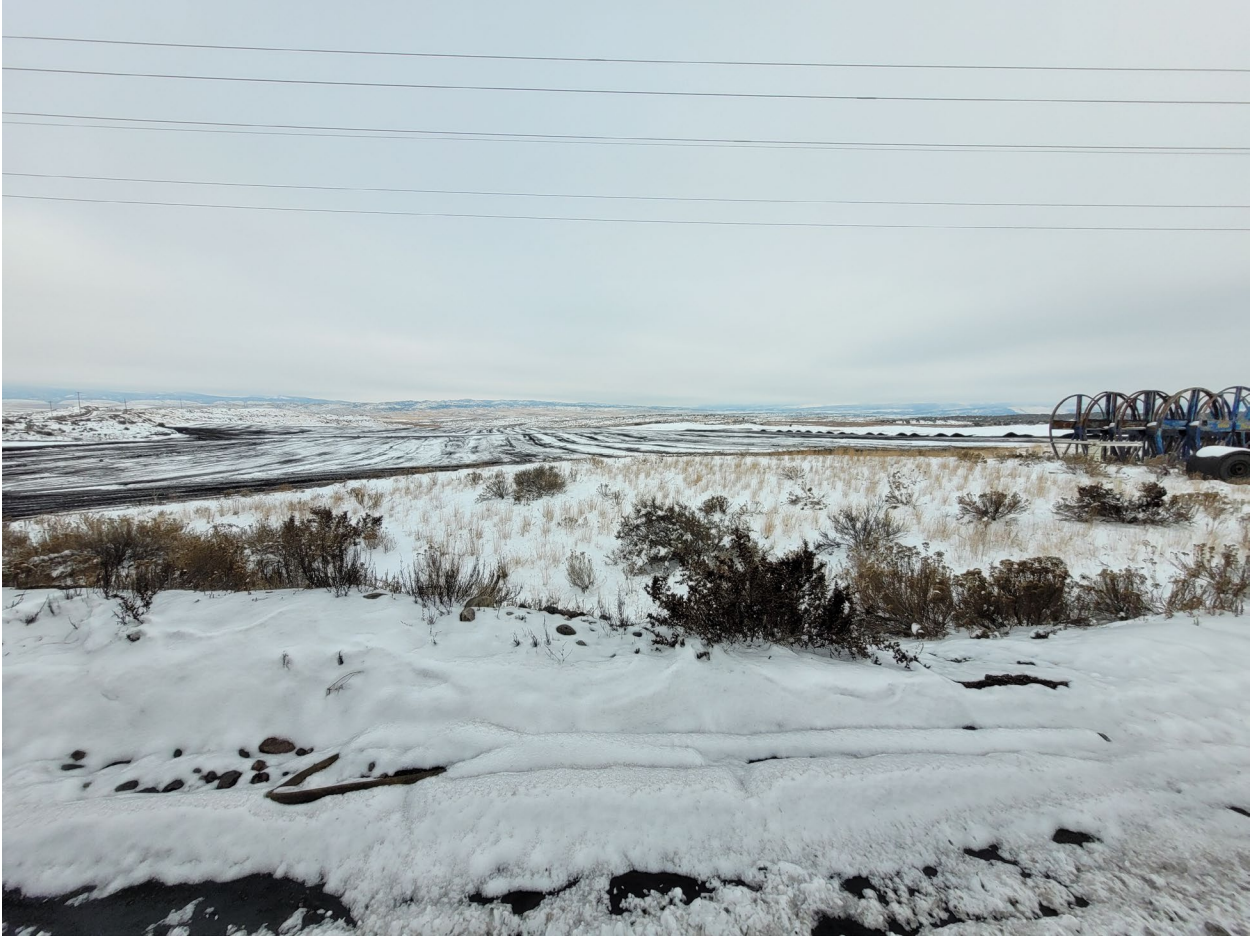
The active RP2/3/4, RP5A, and RPA refuse piles were inspected. The inactive RP1 refuse pile was also inspected. No major stability issues were noted. Minor rilling was observed on the embankments of the RP2/3/4 and RP5A piles. Mr. Blunt indicated the rills would be monitored and repaired as needed during regular spring maintenance for the minesite. See Figures 22 - 23.
